Recreational Swimming Water Quality in Northland

Summer 2015-2016

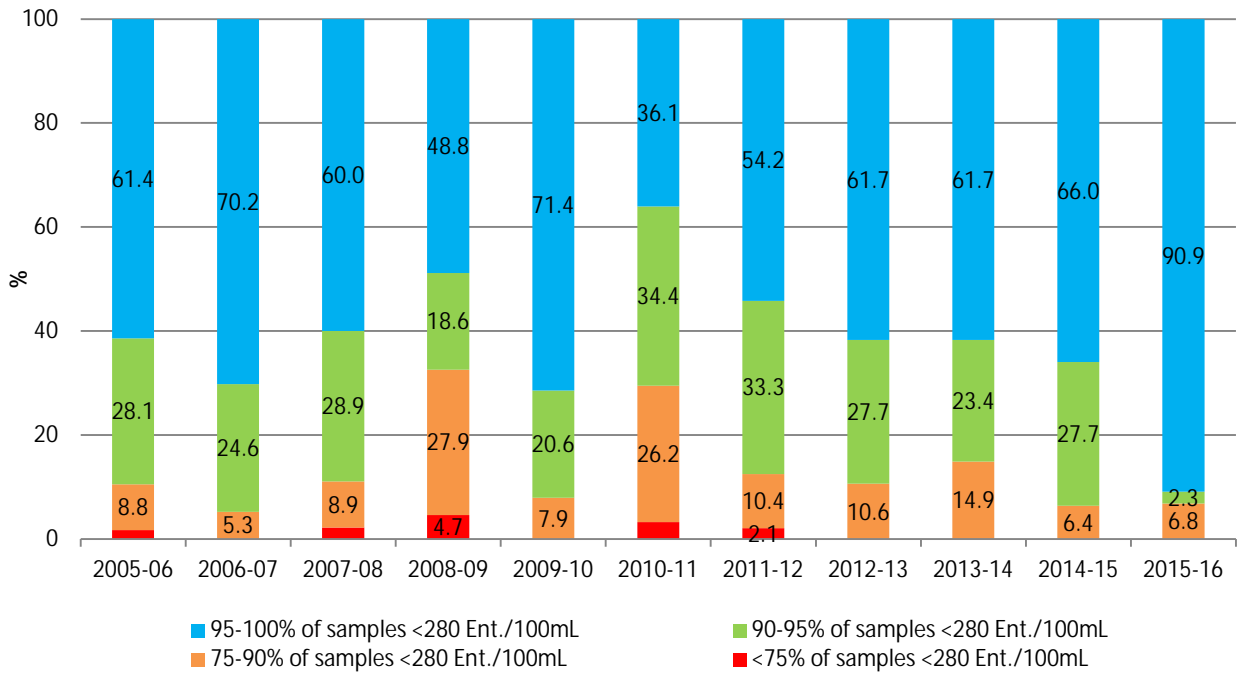
Figure 2: Yearly overall percentage of coastal sites with corresponding percentage of samples within each category from 2005 to 2016

Over 90 percent of sites monitored in 2015-16 had more than 95 percent of samples fall below the 'Action' level guidelines. No sites had less than 75 percent compliance with the guidelines. Overall, the results from faecal indicator bacteria testing in 2015-16 show a significant improvement compared to previous summer monitoring periods.

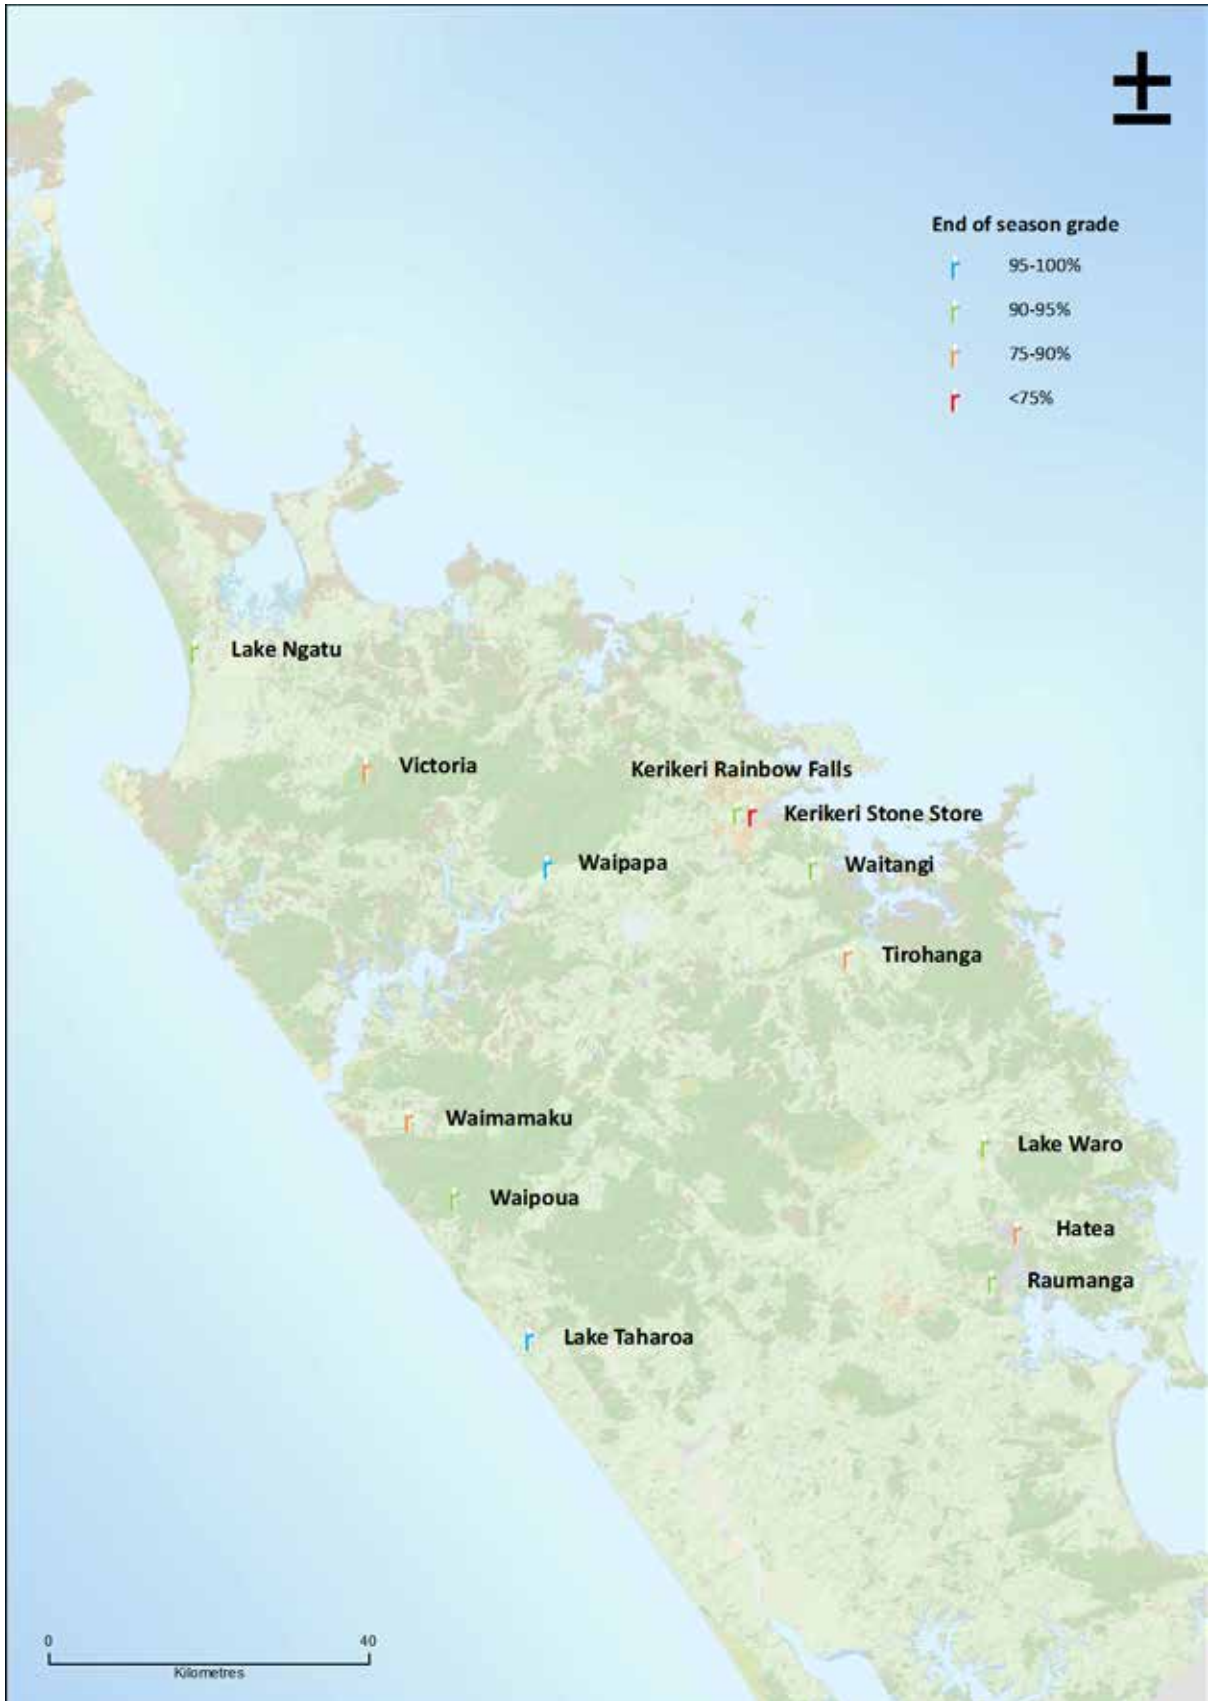
Figure 3: Freshwater end of season grading 2015-16

The map above summarises the end of season grading for samples taken from each of the 13 freshwater sites monitored in Northland during the 2015-16 sampling season (23 November 2015 to

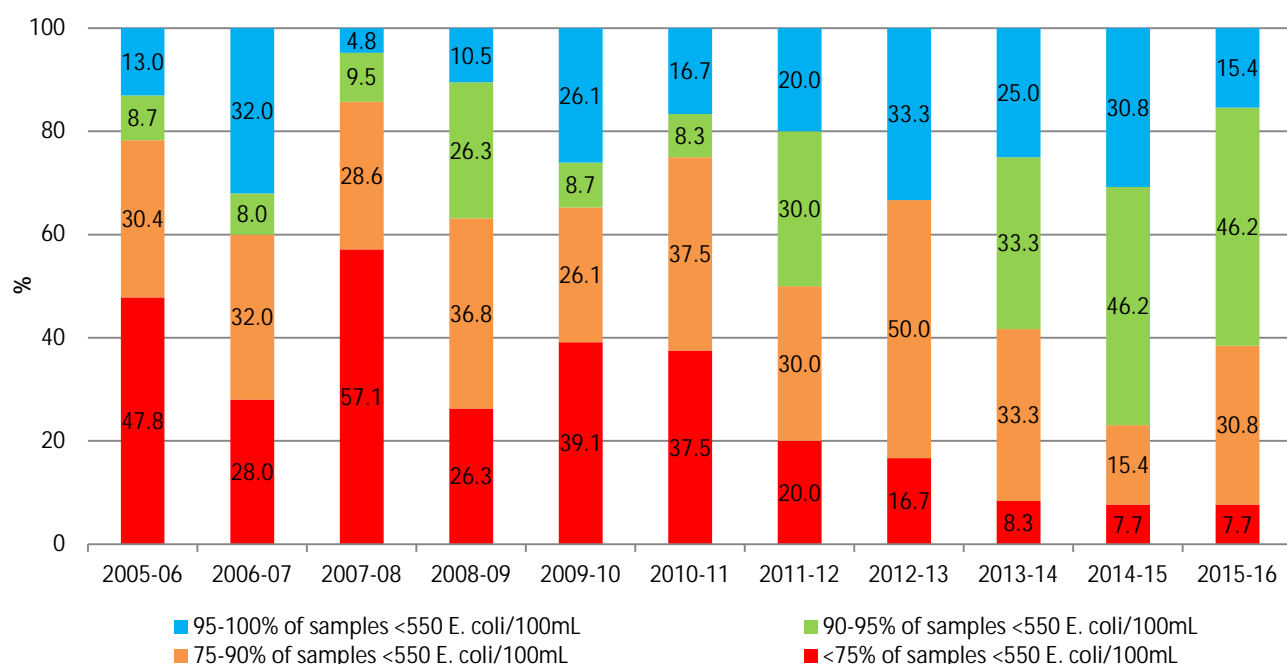
Figure 4: Yearly overall percentage of freshwater sites with corresponding percentage of samples within each category from 2005 to 2016

Over 60 percent of sites in 2015-16 had more than 90 percent of samples fall below 'Action' faecal indicator bacteria levels. This is lower in comparison to 2014-15 which recorded 77 percent of sites with more than 90 percent compliance with the guidelines. The number of sites with less than 75 percent of samples below 'Action' level in 2015-16 was similar to the 2014-15 monitoring period. Overall, the last three summer monitoring periods have recorded the most comparable results for each compliance category.
