## 35 Moureeses Bay

## NORTHLAND REGIONAL COUNCIL

Coastal Erosion Hazard Assessment

Moureeses

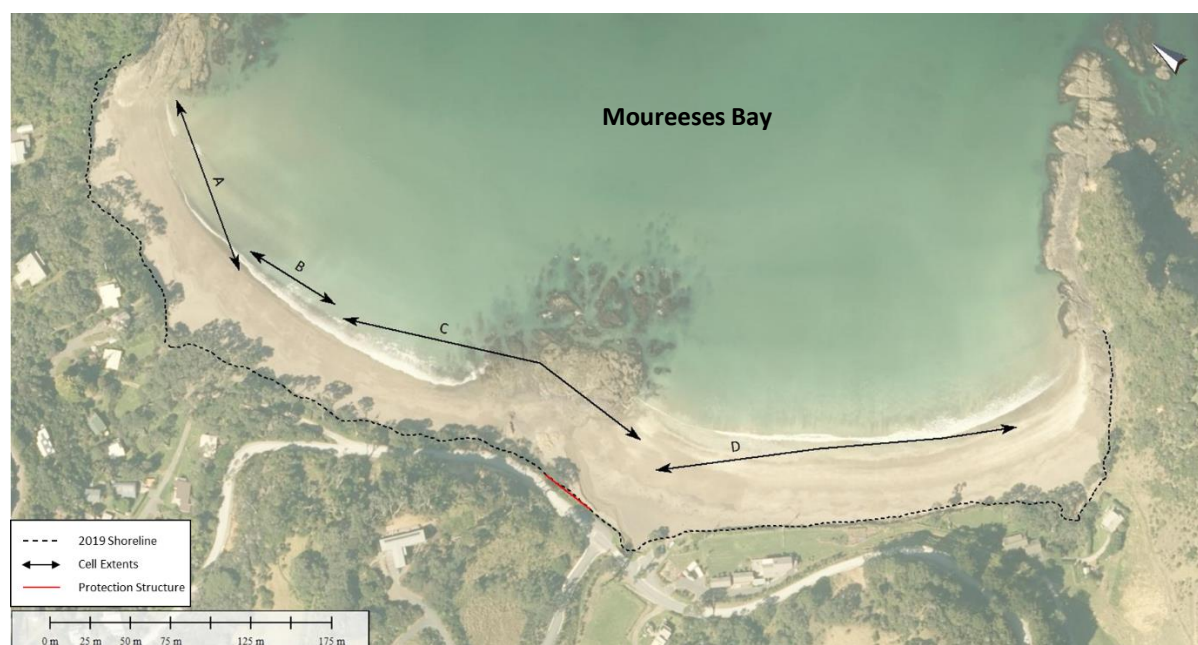
Figure 35.1: Map showing 2019 shoreline position and cell extents with background aerial imagery from 2014.

Moureeses Bay is an east facing beach bounded by headlands and reefs located 4 km north of Whananaki. Figure 35.1 shows the site and its division into four coastal cells for the purpose of assessing coastal erosion hazards. Site photos are presented in Figure 35.2 to show the geomorphic features of these cells.

The site is split into four cells based on discrete spatial differences in geomorphology, resulting in two cliff sites and two consolidated coastal terrace cells. Of the cliff sites, Cell A is located at the north end and is characterised by a modern dynamic beach face that is backed by a vegetated cliff of Waipapa greywacke geology with an average height of 23 m (Figure 7.1A). The other cliff cell (Cell C) is located at the central headland and has the same geology, but a graded road has levelled the cliff to a mean height of 8 m. Both cliff cells have the same stable angle and cliff sea level rise response factor as assessed by an engineering geologist.

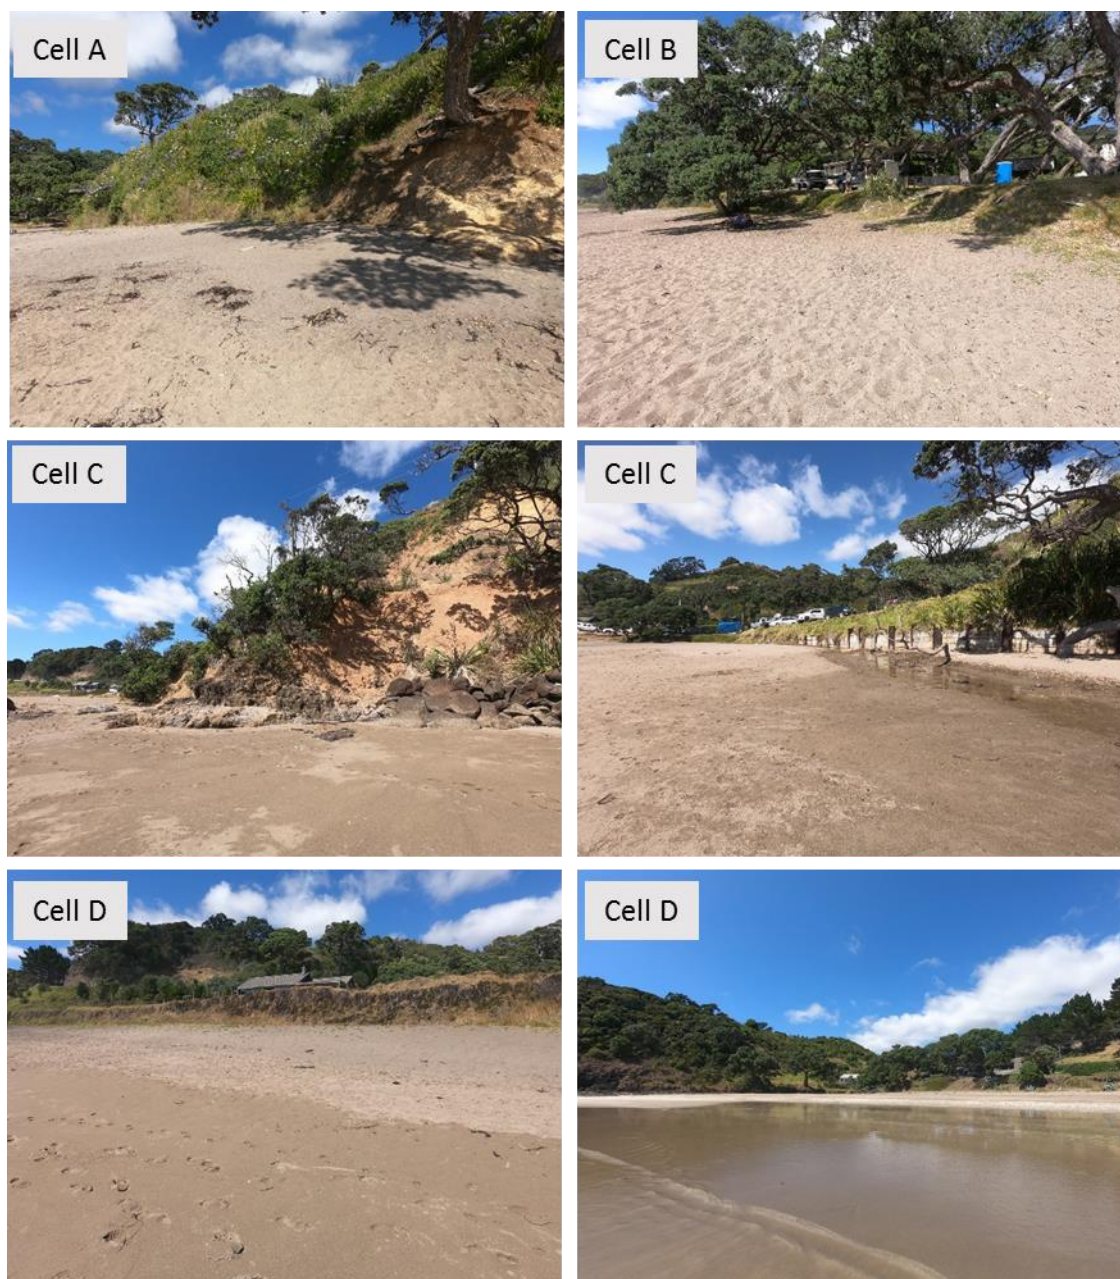
Figure 35.2: Photos from Moureeses Bay site visit on 21/01/2020.

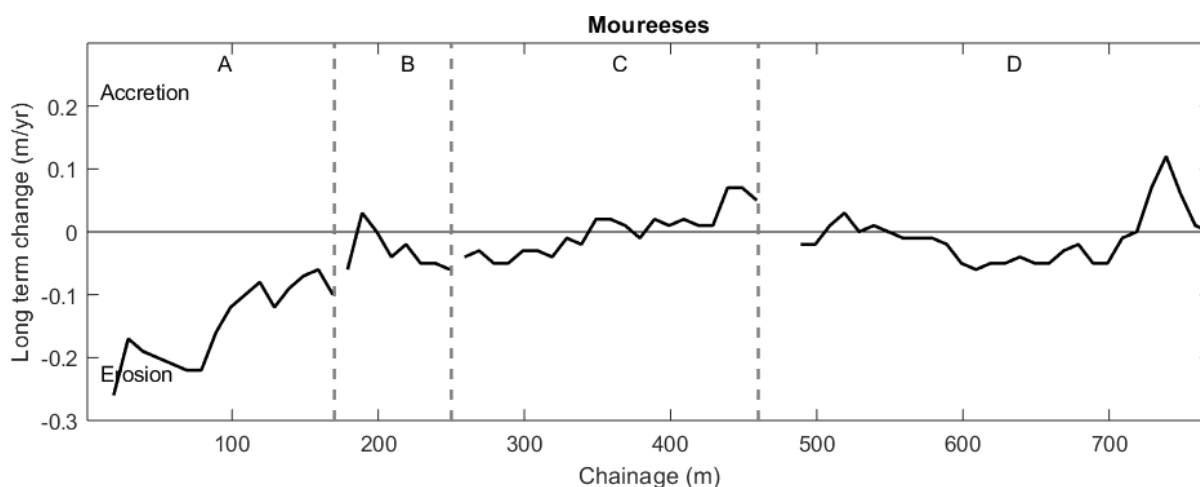
Figure 35.3: Rate of long-term shoreline change along the site showing each cell.

Historic shoreline change at Moureeses Bay is spatially variable, with the highest rate of erosion at the northern cliff section (Cell A) where the mean long-term rate is -0.15 m/yr. The headland cliff at the centre of the site (Cell C) was more stable with a mean long-term rate of -0.02 m/yr, which is potentially influenced by construction and maintenance of the road. The southern and northern coastal terrace sites were historically stable, with a mean long-term rate of -0.03 and -0.02 m/yr respectively. Adopted long-term rates did not consider positive values because erosion on consolidated shorelines is not balanced by accretion. Positive rates may result from landslides and slips.

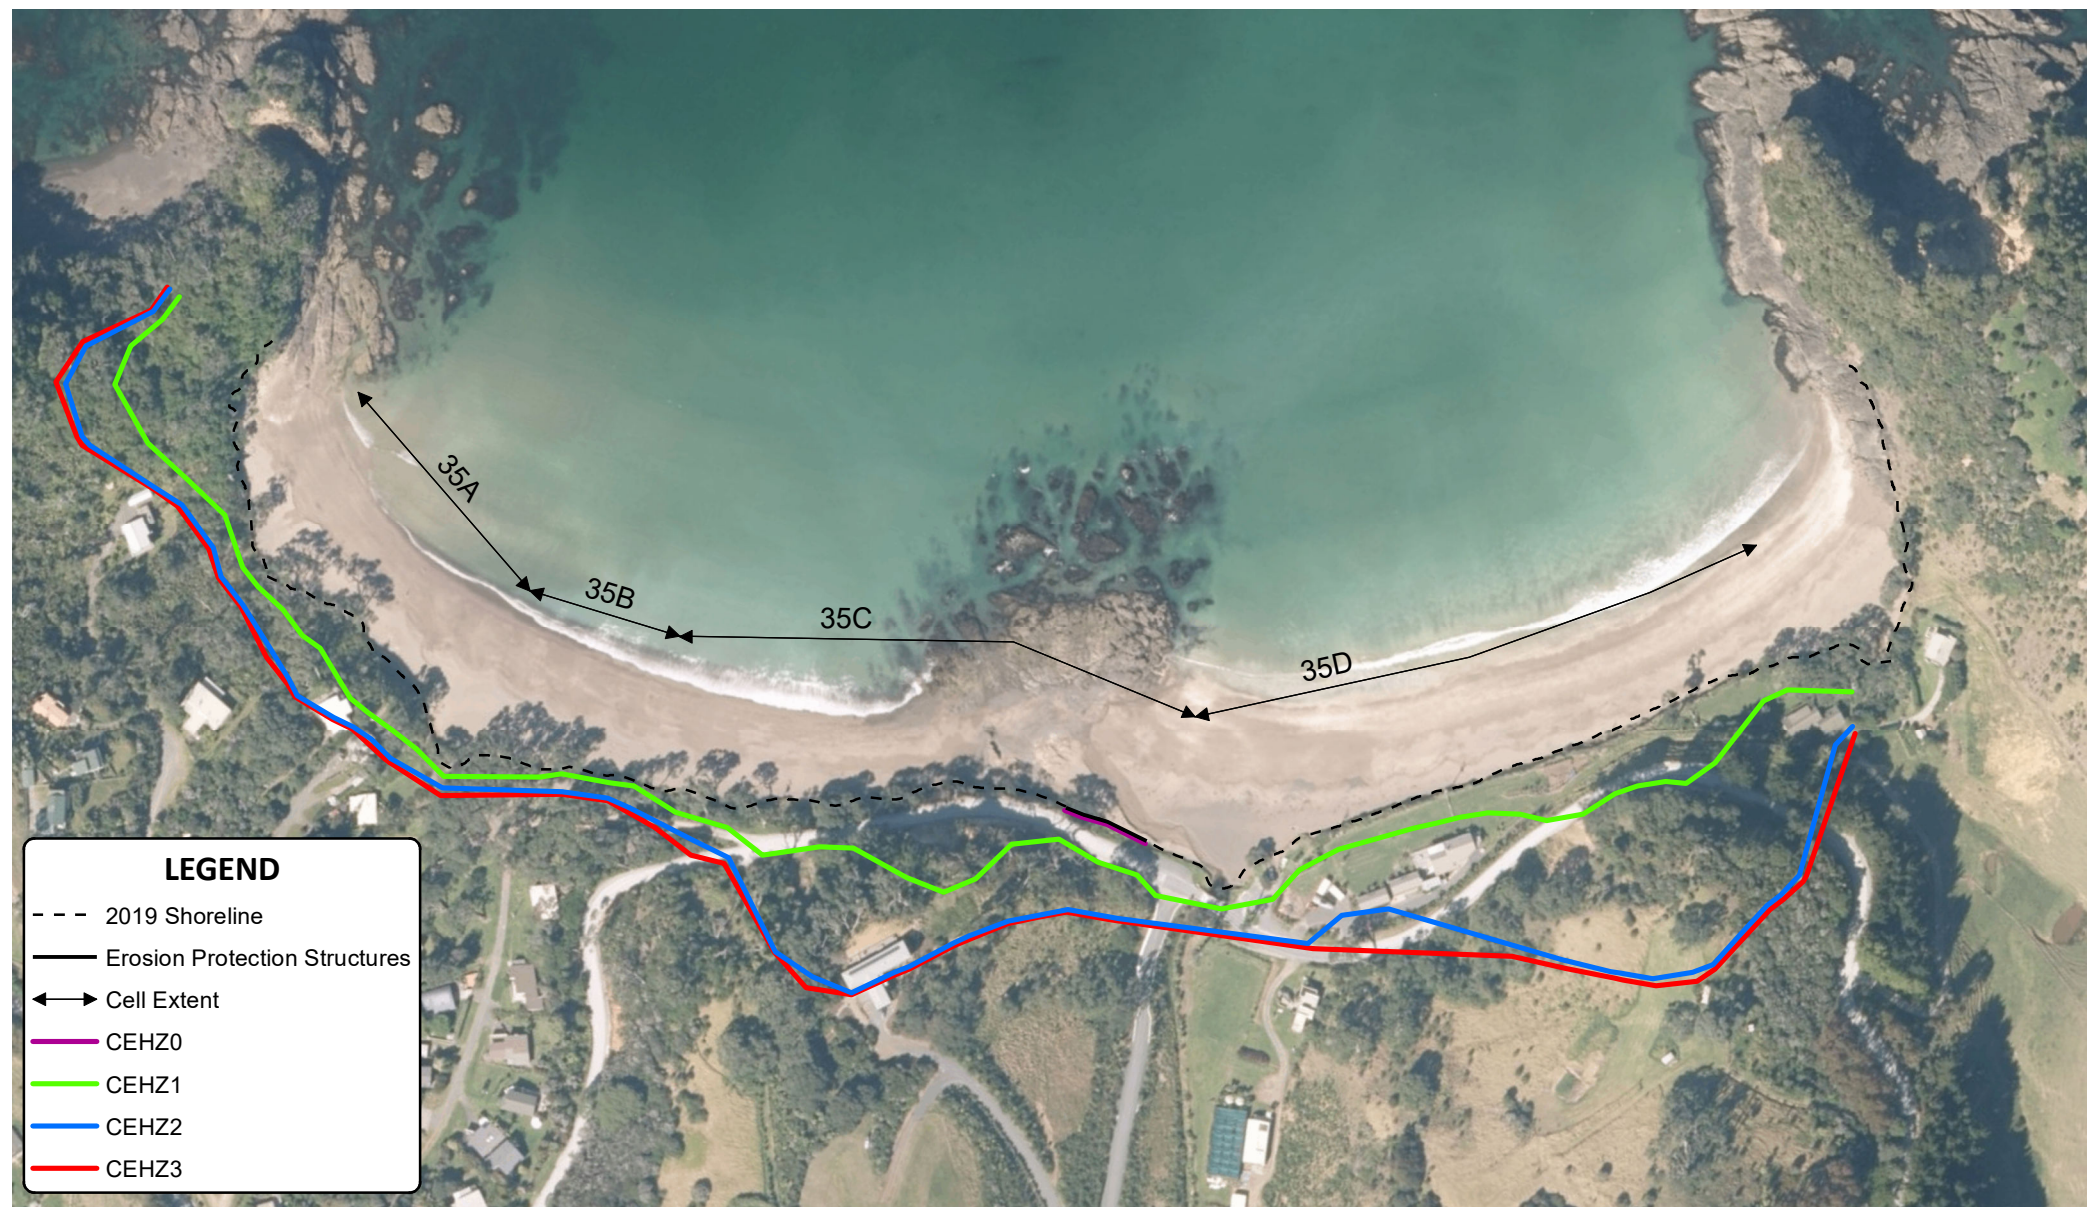
Figure 35-8

Notes: Dashed CEHZ indicates greater uncertainty around stream mouths and backshore topography.  
Northland 0.4m Rural Aerial Photos (2014-2016).

Histograms of individual components and resultant CEHZ distances computed using a Monte Carlo technique are shown in Figure 35.4 to Figure 35.7. Future shoreline (cliff toe) distances are presented within Table 35.3 to Table 35.5 and mapped in Figure 35.8.

The total coastal erosion hazard zones for Moureeses were identified using the cliff projection method, where LiDAR derived profiles were used to project the stable angle and future toe at transect locations spaced in 10 m intervals for the length of each cliff cell. A summary of the resulting total coastal erosion hazard zone is presented in Table 35.6.

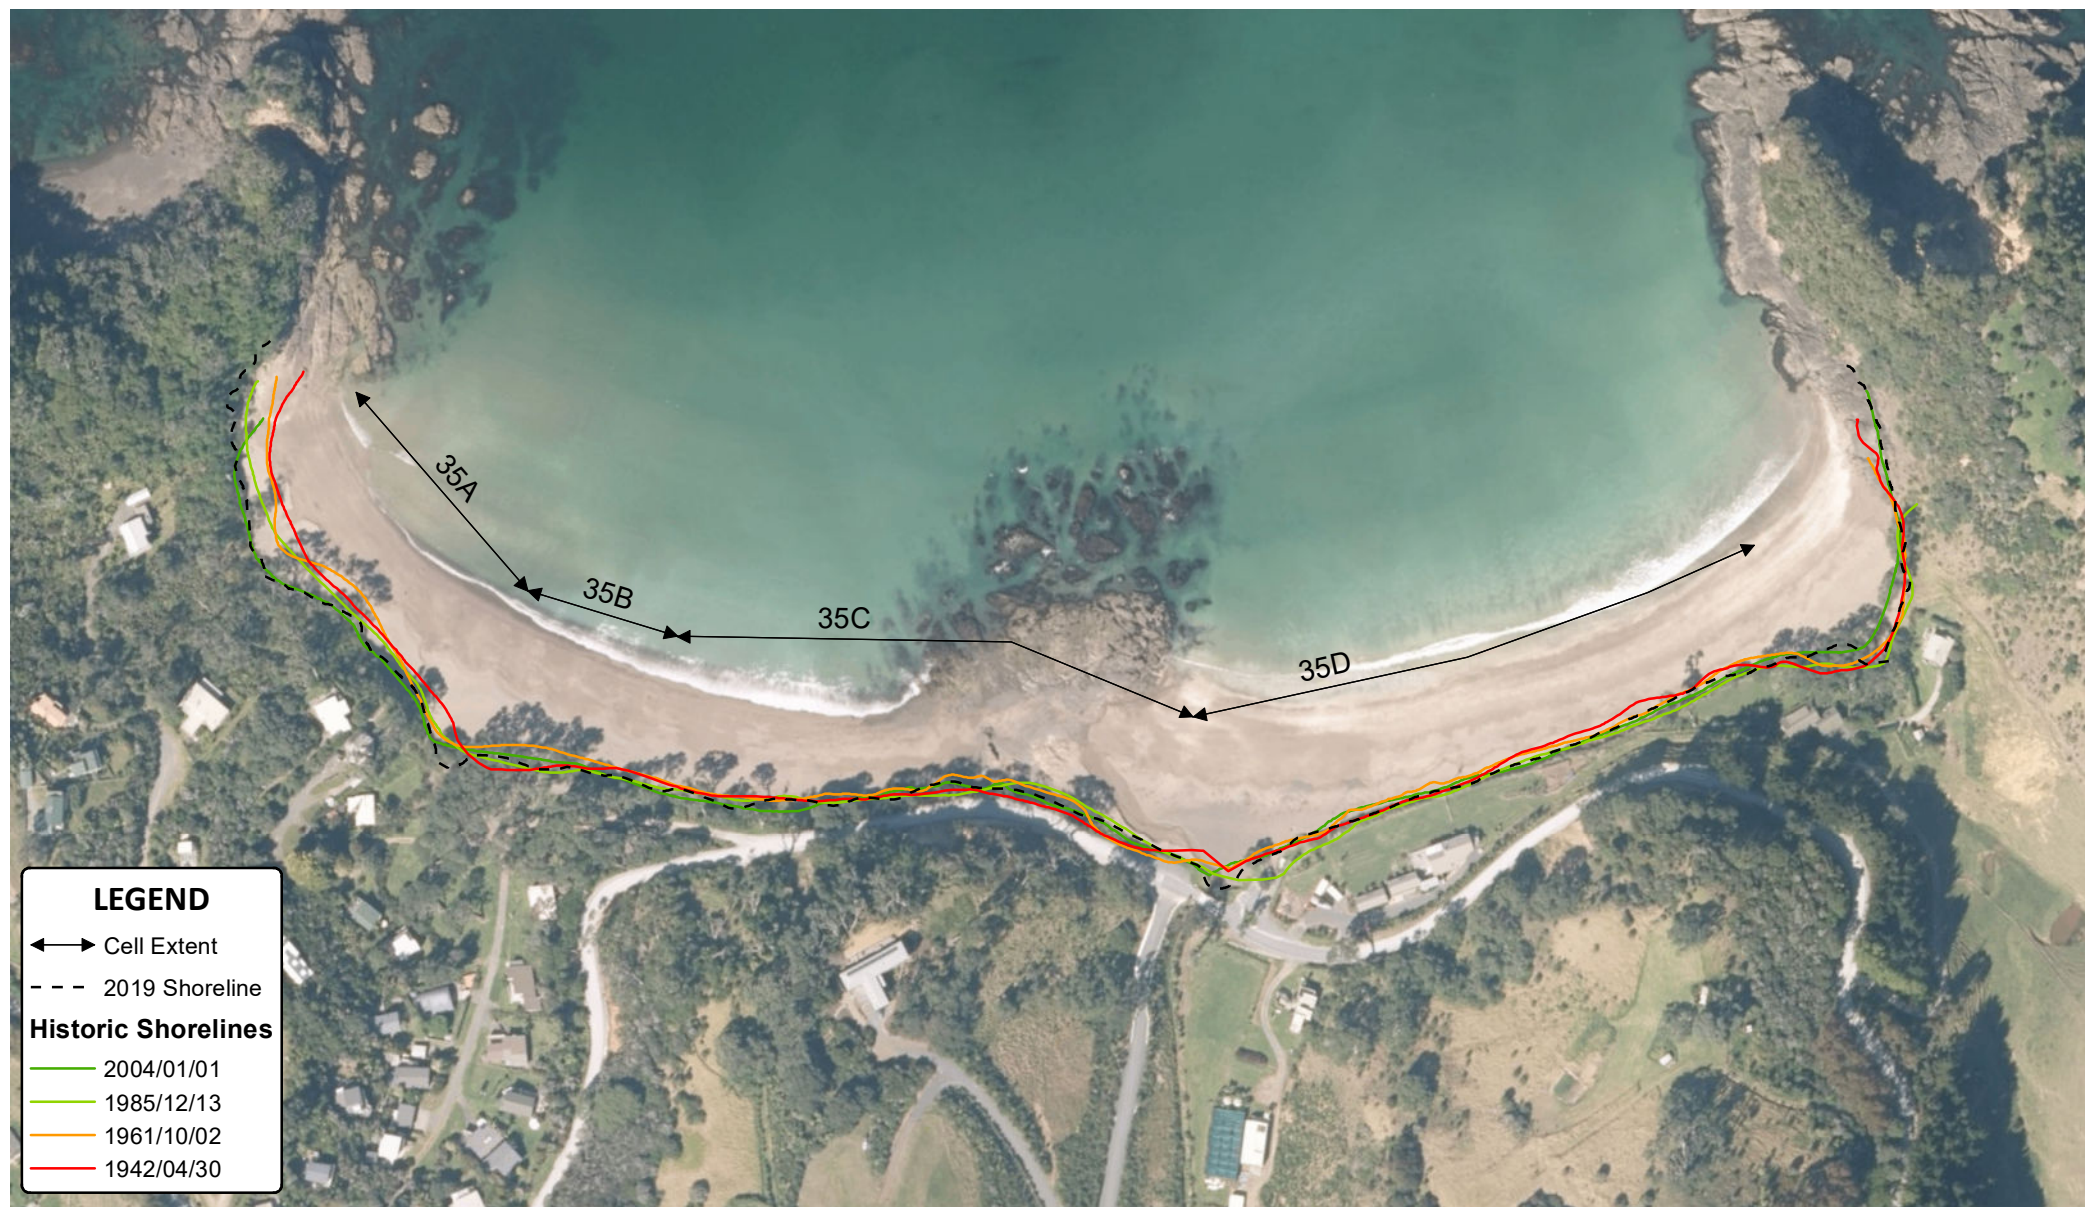
Figure 35-9

Historic Shorelines

Figure 35.9 shows the available historic shorelines for Moureeses Bay.
