29 Tokerau Beach

Coastal Erosion Hazard Assessment

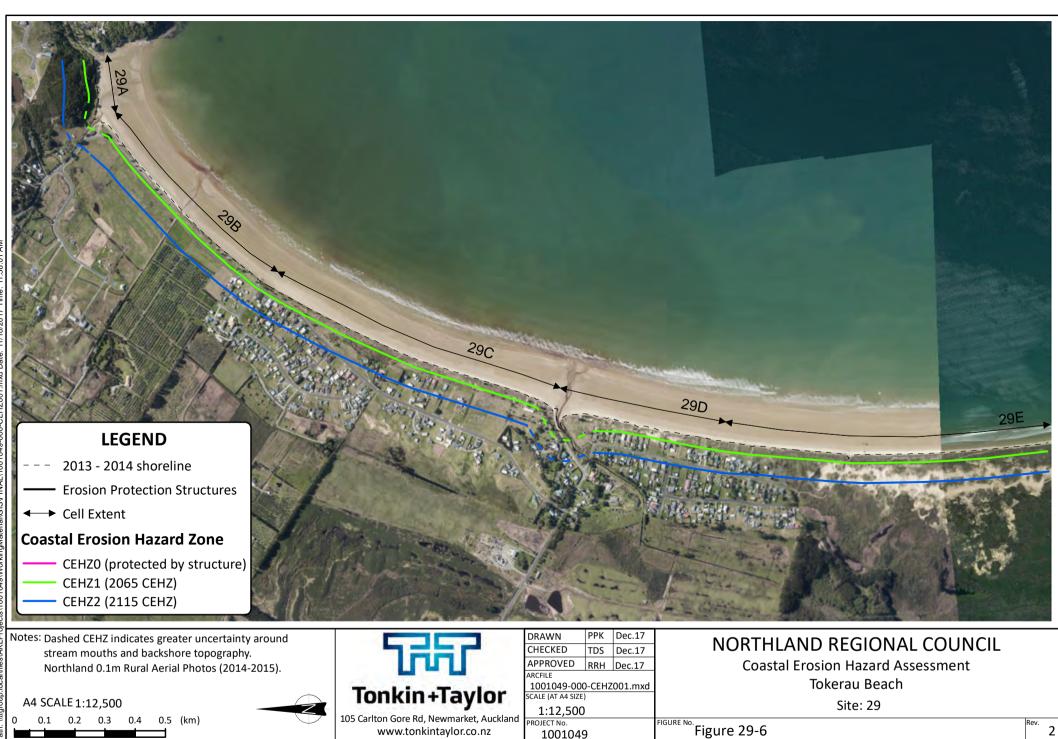
Coastal Erosion Hazard Zone widths are presented within Table 29-2 and Figure 29-6. CEHZ1 values range from 26 to 33 m and CEHZ2 values range from 92 to 105 m, primarily due to the flat offshore slope and SLR-induced recession. CEHZ's have been mapped in agreement with the calculated values.
