Te Hiku

Ngatuwhete (Aupouri), NRC Lake No. 23

Summary	Ngatuwhete
Surveyed:	2005 and 2019
Overall ranking:	Moderate: Shallow dammed water body with limited vegetation, possibly good wader habitat.
Threats:	Little threat from invasive species, nutrient enriched.
Management recommendations:	No monitoring.

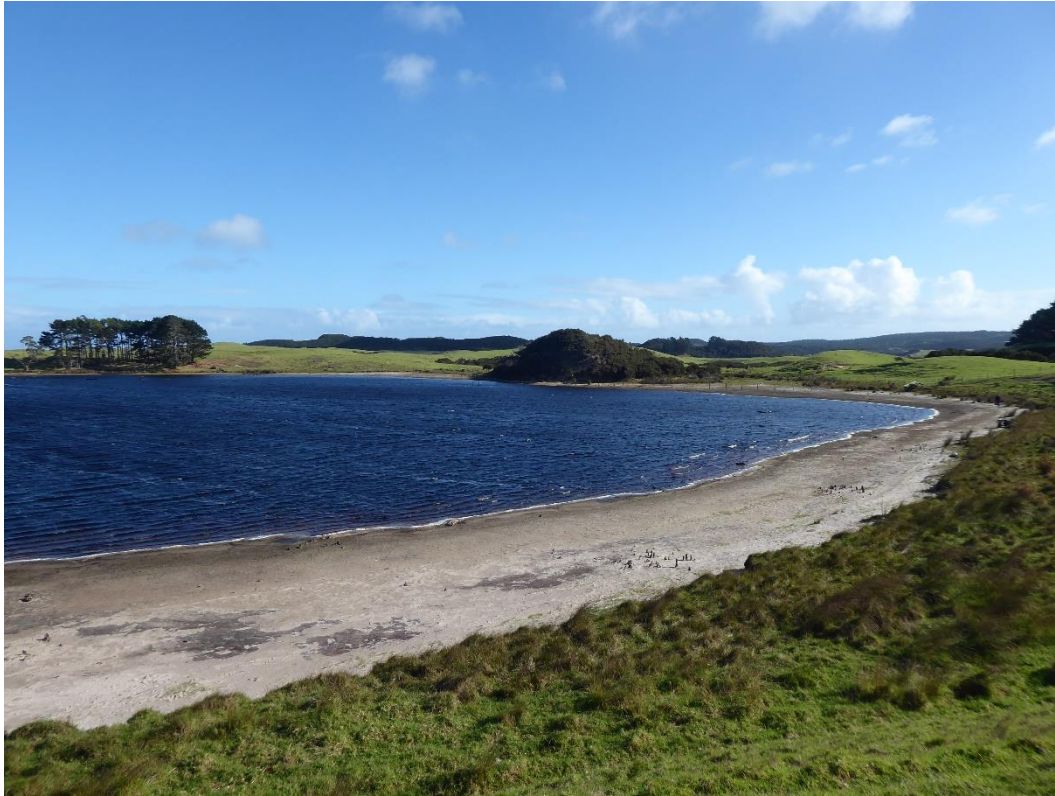
Ngatuwhete (2019), with a mostly pasture catchment, note the exposed beach providing habitat for native annual species.

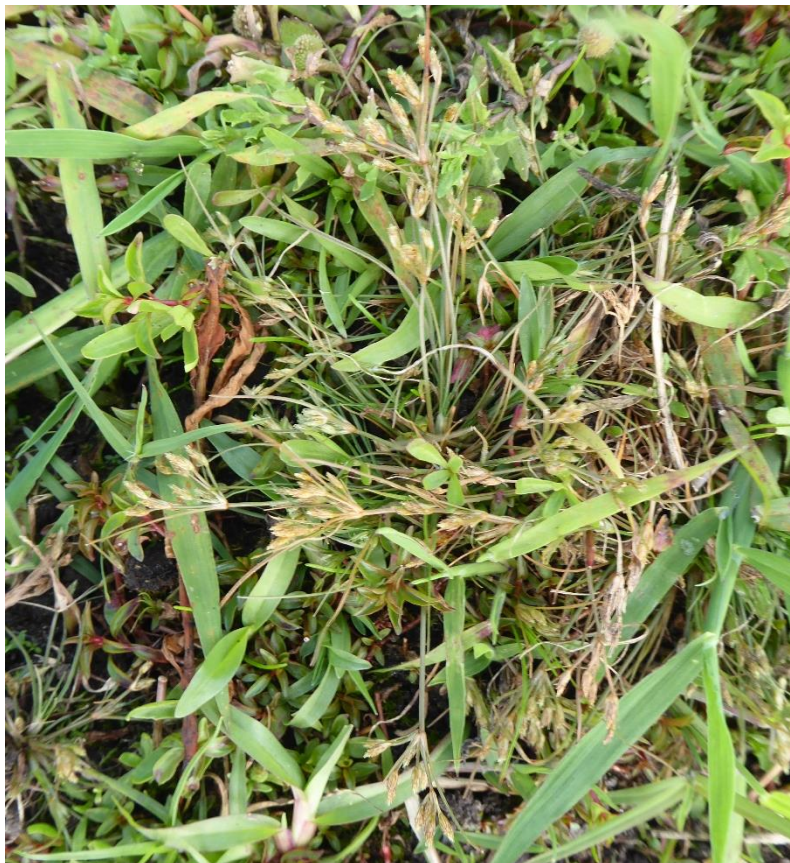
The naturally uncommon *Fimbristylis velata* on the margin of Ngatuwhete (2019)

Fimbristylis velata is assessed as At Risk – Naturally Uncommon, restricted to similar habitats in the northern North Island.

A 2019 Lake Ecological Value rating of 7 (Moderate) was scored due to the narrow fringe of emergent species and lack of submerged vegetation. This had increased from 5 in 2005, as a result of a greater species richness and the presence of the At-Risk *Fimbristylis velata*.

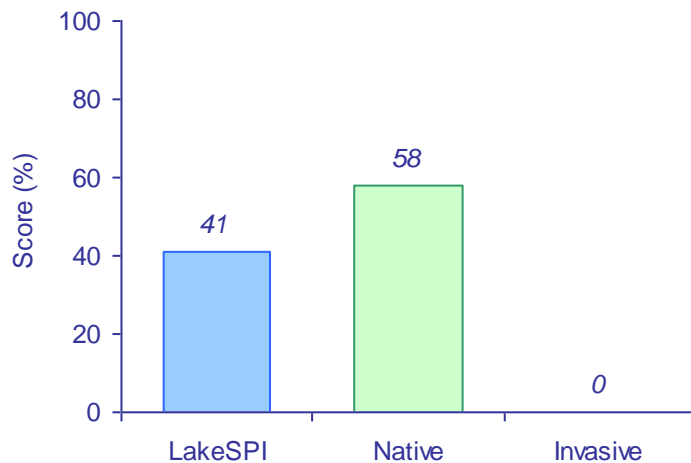
LakeSPI Index as % of potential score, Native Condition Index, and Invasive Impact Index (from left to right).

A moderately low LakeSPI score of 41% reflects the almost de-vegetated lakebed, although there were no invasive exotic species present (*L. palustris* is not ranked as invasive by LakeSPI). Profiles were limited so this LakeSPI assessment should be considered provisional. Based on the 2019 survey, the lake appeared to have no submerged vegetation.
