Kaihu right bank from Waihue Road to Taita Stream confluence, and Taita Stream left bank from confluence to SH12 (survey RB5)

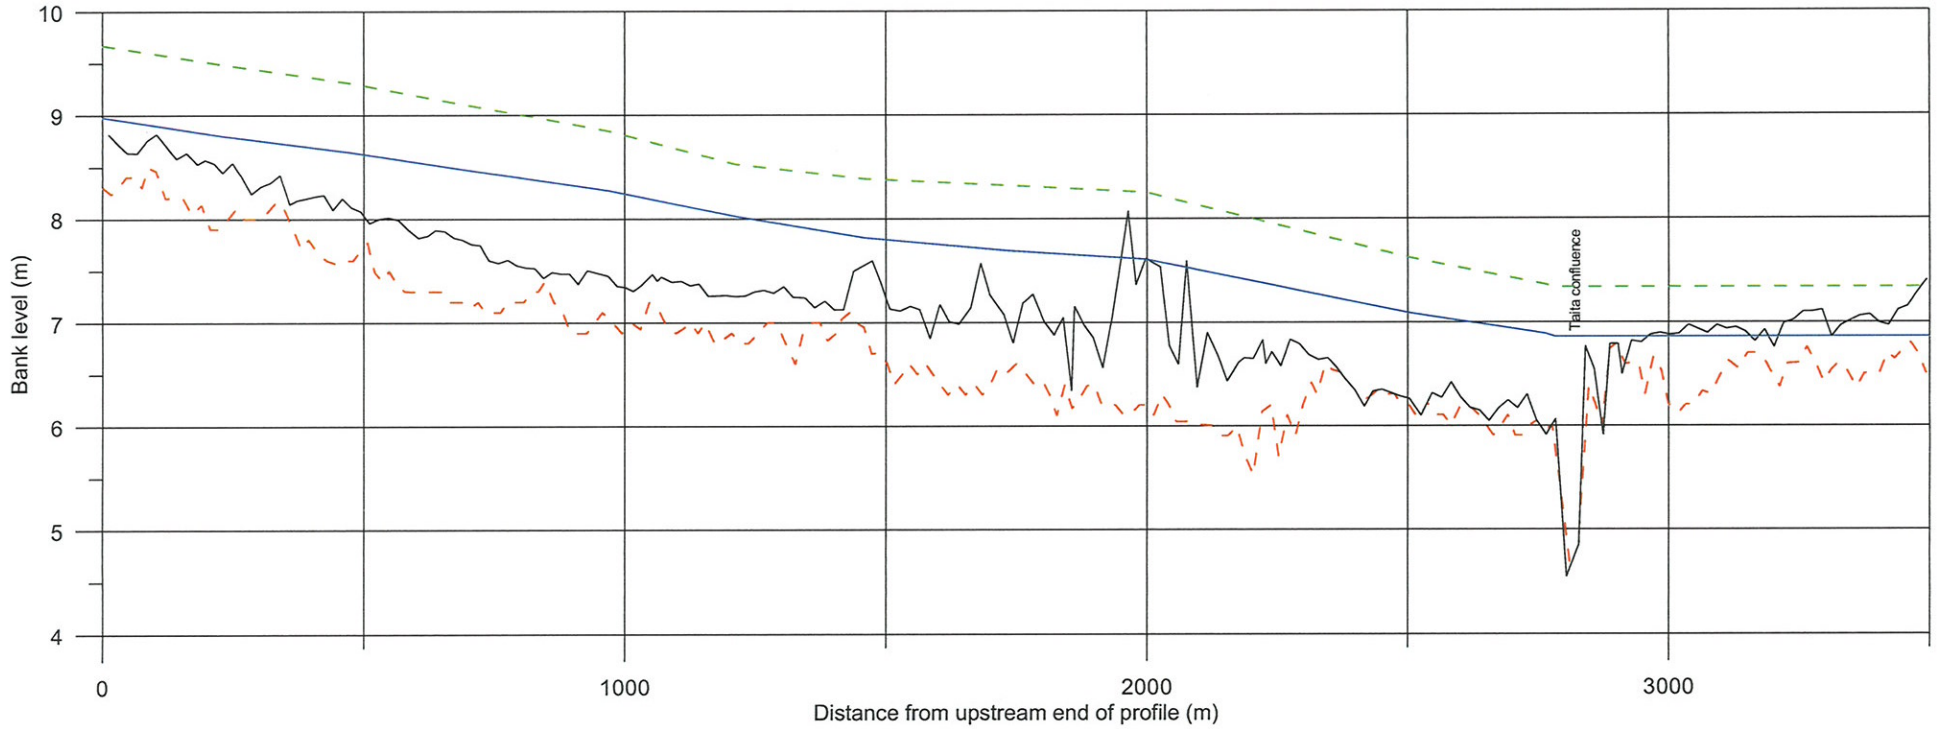
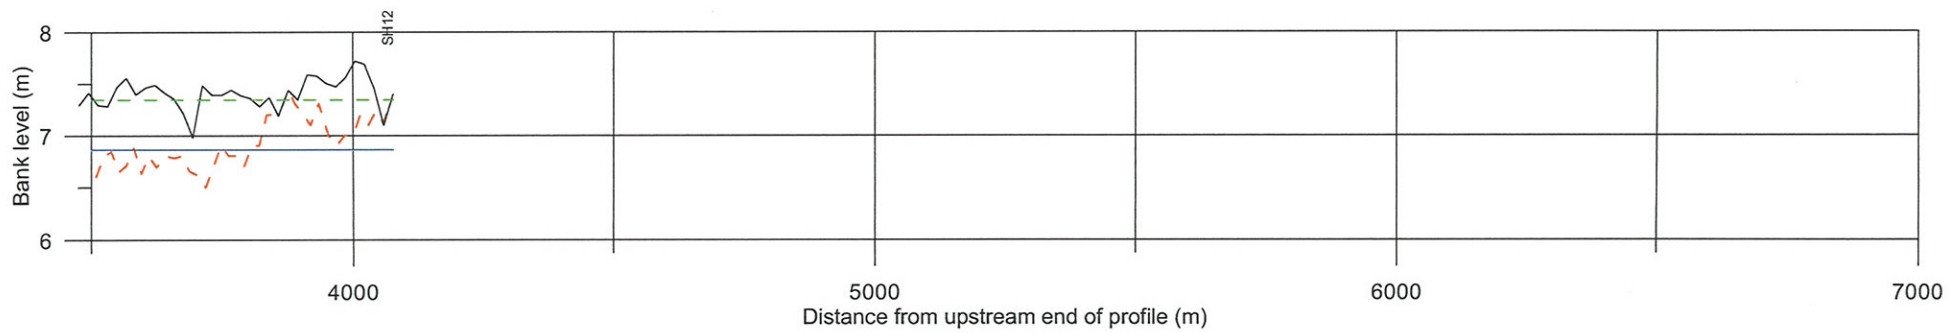
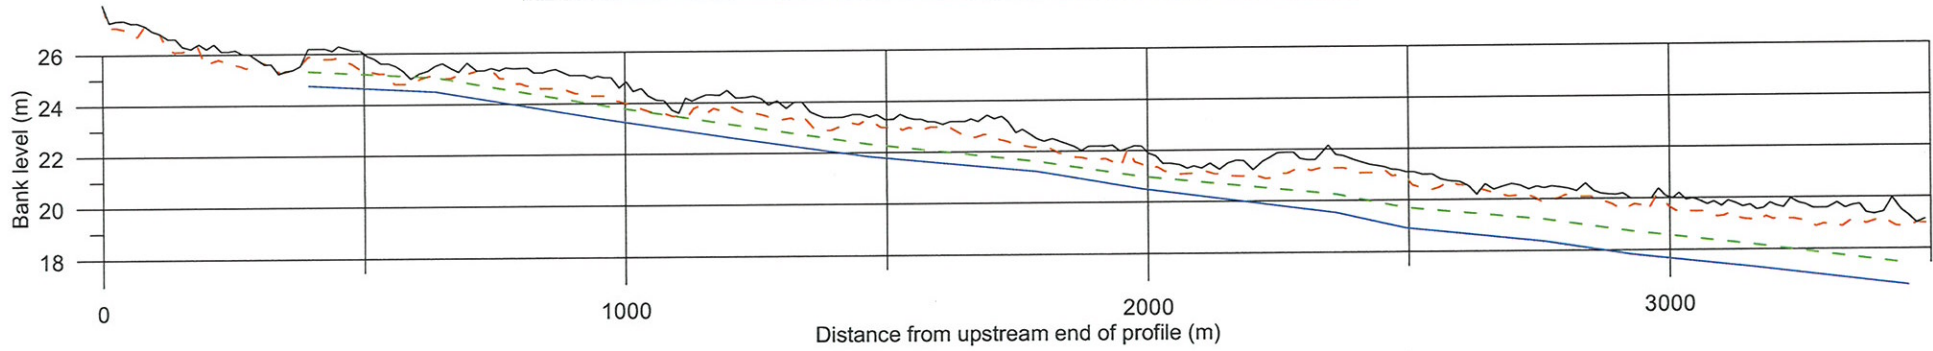
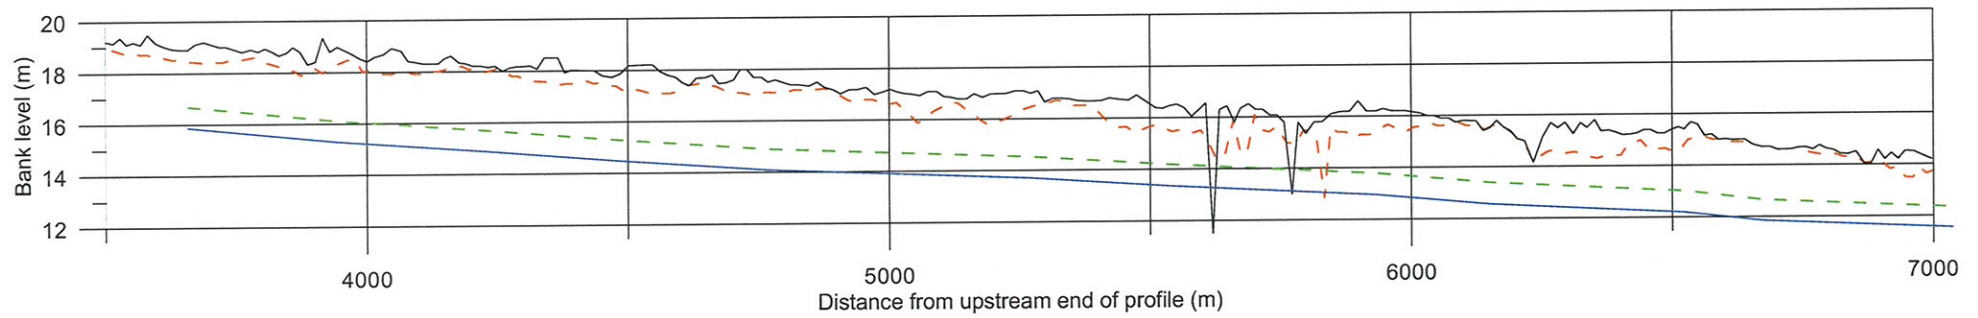
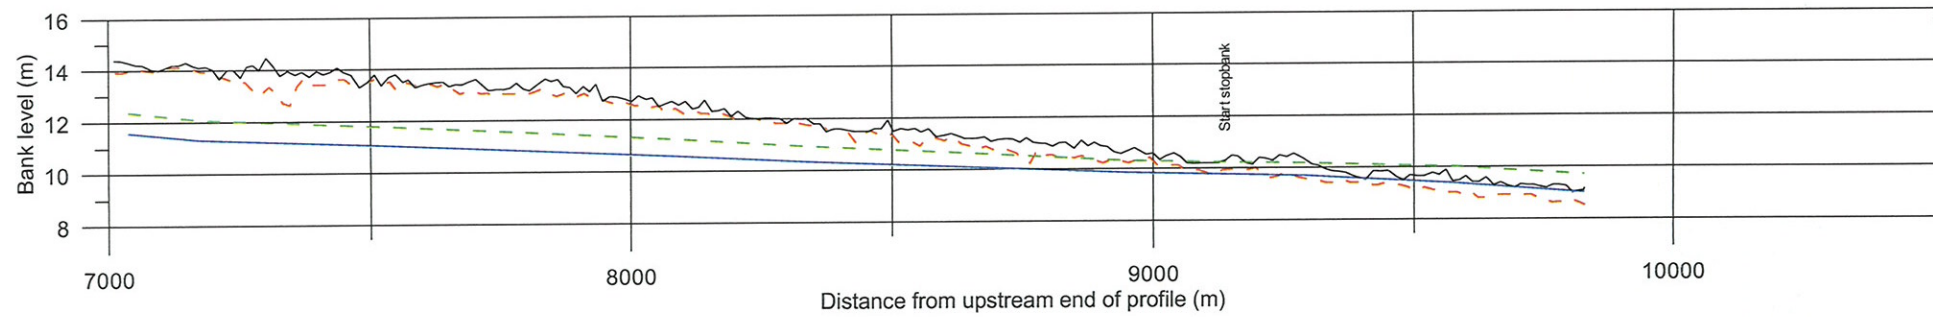
- - - Estimated natural unmodified bank level
- Bank crest surveyed 2010
- Maximum water level in 6 month ARI flood, with no bank overtopping
- - - Maximum water level in 1 year ARI flood, with no bank overtopping
