18 Bland Bay

Coastal Erosion Hazard Assessment

NORTHLAND REGIONAL COUNCIL
 Coastal Erosion Hazard Assessment
 Bland Bay
 Site: 18

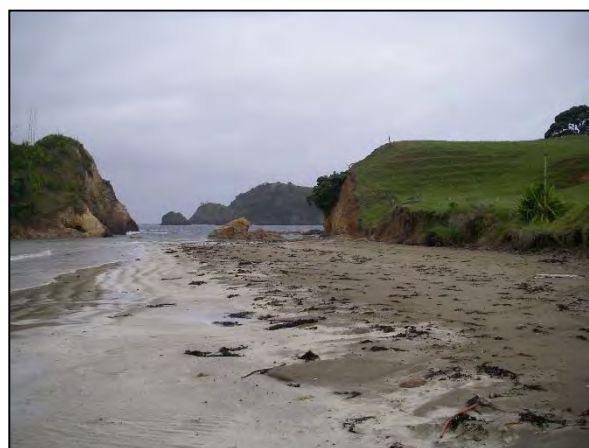
Site Photograph A (southern end)

Another small stream is located near the southern end of the site situated adjacent to Waitapu reef. Waitapu reef is located approximately 700 m from the southern end of the site. The beach morphology changes south of this point with a relatively flat backshore area that has a vertical erosion scarp.

The southern 150 m of the site is a cliff shoreline, which is a sedimentary melange formation.

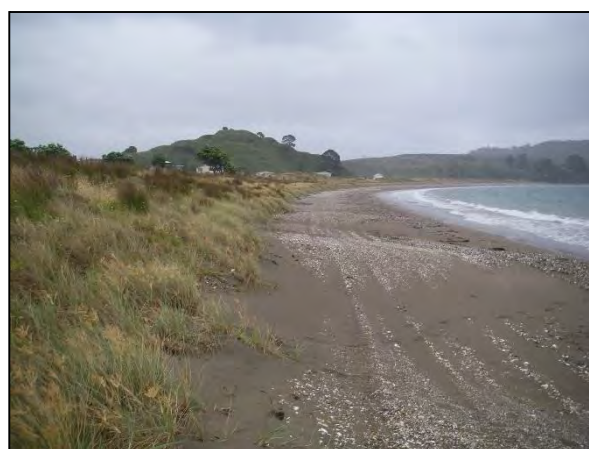
Site Photograph B (centre)

The beach comprises fine to medium sand with some shell and pebble component. The beach has a berm width of approximately 5 m above the high tide line along the northern 1 km of the site. The dune system is well developed along the northern 1 km of shoreline, with healthy spinifex vegetation present.

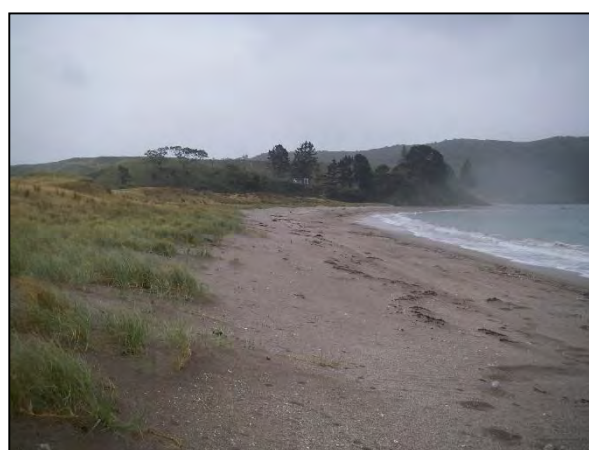
Site Photograph C (northern end)

A small stream enters the site shoreline at the northern end, which has a minimal effect on shoreline position. The dune elevation and berm width decreases toward the southern end of the site.

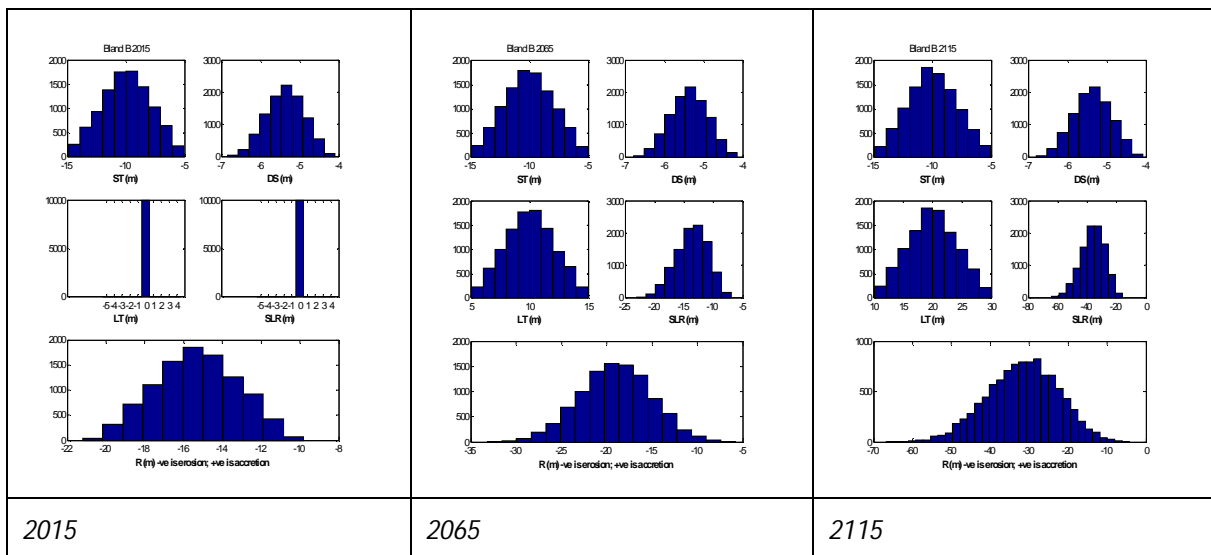
Figure 18-2 Histograms of parameter samples and the resultant shoreline distances for 2015, 2065 and 2115 timeframes for cell 18B

Histograms of individual components and resultant CEHZ distances using a Monte Carlo technique are shown in Figure 18-1 to figure 18-5.

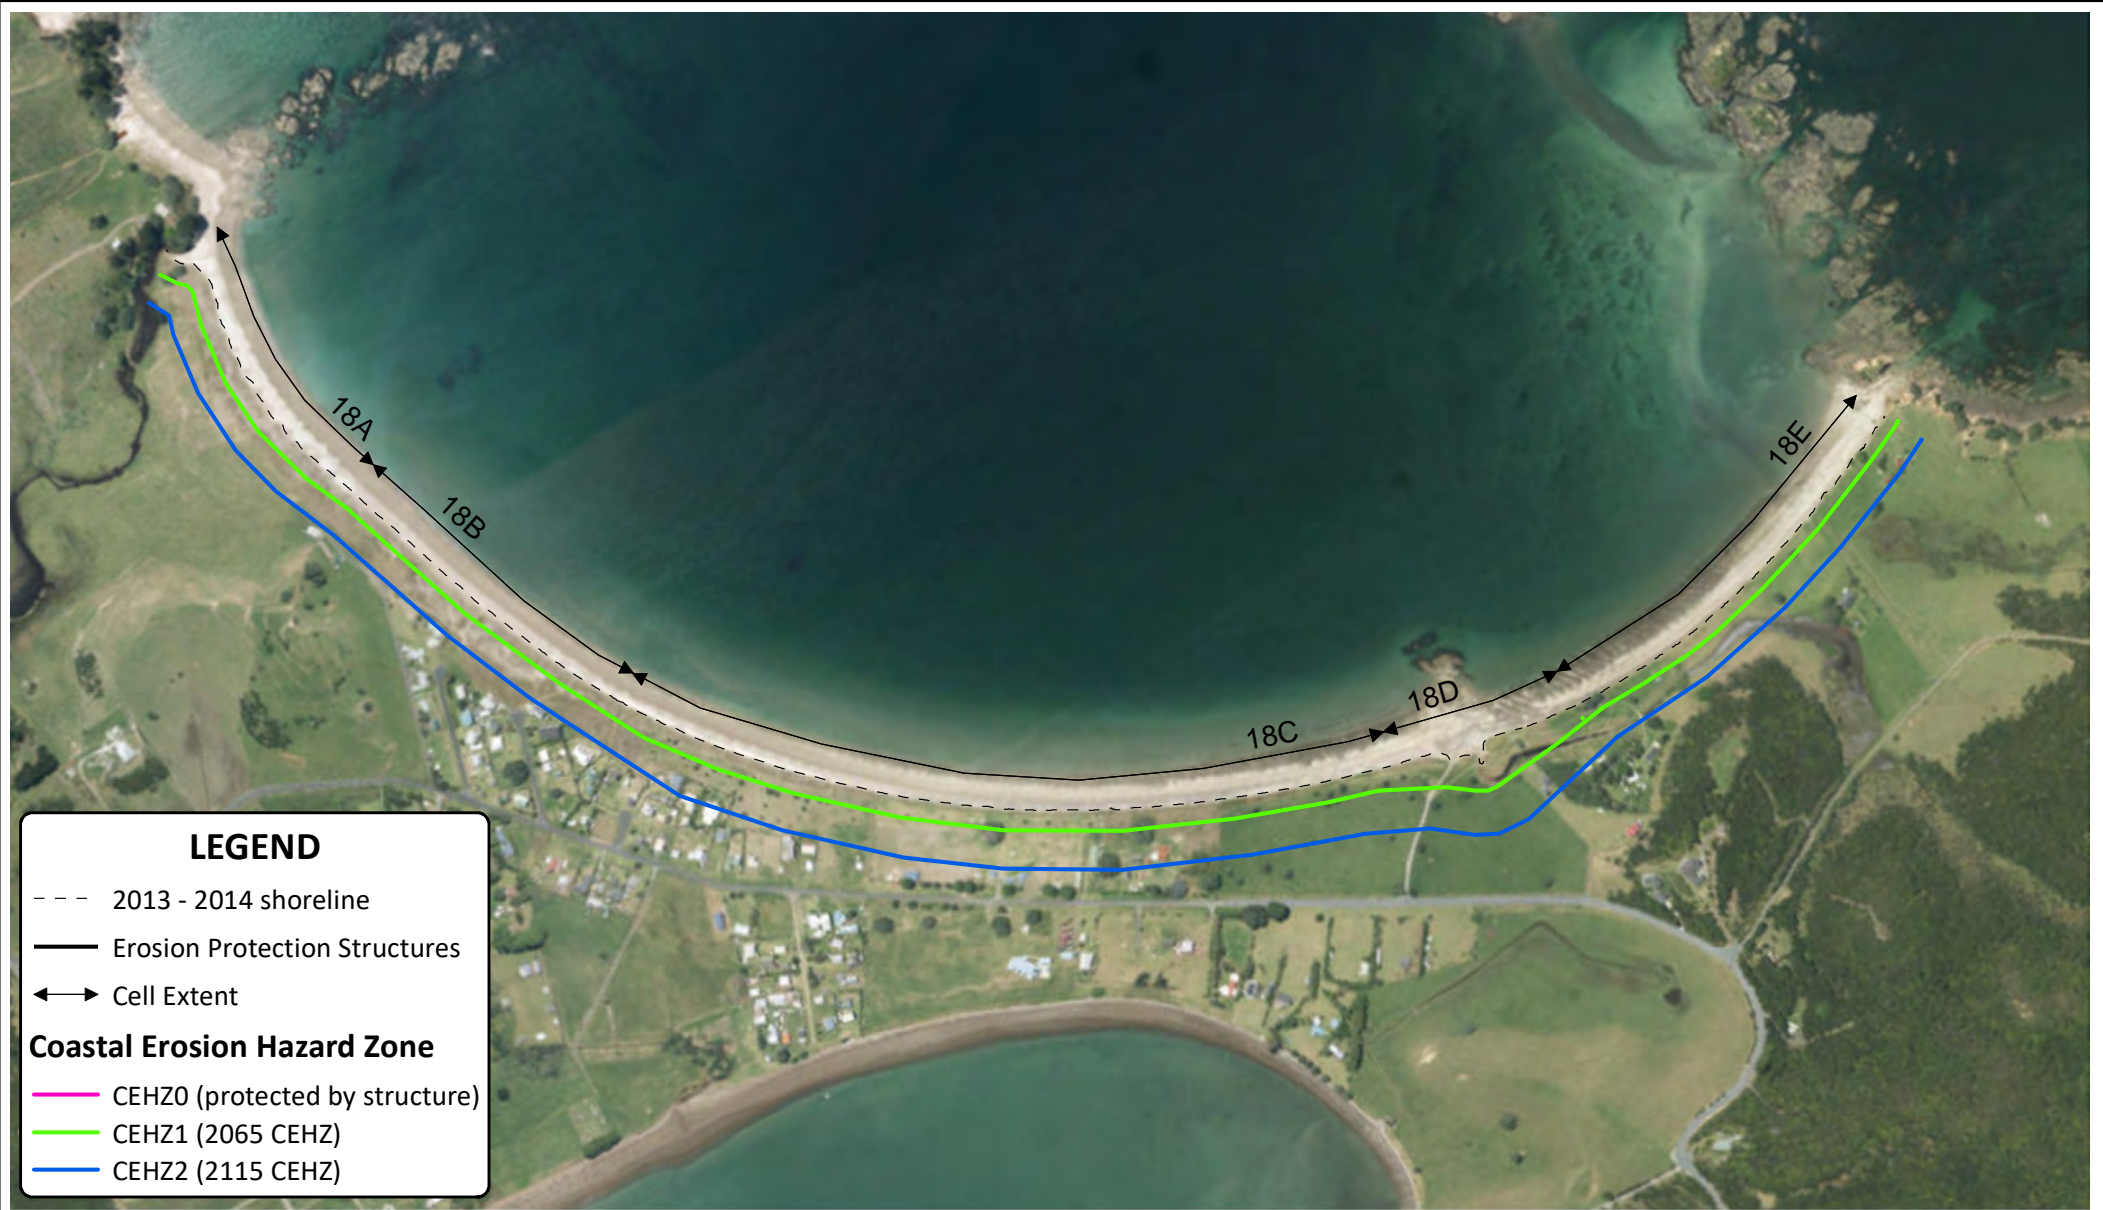
FIGURE No. Figure 18-6

Notes: Dashed CEHZ indicates greater uncertainty around stream mouths and backshore topography. Northland 0.1m Rural Aerial Photos (2014-2015).

Coastal Erosion Hazard Zone widths are presented within Table 8-2 and Figure 18-6. CEHZ's have been mapped in agreement with the calculated values.

Note that cell 18A and 18B have experienced accretion since about 1971 over approximately 600 m, with CEHZs offset from the accreted most recent shoreline.

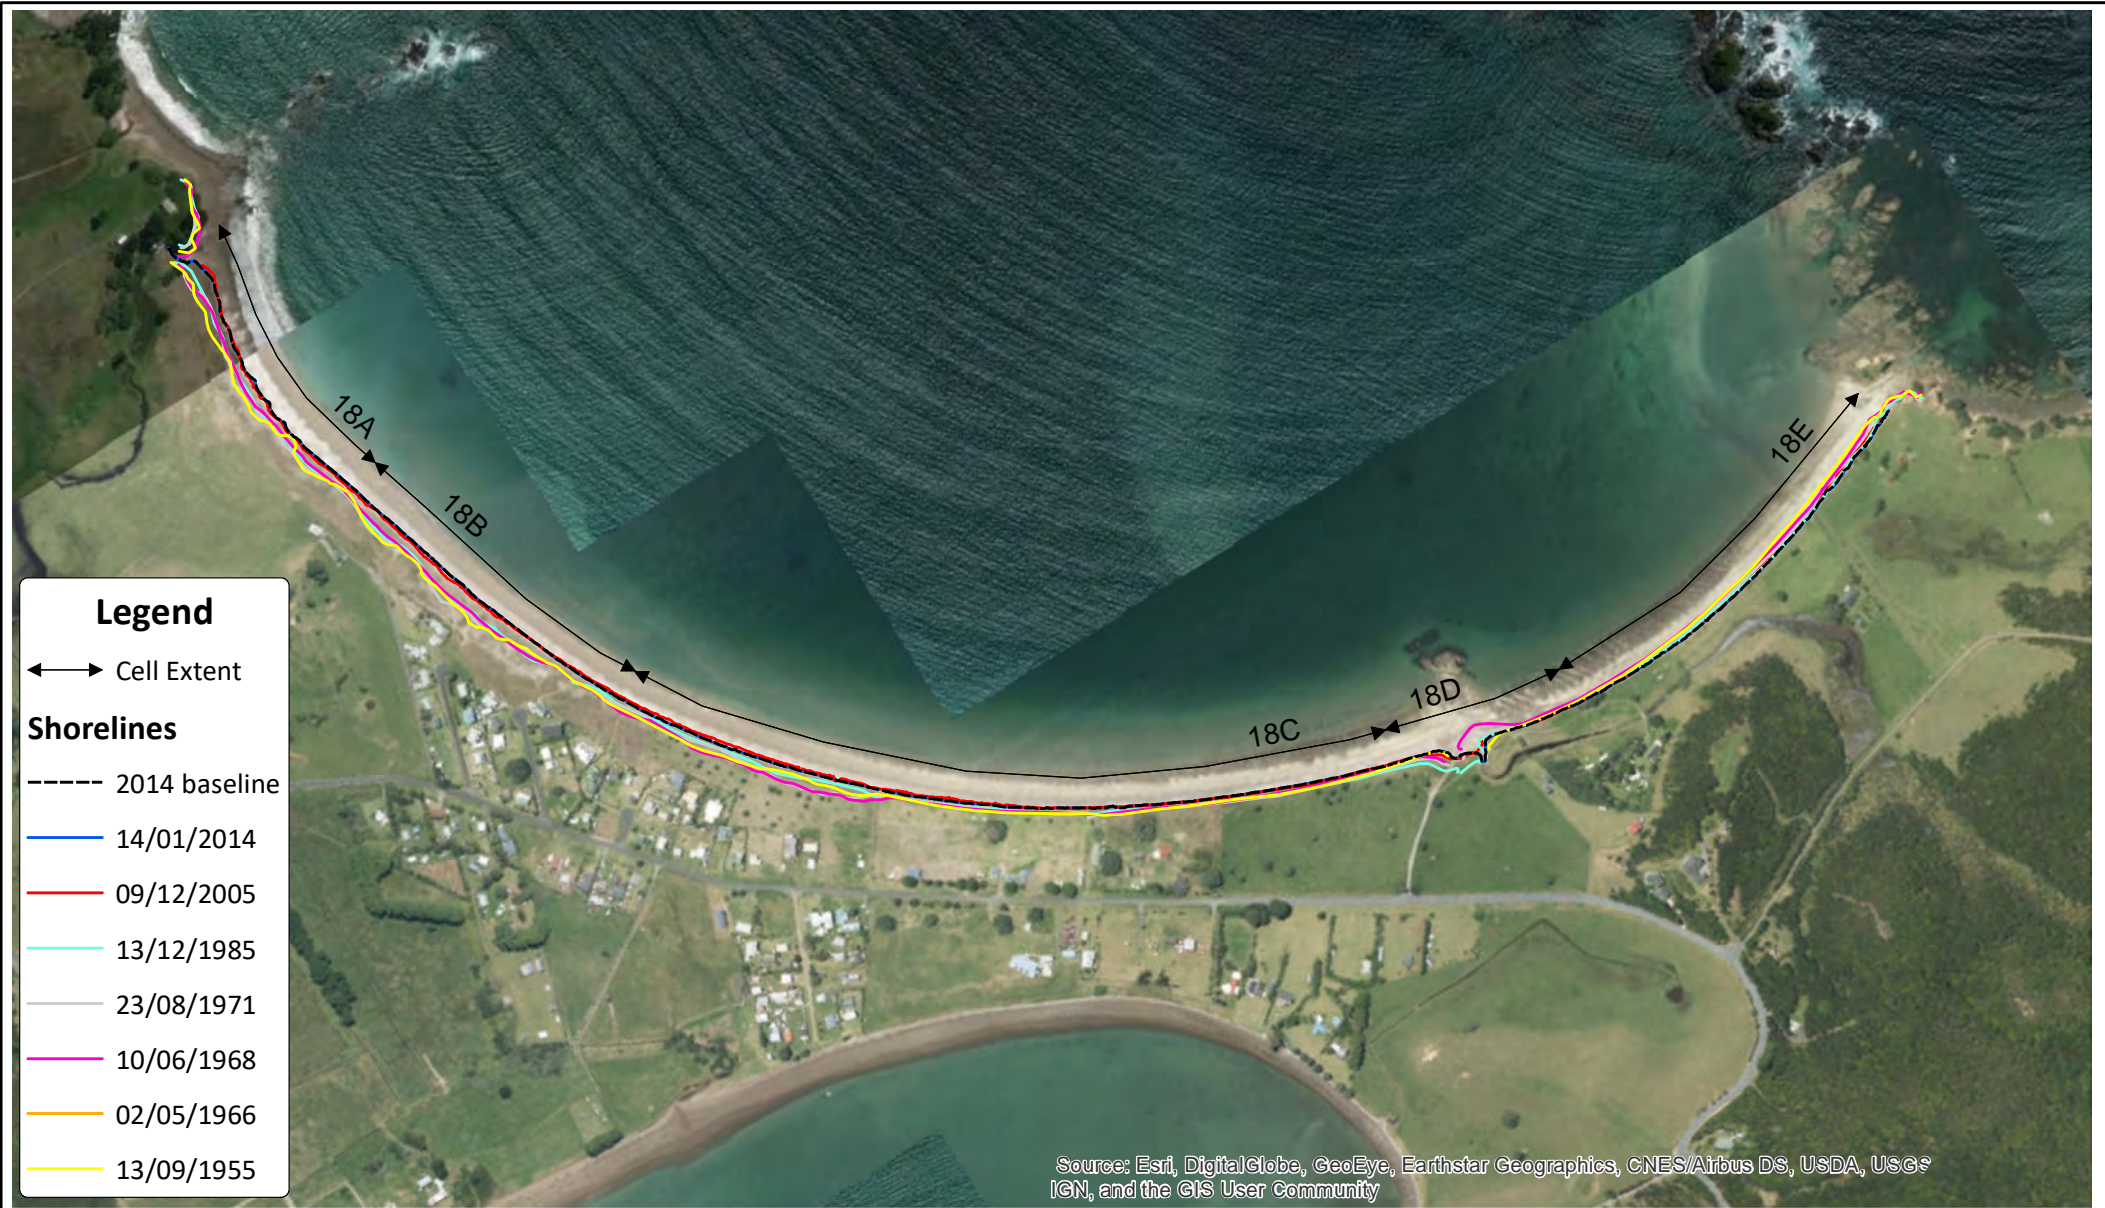
NORTHLAND REGIONAL COUNCIL
Historic shorelines
Bland Bay
Site: 18

Figure 18-7 shows the available historic shorelines for Bland Bay.
