Te Hiku

Lake Waihopo, NRC Lake No. 78.

Summary	Waihopo
Surveyed:	2004, 2006, 2009, 2013, 2017 and 2025.
Overall ranking:	Outstanding: A mesotrophic lake, with well-developed submerged vegetation and dense emergent vegetation supporting numerous endangered biota.
Threats:	Low risk of invasive species introductions. Potential for future nutrient enrichment from farming in the catchment.
Management recommendations:	Recommend fully fencing the lake and investigate the southwestern drain to identify any mitigation options for nutrient addition. Lake ecological condition monitoring every 5 years.

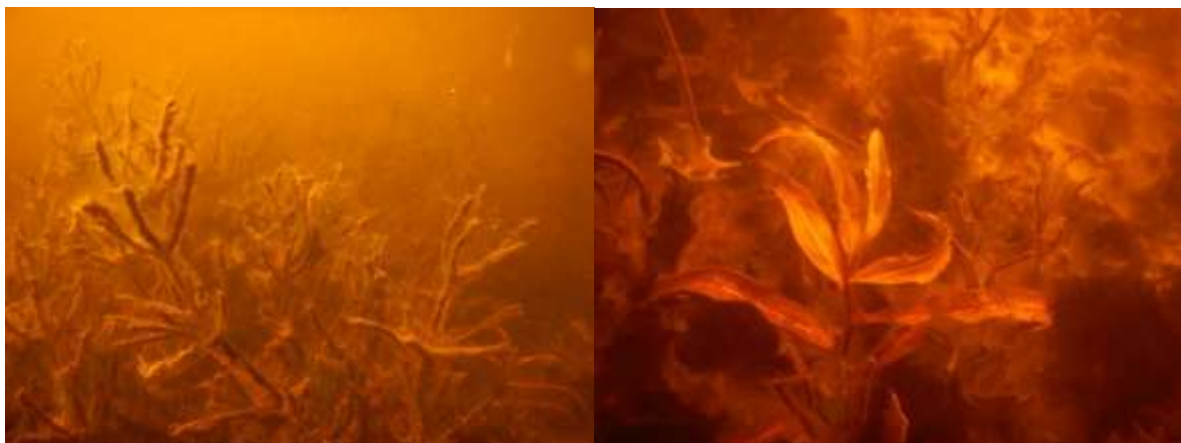
In 2025, a diver survey of five LakeSPI sites was undertaken to depths of 2.8 to 3.4 m. A low diversity vegetation comprised of *Nitella* sp. aff. *cristata* and lesser amounts of *Chara australis* charophyte meadows, with scattered taller plants of *Potamogeton cheesemanii* extended from the edge of emergent vegetation to a maximum depth of 3 m, with low covers (>10%) of these plants growing to 3.2 m. At one site where kuta was absent, a much more diverse assemblage of submerged macrophytes occurred, with *Chara acanthopitys*, *Nitella hyalina*, *Myriophyllum propinquum*, *Glossostigma elatinoides* and the invasive weed *Utricularia gibba* additionally found at this site.

Lake Waihopo: *Chara australis* (left), *Potamogeton cheesemanii* (right) (Mary de Winton, 2025).
