42 Whakapirau

NORTHLAND REGIONAL COUNCIL

Coastal Erosion Hazard Assessment

Whakapirau

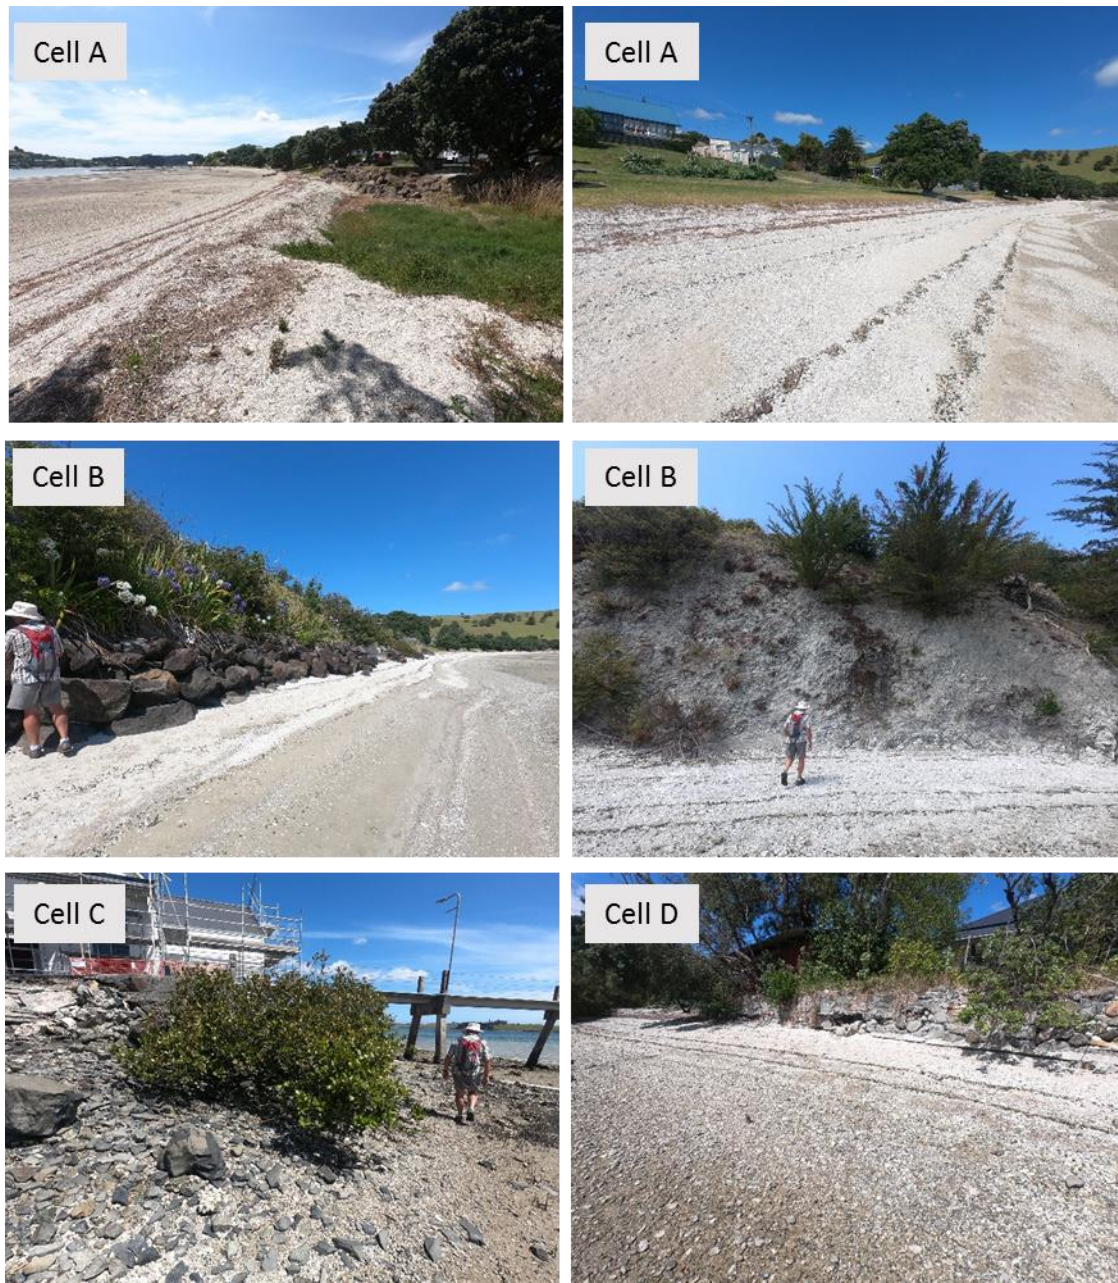
Figure 42.2: Photos from Whakapirau site visit on 20/01/2020.

Whakapirau is a small town on the Kaipara Harbour, located on the bank of the Arapaoa River and the entrance to the Pahi River. Figure 42.1 shows the site and its division into four coastal cells for the purpose of assessing coastal erosion hazards. Site photos highlighting key features of the coast at Whakapirau are presented in Figure 42.2.

The site is estuarine with a navigable tidal channel located 100-200 m from the shoreline. The site extends for 900 m alongshore and includes a reclaimed wharf section to the north and a small coastal terrace and beach to the south where the main town is located. The beach section is backed by a natural valley with an underlying geology of Northland Allochthon and the surrounding hills and cliffs flanking the beach are Mahurangi Limestone.

The site is a combination of estuarine beaches, Mahurangi Limestone cliff, reclaimed wharf and estuarine beach with mangrove influence. A narrow tidal flat extends seaward for 60-150 m from the beach toe to the tidal channel. Local wind wave generation at low tide is limited to high tide with a maximum fetch less than 2 km in a southwest direction. Wave height at the coast may also be depth limited by the tidal flat, and it is likely that the coastal processes are tidal dominant. Site observations indicated that the cliff section north of the town was crumbling and unstable. The cliff to the south of town is not included in this assessment. There was little evidence of erosion at the main estuary beach in front of the town.

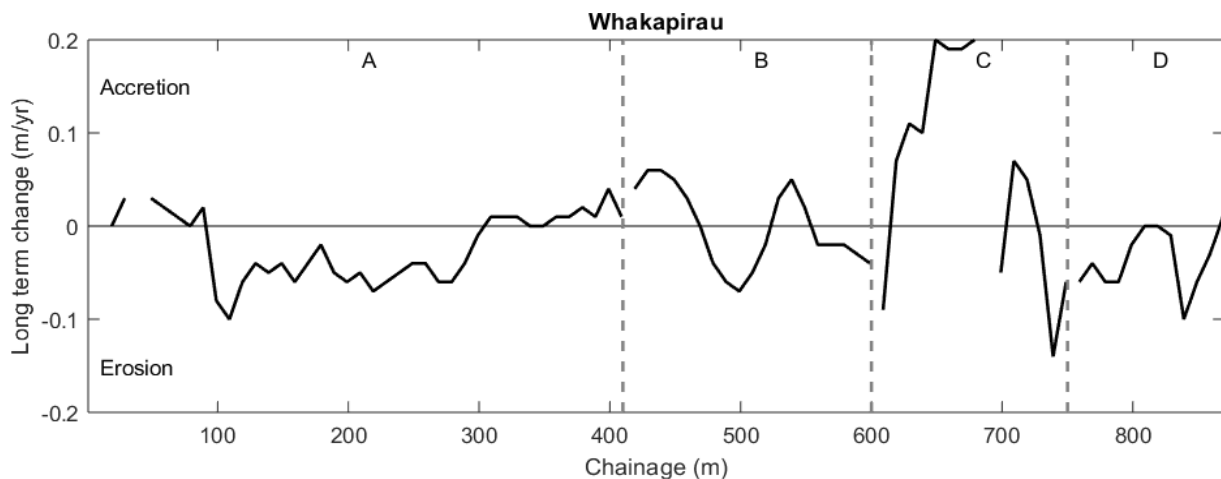
Figure 42.3: Rate of long-term shoreline change along the site showing each cell.

Analysis of historic shoreline position indicated a general trend of erosion along the coastal terrace coast at Cell A, with an average long-term rate of -0.05 m/yr. Despite the appearance of a crumbling cliff, historic shoreline analysis indicates a reasonably stable cliff at Cell B with an average long-term rate of -0.03 m/yr. Historic shoreline change at the northern estuarine coastal terrace Cell indicated a general erosion trend with an average long-term rate of -0.05 m/yr. A long-term rate of 0 ± 0.1 m/yr was adopted for the reclaimed wharf site as no long-term rates could be derived from historic shorelines.
