Te Hiku

Half Mile Lagoon (Aupouri), NRC Lake No. 62

Summary	Half Mile Lagoon
Surveyed:	2005.
Overall ranking:	Zero: Almost completely dry. Small pools with no submerged or tall emergent vegetation situated in pasture.
Threats:	Further decline of water levels would lead to the loss of this waterbody.
Management recommendations:	No monitoring.

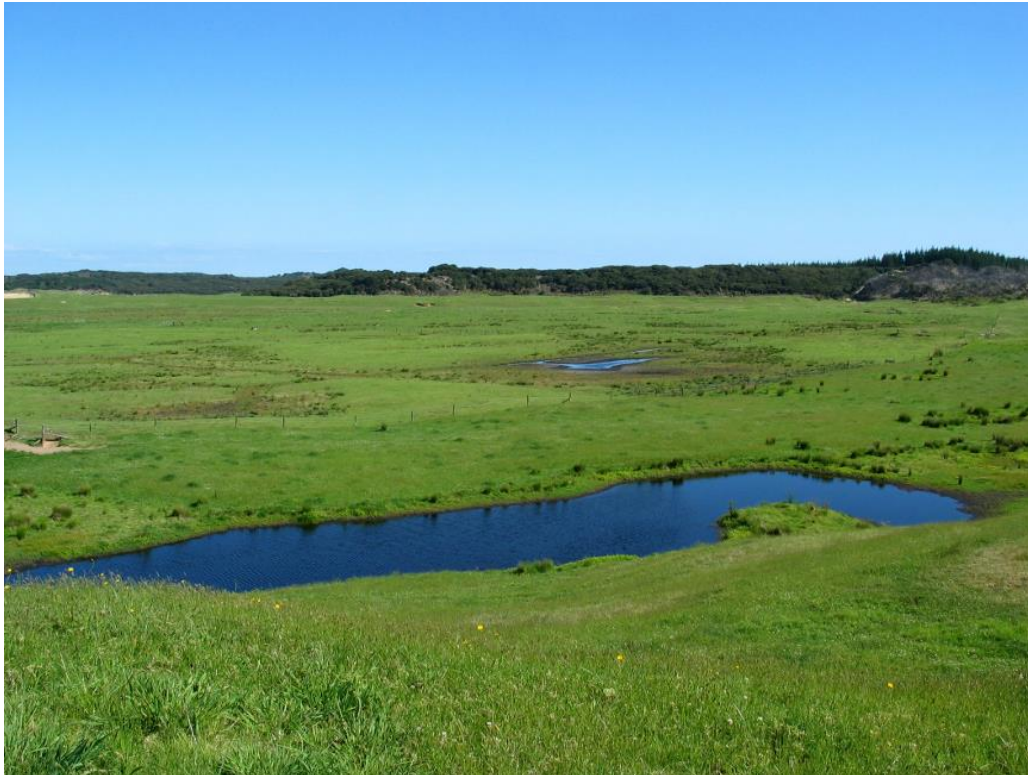
Half Mile Lagoon. Remnant pools in pasture previously occupied by a much larger waterbody.

Half Mile Lagoon is situated 1599378E, 6157875N, and once covered an area 3.6 ha. The plate shows the largest of the remaining pools (approximately 100 m²).

No monitoring.
