12 Sandy Bay

Coastal Erosion Hazard Assessment

NORTHLAND REGIONAL COUNCIL
 Coastal Erosion Hazard Assessment
 Sandy Bay
 Site: 12

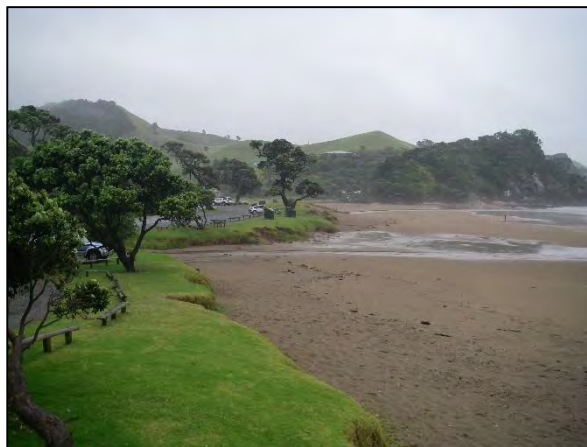
Site Photograph A (central area and stormwater outfall)

The southern 250 m of the site is a cliff shoreline which comprises Greywacke material (cell 12D). The central 150 m of the site is an eroding shoreline with a minimal dune system. The backshore elevation ranges from RL 3 to 5 m in this area (cell 12C). A stormwater outlet enters the site near the centre of the site, which has caused local retreat of the dune toe.

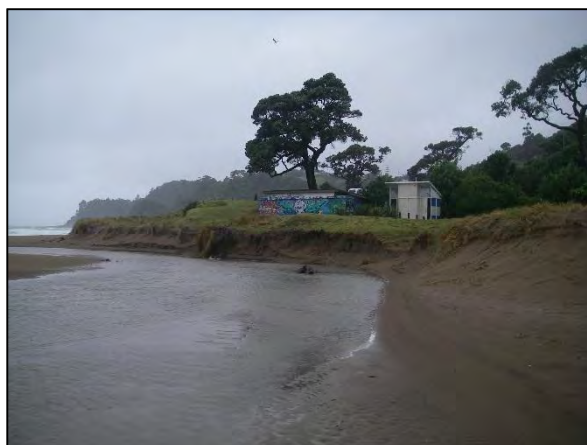
Site Photograph B (stream looking south)

Two streams enter the shoreline at the northern end of the site, with the main stream located approximately 200 m south of the northern extent of the site. The main stream flows north for approximately 100 m causing beach lowering and fluctuations in this area over time.

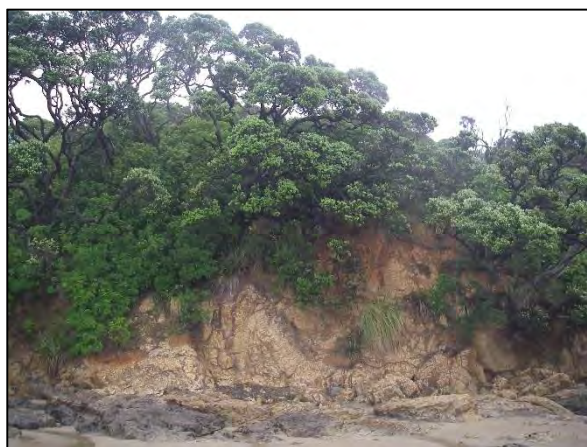
Site Photograph C (southern cliff area)

Adopted component values are presented within Table 12-1. The beaches are relatively exposed to storm waves from the E to NE and short-term erosion rates range from 15 to 25 m. Long-term shoreline trends are generally variable at the north end of the beach and erosional at the south. The Greywacke cliff at the southern end of the bay is approximately 20 m high with a stable angle of repose of between 18 and 27°.

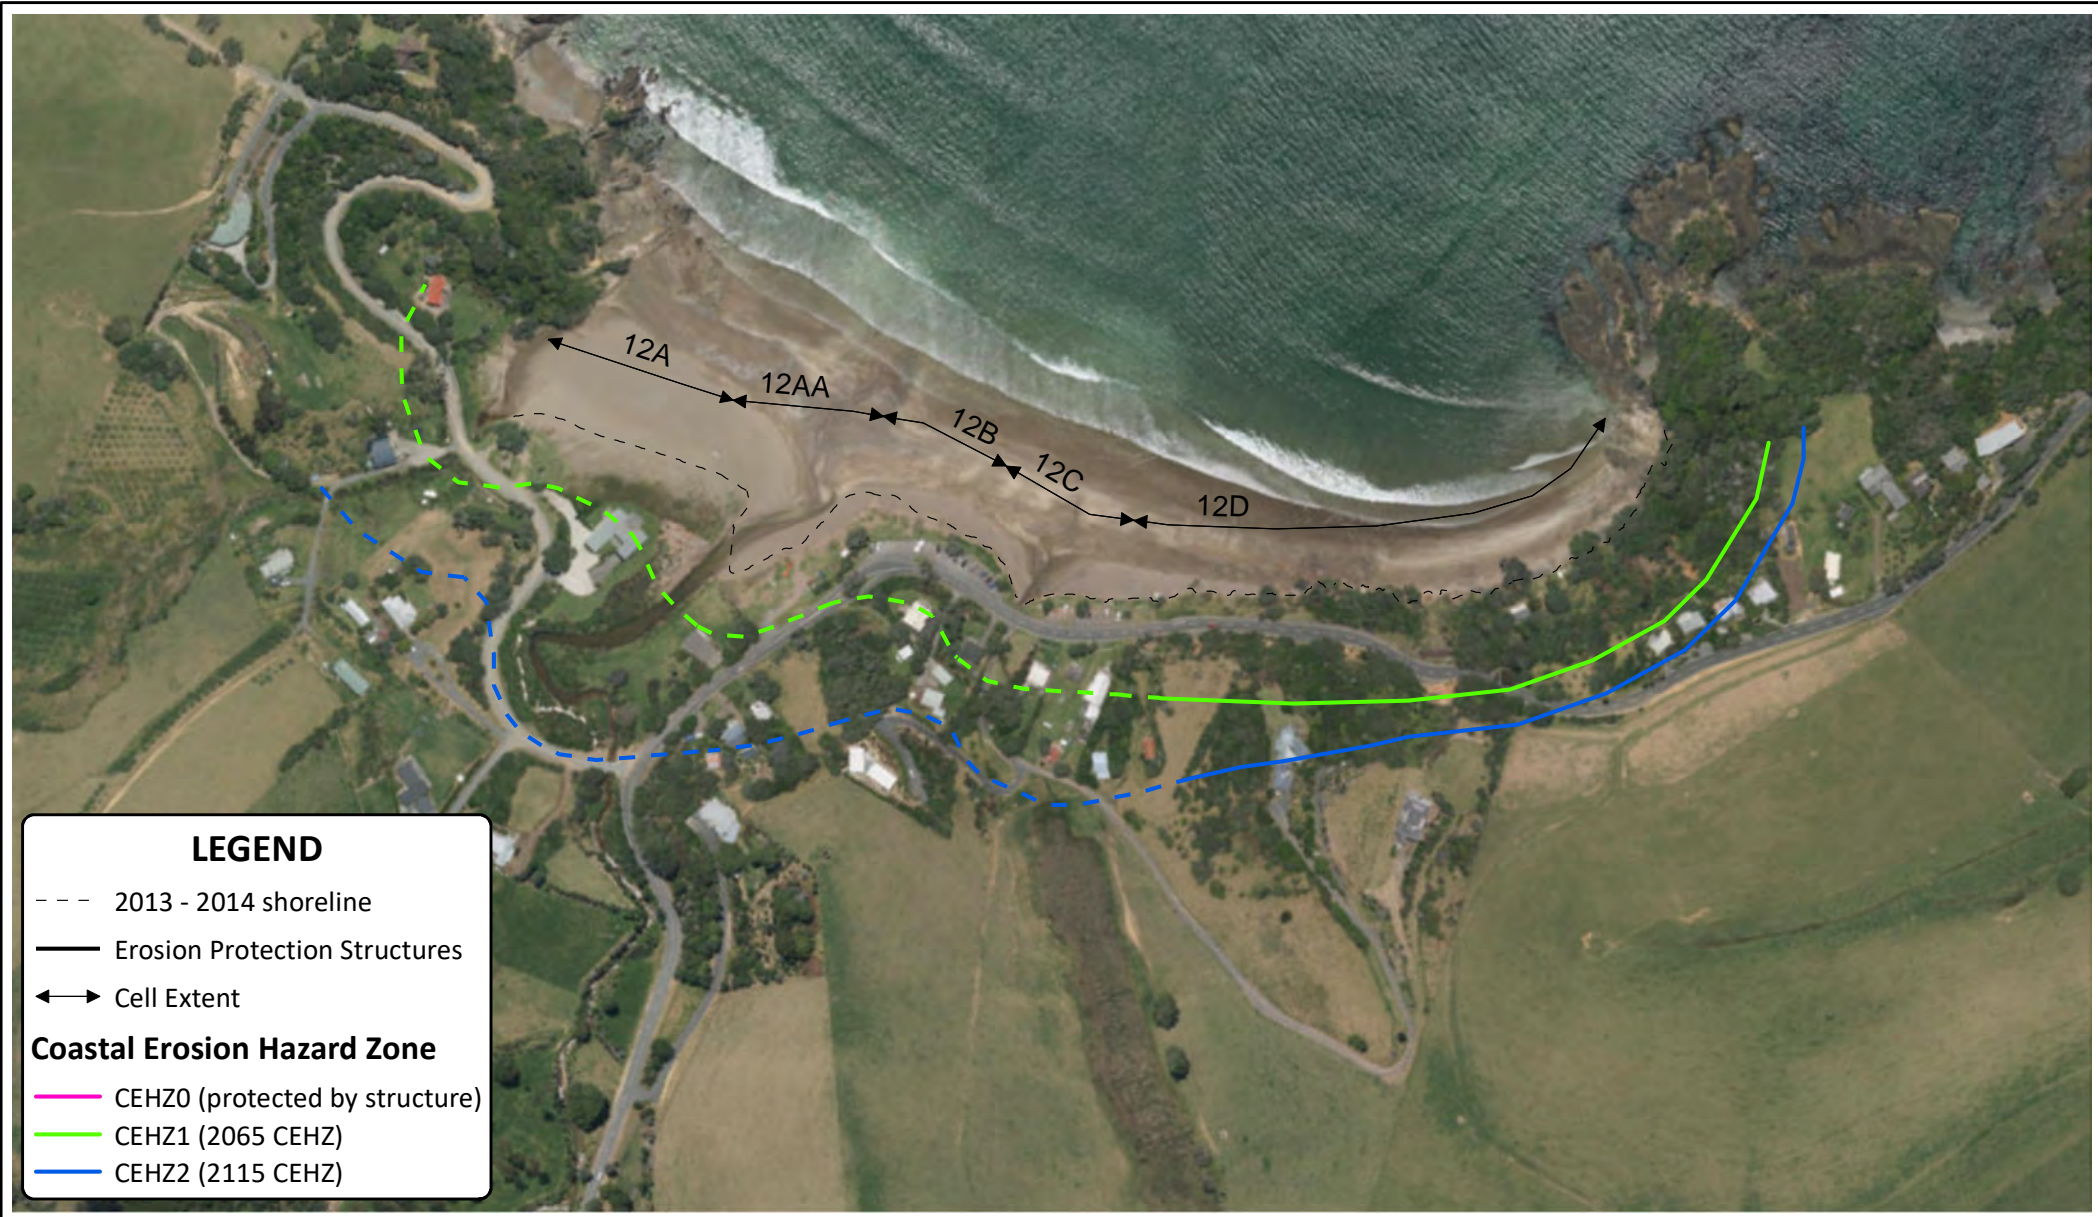
FIGURE No. **Figure 12-6**

Notes: Dashed CEHZ indicates greater uncertainty around stream mouths and backshore topography. Northland 0.1m Rural Aerial Photos (2014-2015).

Coastal Erosion Hazard Zone widths are presented within Table 12-2 and Figure 12-6. CEHZ1 values range from 34 to 51 m and CEHZ2 values from 70 to 113 m. These larger values are

attributed to the erosional trends of the southern beach and cliff and the relatively flat offshore slopes which result in large sea level rise response.

CEHZ's have been mapped in agreement with the calculated values. Except around the streams where fluvial effects increase uncertainty and where the backshore morphology transitions from sand dunes to hill slope. In both these cases lines are dashed to reflect the uncertainty and should be considered on a site-specific basis.

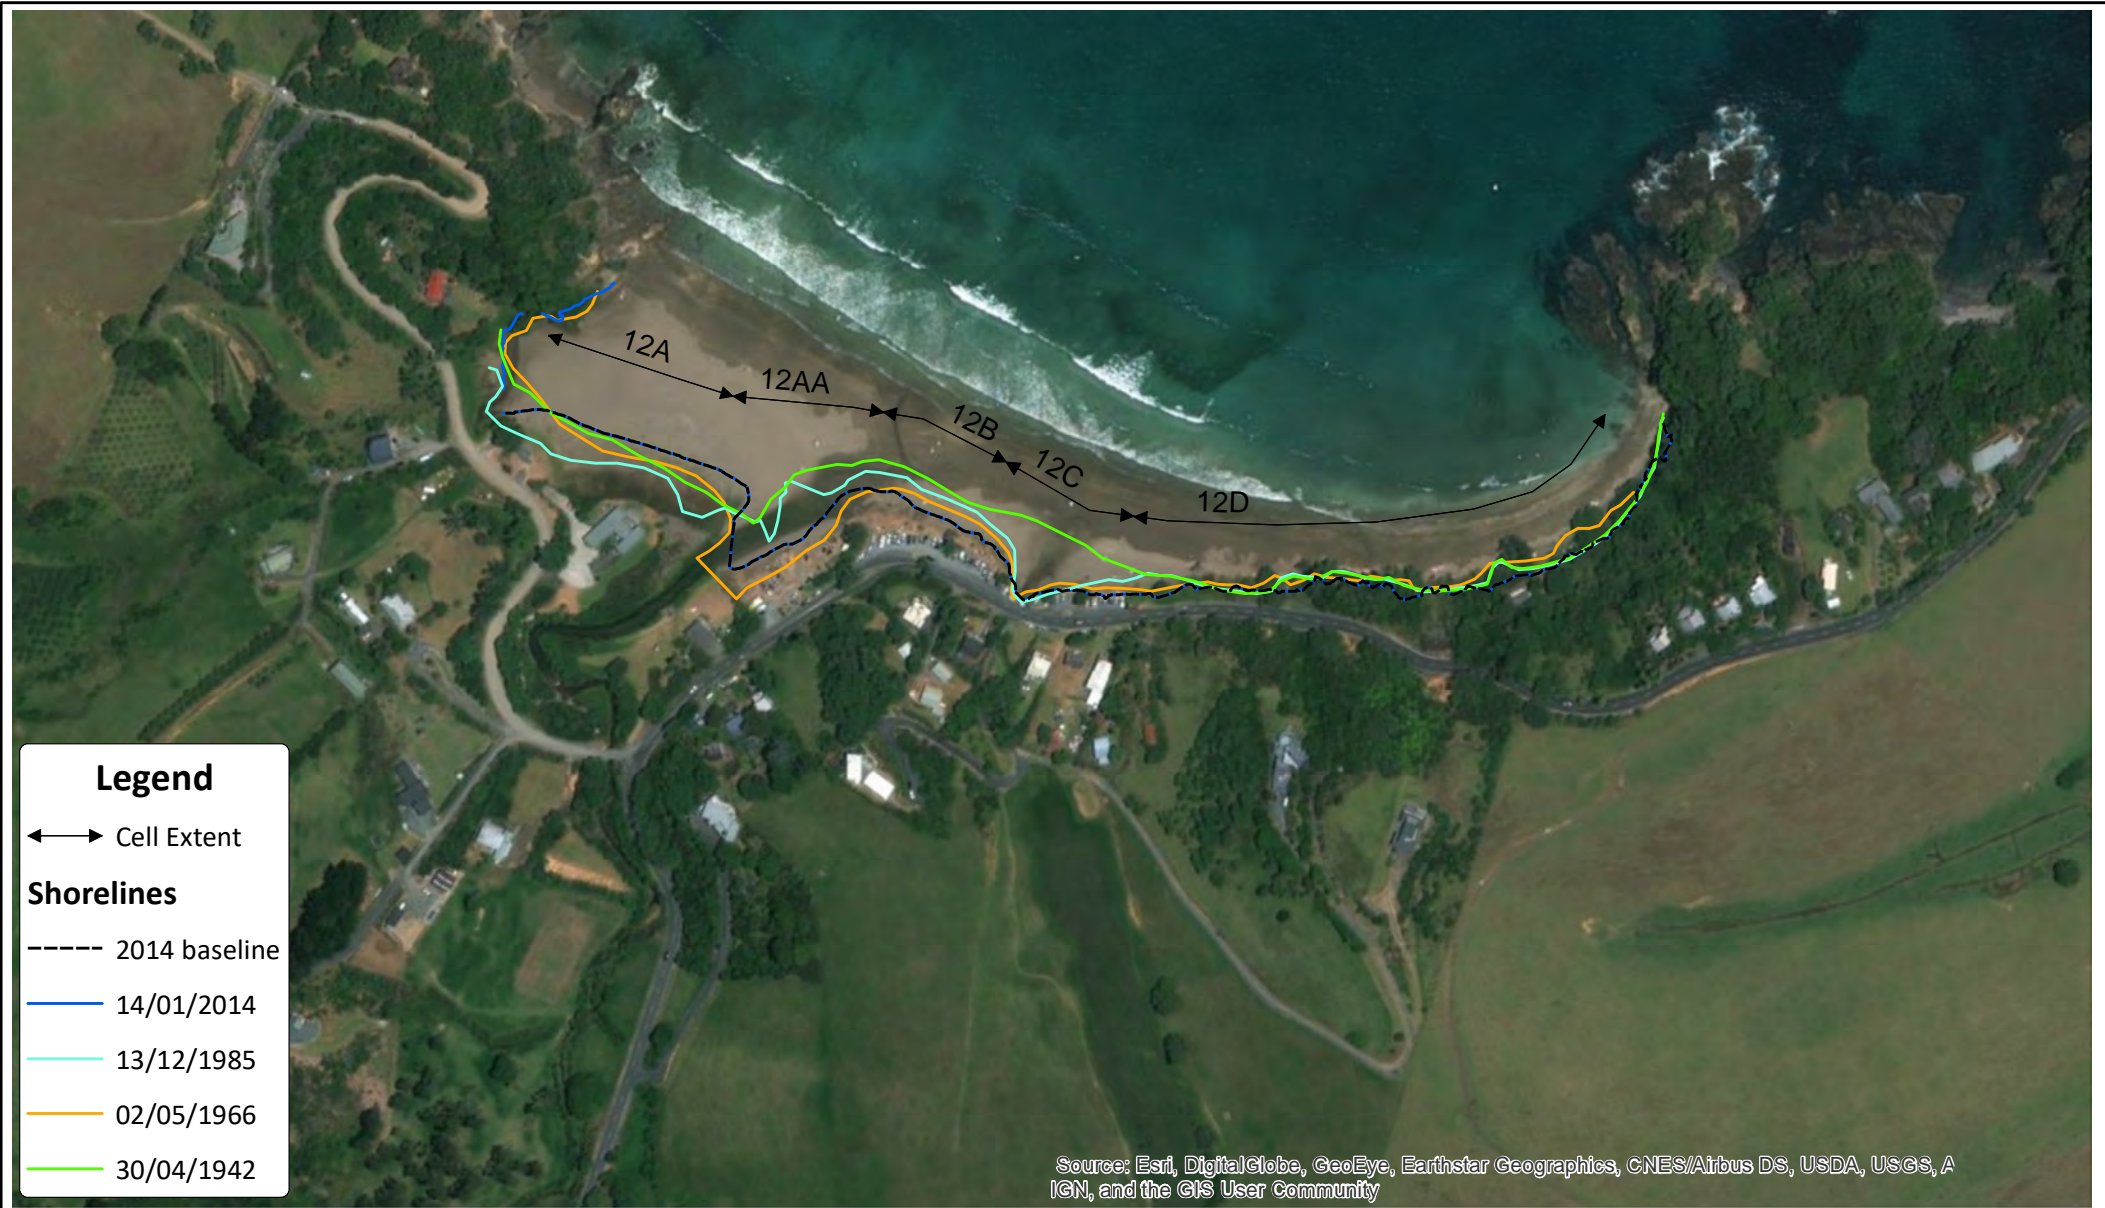
NORTHLAND REGIONAL COUNCIL
Historic shorelines
Sandy Bay
Site: 12

Figure 12-7 shows the available historic shorelines for Sandy Bay.
