**6.10 Lake Rotokawau (Pouto), NRC Lake No. 364; surveyed in 1985, 1988, 2001, 2005 and 2007**

**6.11 Lake Roto-otuauru / Swan, (Pouto), NRC Lake No. 355; surveyed in 2005, 2009 and 2010**

**6.12 Lake Rotopouua (Pouto), NRC Lake No. 348; first surveyed in 2008**

**6.13 Lake Rototuna (Pouto), NRC Lake No. 328; surveyed in 1988, 2001, 2005 and 2007**

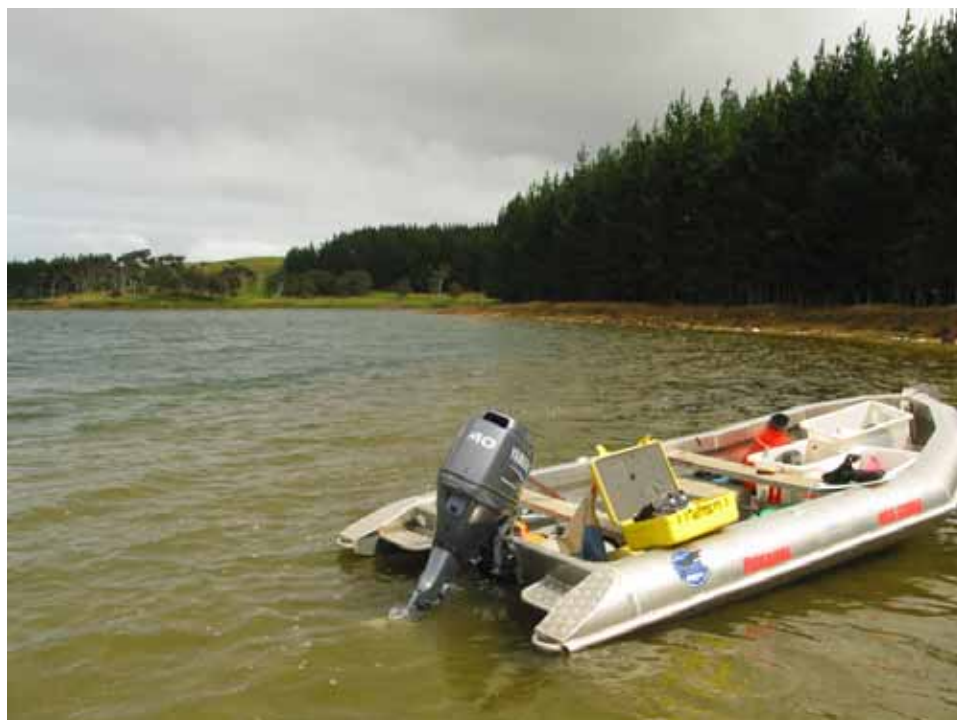
**Plate:** Lake Rotokawau showing the exposed north east shoreline with few emergent species.

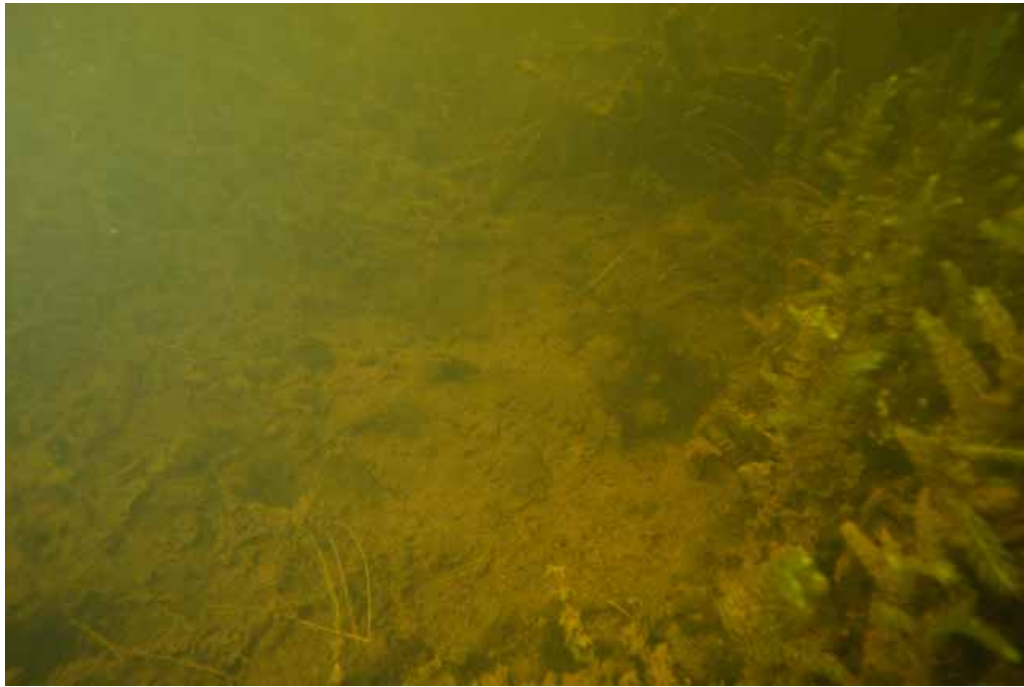
Grass carp were introduced in May 2009 to eradicate the *C. demersum* and *E. densa*. In April 2010 virtually all the *E. densa* had gone and about half the *C. demersum* (photo in plate below).

**Plate** Lake Swan after 11 months of grass carp grazing with a few remnant stalks of *E. densa* (foreground left) and the rest *C. demersum*.

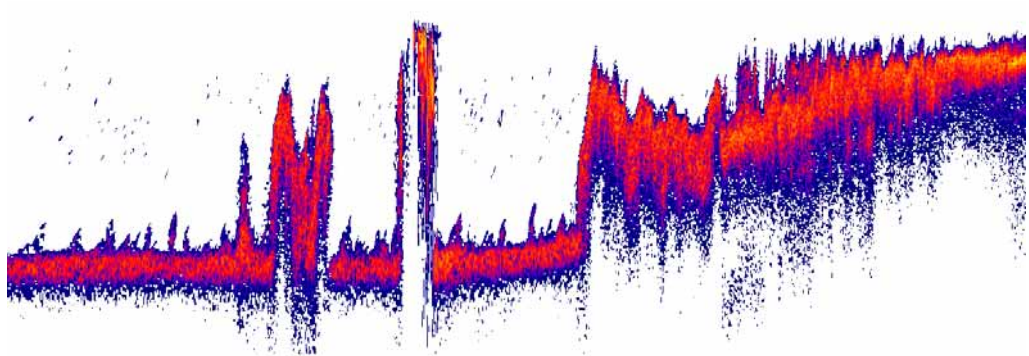
**Sonar image Profile 2:**

The sonar image shows an outline of the weed beds in April 2009. This transect is about 150 m long and the maximum depth is 5 m to the top of the red band (soft sediment) at left of image. See the map of Lake Roto-otuauru for profile location.

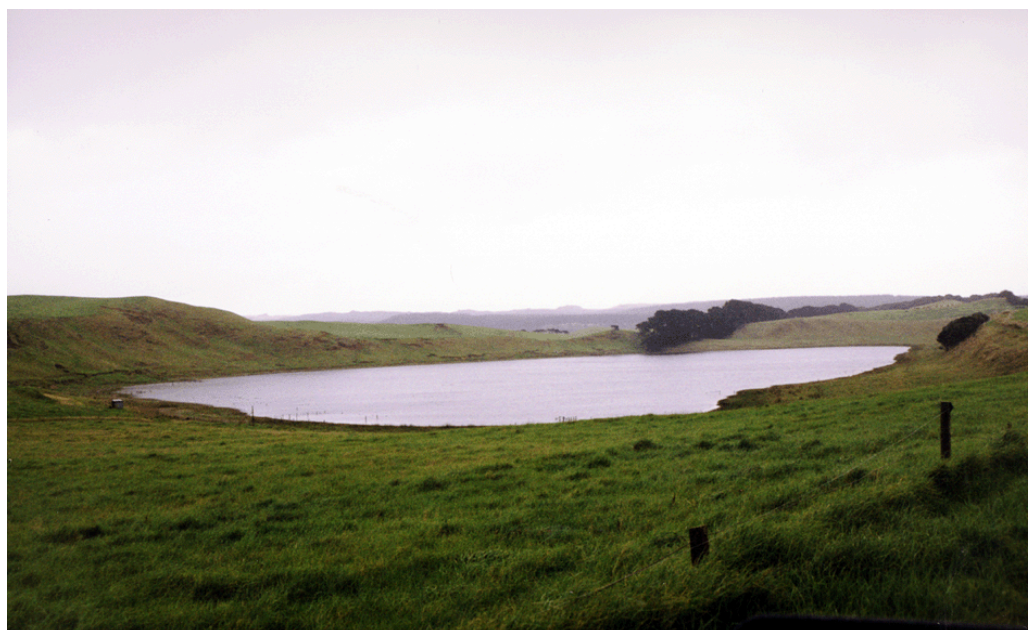
**Plate:** Lake Waingata surrounded by pasture with emergent vegetation completely lacking.

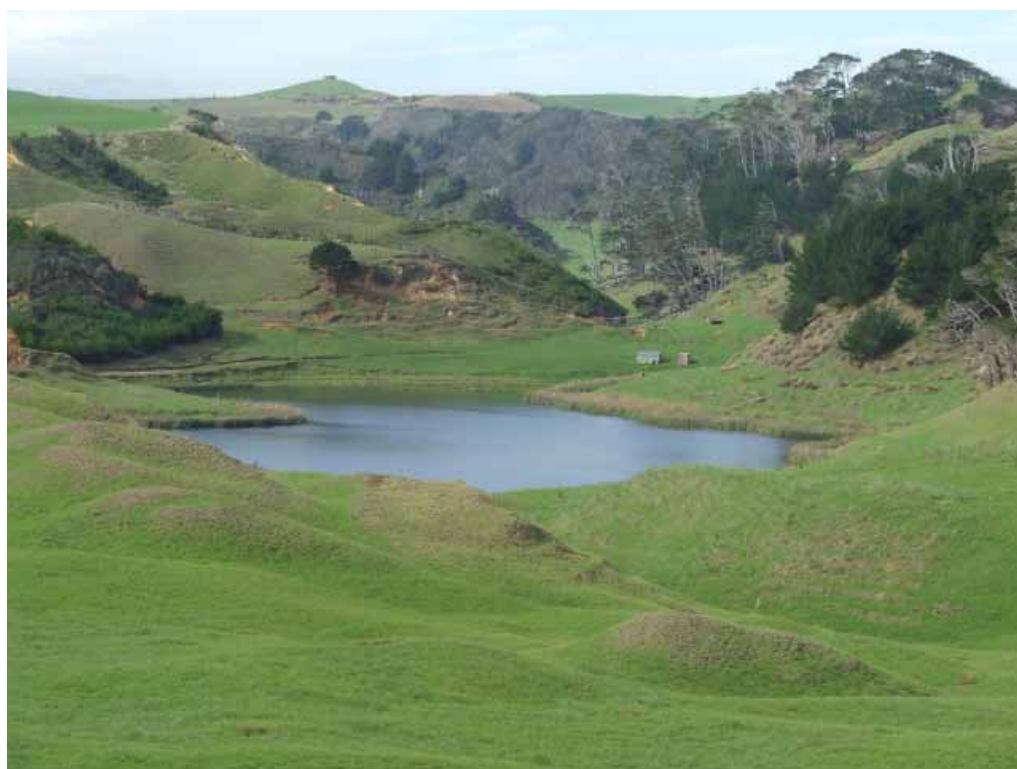
**Plate:** Lake Wainui viewed from the north (access point south end by sheds). Note the steep sided pasture catchment. Photo Lisa Forester 2010.

Recommend fencing lake and enhance/stabilise the steep catchment with marginal plantings.

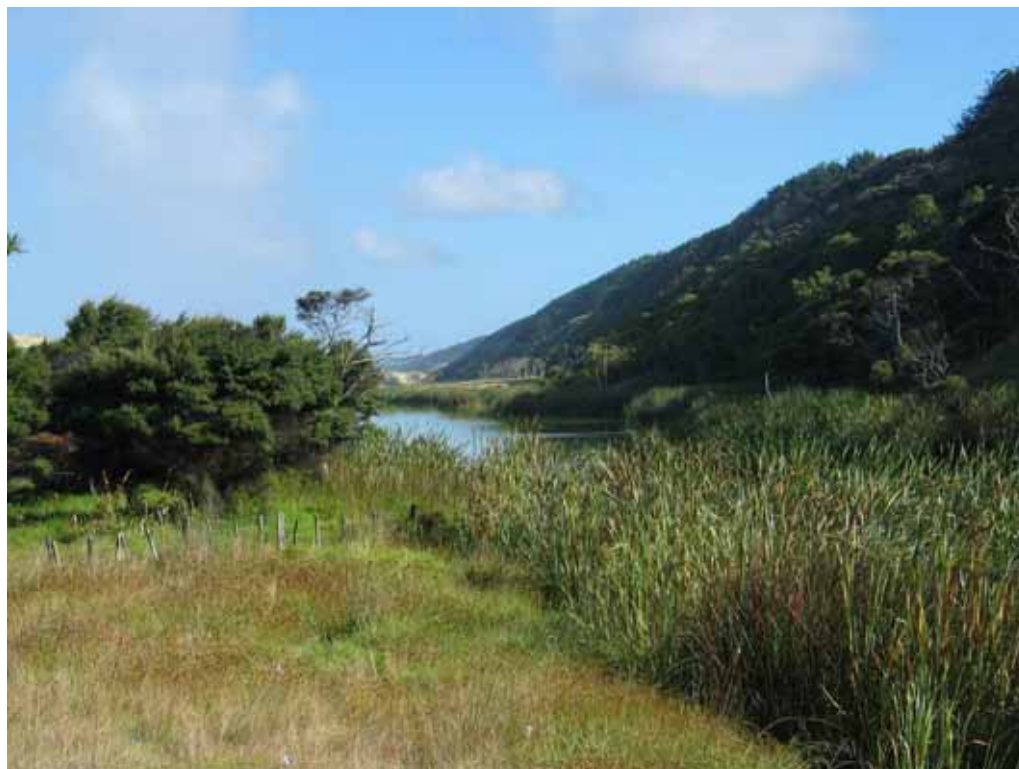
**Plate:** Lake Wairere surrounded by rough pasture and scrub to the west (left) and steep scrub covered cliffs to the east. Note the raupo (*Typha orientalis*) dominated emergent vegetation.

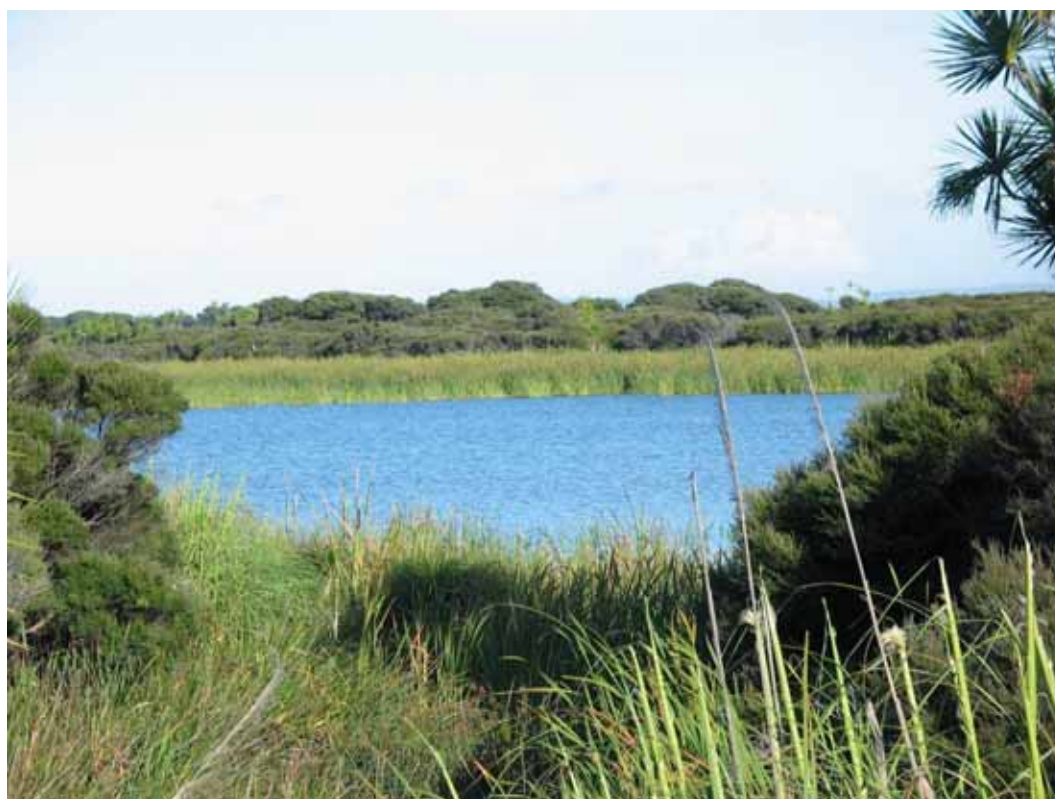
**Plate:** Lake Whakaneke surrounded by manuka scrub with dense emergent vegetation dominated by *Typha orientalis* and *Schoenoplectus tabernaemontani*.
