## 5. Kai-Iwi and north Dargaville lakes

### 5.1 Freidrich's Lake (north Dargaville), NRC Lake No. 282; surveyed in 2005.

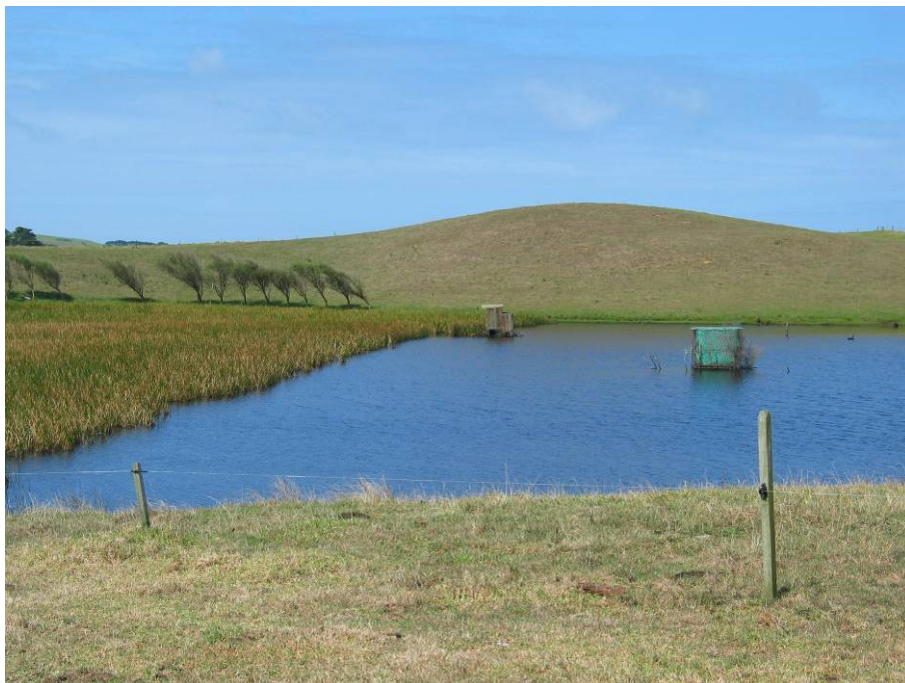
**Plate:** Freidrich's Lake showing the artificially maintained area of open water evidenced by the straight line of emergent kuta (*Eleocharis sphacelata*).

*Eleocharis sphacelata* was the dominant emergent vegetation and would fill the lake if the owner had not sprayed it. The straight edge to the *E. sphacelata* beds was taken as evidence of spraying, presumably for duck hunting purposes. Biodiversity has been enhanced by this action as it creates habitat for submerged species. The invasive weed *Alternanthera philoxeroides* was well established amongst marginal kikuyu (*Pennisetum clandestinum*).

No lake condition monitoring recommended.

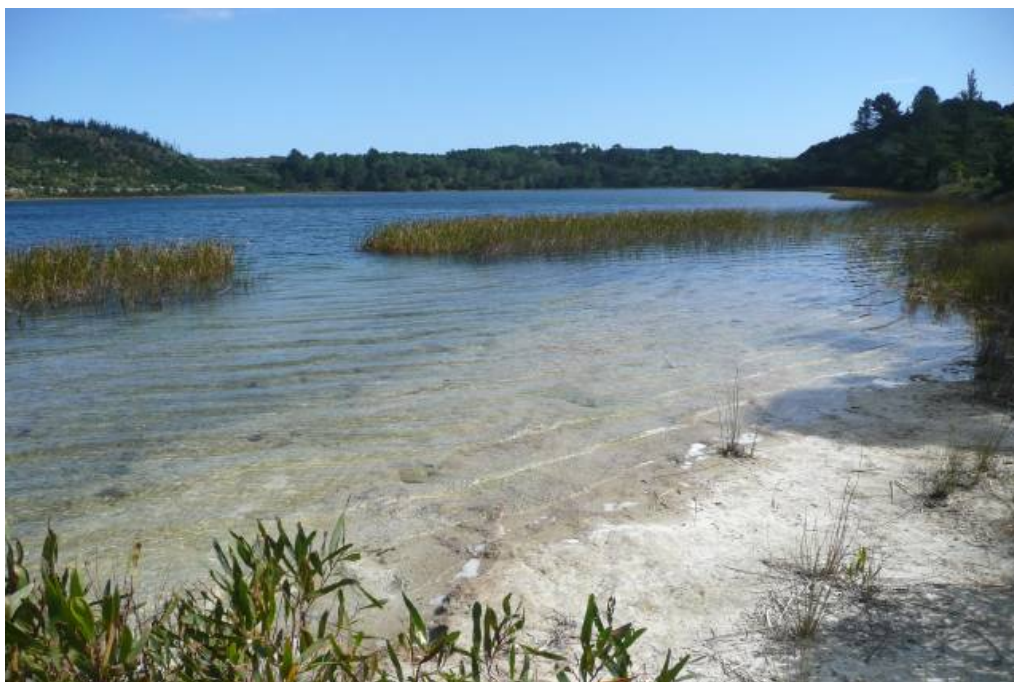
**Plate:** Lake Kai-iwi from the access point showing an extensive margin of emergent vegetation and the only sandy margin on the lake.

Lake condition monitoring every 5 years, pest plant surveillance annually. Prevent uncontrolled access for boats.

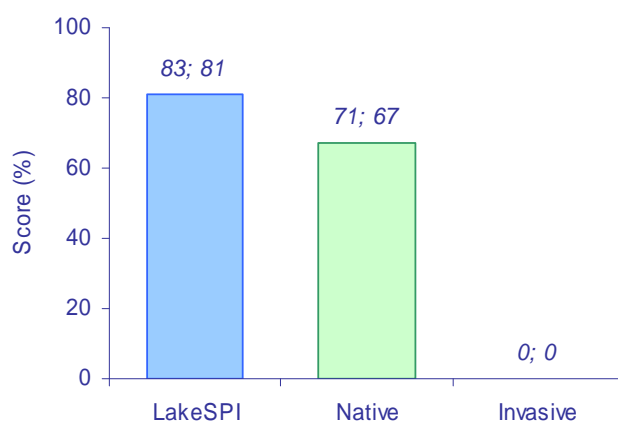
**Figure:** 2007 LakeSPI Index as % of potential score, Native Condition Index, and Invasive Impact Index (from left to right) with 2005; 2007 values shown respectively.

The high LakeSPI score of 81% reflects the extent of vegetation development, the presence of several key native plant communities and absence of invasive exotic species.

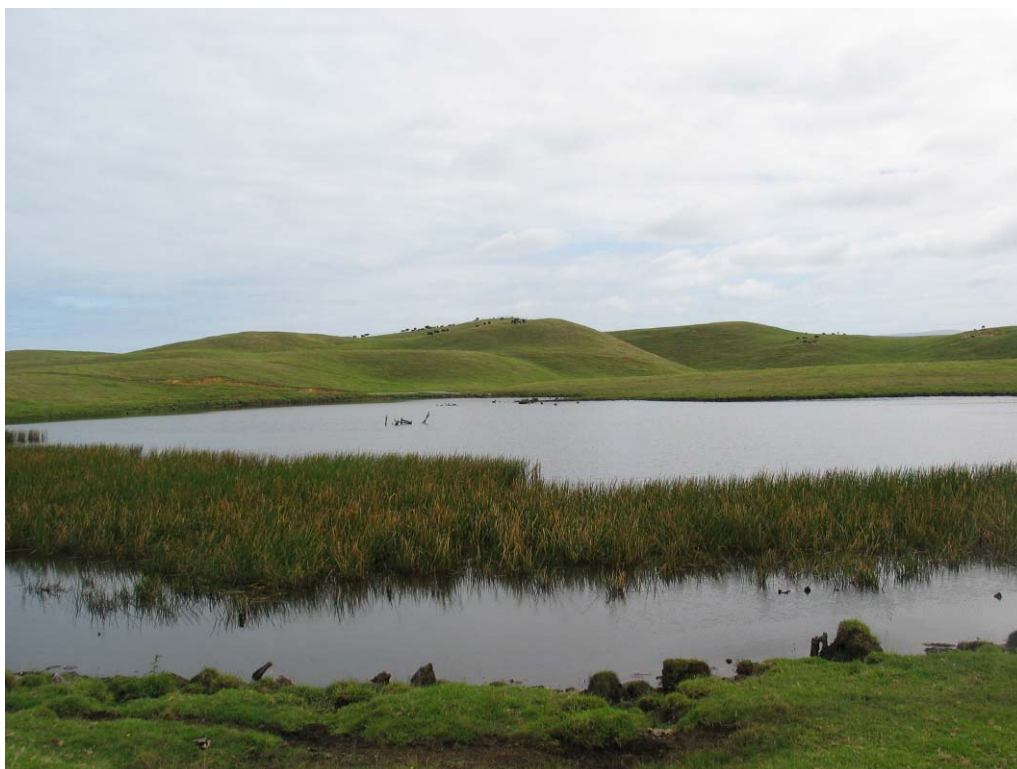
**Plate:** McEvoy's Lake showing the pasture catchment and impacts of cattle access.

The dominant emergent species was *Eleocharis sphacelata* which formed a 3 to 5 m wide zone, excluded from the lake edge by cattle grazing/trampling. A zone of exposed turf plants was occasionally seen including *Myriophyllum propinquum* and *Potamogeton cheesemanii*.

No management recommendations apart from cattle exclusion.

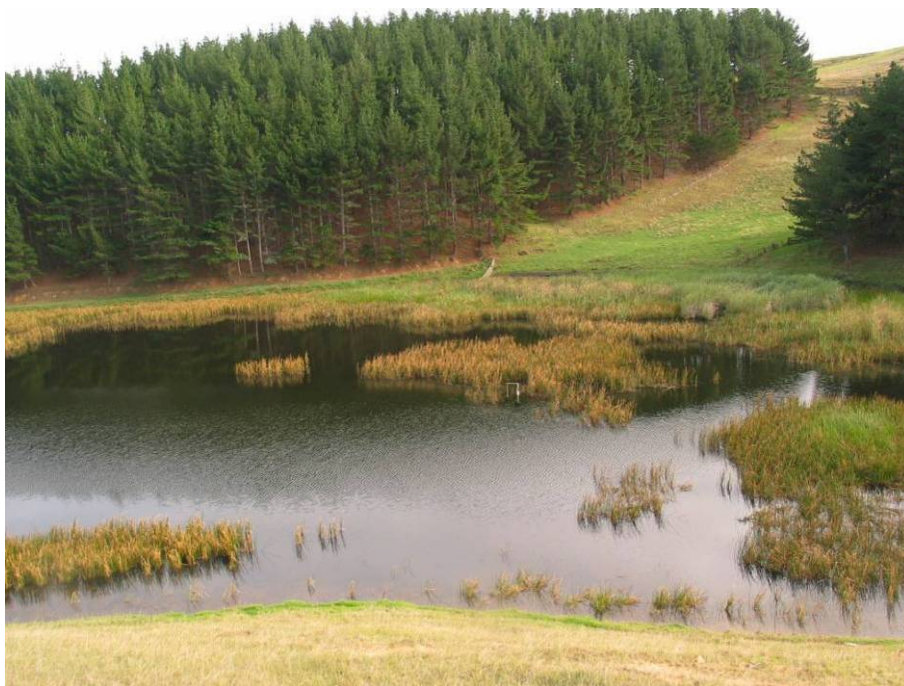
**Plate:** Midgley's Lake showing the pasture and plantation pine catchment and extensive emergent vegetation.

Lake condition monitoring every 5 to 10 years.

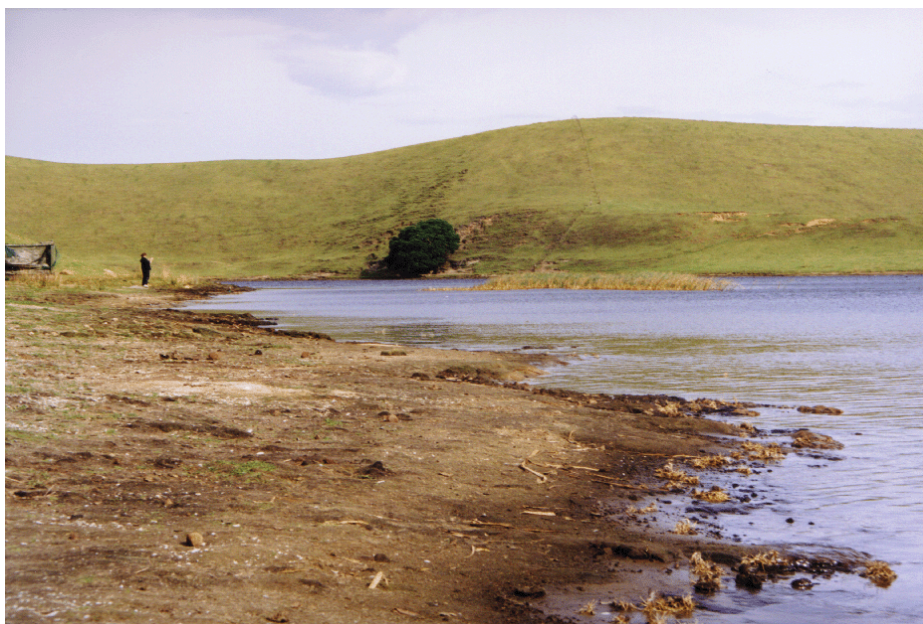
**Plate:** Shag Lake showing the impact of intense cattle grazing on the lakeshore.

The dominant emergent species occupying 30% of the shoreline was *Eleocharis sphacelata*, which formed a 3 to 5 m wide zone, excluded from the lake edge (depths less than 1 m) by cattle grazing/trampling, and extending to depths of 2 m.

No management recommendations apart from cattle exclusion.

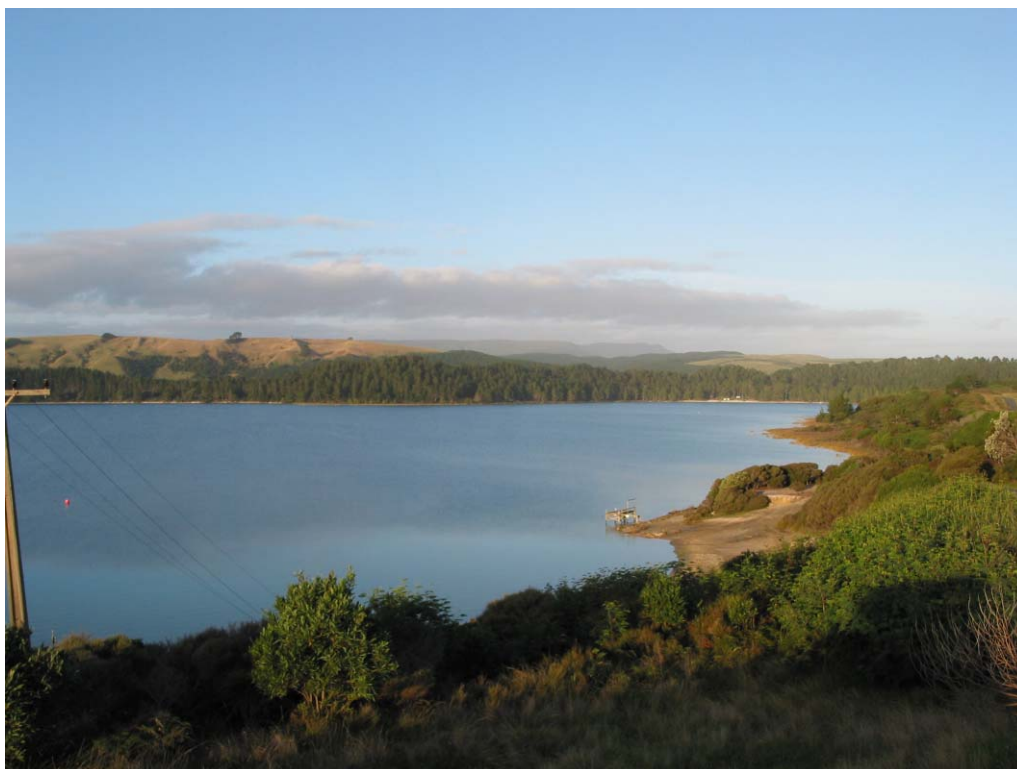
**Plate:** Lake Taharoa from access road, note the exposed beach and paucity of emergent vegetation.

Much of shore was wave exposed, with hard iron pan or sand, and unsuitable for emergent vegetation development. Low covers (25%) of oioi (*Apodasmia similis*) and *Schoenus brevifolius* were present in places, and seedlings of *Eleocharis sphacelata* were also observed at one site. A survey of marginal zones of Lake Taharoa in 2007 recorded the following additional emergent, or potentially emergent species: *Baumea arthropphylla*, *Baumea articulata*, *Baumea juncea*, *Eleocharis acuta*, *Eleocharis sphacelata*, *Ficinia nodosa*, *Isachne globosa*, *Isolepis prolifer*, *Juncus pallidus* and *Typha orientalis*. The nationally 'at-risk' *Centrolepis strigosa* was found in the marginal turf of this vegetation in 2009. This is the first known collection from the Kai-Iwi Lakes since the 1980's.

Surveillance for pest plant introductions at access points annually, and lake condition monitoring at 5 year intervals.

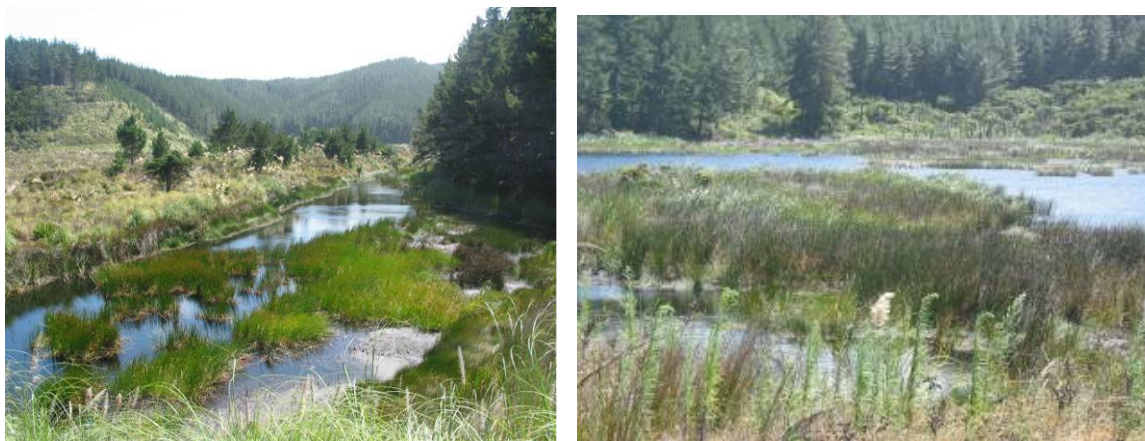
**Plate A:** Te Riu Lagoon, showing the west half of the lagoon left and eastern on the right.

Lake condition monitoring every 5 years.

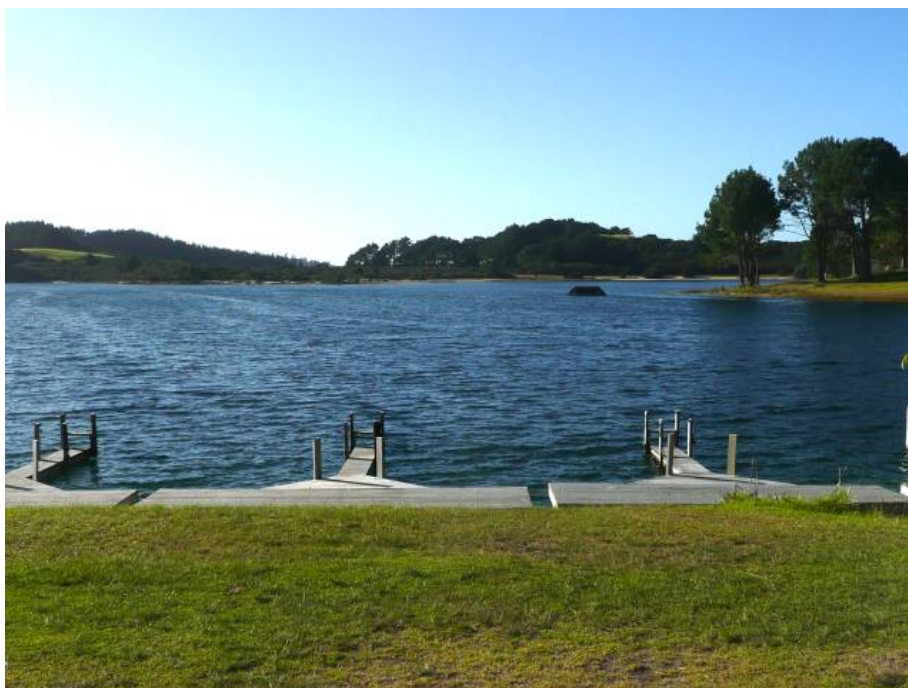
**Plate:** Lake Waikere, view from the boat ramp at the west end of the lake.

Pest plant surveillance at access points annually. Lake condition monitoring every 5 years.

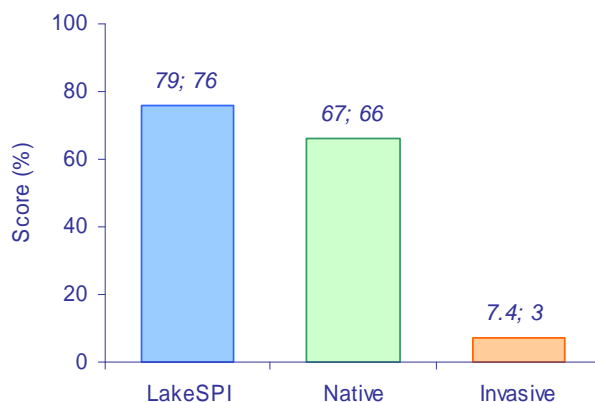
**Figure:** 2007 LakeSPI Index as % of potential score, Native Condition Index, and Invasive Impact Index (from left to right) with 2005; 2007 values shown respectively.

A relatively high LakeSPI score of 76% driven by the large extent of vegetation development, presence of charophyte meadows with little impact from invasive exotic plants.
