# MANGERE CATCHMENT

## WATER QUALITY UPDATE

Date: April 2016

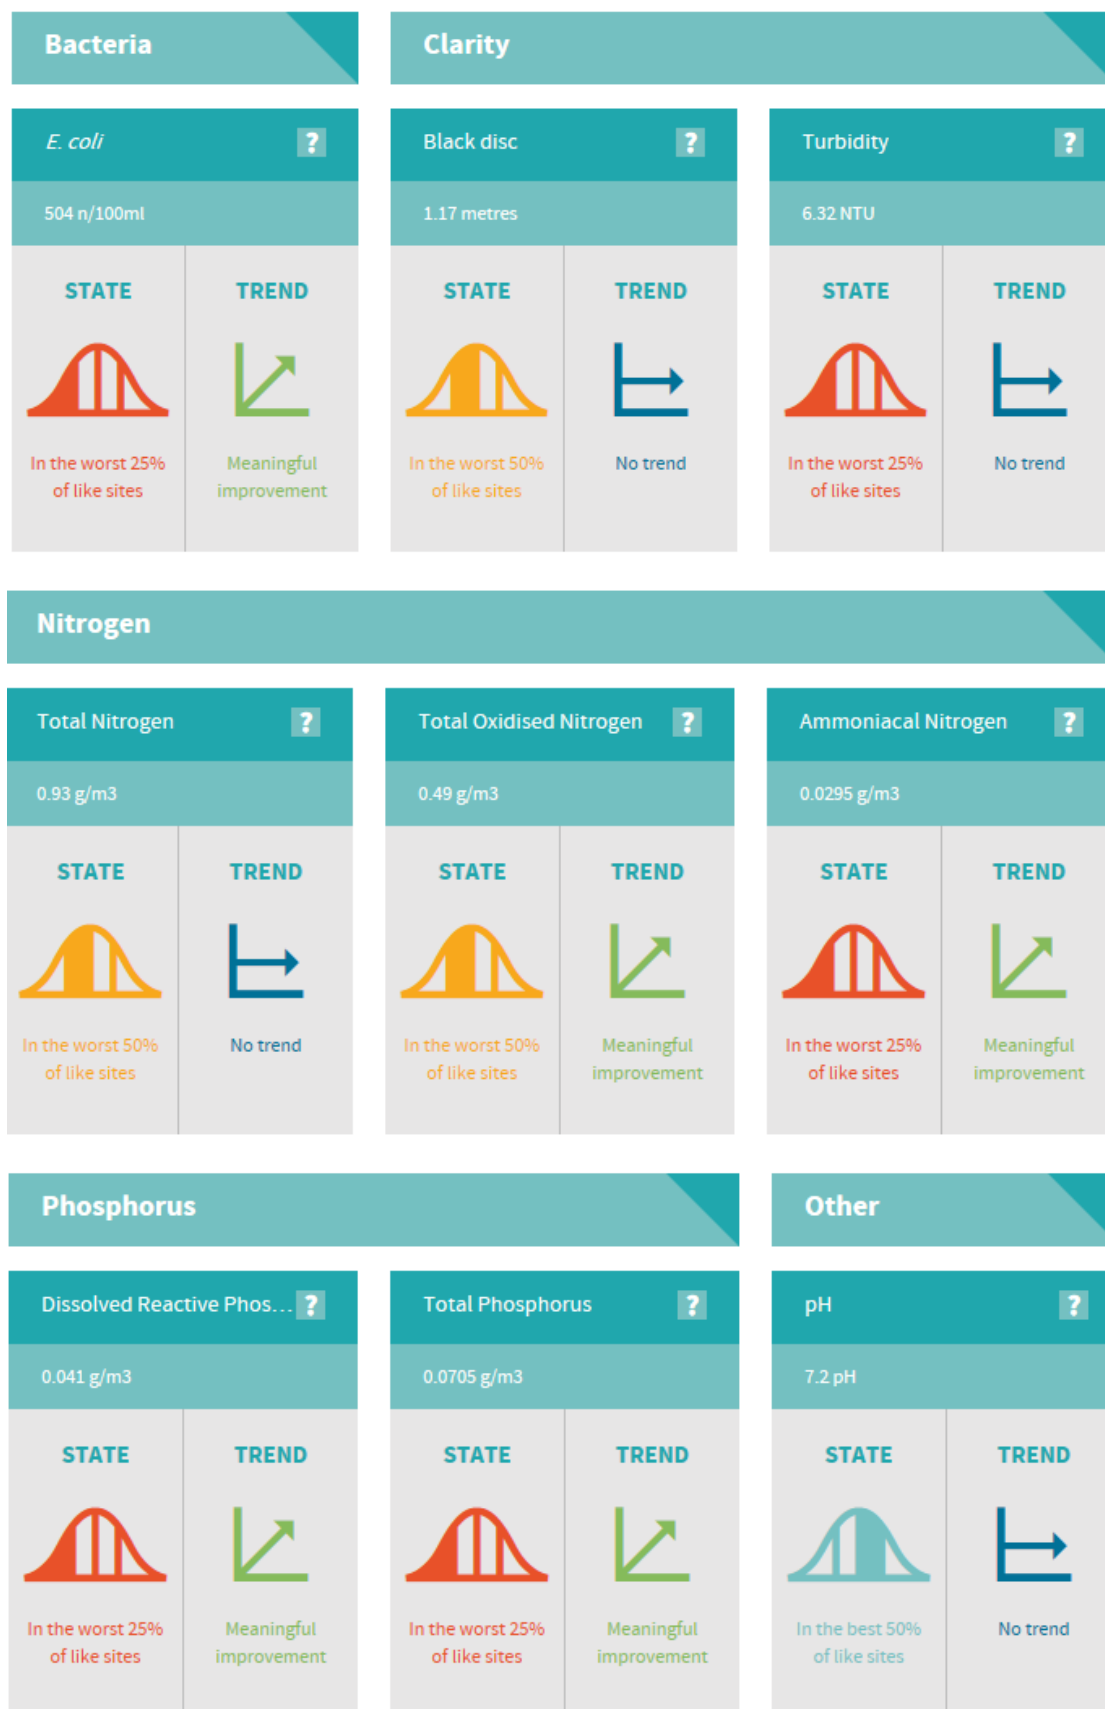
Figure 2: Current water quality state of the Mangere at Knight Road RWQMN site compared to similar sites in New Zealand with 10 year trends for nine water quality parameters (excerpt from Land Air Water Aotearoa (LAWA) website).

Currently the only site with long term water quality data in the Mangere catchment is the Mangere at Knight Road which is a RWQMN site as well as being one of the priority catchment sites. This site has been monitored since 1996 and has traditionally had some of the poorest water quality results in the Northland Region. It currently has results for *E. coli*, turbidity, ammoniacal nitrogen, dissolved reactive phosphorous and total phosphorous which rank it amongst the worst 25 percent of similar sites in New Zealand as reported on the Land Air Water Aotearoa ([LAWA](http://www.lawa.org.nz))<sup>1</sup> website (Figure 2).

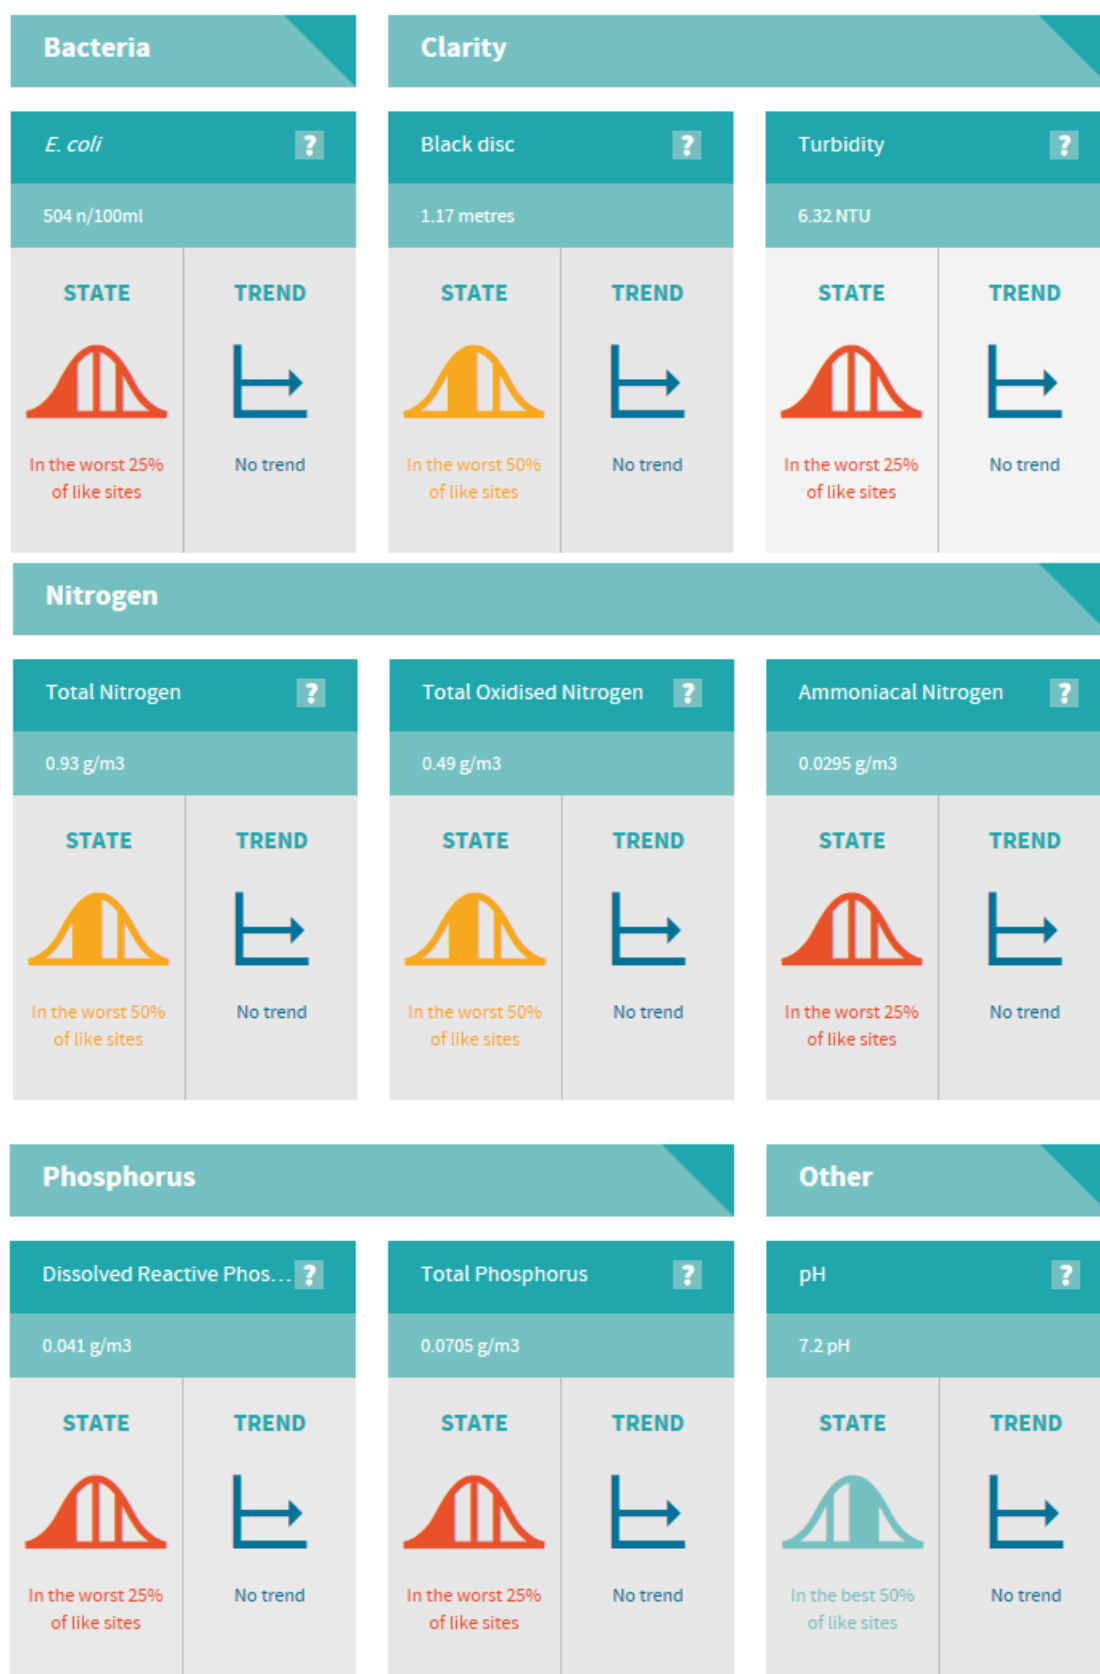
Figure 3: Current water quality state of the Mangere at Knight Road RWQMN site compared to similar sites in New Zealand with five year trends for nine water quality parameters (excerpt from Land Air Water Aotearoa (LAWA) website).

Trend analysis for the past ten years show a number of meaningful improvements in *E. coli* and nutrient levels probably as a result of improved farm management practices as well as fencing and planting within the catchment (Figure 2). However, when the time period for analysis is reduced to the last five years, results indicate a levelling off with no meaningful improvement (Figure 3).

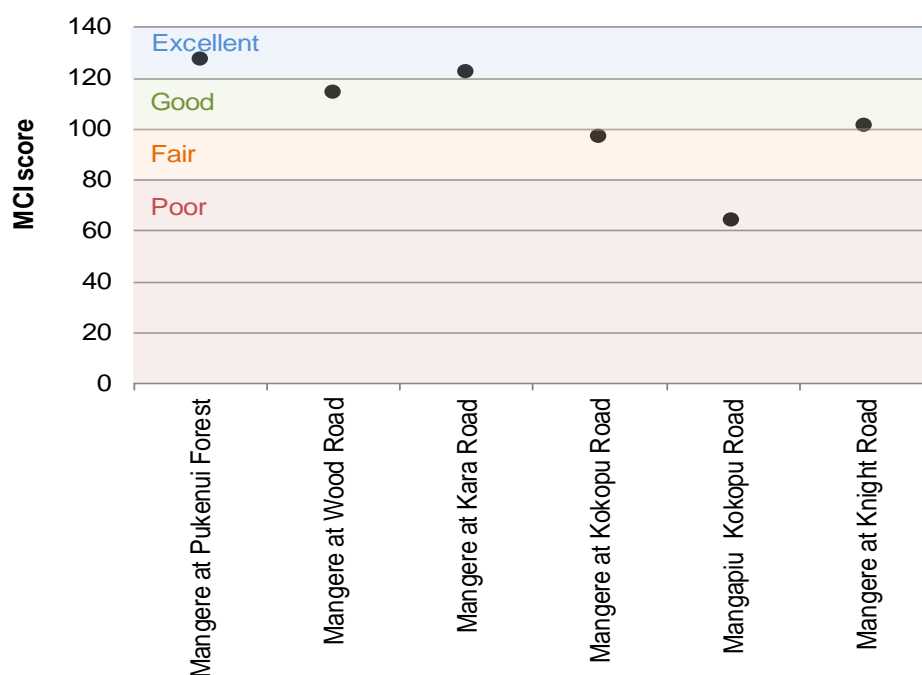
Figure 11: Macroinvertebrate Community Index results for Doubtless Bay, summer 2014/15.

Results for summer 2014/15 (Figure 11) suggest that:

- two sites have excellent water quality,
- two sites have good water quality,
- one site has fair water quality,
- and one has poor water quality.

The streams with the poorest macroinvertebrate scores correspond to those with the lowest dissolved oxygen levels (Figure 10): Mangapiu at Kokopu Road and Mangere at Knight Road. The Mangere at Pukenui Forest recorded the highest MCI score of all sites at 127 followed by the Kara Road site with an MCI score of 122.
