6 One Tree Point

Coastal Erosion Hazard Assessment

NORTHLAND REGIONAL COUNCIL
Coastal Erosion Hazard Assessment
One Tree Point
Site: 6

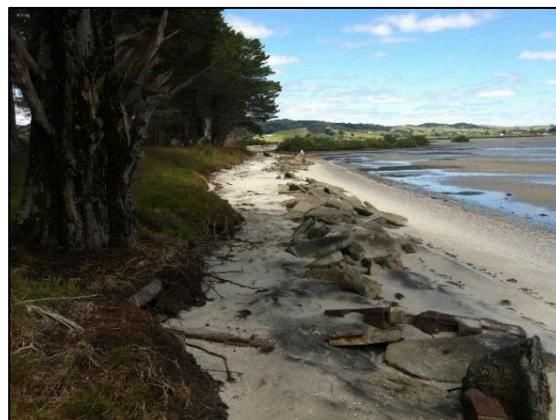
Site Photograph C (western spit shoreline)

The barrier spit located at the western end of the site has a relatively low backshore elevation and is experiencing erosion over the southern half of its extent. A sandy beach comprising fine sand exists along the spit shoreline, which transitions to intertidal mud flats approximately 10 m offshore.

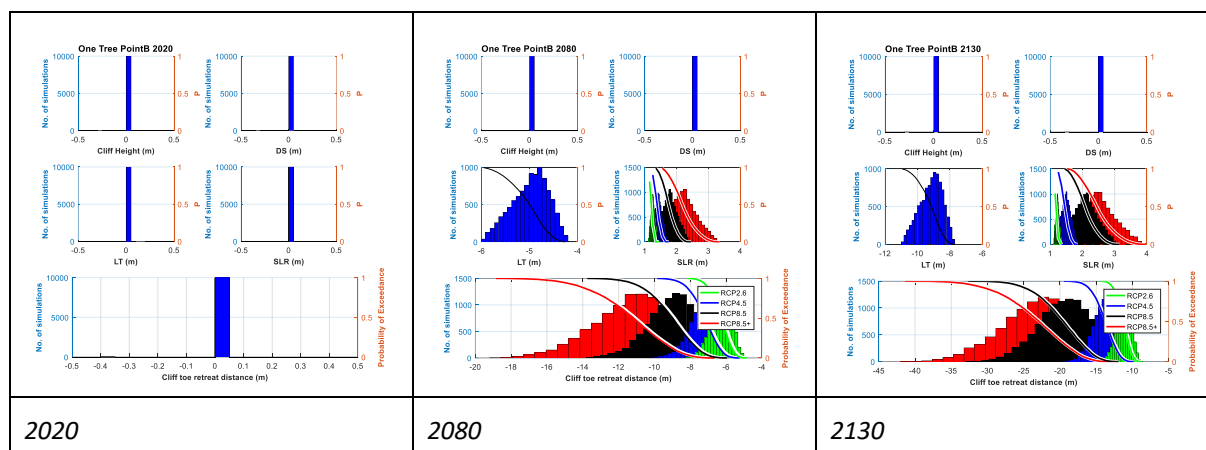
Figure 6-2 Histograms of parameter samples and the resultant shoreline distances for 2020, 2080 and 2130 timeframes for cell 6B

For cell 6B to cell 6D the cliff projection method has been adopted with future shoreline distances shown in Figure 6-2 to Figure 6-5 and Table 6-2 instead of CEHZ distances. The future shoreline (cliff toe) distances range from 4 to 8 m to 2080 and 13 to 23 m to 2130.

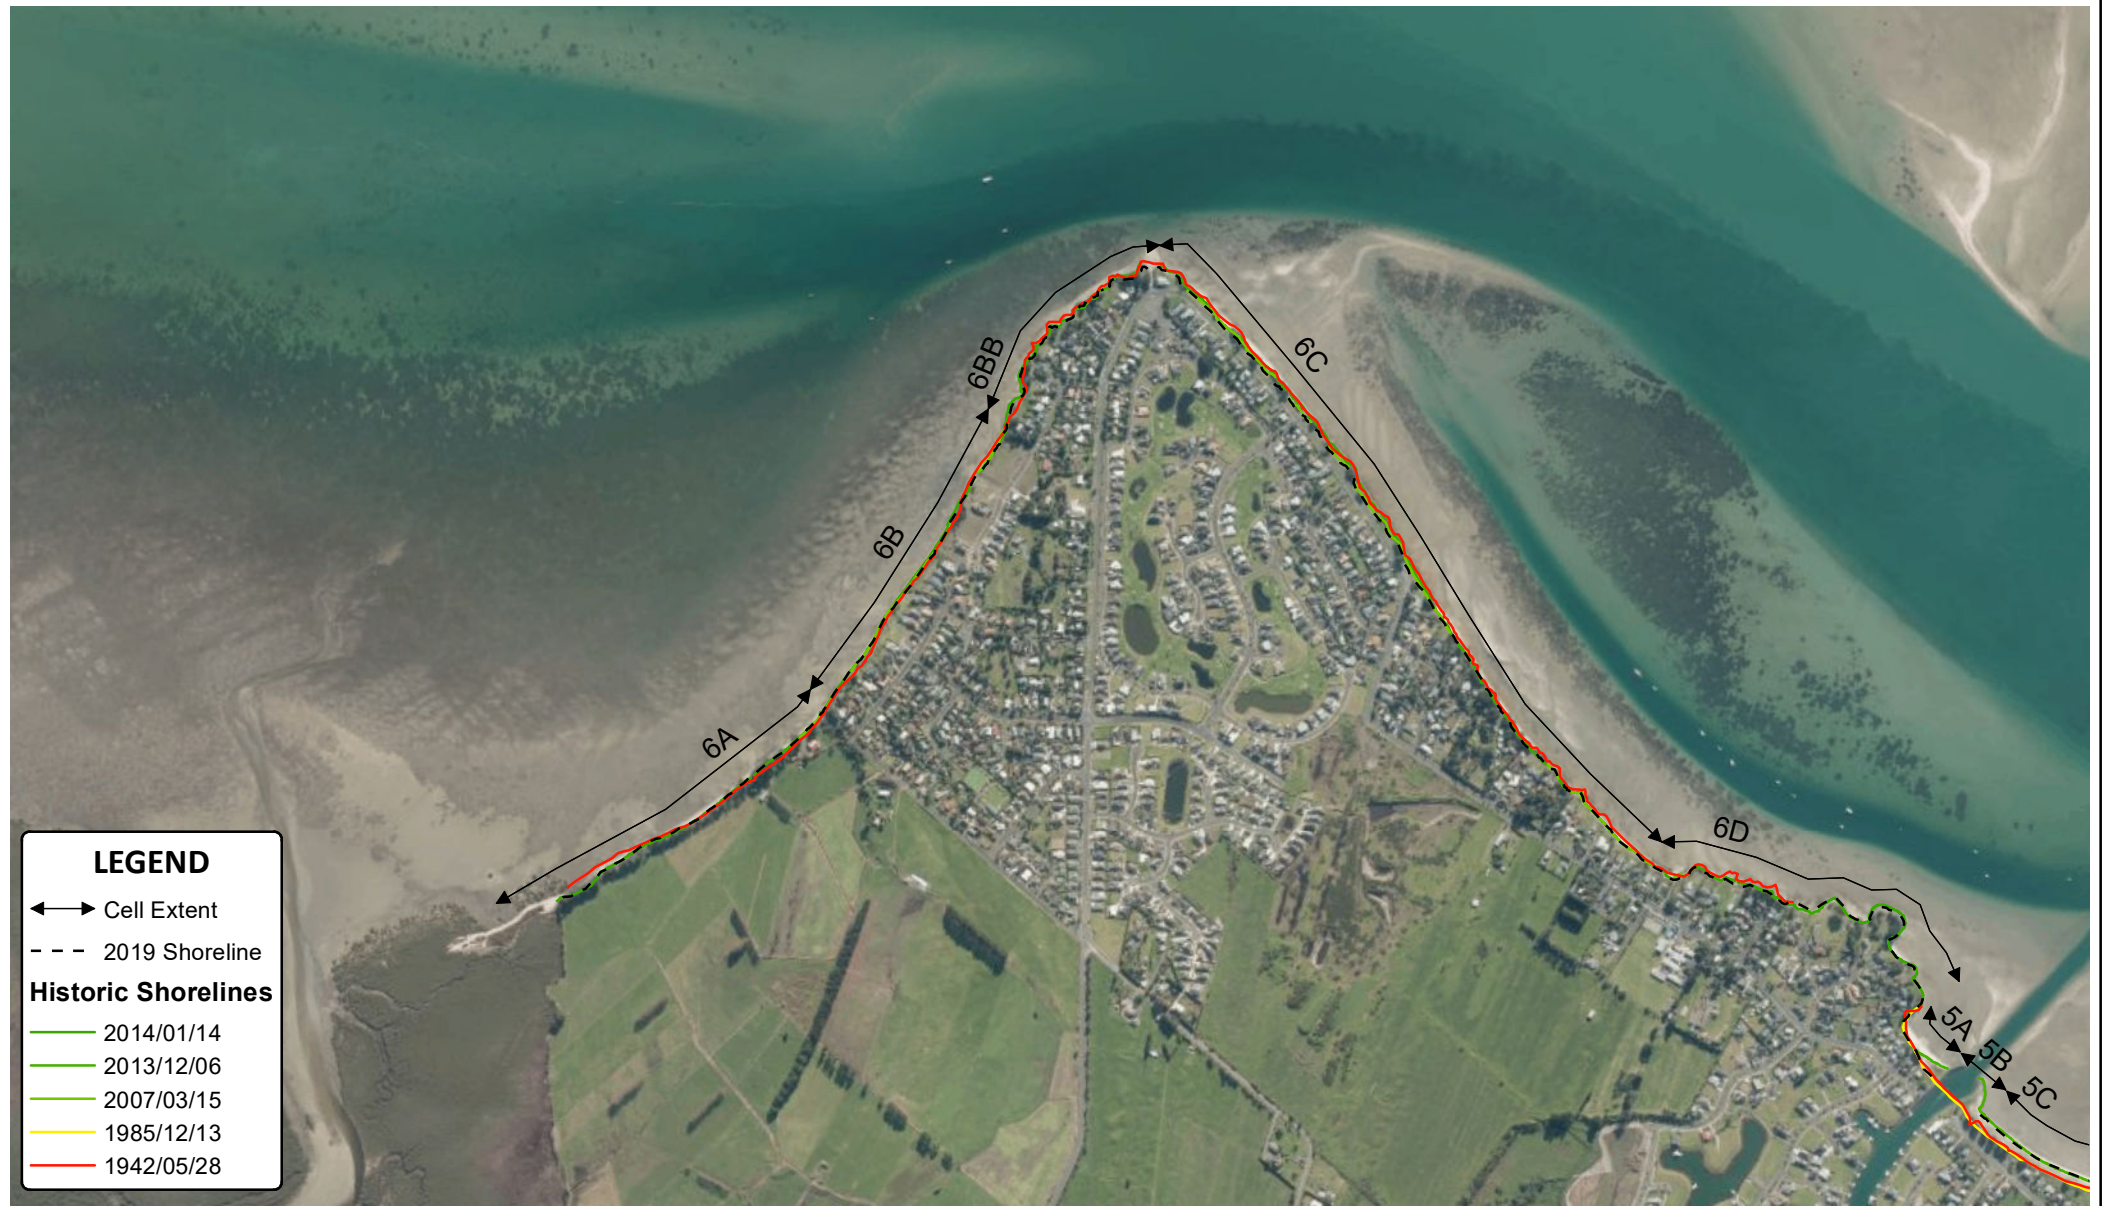
Historic Shorelines

Figure 6-7 shows the available historic shorelines for One Tree Point.
