3 Ruakaka

Coastal Erosion Hazard Assessment

NORTHLAND REGIONAL COUNCIL
 Coastal Erosion Hazard Assessment
 Ruakaka
 Site: 3

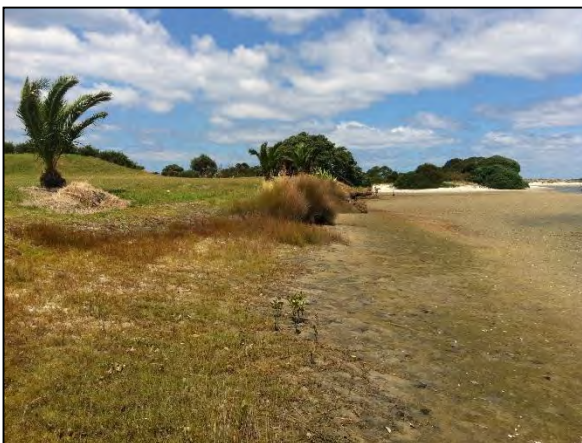
Site Photograph A (estuary)

The shoreline within the estuary has a more varied dune crest elevation, which has experienced larger shoreline fluctuations over time. The river entrance has spit features located on both the north and south side of the channel. The spit features have grown in toward the channel over time. The main channel follows the southern shoreline and has caused some erosion to the inside of the spit.

The estuary shoreline and associated spits are dynamic and have changed significantly over time. The spit south of the river has generally built out in a northerly direction. A historic spit feature has been stranded within the estuary as the shoreline has prograded seaward. This is the current location of the Ruakaka camp ground. We have used the historic 1960 shoreline as a baseline in this area to allow for the inlet migration over time.

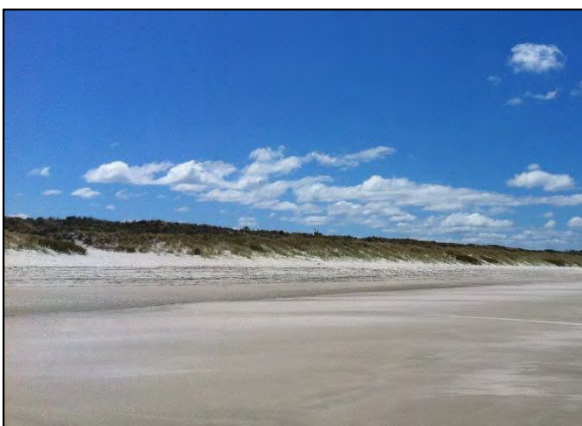
Site Photograph B (south)

The open coast shoreline has a sandy beach comprising fine sand. The beach has a minimal berm width of less than 5 m above the high tide line. The dune system is in a relatively healthy state mostly covered by spinifex vegetation. The dune system has crest elevations of between RL 3 to 9 m.

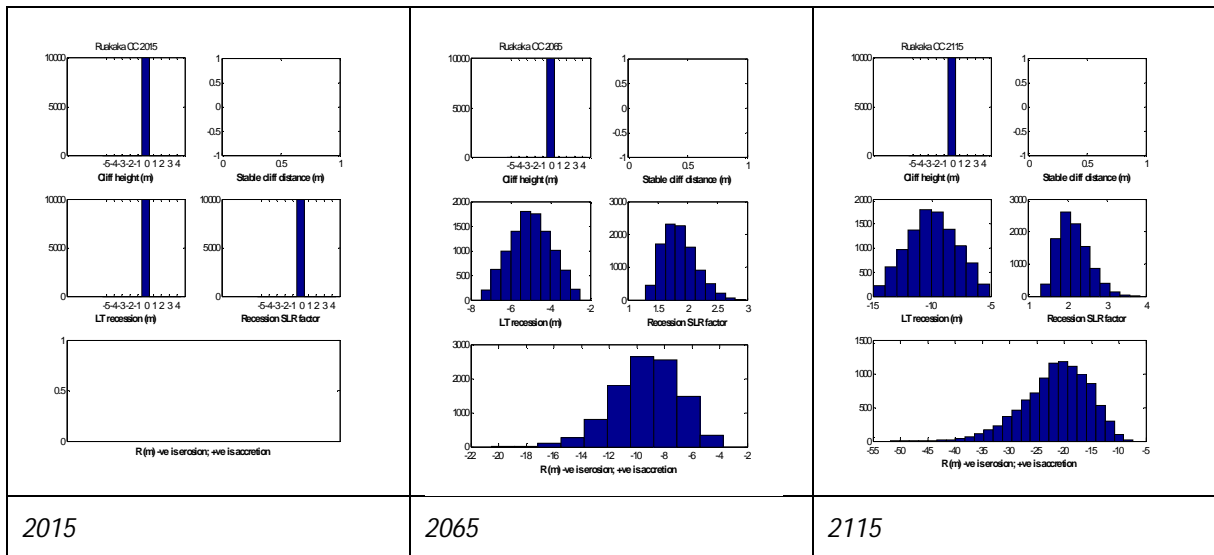
Figure 3-4 Histograms of parameter samples and the resultant shoreline distances for 2015, 2065 and 2115 timeframes for cell 3CC

Histograms of individual components and resultant CEHZ distances using a Monte Carlo technique are shown in Figure 3-1 to Figure 3-6. Coastal Erosion Hazard Zone widths are presented within Table 3-2 and Figure 3-7.

For cell 3CC the cliff projection method has been adopted with future shoreline distances shown in Figure 3-4 and Table 3-2 instead of CEHZ distances.

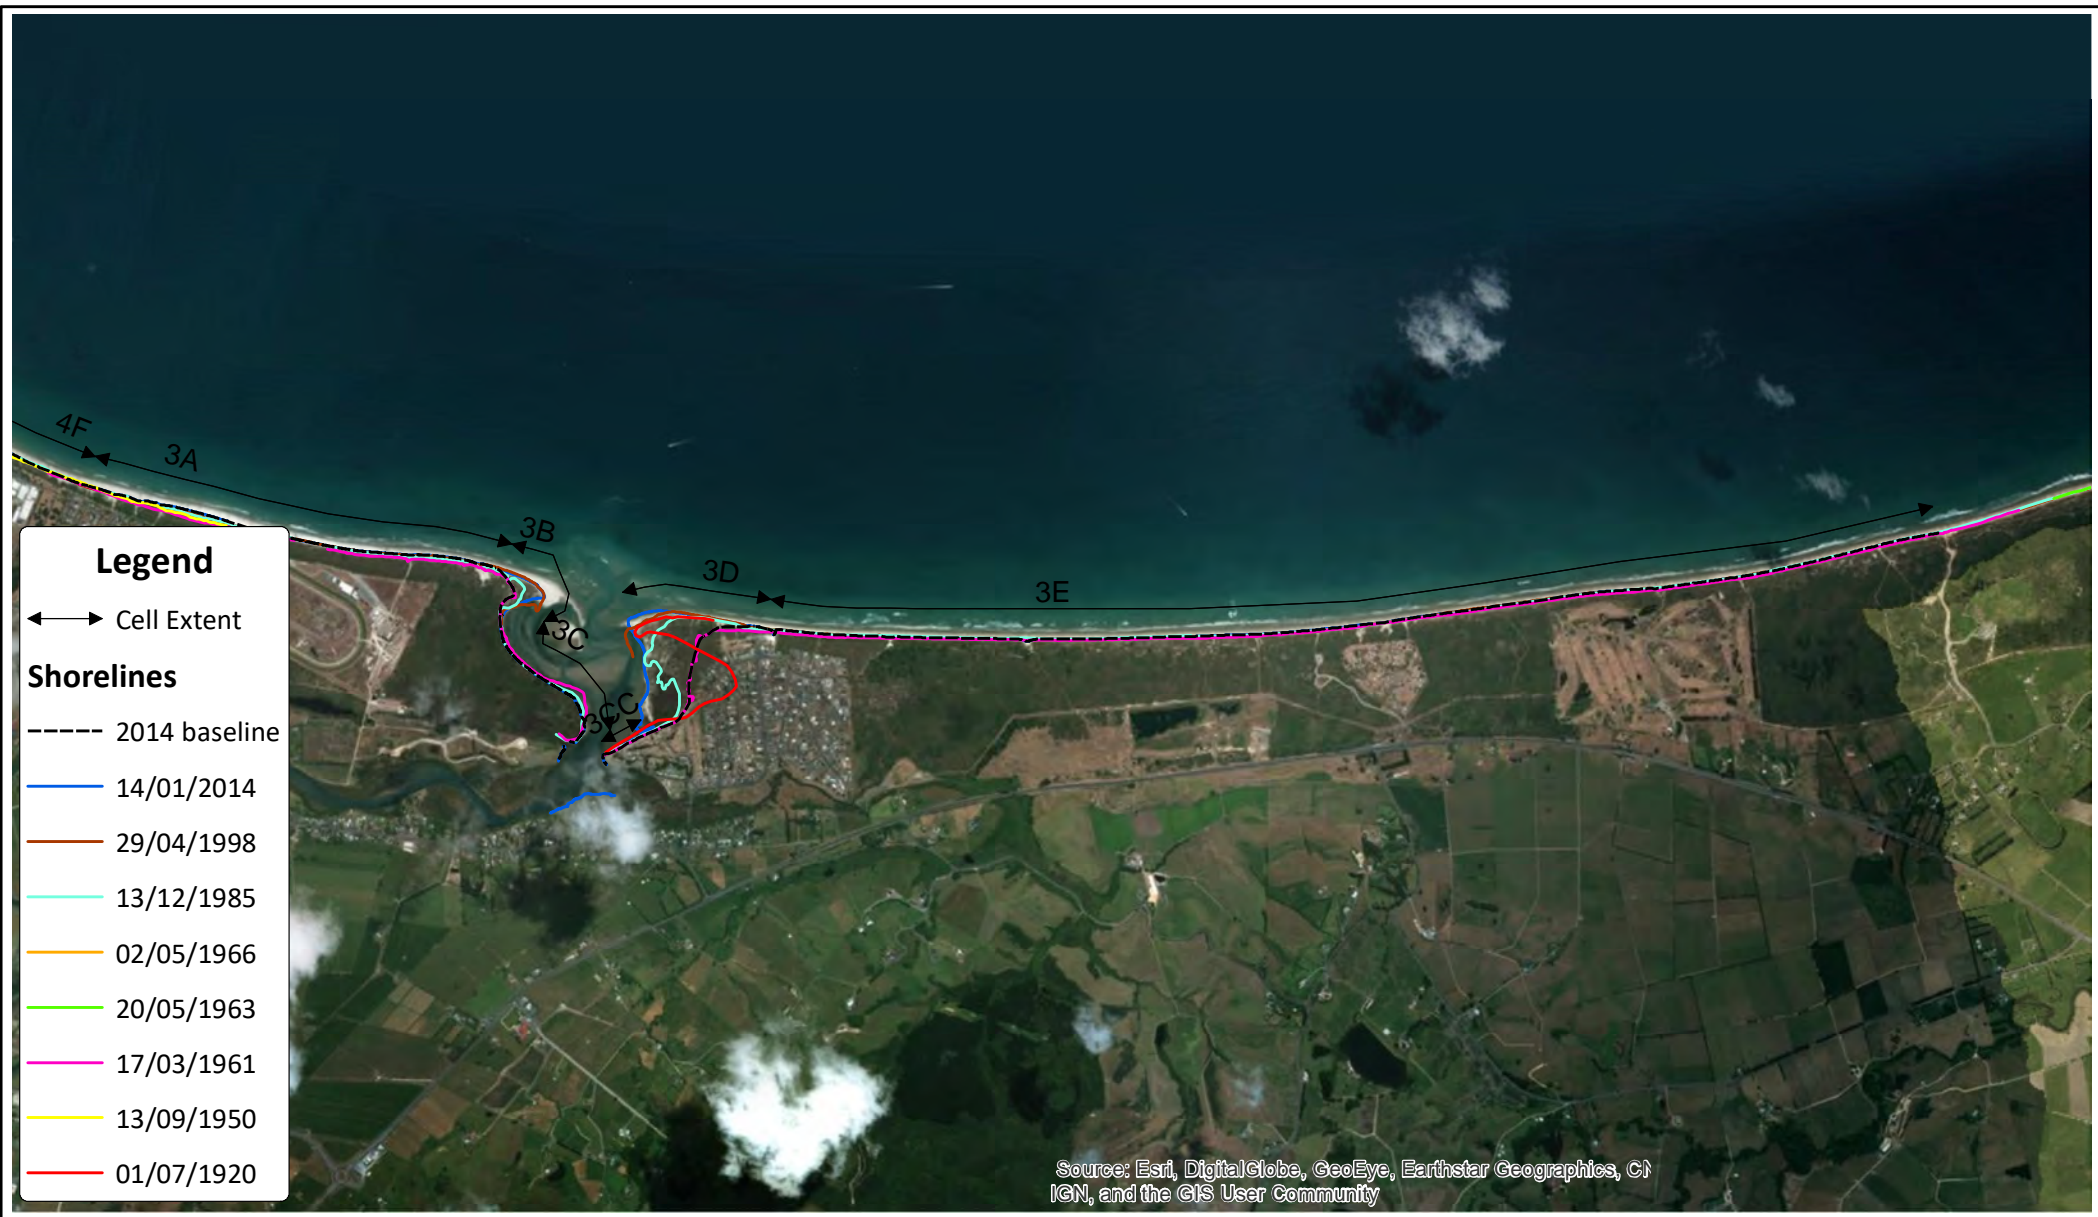
| FIGURE No. | Figure 3-8 | Rev. | 2 |

NORTHLAND REGIONAL COUNCIL
Historic shorelines
Ruakaka
Site: 3

Figure 3-8 shows the available historic shorelines for Ruakaka.
