Recreational Swimming Water Quality in Northland Summer 2019-20

Recreational Swimming Water Quality in Northland

Summer 2019-20

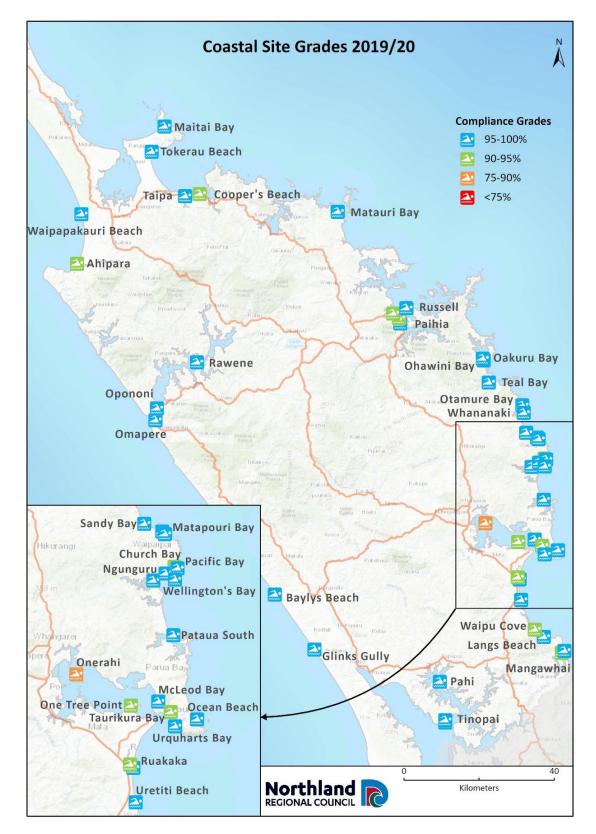
Figure 1: Coastal end of season grading 2019-20

Figure 1 displays the end of season grades for samples taken from each of the 46 coastal sites monitored in Northland during the 2019-20 sampling season (2 December 2019 to 2 March 2020). The grades indicate the percentage of samples which fell within the "suitable" for swimming category at each site over the summer period.

Each 'Action' result has been cross-referenced with accumulated rainfall data collected 72 hours prior to sampling, indicating whether rainfall related runoff from land was contributing to elevated results (refer to tables below). Overall, seven 'Action' level results were recorded for six of the 46 coastal sites, of which 14 percent were likely to have been related to rainfall.

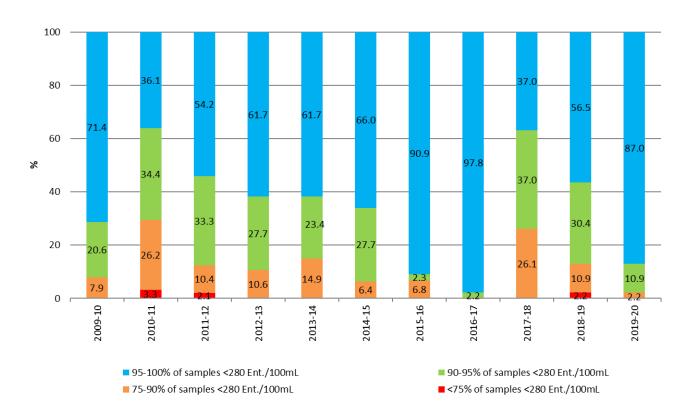
Figure 2: Yearly overall percentage of coastal sites with corresponding percentage of samples within each category from 2009 to 2020.

Eighty-seven percent of sites monitored in 2019-20 had more than 95 percent of samples fall within "suitable" level guidelines. No coastal sites had less than 75 percent compliance with the guidelines. Overall, the results from faecal indicator bacteria testing in 2019-20 were better than 2018-19 which is likely attributed to less rainfall events during the summer.

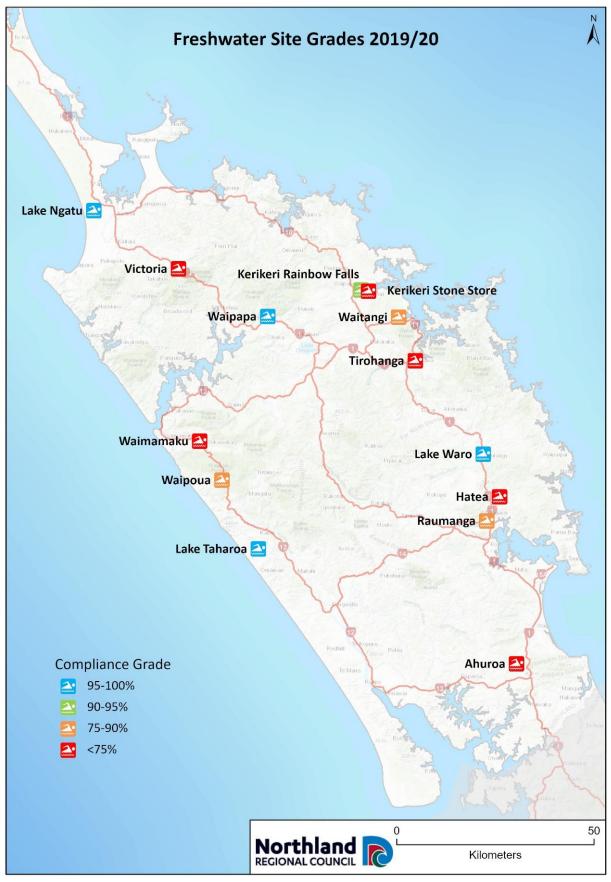
Figure 3: Freshwater end of season grading 2019-20

Figure 3 displays the end of season grades for samples taken from each of the 14 freshwater sites monitored in Northland during the 2019-20 sampling season (2 December 2019 to 2 March 2020). The grades indicate the percentage of samples which fell within the "suitable" for swimming category at each site over the summer period.

Each 'Action' result has been cross-referenced with accumulated rainfall data collected 72 hours prior to sampling, indicating whether rainfall related runoff from land was contributing to elevated results (refer to tables below). Overall, 20 'Action' level results were recorded for seven of the 14 freshwater sites, of which 35 percent were likely to have been related to rainfall.

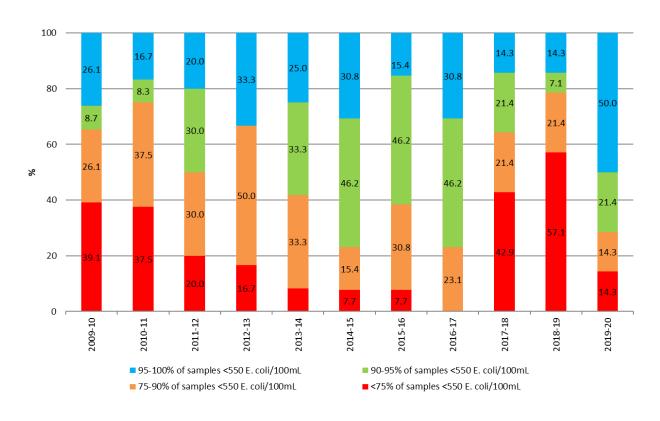
Figure 4: Yearly overall percentage of freshwater sites with corresponding percentage of samples within each category from 2009 to 2020.

Over 70 percent of sites in 2019-20 had more than 90 percent of samples fall within the "suitable" faecal indicator bacteria levels. This is higher in comparison to 2018-19 which recorded around 20 percent of sites in the same category. Around 14 percent of sites fell in the less than 75 percent compliance category in 2019-20 which is less than previous results.
