North of Dargaville

Waipoua Lagoon South (Waipoua) NRC Lake No. 201

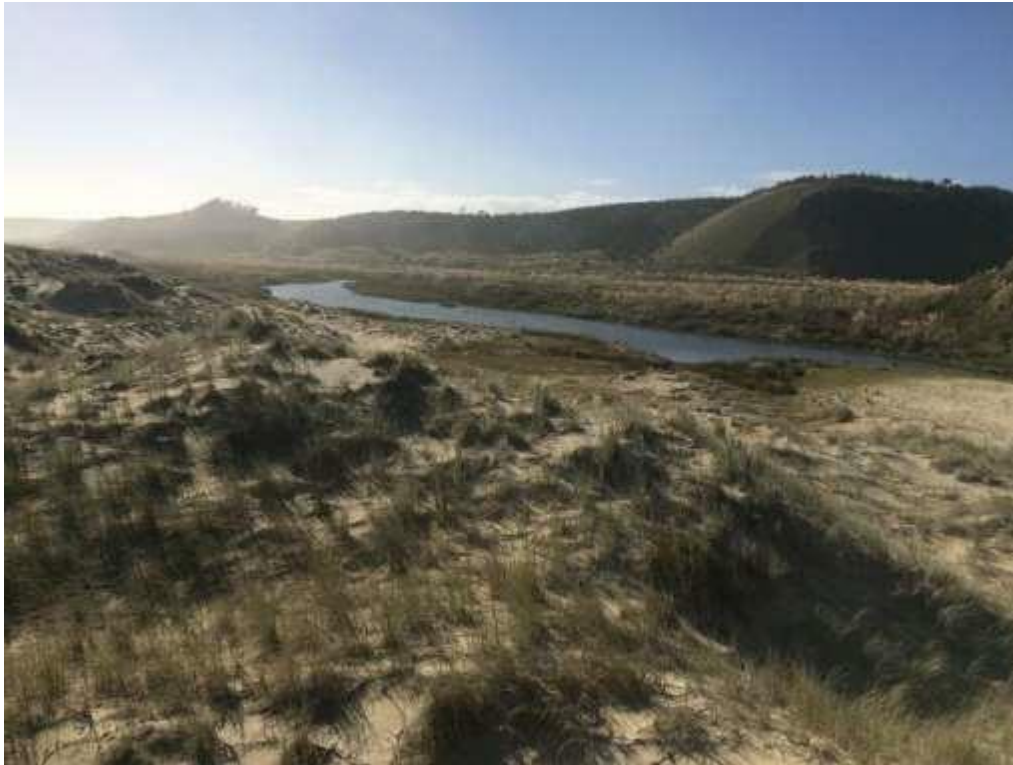
Figure 3-10: Waipoua Lagoon South. Photo taken from the southern end (Photo: Lisa Forester, NRC 3 May 2018).

Moderate to Low: A narrow lagoon, situated at the seaward end of an unnamed stream, formed by dune encroachment at the outlet. A mostly native submerged vegetation, in water up to 1 m deep.

A small (0.63 ha) lagoon (1645020E, 6050455N) with a 30 m wide channel extending for around 250 m. The maximum depth was approximately 2 m. The seaward end of the catchment was open spinifex (*Spinifex sericeus*) and pampas (*Cortaderia selloana*) dominated duneland. The upper catchment of the unnamed stream was around 25% pine plantation forest, with the remainder a combination of pasture, scrub and wetland vegetation. Access is via 4-WD on forestry roads, then driving along the beach.

No monitoring.
