Addendum to the Archaeological Assessment of Effects: Awanui Flood Scheme Project

18 August 2020

Document: Archaeological Assessment of Effects: Awanui Flood Scheme Upgrade
 Ref: 2019-123
 Date: 20 August 2020
 Prepared by: Russell Gibb

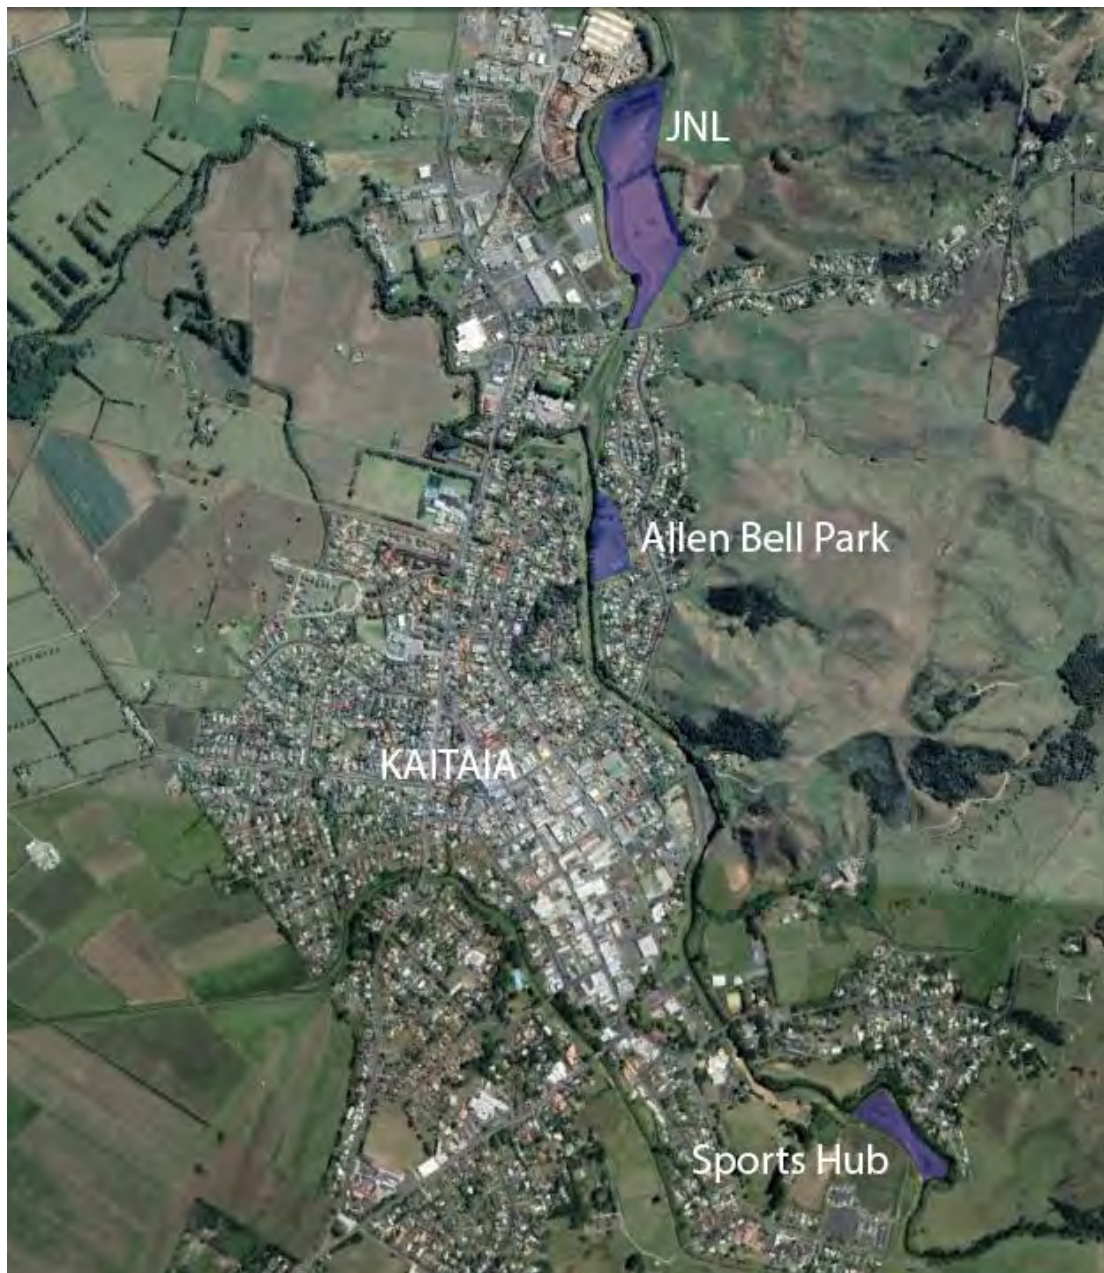
Figure 2: The three sites covered by HNZPT Authority 2020-338.

The first archaeological authority issued by HNZPT (2020-388) is for work at the JNL, Sports Hub and Allen Bell Park sites (Figure 2). To date, work has only been undertaken at the JNL site, which is 80% complete, with delays to the works programme attributed to the impacts of Covid-19 and associated lockdown periods. The JNL works were archaeologically monitored during the initial stripping of topsoil by machine excavator and with periodic visits during the earthworks also undertaken. Iwi representatives are also in attendance at times during the earthworks. No archaeological material has so far been encountered during the earthworks.

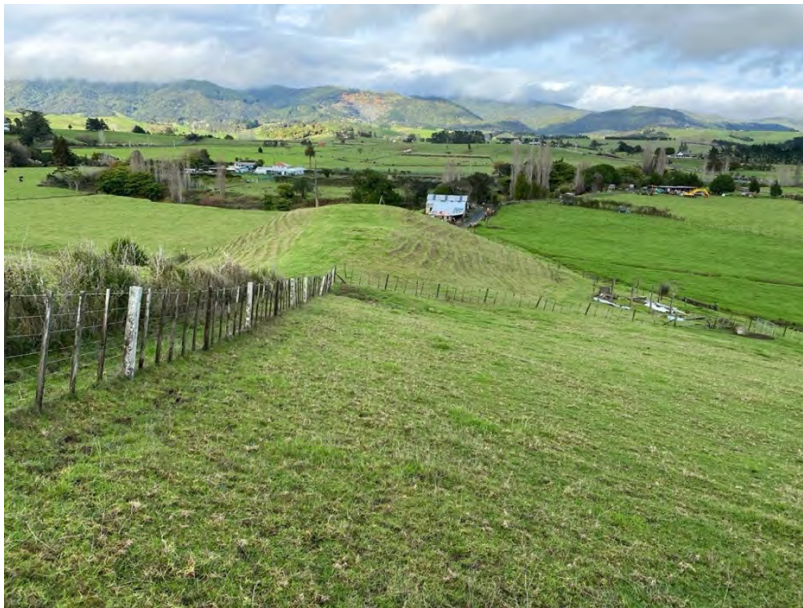
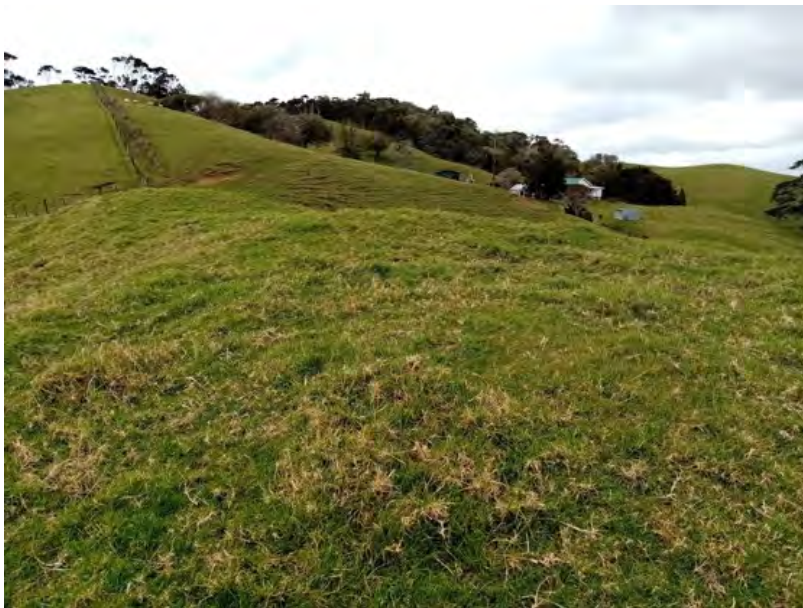
A small ridgeline pit and terrace site located on the flat area of the lower spur immediately north of the farm sheds on the Peterson property (Figure 5 - Figure 6). The site consists of several well defined platforms with pit depressions, which are likely to be whare sites, with some evidence of fire cracked rock and charcoal in stock-disturbed ground on the lower slope of the site. The site is in relatively good condition although there is some historic and recent stock damage. Cattle grazing continues on the site. The site does not continue upslope past the upper platform and there is no sign of defensive features at the site.

Figure 5: Looking south at the top of O04/1091.

Figure 6: Looking northeast across the top of O04/1091.

The spillway and fill areas that cross the Peterson property will affect two sites: O04/1091 and O04/1094. Part of the spur at the end of the ridge where O04/1091 is located needs to be removed to form a batter on the spur end to enable earthworks for the spillway. This is so the spillway can be formed across the paddock at a suitable distance from the bend in the river to protect the integrity of the new spillway and river bank. This will impact a section of the archaeological features on top of the spur which will require archaeological mitigation prior to the removal of the spur end. The extent of the works on the ridgeline are constrained by a power pole set in the site.

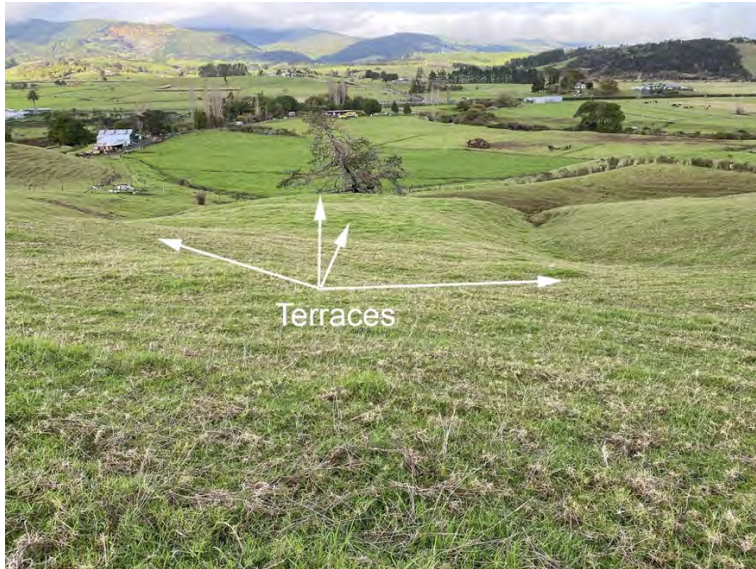
A number of terraces of varying sizes located on a south facing slope above and to the west of O04/1091 (Figure 7). The terraces are small slightly ephemeral terraces with no observable pit features and are in good condition. Old house or shed foundations are located on one of the lower southerly terraces (Figure 8). These likely relate to an 'old house' annotated on survey plan ML 9561 (1914). An existing track has been cut across the slope between the terraces but does not impact on any of the terraces.

Figure 7: Looking south at the terraces comprising site O04/1092.

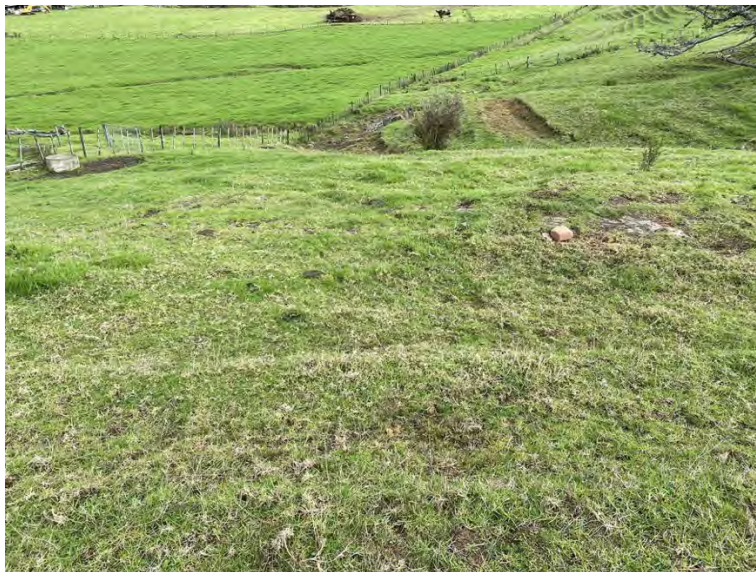
Figure 8: Westerly facing terraces with the remains of foundations on the mid terrace.

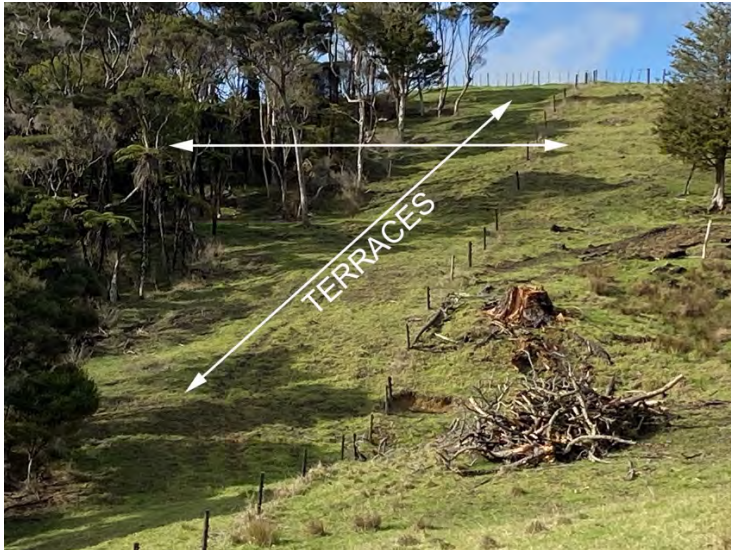
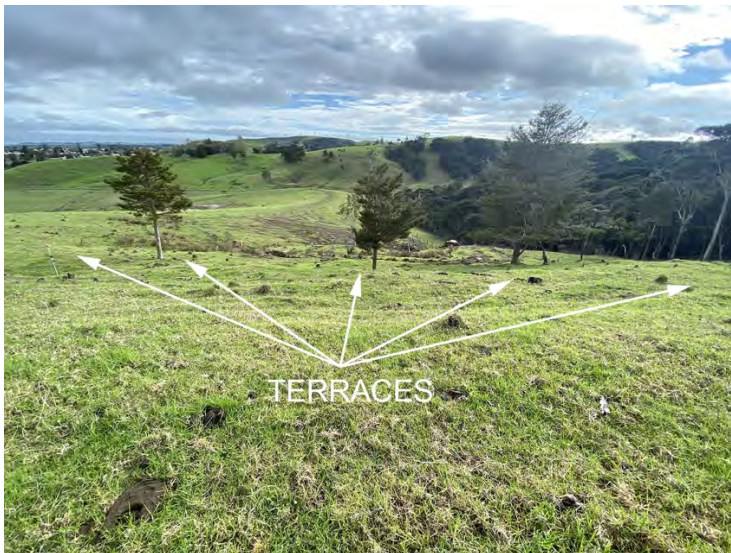
A large number of terraces located on the ridgeline above O04/1093 running down the spur and on the north facing slope overlooking the valley floor to the north (Figure 9 - Figure 10). The terraces on the ridgeline are small but well defined, with the terraces on the slope generally larger in size. The site extends some way into the neighbouring bush-covered property to the north but this area was not surveyed in detail as there was no access permission. It is possible that this site is part of Manurewa Pa (O04/139) located 400m to the east further up the same ridgeline, but this could not be verified without access to the property, nor verified by desktop as the area is covered in dense bush. The terraces are mostly well preserved with some evidence of past vegetation cover on a few terraces and one example of recent damage by tracking from an excavator (Figure 11).

Figure 9: Looking south upslope at the terraces. The terraces also run along the top of the ridgeline and in to the bush to the east.

Figure 10: Looking north down on the terraces on the slope.

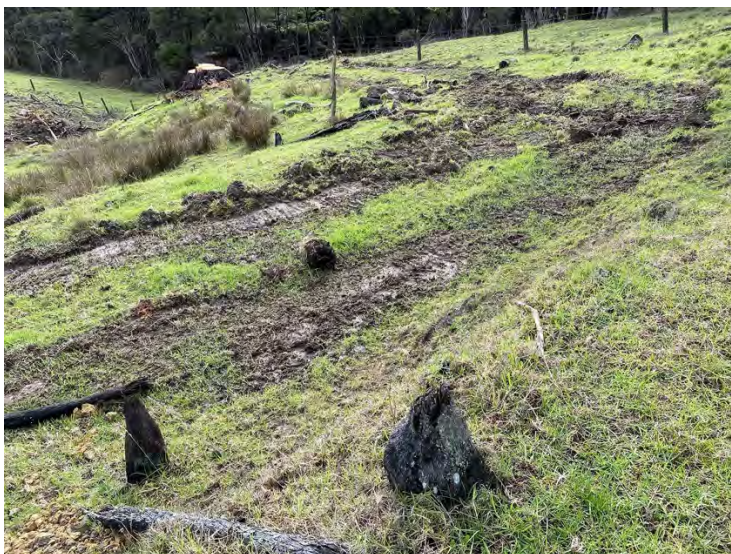
Figure 11: Recent tracking damage across a large terrace.

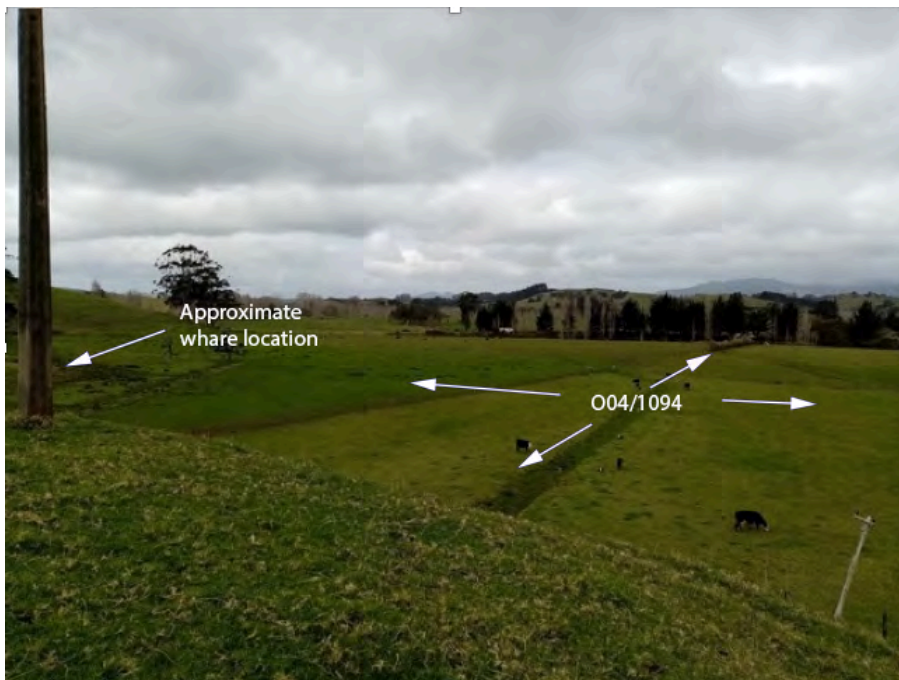
Figure 14: Looking southeast over O04/1094 and the approximate location of the old whare from site O04/1091.

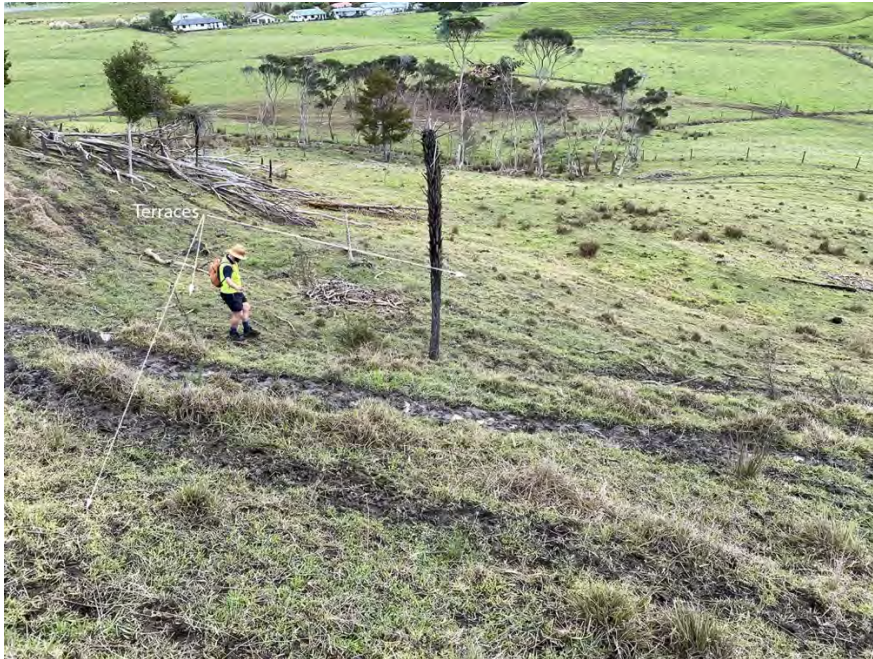
An area of terraces immediately southwest of, and approximately 100m, from the end of O04/1093. The terraces are well defined north facing features located on the slope immediately below the ridgeline (Figure 15).

Figure 15: Looking northwest over terraces.

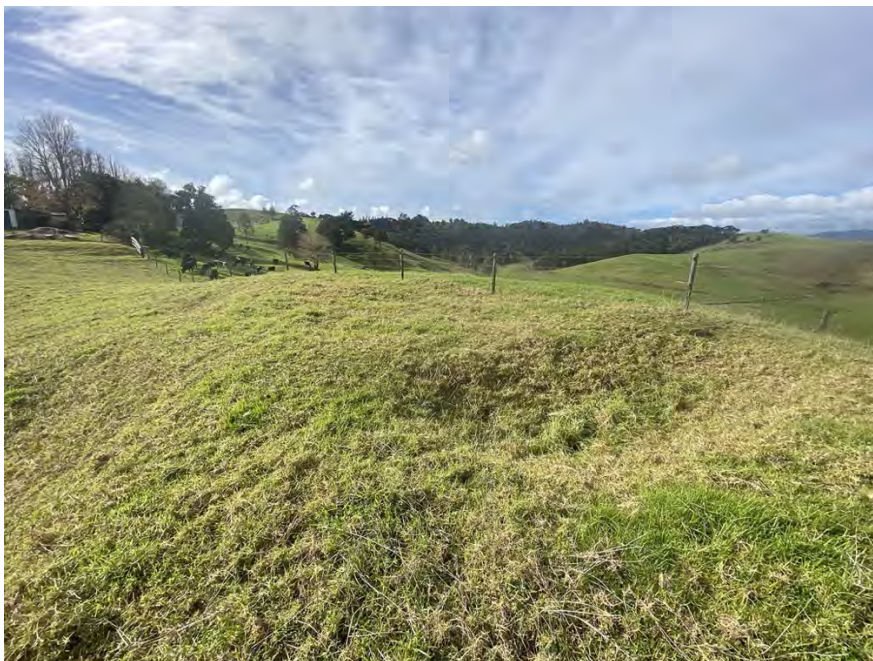
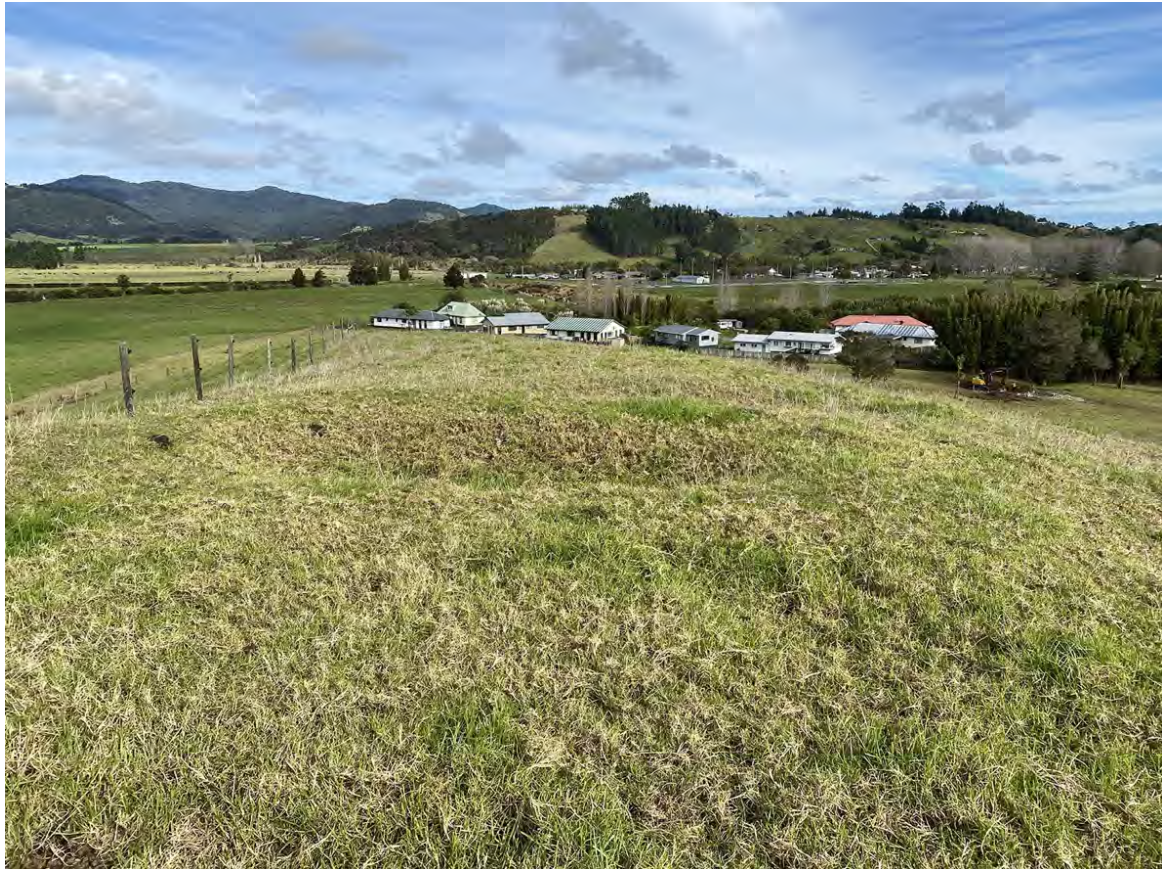
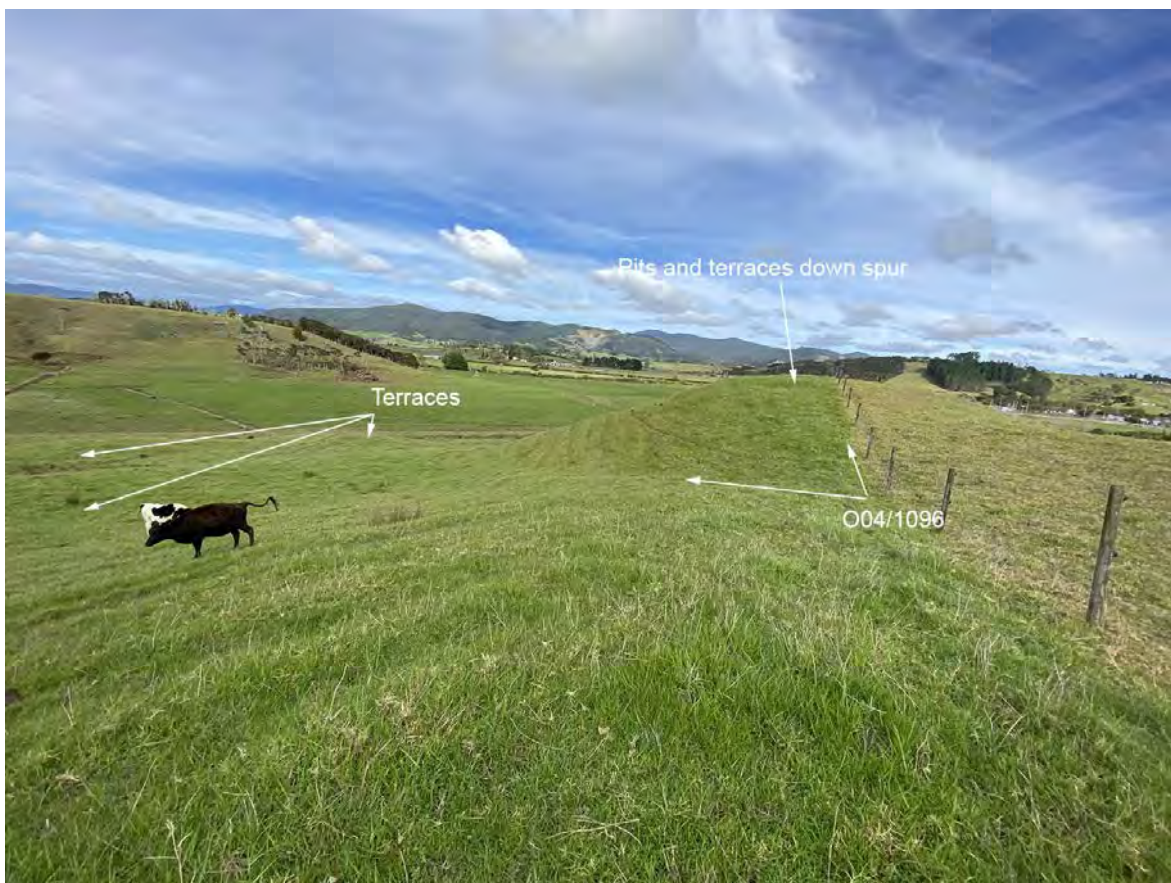
A pit and terrace complex with several well-preserved pits, ephemeral depressions and well defined terraces that flow down a south facing ridgeline. Immediately east of the ridge on the adjoining slope are several large terraces overlooking the valley floor (Figure 16 - Figure 18). This site is in excellent condition and possibly extends further upslope to the top of the ridge where an old house is now located, and which may have utilized terraces that were once part of the site.

Figure 16: Looking northeast across the top platform with a large pit in the foreground.

Figure 17: Large pit on the top platform of O04/1096.

Figure 18: Looking south from the top of O04/1096 with large terraces to the east.

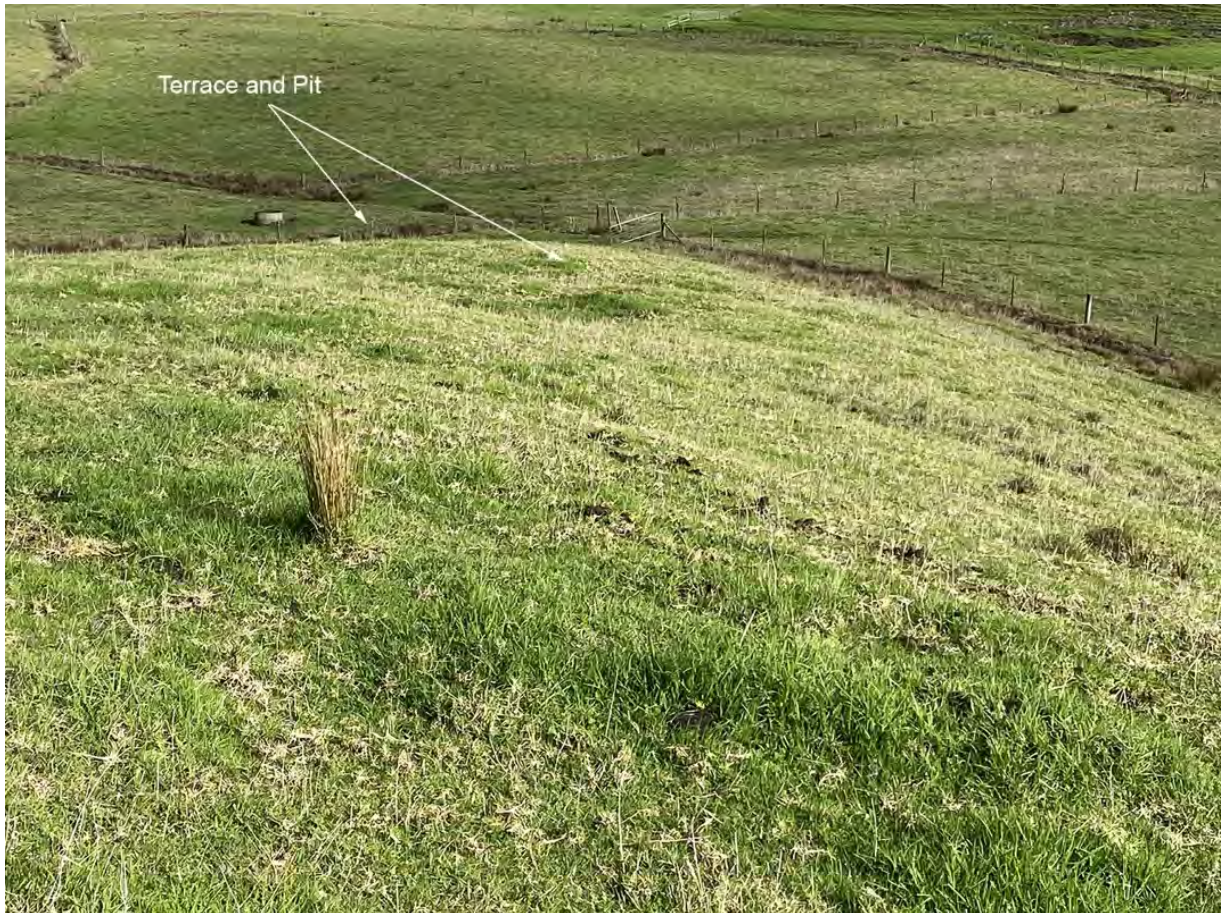
A small set of terraces with some ephemeral pit features located on a low lying westerly facing slope that joins up to the ridgeline where O04/1093 and O04/1095 are located (Figure 19).

Figure 19: Terraces and pits on O04/1097.

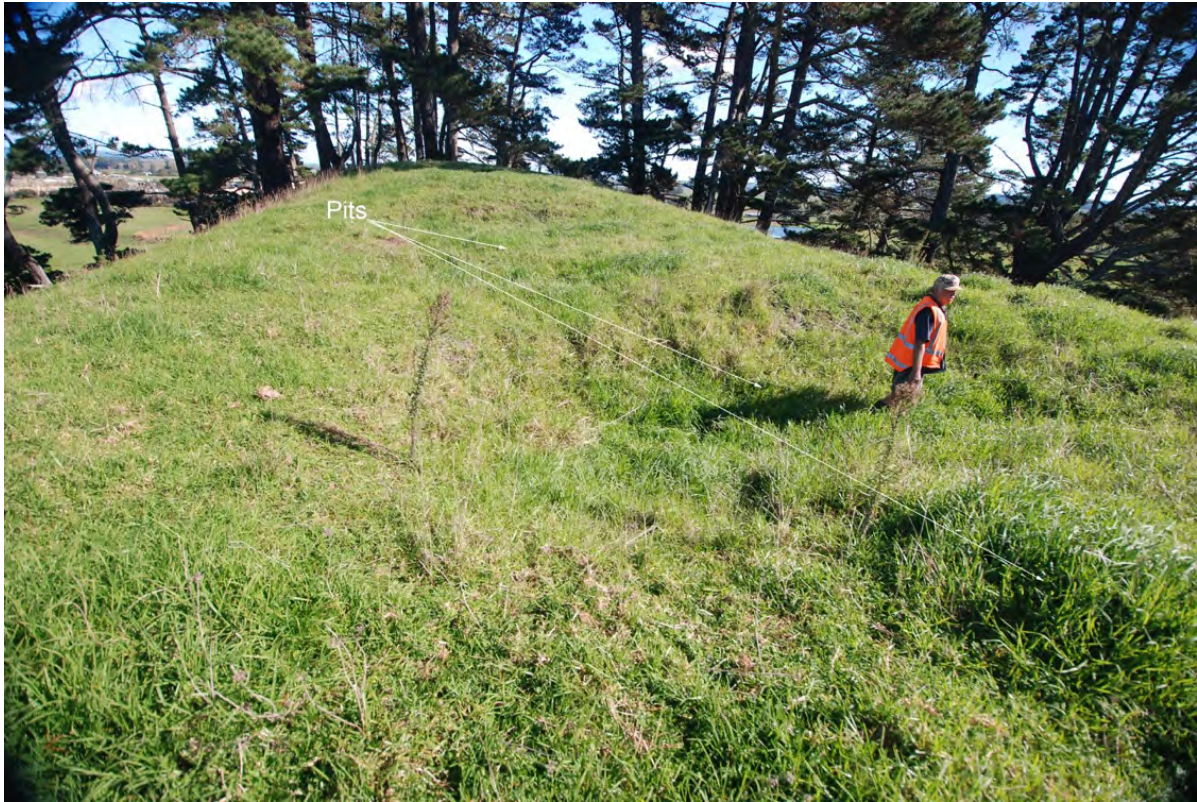
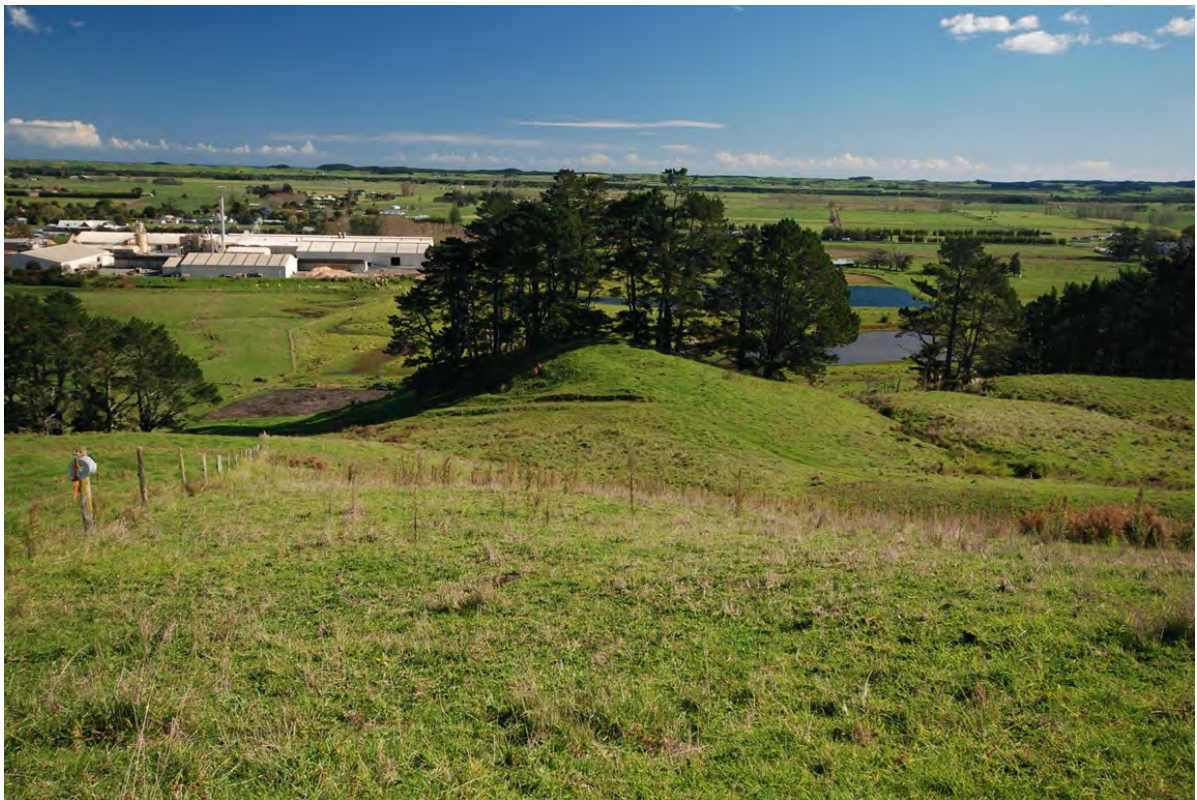
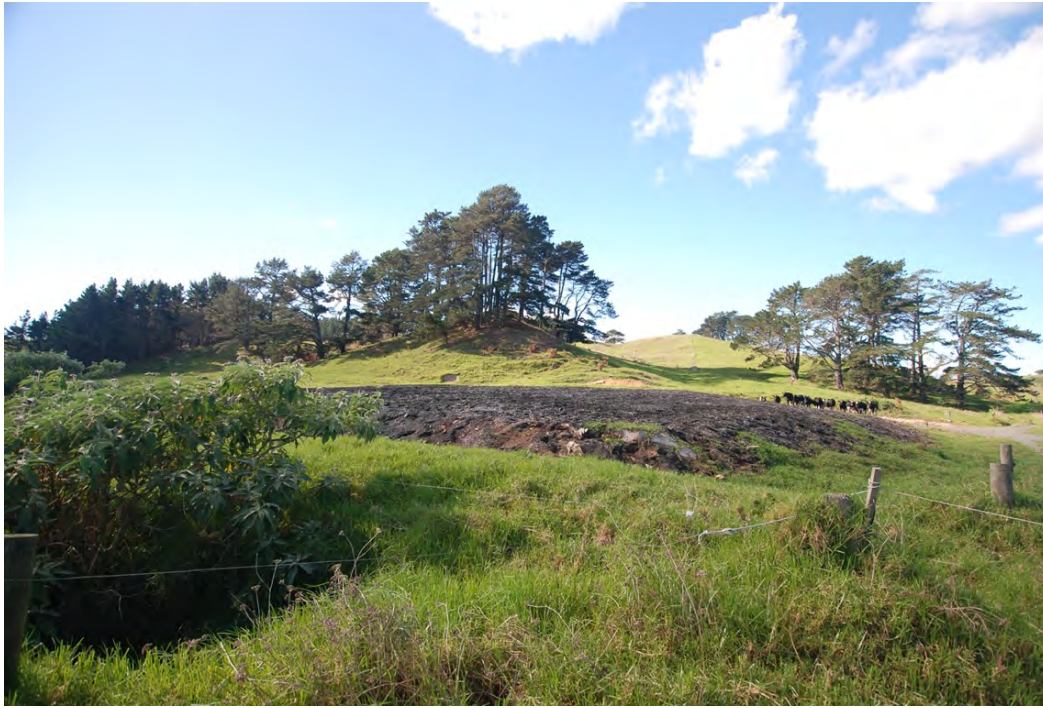
A large pit/terrace site located on the spur at the end of a west facing ridge, immediately east of the JNL site. The site consists of seven pits, three of which are large, well defined pits located over two main platforms long the end of the spur (Figure 20 - Figure 21). There is some evidence of terracing along the lower face of the spur. A stand of pines is located at the end of the spur and down the front slope and a farm track is located along the eastern edge of the site, but the site appears to have suffered little damage. Where the bottom of the spur connects to the lower plain there is an area of material (wood byproduct) that has been dumped and leveled by the mill, and the face of the natural scarp slightly modified to accommodate this (Figure 22).

Figure 20: Looking across the main platform and alignment of large pits.

Figure 21: Looking down at O04/1098 (in front of pines) with the JNL in the background. This photo was taken from the western edge of pa site O04/1099.

Figure 22: Looking east towards O04/1098 (beyond pines) with spoil heap in front of the site.

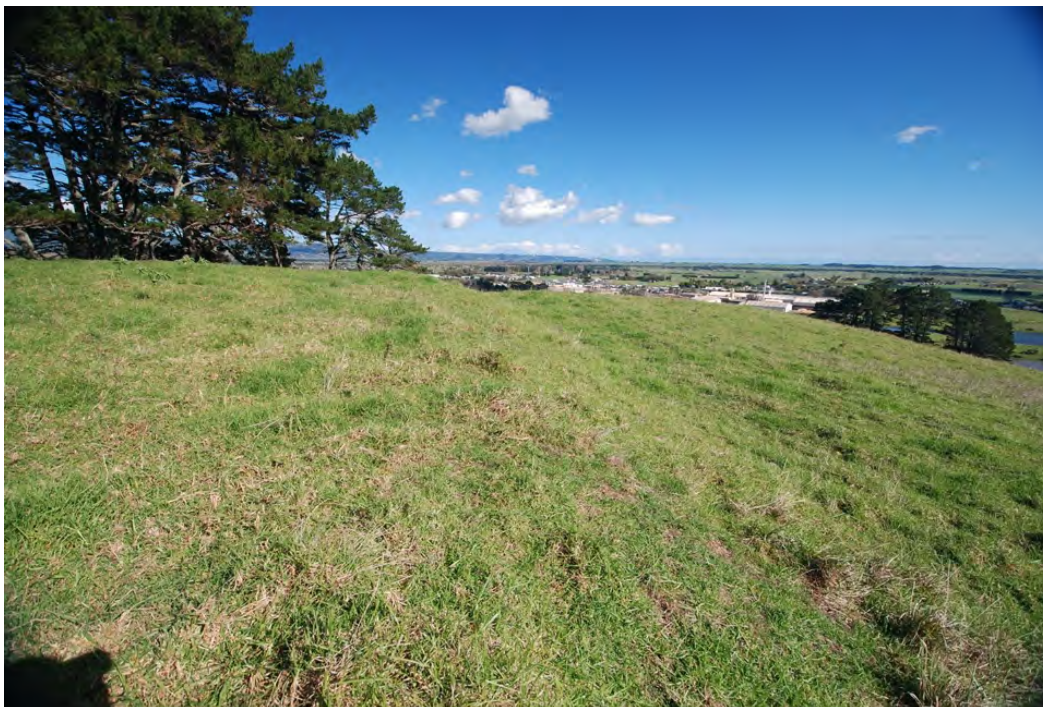
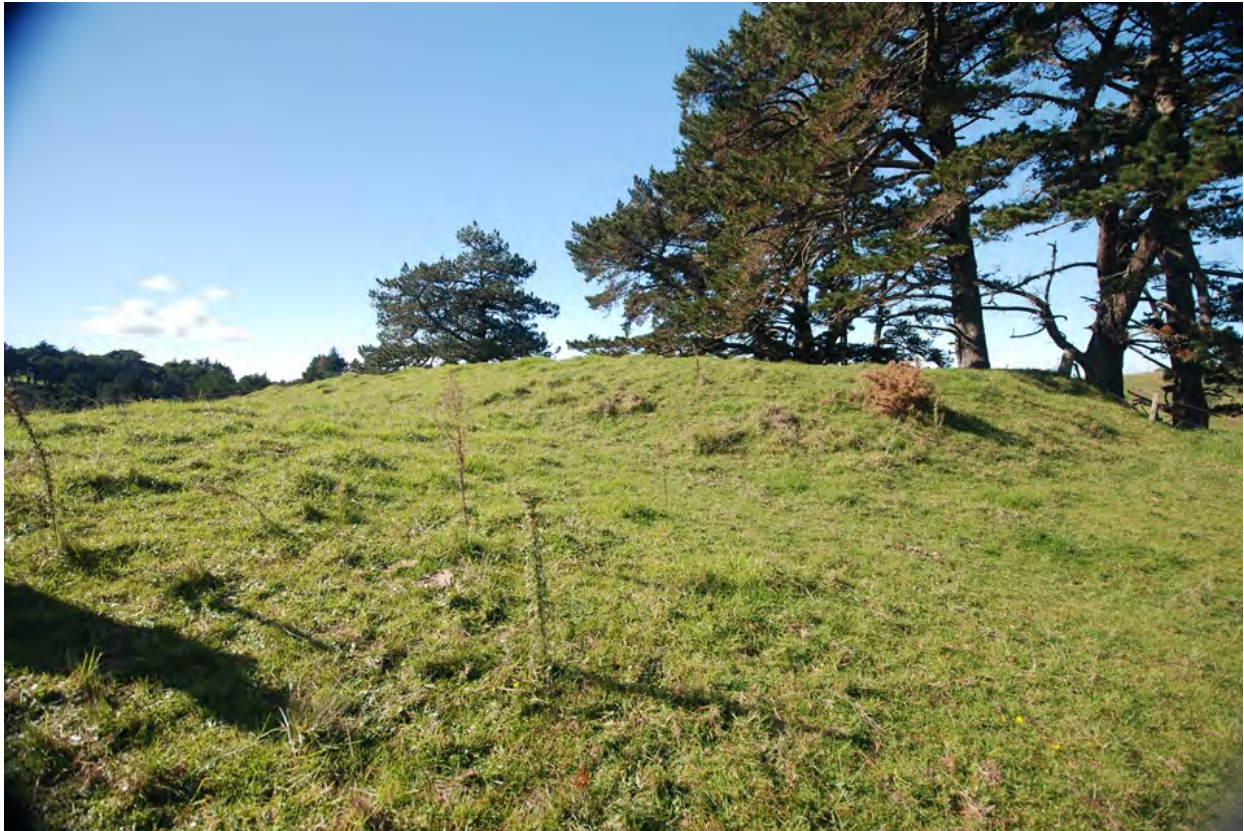
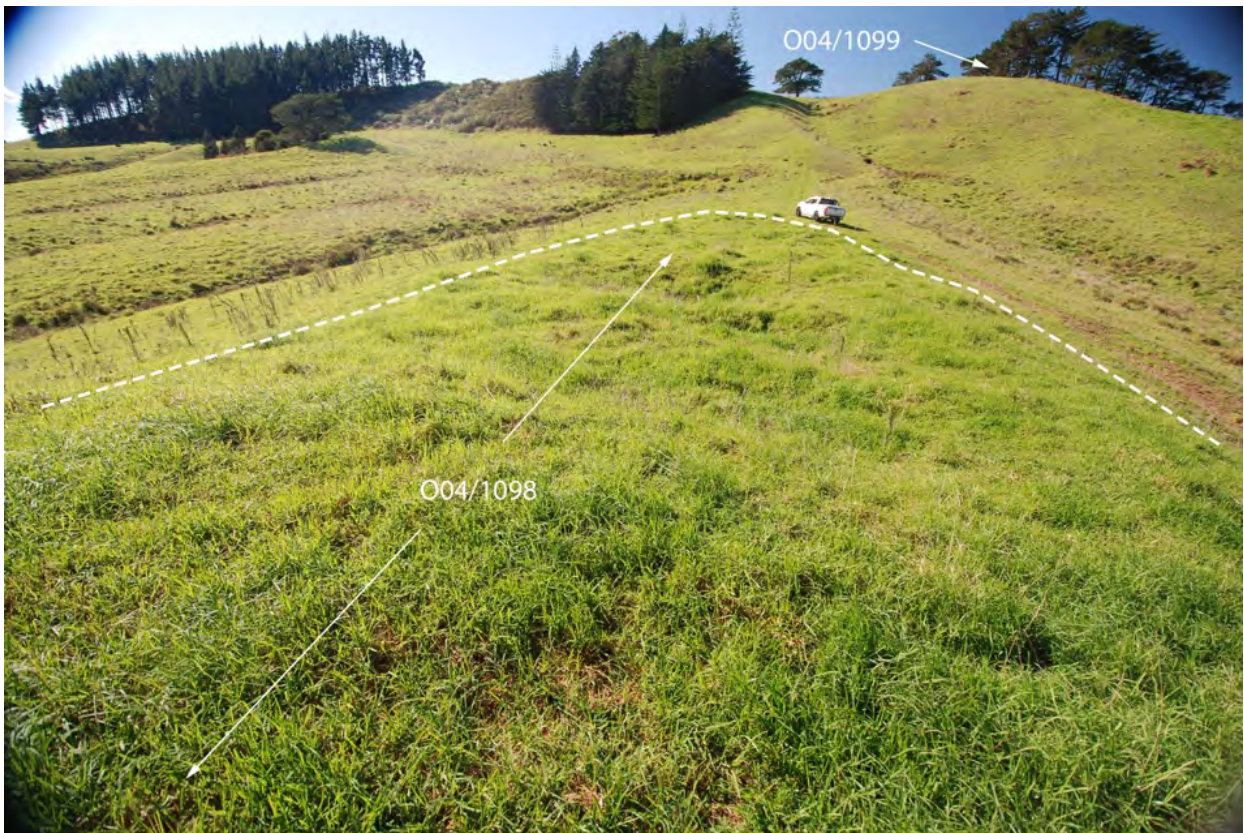
A small rectangular-shaped ring ditch pa with the ditch dug around three sides of the pa and protected on the south-eastern side by a steep east-facing slope (Figure 23 - Figure 24). The ditch has been filled and what remains is a shallow ephemeral ditch in most parts, but with a little more definition on the eastern end of the pa where it cuts towards the steep bank. There are no obvious depressions on the platform of the pa which is a single level platform. Immediately outside of the pa is an area of flat ground that has no obvious features but may have features that are currently obscured by the long grass and previous farming related surface modifications. This site is located further upslope and on the same ridgeline as O04/1098 (Figure 25).

Figure 23: View looking east across the pa platform with large terrace to the right.

Figure 24: Looking southwest towards the pa with the faint ditch visible in front of the bank.

Figure 25: View from O04/1098 towards pa O04/1099 (top right).

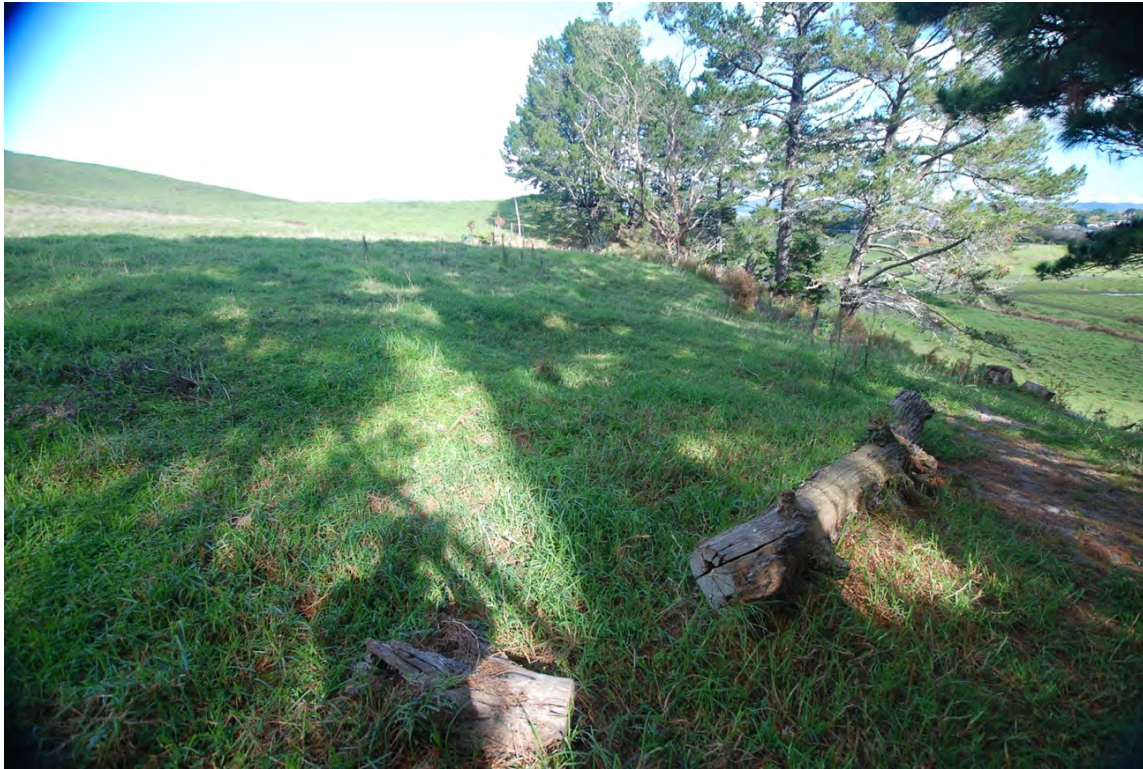
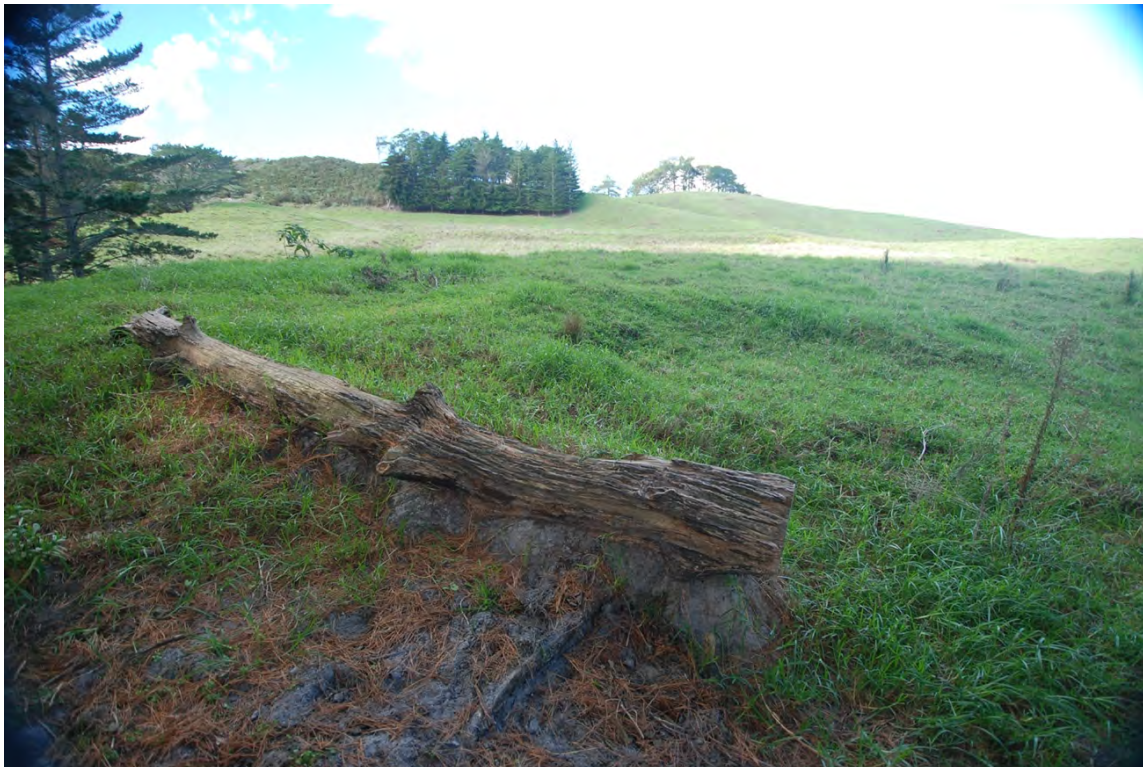
A small pit/terrace site on the spur on the ridgeline immediately north of the ridgeline that O04/1098 is located on and about the same elevation. The site consists of two main terraces with possible whare and pit depressions (Figure 26 - Figure 27).

Figure 26: View from the end of the spur across O04/1100

Figure 27: Pit depressions on O04/1100. View is looking southwest with pa O04/1099 in the distance (top right).

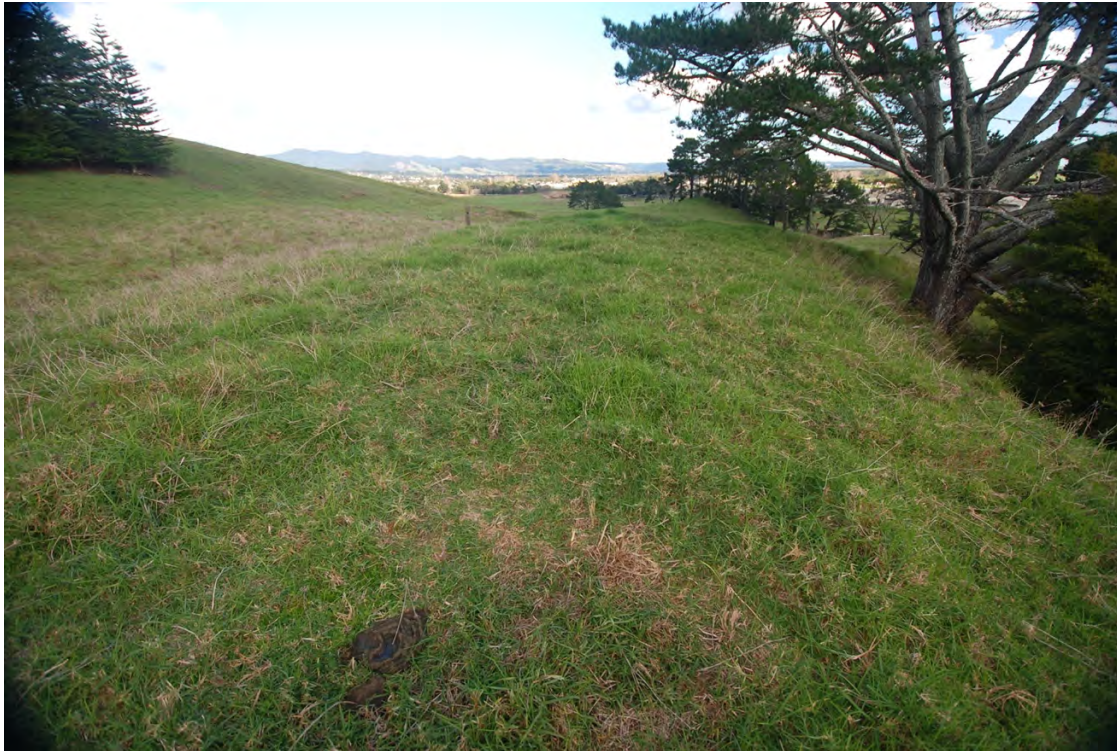
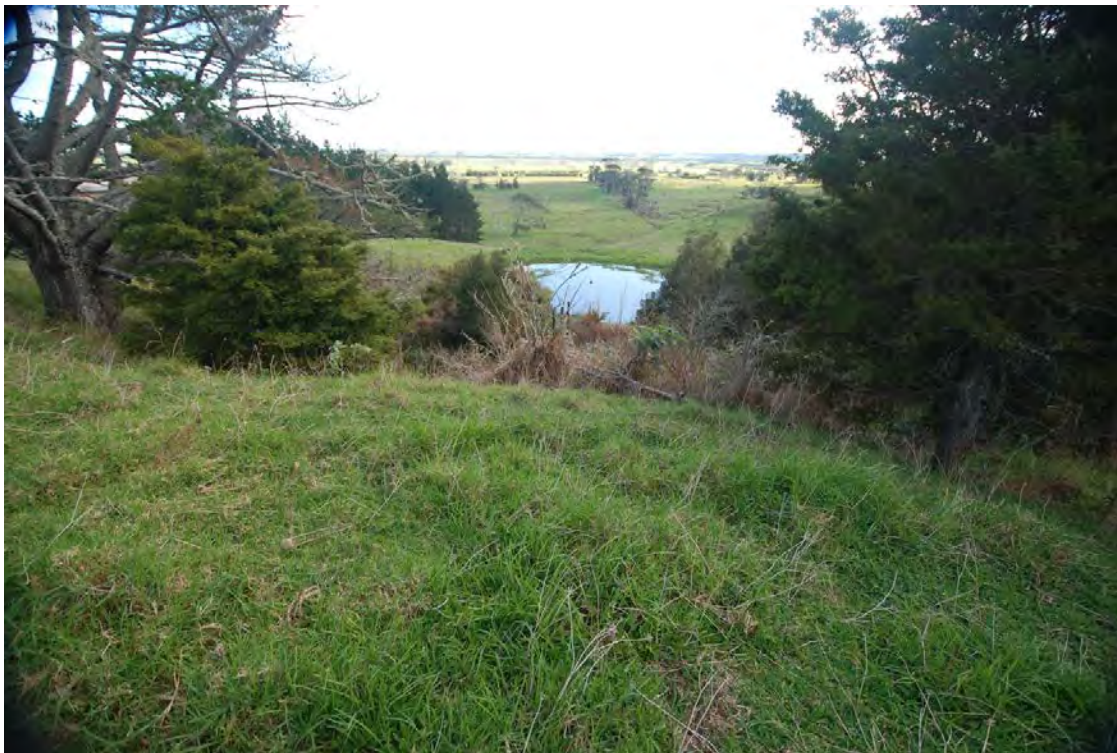
A small pit/terrace site consisting of three small terraces and several pit depressions located further upslope and on the same ridgeline as O04/1100 (Figure 28). This site is located immediately above a natural spring that has been dammed to form a farm pond (Figure 29).

Figure 28: Looking southwest across the O04/1101. Site O04/1100 is in the distance by the pine (center right of image).

Figure 29: View from the site at the dammed spring area.

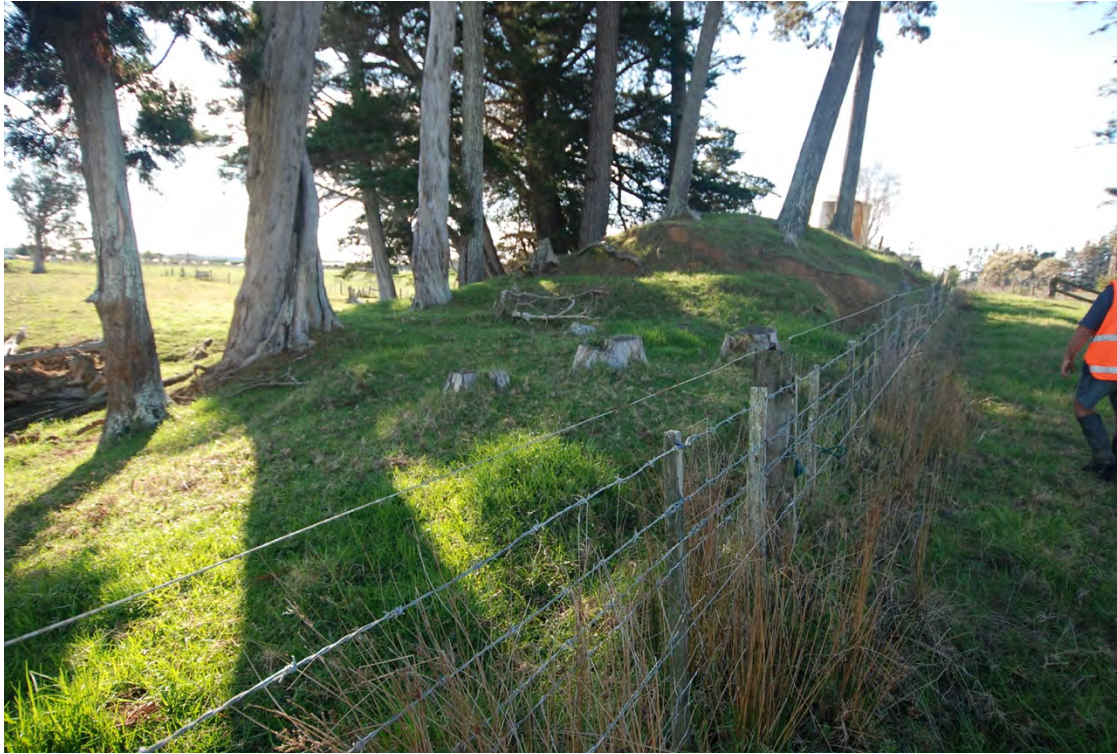
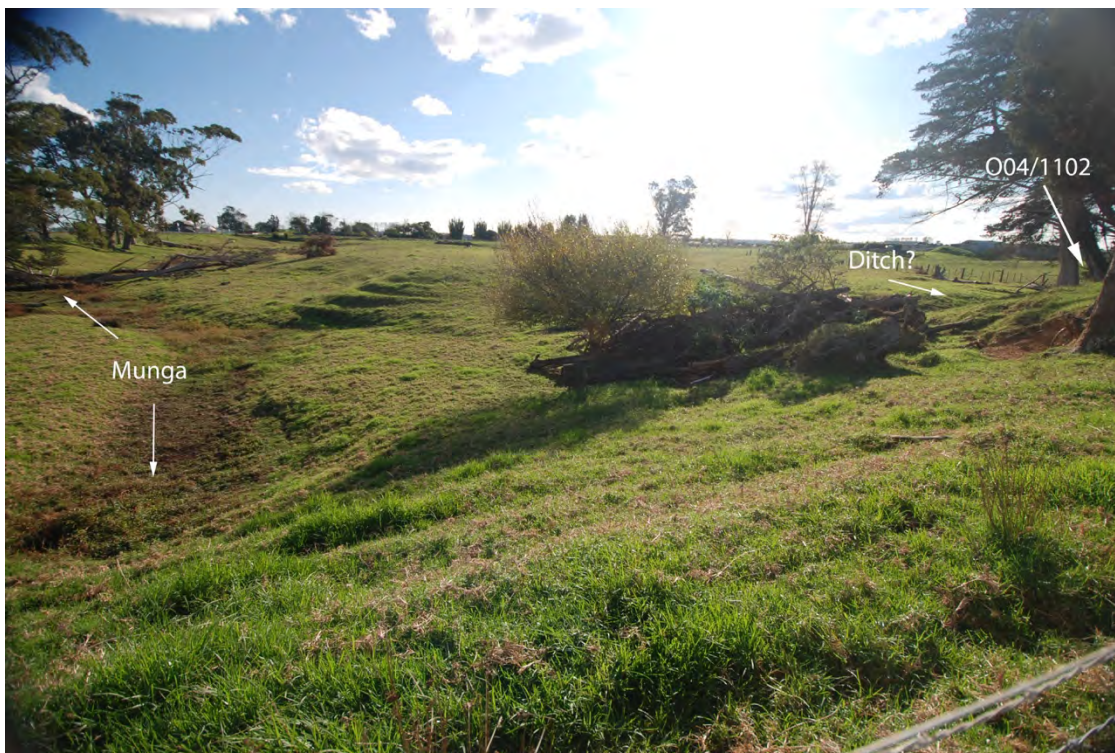
A small riverside pa that was originally protected by a large area of swamp and an old river bend, now a munga. The site runs north-south parallel to the river with the western side protected by a possible ditch and southern end by the old natural river course (Figure 30 - Figure 31). The site is in reasonable condition but has been significantly modified at the northern end where quarrying has occurred (Figure 32).

Figure 30: Pa O04/1102 viewed from the south. The river is located immediately to the right of the river terrace.

Figure 31: Looking west from the southern end of the pa showing the old munga and possible ditch.

| Value | Assessment |
|---|--|
| Condition and Integrity | The condition of the site is poor due to previous quarrying and the presence of pine on the site |
