Addendum to the Archaeological Assessment of Effects: Awanui Flood Scheme Project

18 August 2020

Document: Archaeological Assessment of Effects: Awanui Flood Scheme Upgrade
 Ref: 2019-123
 Date: 20 August 2020
 Prepared by: Russell Gibb

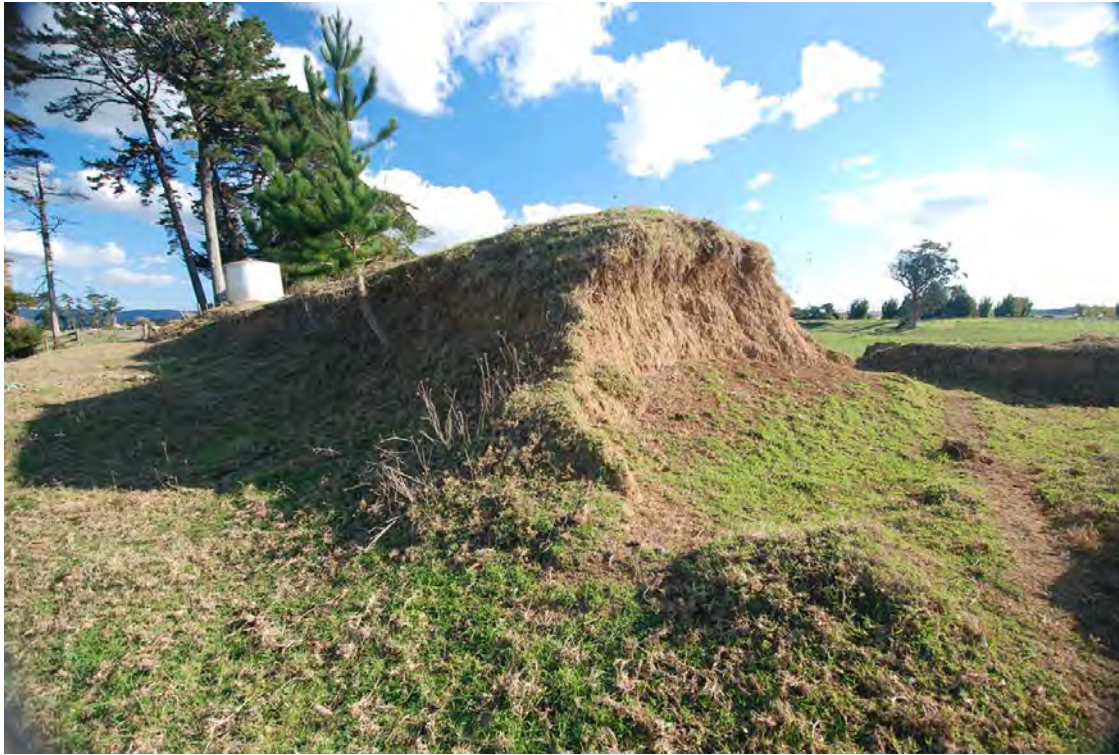
A small riverside pa that was originally protected by a large area of swamp and an old river bend, now a munga. The site runs north-south parallel to the river with the western side protected by a possible ditch and southern end by the old natural river course (Figure 30 - Figure 31). The site is in reasonable condition but has been significantly modified at the northern end where quarrying has occurred (Figure 32).

Figure 32: Quarried face on northern end of O04/1022.

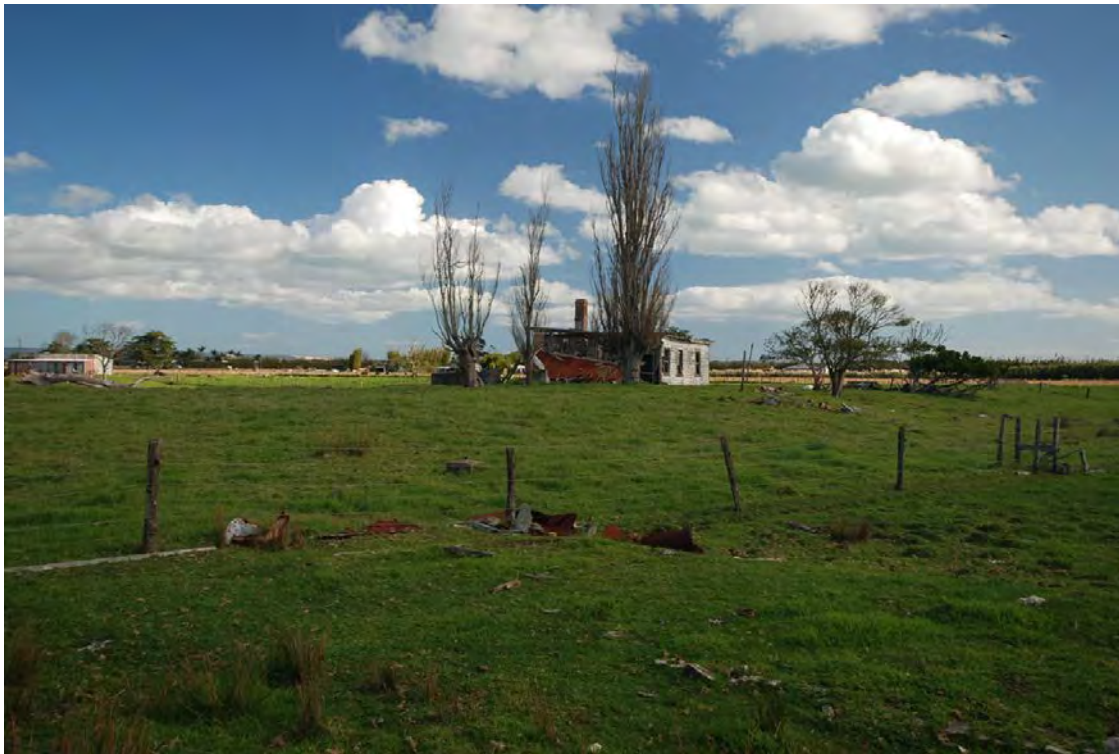
Figure 33: Looking west from the river's edge at the old Matthews homestead.

The remains of a historic homestead once belonging to a descendent of the Matthews family. Formerly the home of Ronald Hayward Matthews (born 1882, died 1975) and Marionetta Euphemia Dinwoodie (born 1897, died 1981).

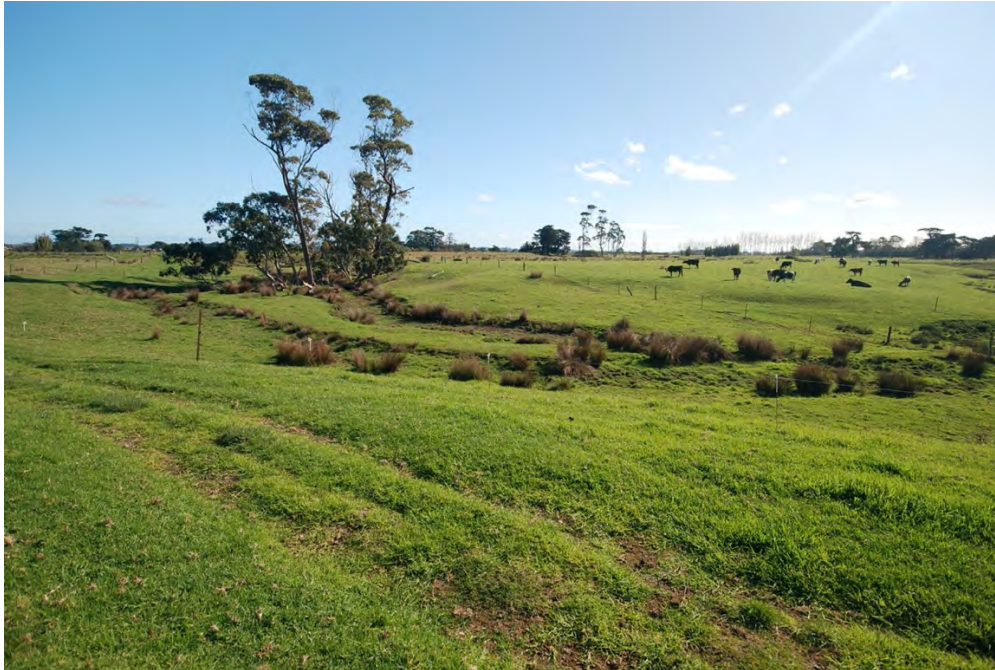
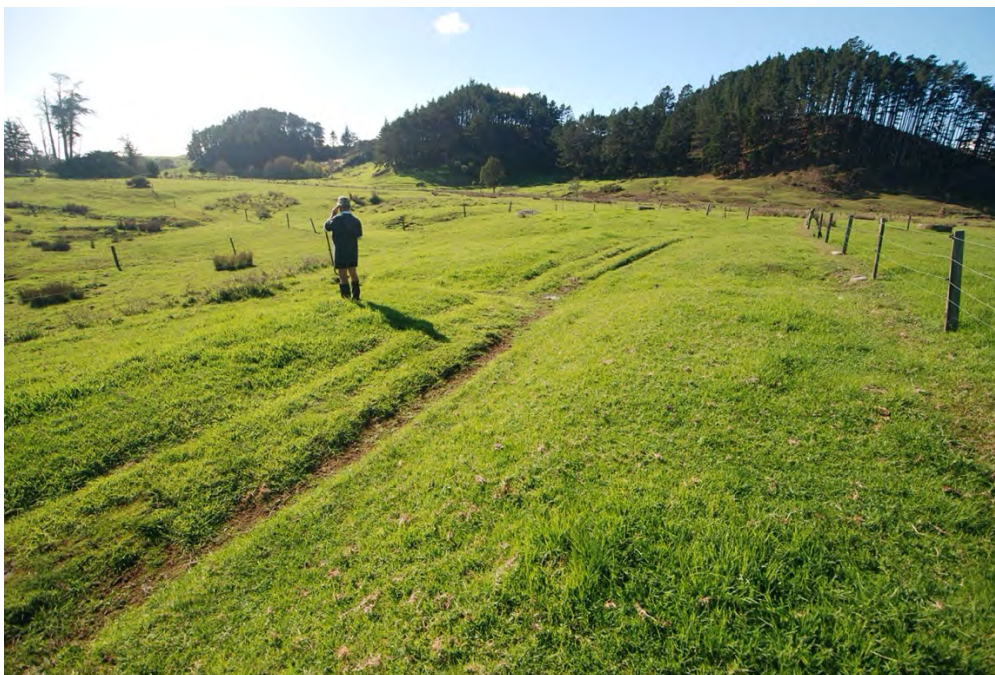
This site is the location of a buried waka, canoe landing spots, find spots and a likely occupation area (Figure 34 - Figure 35). The extent of the site is unknown but it likely extends across a flat raised paddock adjacent to a large munga. The buried waka was known to Kevin Matthews grandfather Ronald Hayward Matthew who gave the location. Around this location are several channels cut into the munga which are interpreted as old canoe landings from when the munga was part of the flowing river system. A hoanga was found by Kevin Mathews grandfather and placed by the fence not far from where it originally lay and an anchor stone was later found lying on the edge of the old river bank. Over the years lots of obsidian pieces have been exposed around the area where these 2 stones now lie (K. Matthews pers. Com. 2020) (Figure 36). It is likely that this is an extensive site and there is likely to be in situ evidence of occupation on the large river terrace adjacent to the munga.

Figure 34: Looking northwest across the buried waka channel, located next to the trees.

Figure 35: Canoe landing channels immediately in front of Kevin Matthews.

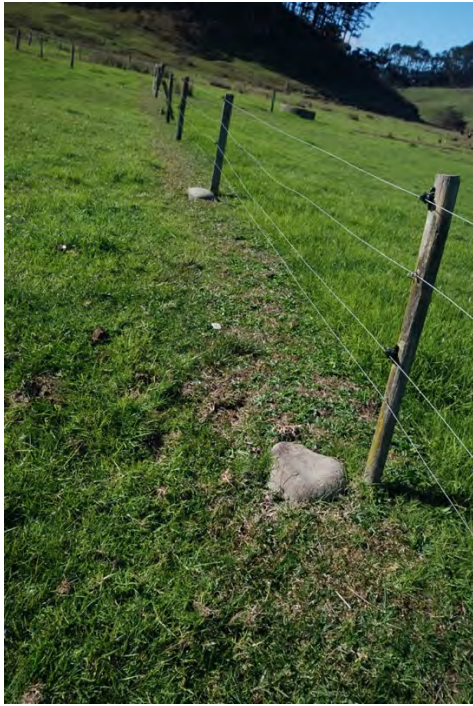
Figure 36: Large haonga (gridstones and anchor stones recovered by Kevin Matthews and placed by fence posts.

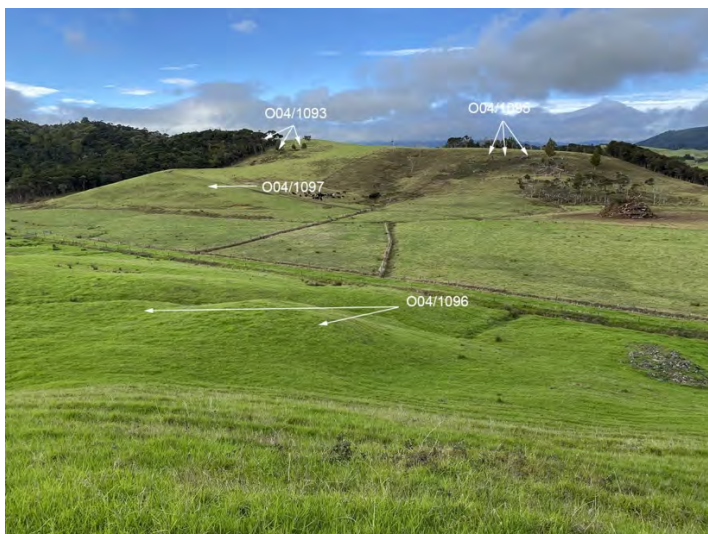
Figure 38: View looking southwest across the valley showing location and proximity of newly recorded sites to each other.

The new sites recorded on the northern side of Manurewa Pa ridgeline (west of the pa) show the modification (terracing) of the north facing slopes for gardening (O04/1093, O04/1095 and O04/1097) and occupation across to the other side of the valley (O04/1096) (Figure 38 - Figure 39). Pit/terrace site O04/1096 was probably a much larger occupation site that extended upslope towards the top of the hill where a house resides, but this could not be verified due to access issues. No evidence of Maori garden drains or any other archaeological features or material was found in the flat paddocks between the river and the base of the hills.

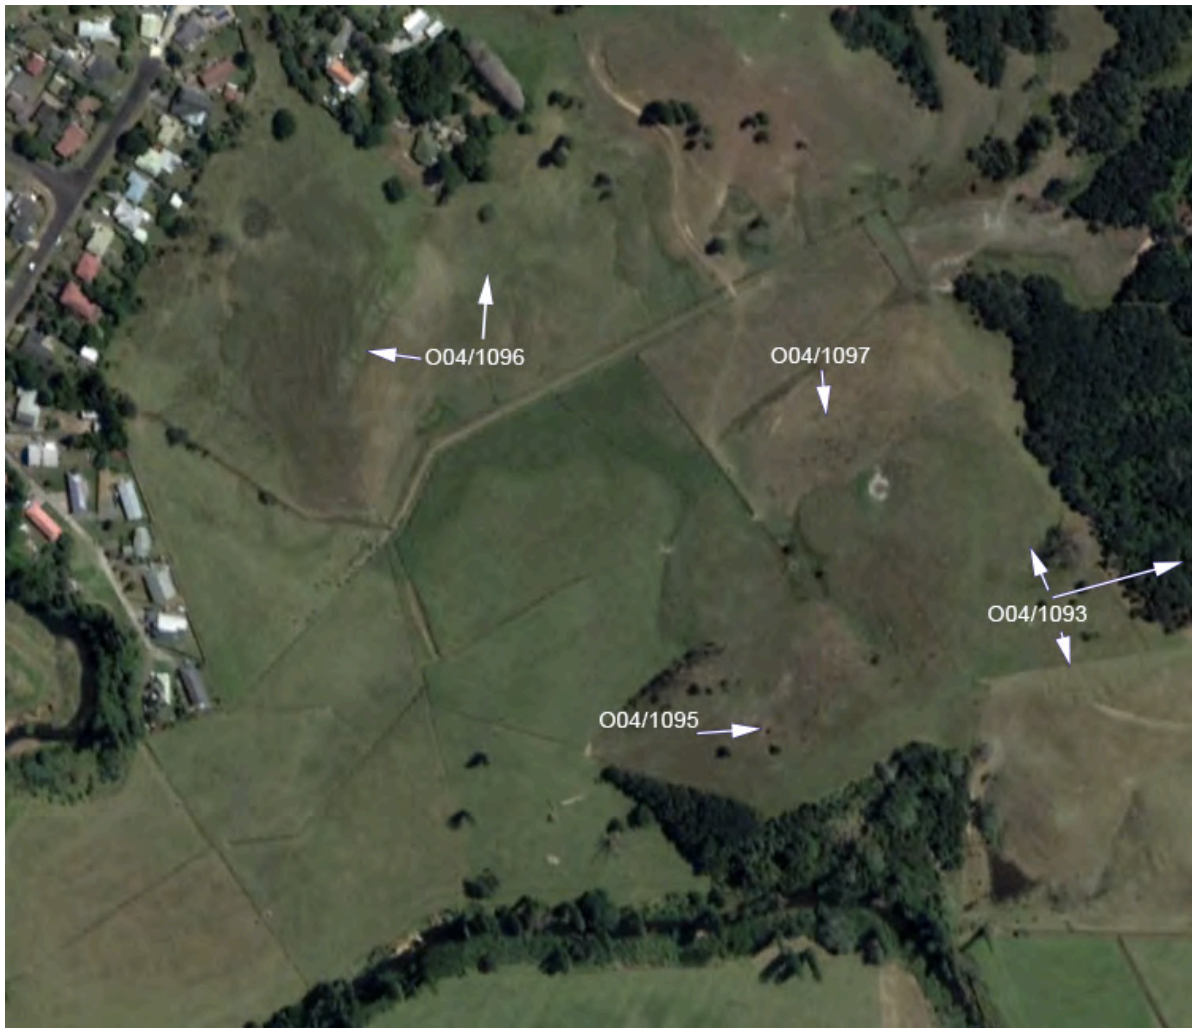
Figure 39: Aerial view of the new sites recorded in the valley behind the Peterson farmhouse.

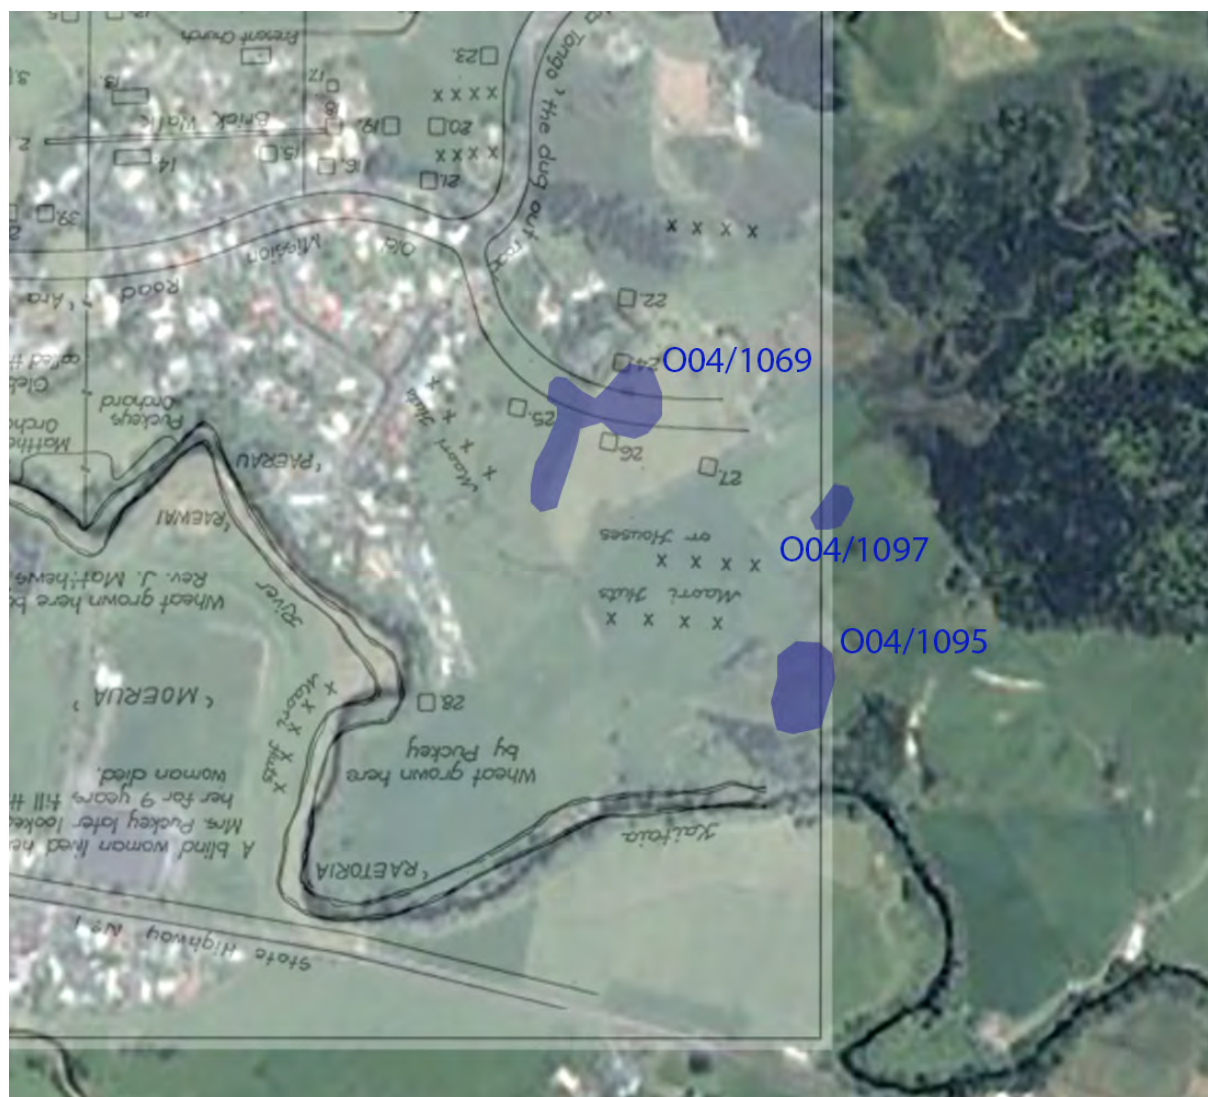
Figure 40: Overlay of sketch plan by F.H.S Mathews and new archaeological sites showing correlation between the two. The small squares annotated on the CMS plan numbered 25-27 are: 25 - Ben Lever's house, 26 - Ford's house, and 27 - Puckey's blacksmith's, which was shifted to this location.

CMS building locations 25-27 will not be affected but the stopbank between fill areas DS5 and 6 may impact in situ remains of building 28. This was Puckey’s barn which had sides made of tea-tree and nikau roof and was noted as being not very large by Mathews. There may be some in situ foundation remains from this structure but little is known about the building apart from Mathews’ brief description in his sketch index. Taonga tuturu (Maori artefacts) have reportedly been found in the DS6 fill area in the past.

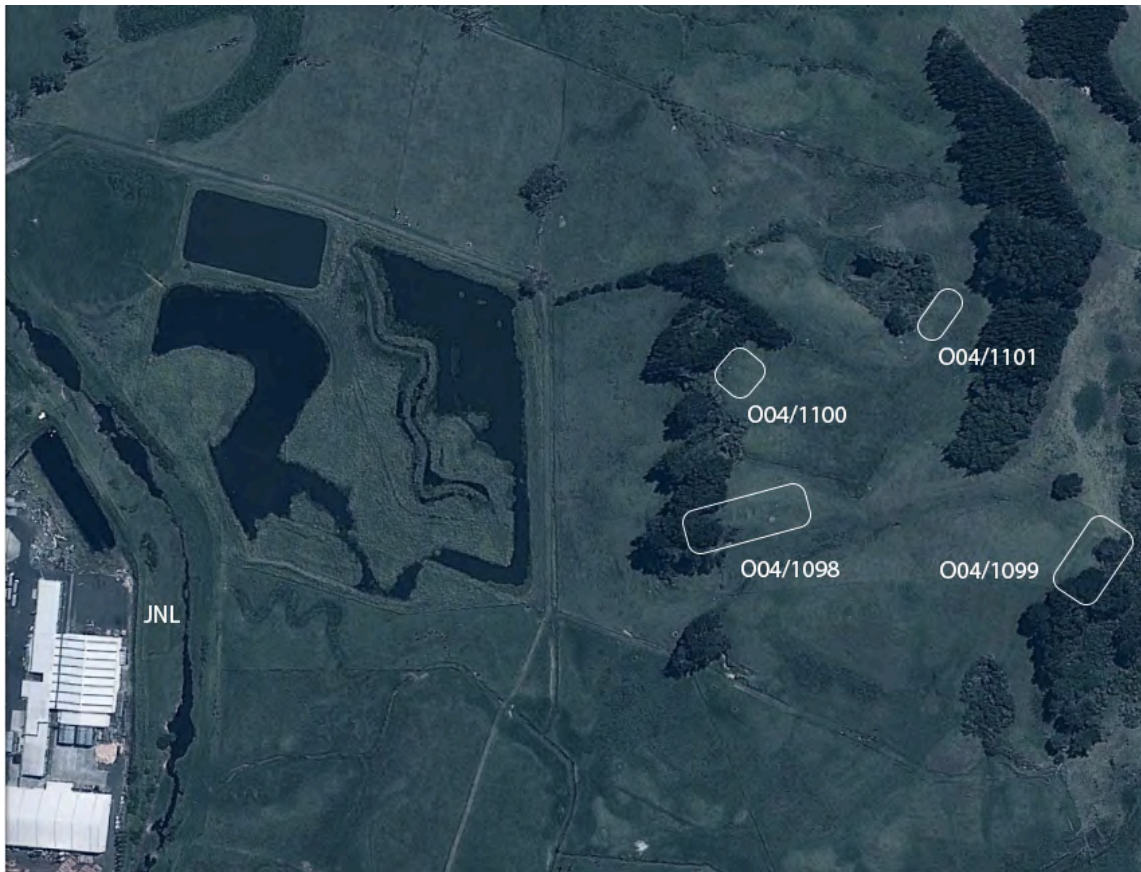
Figure 41: New sites recorded near JNL.

The new sites recorded in the northern project area consist of both pre- and post contact sites. Four of these are clustered on the slopes east of JNL and include a pa (O04/1099), large pit/terrace ridge site (O04/1098), and two small pit/terrace sites O04/1100 and O04/1101). These sites are all westerly facing and overlook the flat valley floor to the Whangātane River and beyond (Figure 41).

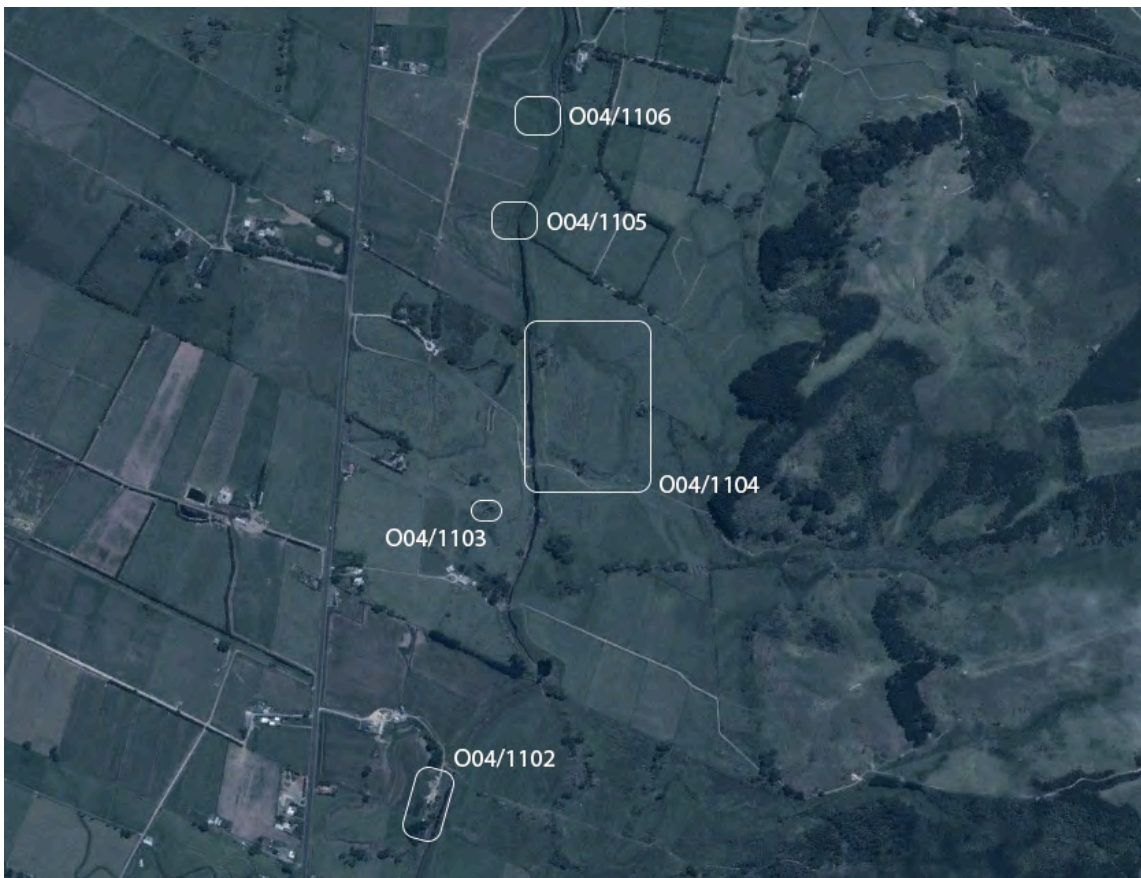
Figure 42: New sites recorded north of JNL in close proximity to the Whangatane River.

Further north, and closer to the Whangātane River, five more sites have been recorded including a riverside pa (O04/1102), occupation area (O04/1104), two important artefact find locations (O04/1105 and O04/1106), and an historic homestead site (O04/1103) (Figure 42). The proximity of O04/1104, O04/1105 and O04/1106 to each other may be of some significance. O04/1104 appears to be a large occupation area with a buried waka, canoe landing spots, in situ artefactual material and possibly a large kainga site. This is one of many riverside sites that once existed along the Whangātane and Awanui Rivers, some of which were noted in the journals and reports of early European visitors to the area.

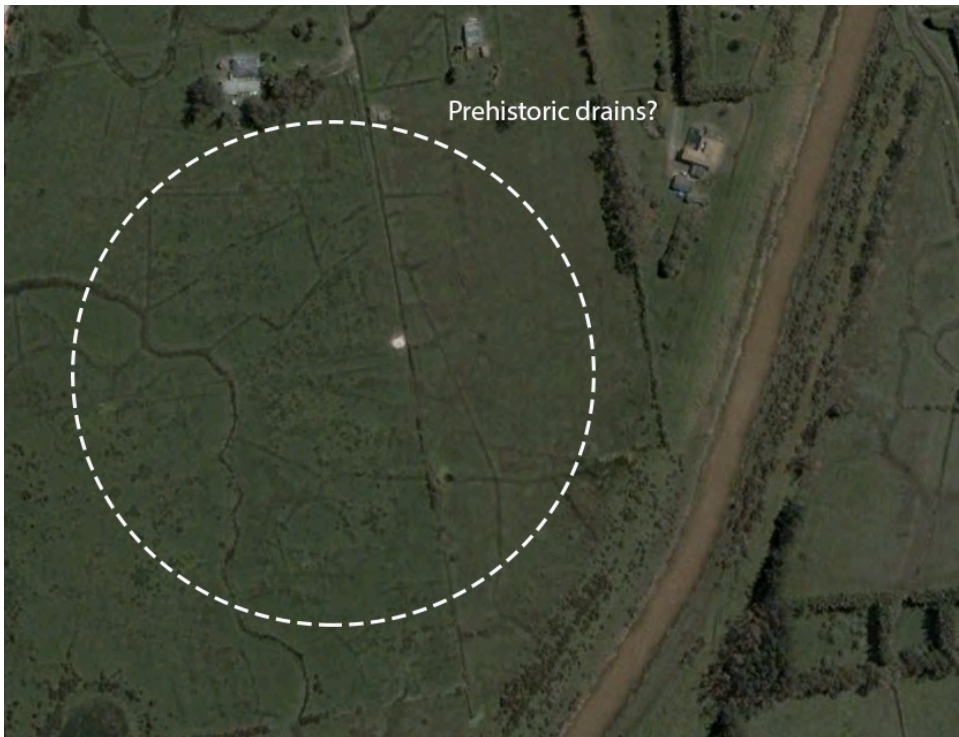
Figure 43: Area of possible early Maori garden drainage system adjacent to the spillway.
