## 27 Taipa beach

### Coastal Erosion Hazard Assessment

**NORTHLAND REGIONAL COUNCIL**  
Coastal Erosion Hazard Assessment  
Taipa Beach  
Site: 27

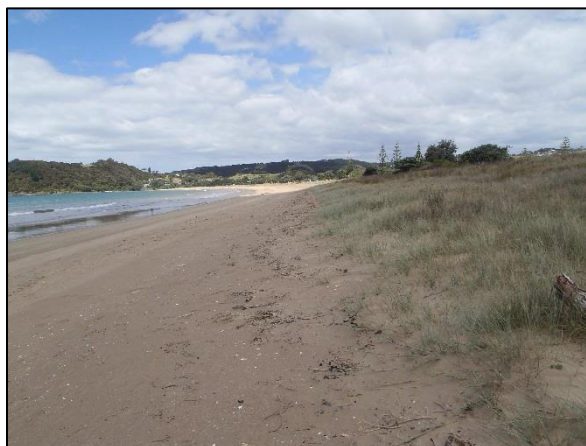
*Site Photograph A (west)*

The site has a sandy beach comprising fine to medium sand. The beach has a berm width less than 5 m above the high tide line. A small stream enters the site at the west end of the site, which does not appear to have any effect on the shoreline at this position.

The dune is well vegetated with spinifex and a foredune is developing along the open coast shoreline. The dune heights range from approximately RL 2 to 5 m along the site. The backshore is developed with the most seaward dwelling located 100 m from the dune toe.

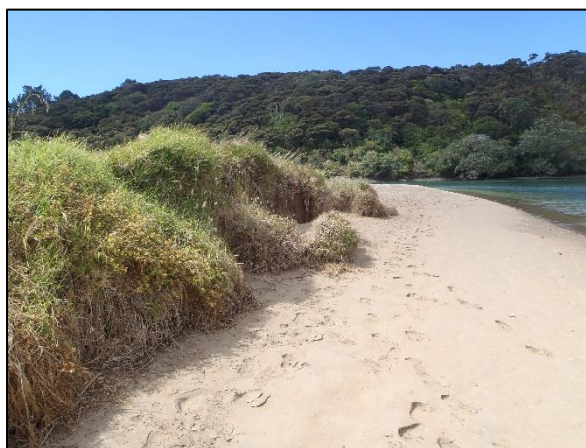
*Site Photograph C (estuary)*

The Taipa River mouth is located at the eastern end of the site. Some erosion is evident on the inside of the spit shoreline.

There are no erosion protection structures along the open coast shoreline. A timber seawall exists along the estuary shoreline.

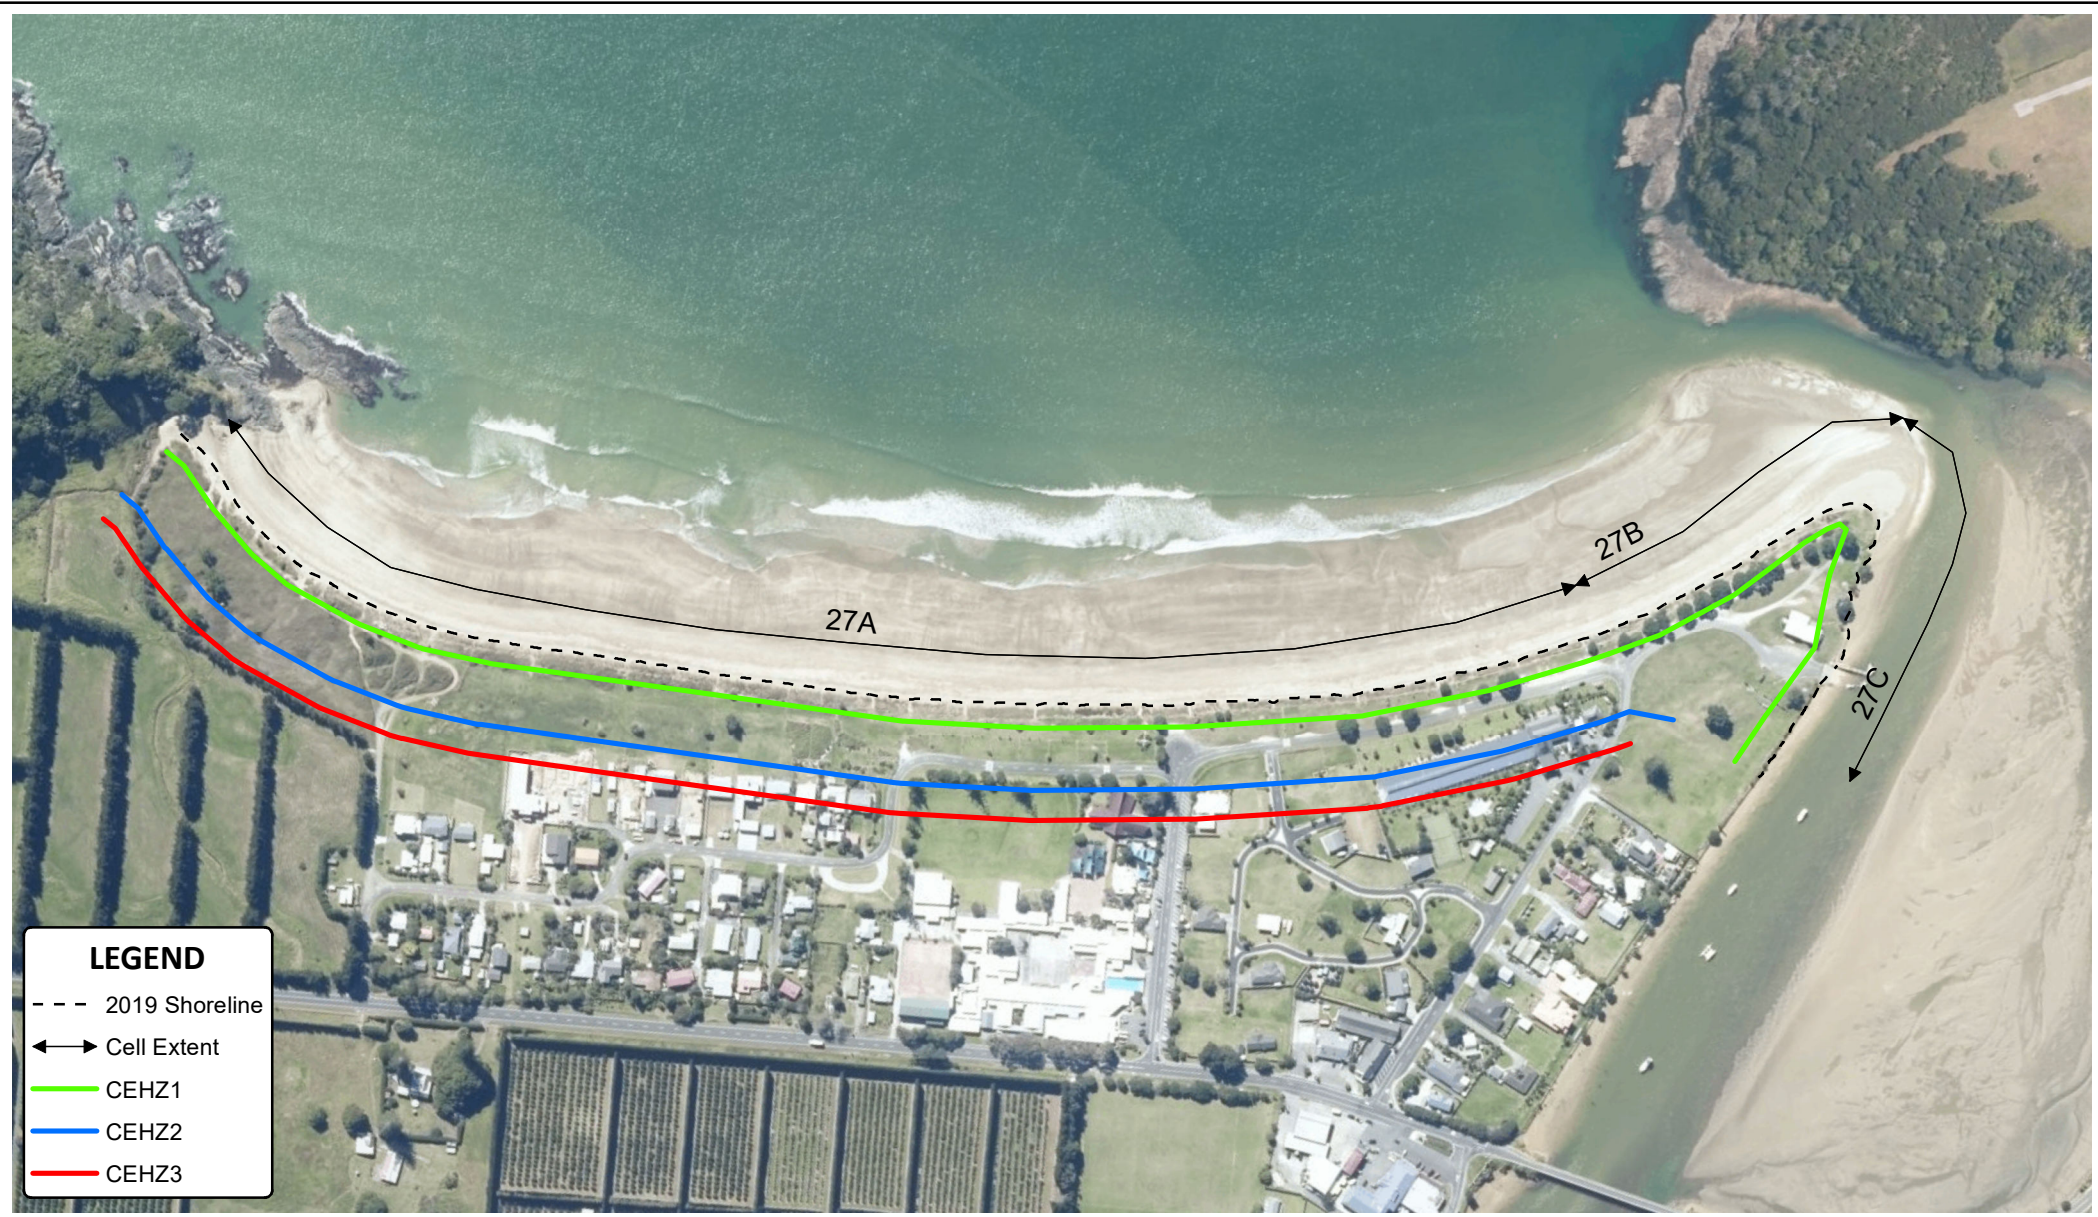
FIGURE No. **Figure 27-4**

Coastal Erosion Hazard Zone widths are presented within Table 27-2 to 27-4 and Figure 27-4. CEHZ1 values range from 15 to 19 m, CEHZ2 values from 56 to 68 m and CEHZ3 values

range from 77 to 89 m. CEHZ's have been mapped in agreement with the calculated values. Note that cell 27A has experienced accretion since about 1961 along its entire

length, with CEHZs offset from the accreted most recent shoreline.

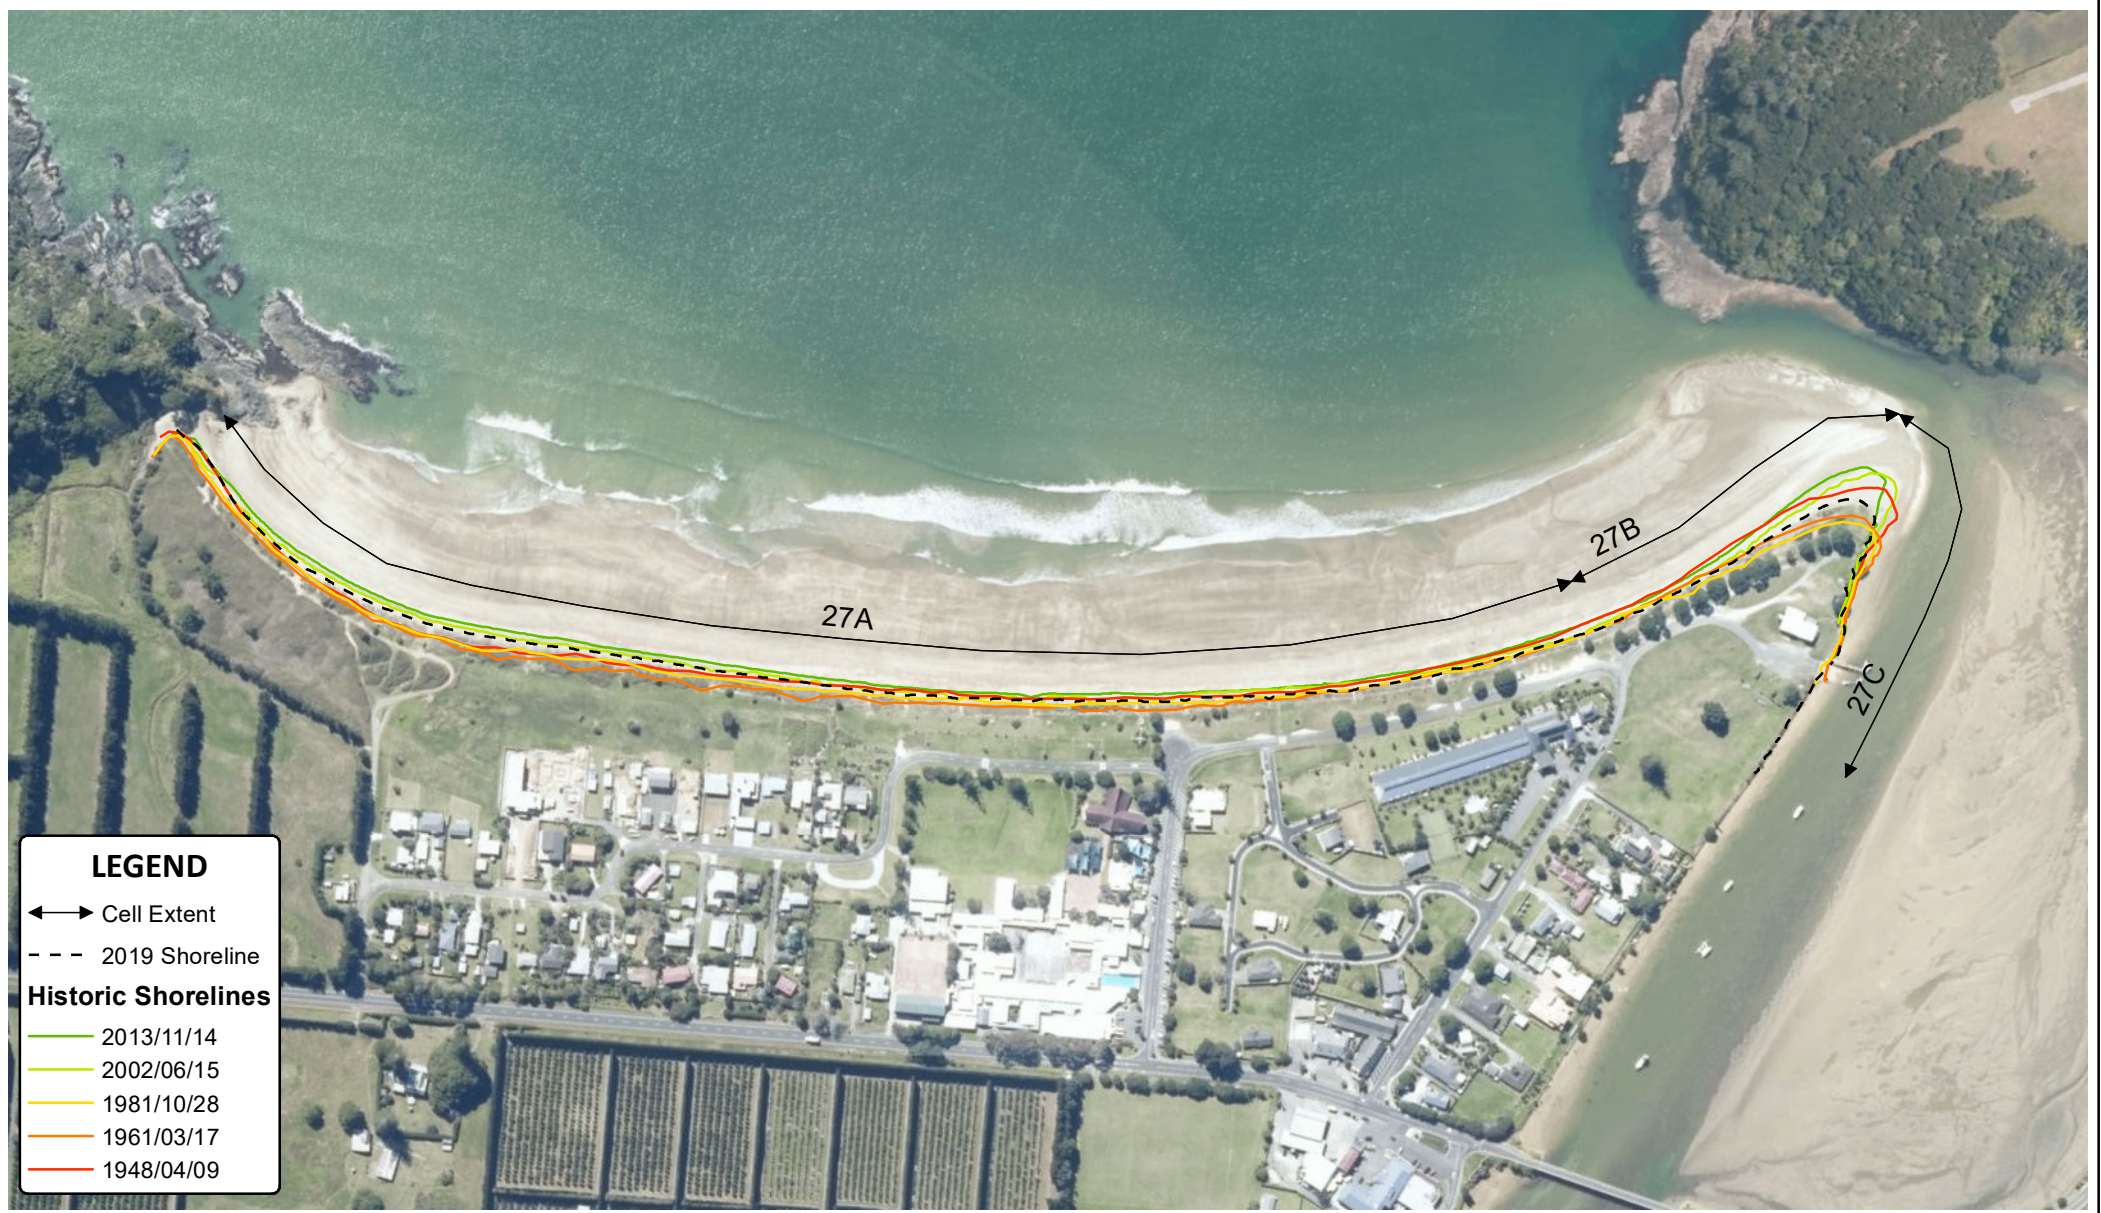
FIGURE No.	Figure 27-5	Rev.	1
------------	-------------	------	---

Figure 27-5 shows the available historic shorelines for Taipa Beach.
