# Northland Lakes Annual Report

Spring 2018

*Prepared for Northland Regional Council*

NIWA CLIENT REPORT No: 2018317  
Report date: October 2018  
NIWA Project: NRC19201

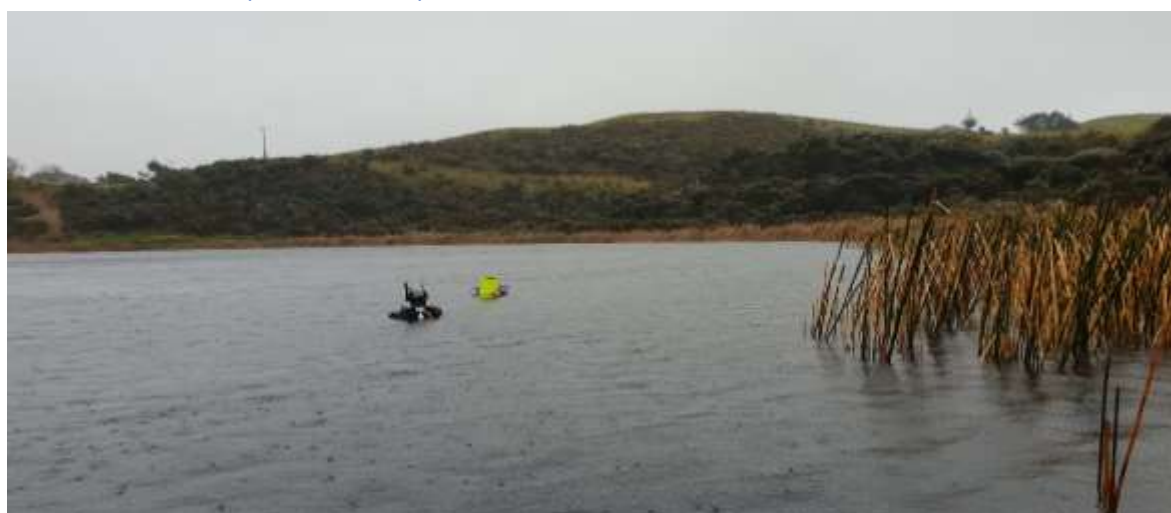
**Figure 3-1: Black Lake.** Divers record submerged and emergent vegetation data in Black Lake, with regenerating forest seen in the catchment. (Photo: Susie Elcock, September 2018)

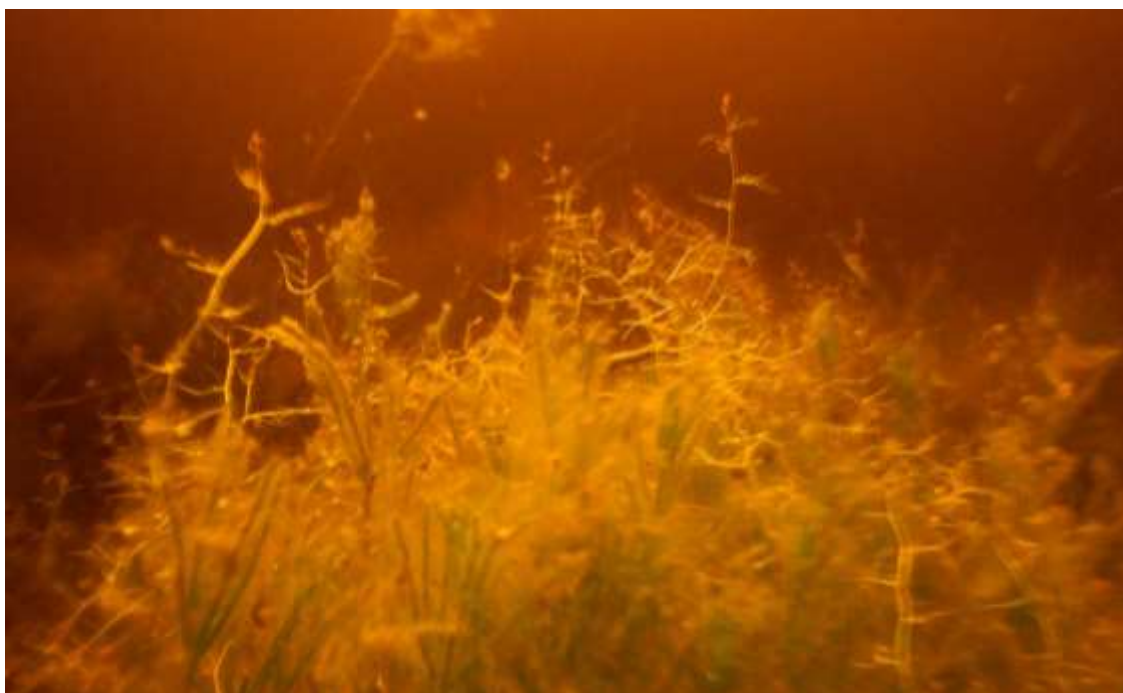
**Figure 3-2: Black Lake.** Photo showing the brown-stained water, with submerged *Chara australis* and *Utricularia gibba*. (Photo: Tracey Burton 18 September 2018).

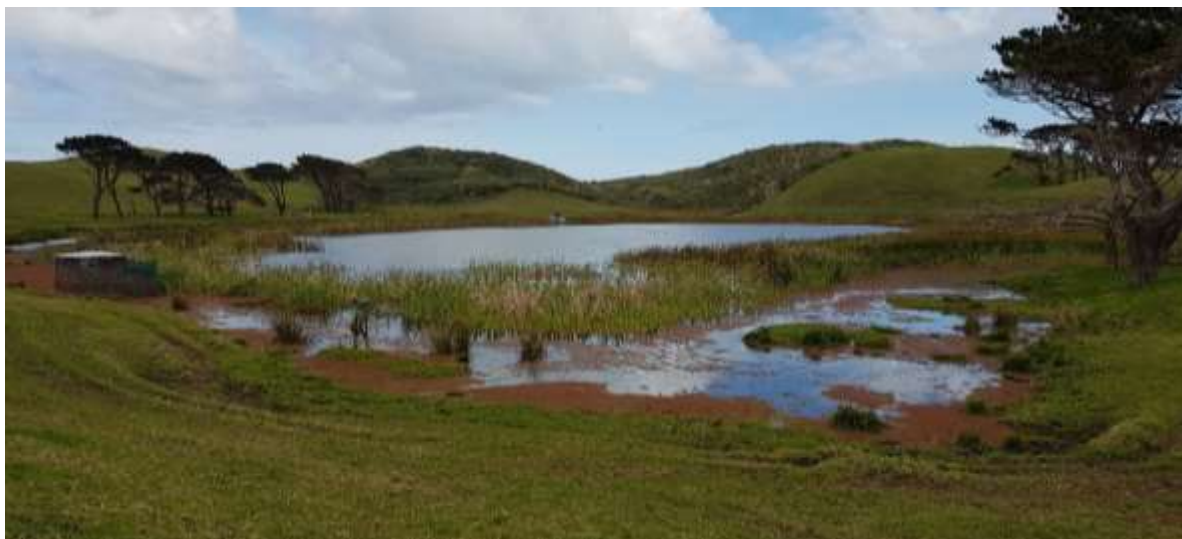
**Figure 3-3: Kelly's Lake.** Photo showing the unfenced lake margins, with a marginal fringe of open water created by cattle trampling/browsing. (Photo: Paul Champion 17 September 2018).

Advocate fencing the margins of this lake to the landowner. No further monitoring.

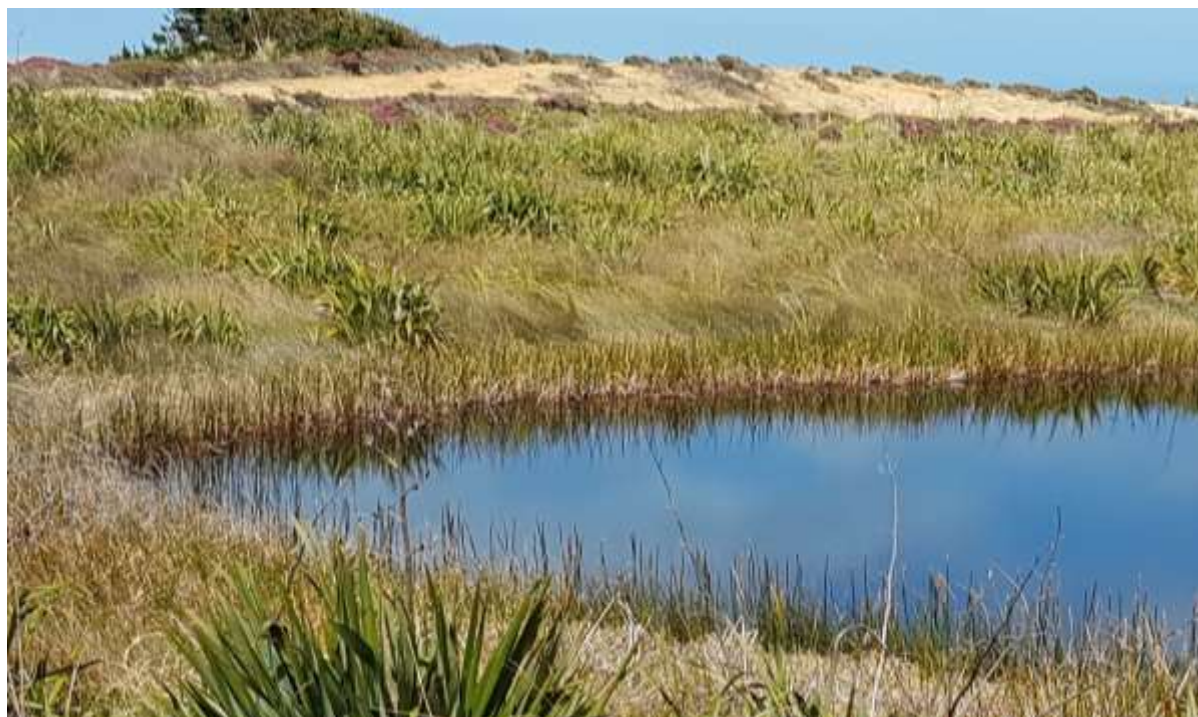
**Figure 3-4: Dune pond near Kelly's Lake.** Photo showing the emergent vegetation fringing the pond, set in coastal scrub vegetation. (Photo: Paul Champion 17 September 2018).

The pond is in good condition, with no immediate threats identified. Occasional monitoring may be warranted.

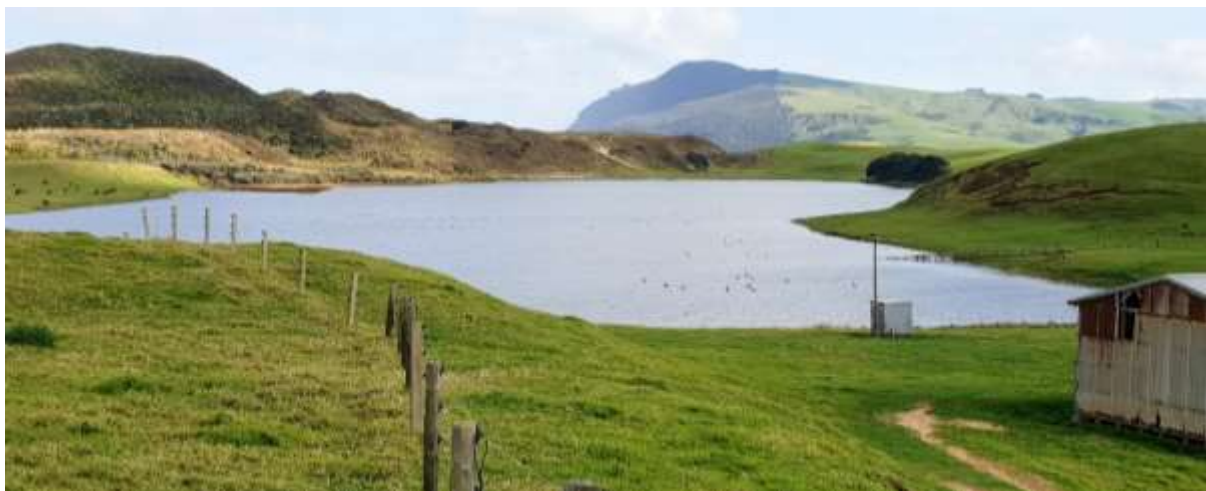
**Figure 3-5: Shag Lake.** Photo taken from the south end of the lake showing the pastoral catchment, with Maunganui Bluff in the distance. (Photo: Tracey Burton 17 September 2018).

Summary		Shag Lake
<b>Surveyed:</b>	2001, 2010 and 2018.	
<b>Overall ranking:</b>	<b>High to Moderate:</b> A nutrient enriched lake with no significant invasive aquatic plants and submerged vegetation present at low covers to 7.4 m. Cattle have access to 85% of the lake margin and have either excluded or displaced emergent vegetation to deep water. Bullies, eels and <i>Gambusia affinis</i> present.	
<b>Threats:</b>	Poor water quality with cattle access to most of the lake. Susceptible to submerged vegetation loss. Although accessed through private land, the lake is threatened by liberation of pest fish and plants.	
<b>Management recommendations:</b>	Fencing the lake will encourage emergent species establishment, increase the biodiversity values of the lake and potentially improve water quality. Undertake 5 yearly ecological monitoring.

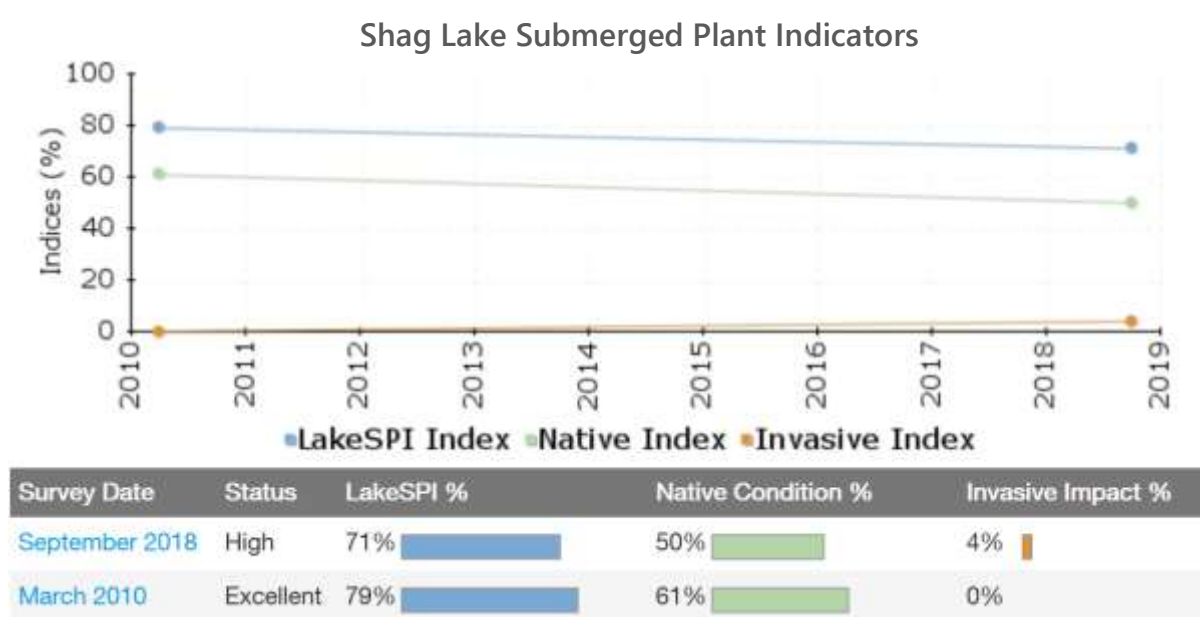
**Figure 3-6: LakeSPI results for Shag Lake.** LakeSPI Indices expressed as a percentage of lake maximum potential.

Shag Lake is categorised as being in high ecological condition with a LakeSPI Index of 71%. This has reduced slightly from 2010, a result of the minor invasive *Juncus bulbosus* being recorded at one site and a loss of charophyte meadows, previously found at two of the five transects in 2010. No species had median average covers exceeding 5% in the 2018 survey.

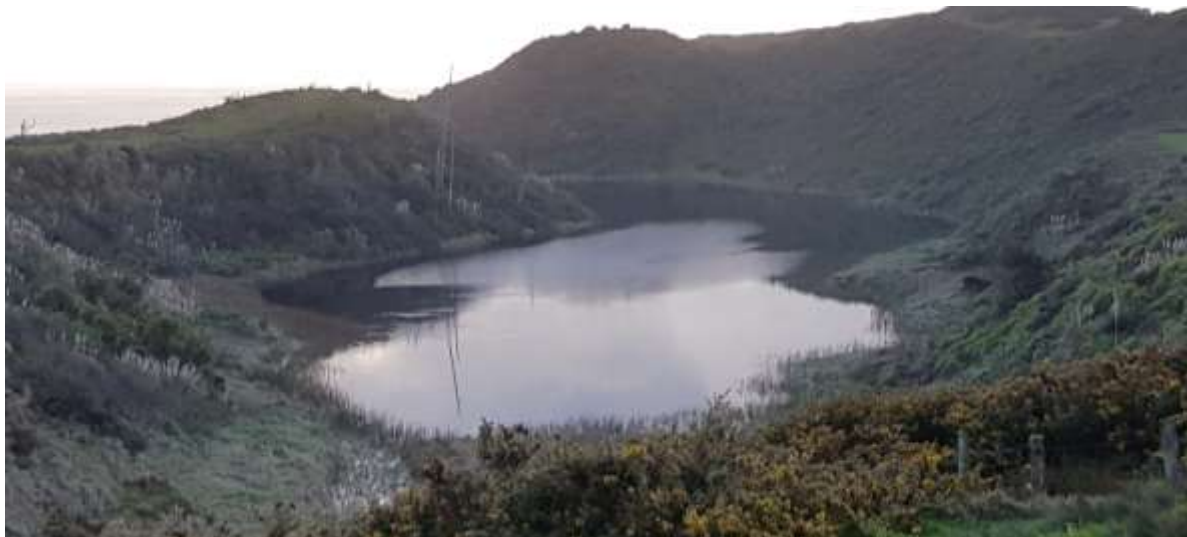
**Figure 3-7: Greville's Lagoon.** Photo from the east, showing the steep-sided fully fenced dune lake margins. (Photo: Paul Champion 17 September 2018).

Summary		Greville's Lagoon
<b>Surveyed:</b>	2005 and 2018.	
<b>Overall ranking:</b>	<b>Moderate:</b> A fully fenced lake with native submerged vegetation, but with pest plants alligator weed ( <i>Alternanthera philoxeroides</i> ) and dense areas of African feather grass ( <i>Cenchrus macrourus</i> ) impacting on the emergent zone and lake catchment.	
<b>Threats:</b>	Difficulty of access makes likelihood of pest plant introduction low, but a major impact could result should introduction occur. Catchment impacts on water quality are unlikely to change in the immediate future.	
<b>Management recommendations:</b>	No monitoring of submerged vegetation is recommended.

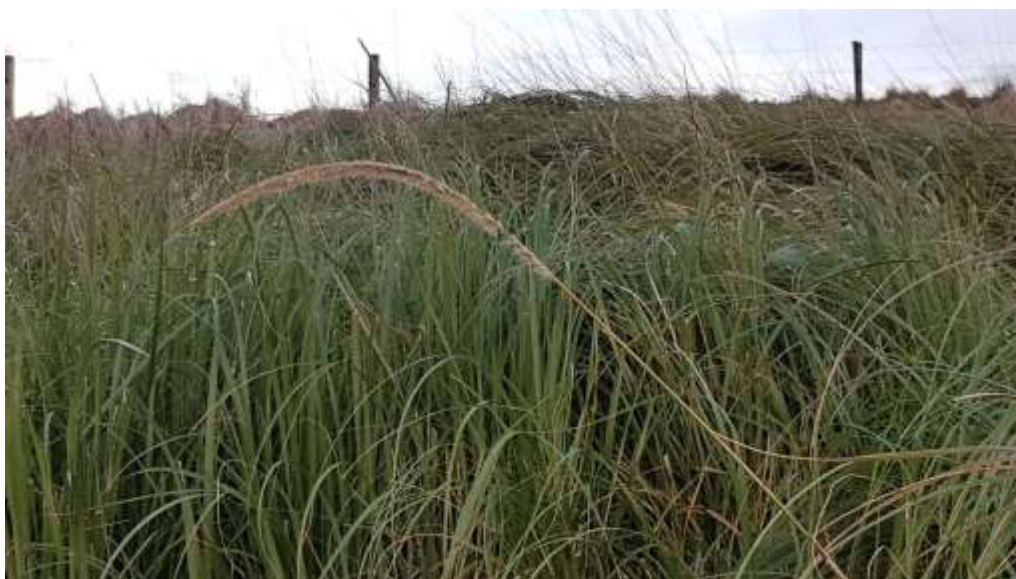
**Figure 3-8: Flowerhead and plants of African feather grass (*Cenchrus macrourus*) on the margin of Greville's Lagoon.** (Photo: Paul Champion 17 September 2018).

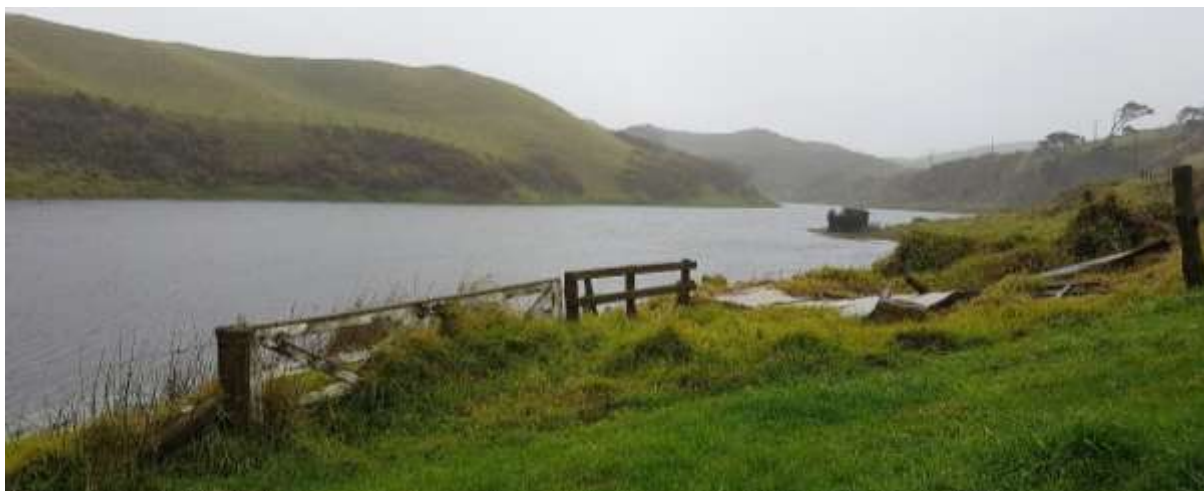
**Figure 3-9: Lake Kapoai.** Photo showing the fenced margin with dense kikuyu (*Cenchrus clandestinus*) dominating the retired margin. (Photo: Paul Champion 18 September 2018).

The problem weed African feather grass (*Cenchrus macrourus*) was noted adjacent to the pump shed on the eastern side of the lake.

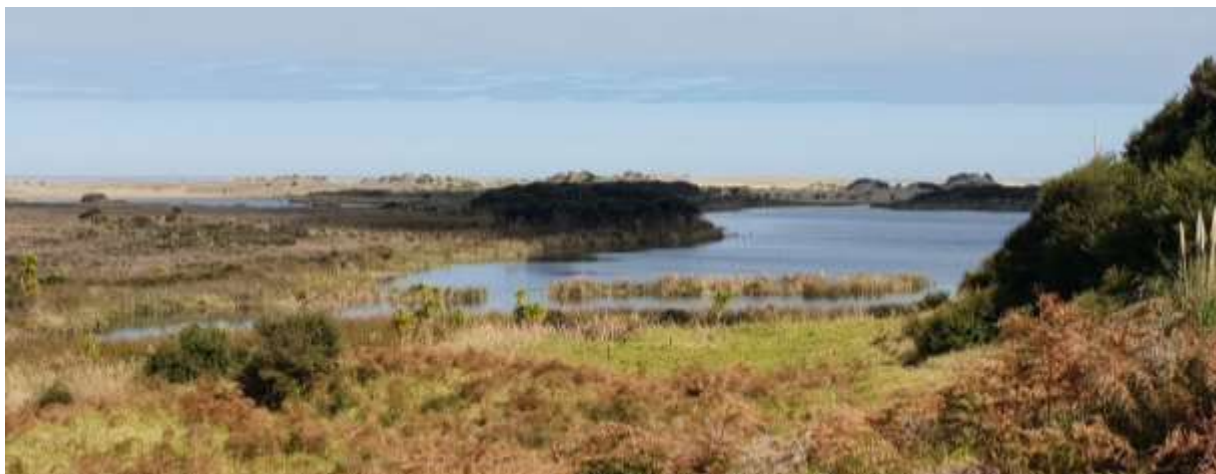
**Figure 3-10: Lake Karaka.** Photo taken from the tall pasture covered dunes to the east of the lake. (Photo: Tracey Burton 20 September 2018).

Lake native biodiversity value monitoring and pest plant surveillance are recommended every 5 years. Consideration of nutrient sources might reveal why this lake is so eutrophic and mitigations measures might be self-evident. Advocate fencing off the eastern shoreline to prevent cattle access to the lake. Information on seasonality of plant condition and water clarity would inform potential management actions.

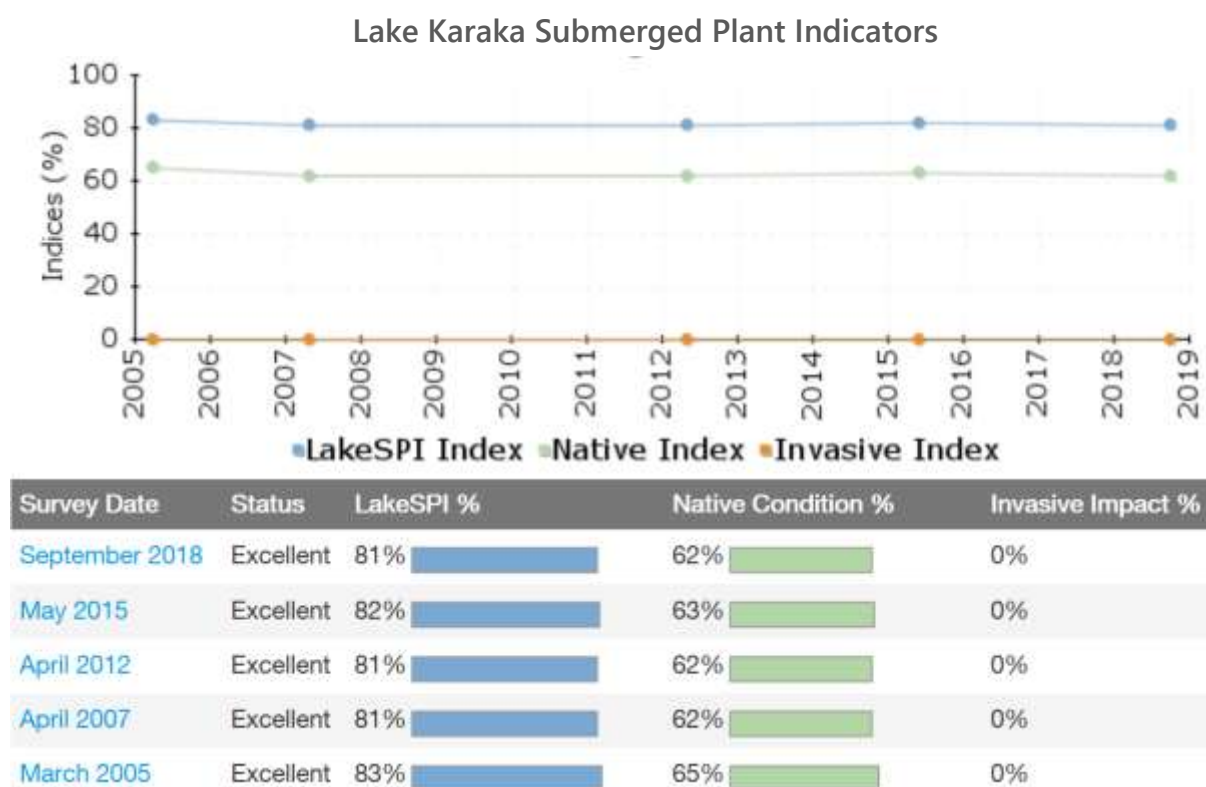
**Figure 3-11: LakeSPI results for Lake Karaka.** LakeSPI Indices expressed as a percentage of lake maximum potential.

Lake Karaka is categorised as being in excellent ecological condition with a LakeSPI Index of 81%.

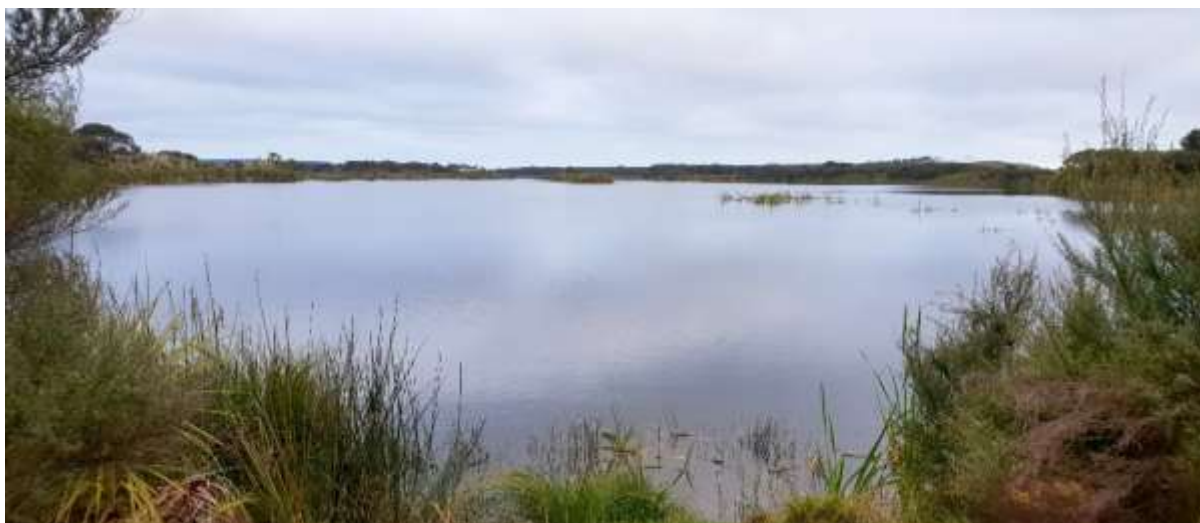
**Figure 3-12: Lake Mokeno.** Photo taken from the northern end of the lake. (Photo: Tracey Burton 20 September 2018).

It is recommended that lake native biodiversity value monitoring and pest plant surveillance is undertaken every five years.

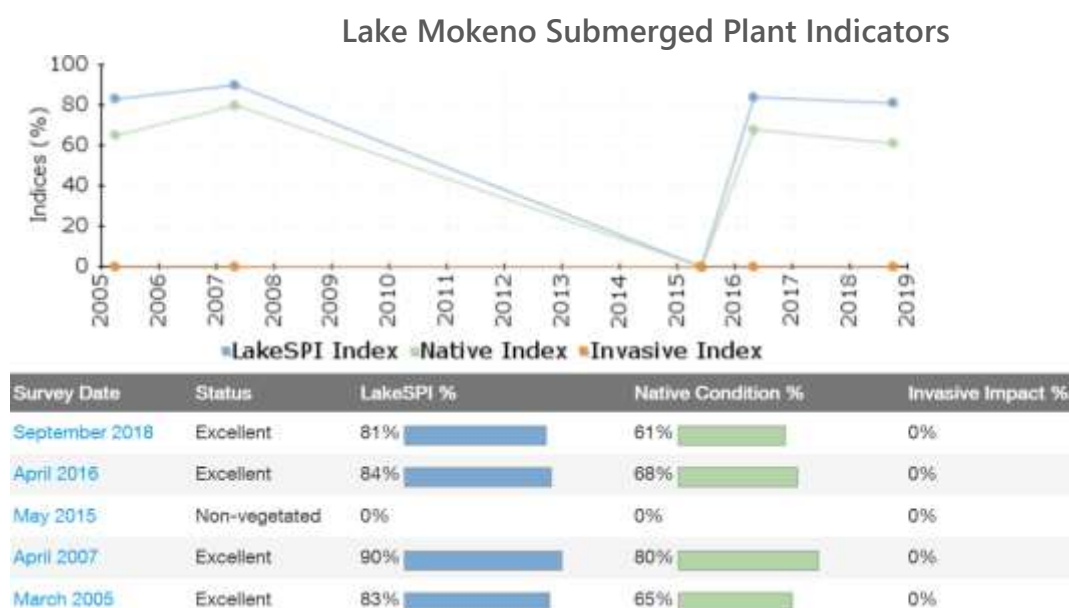
**Figure 3-13: LakeSPI results for Lake Mokeno.** LakeSPI Indices expressed as a percentage of lake maximum potential.

Lake Mokeno is categorised as being in excellent ecological condition with a LakeSPI Index of 81%, one of the highest LakeSPI indices recorded for the Northland lakes.

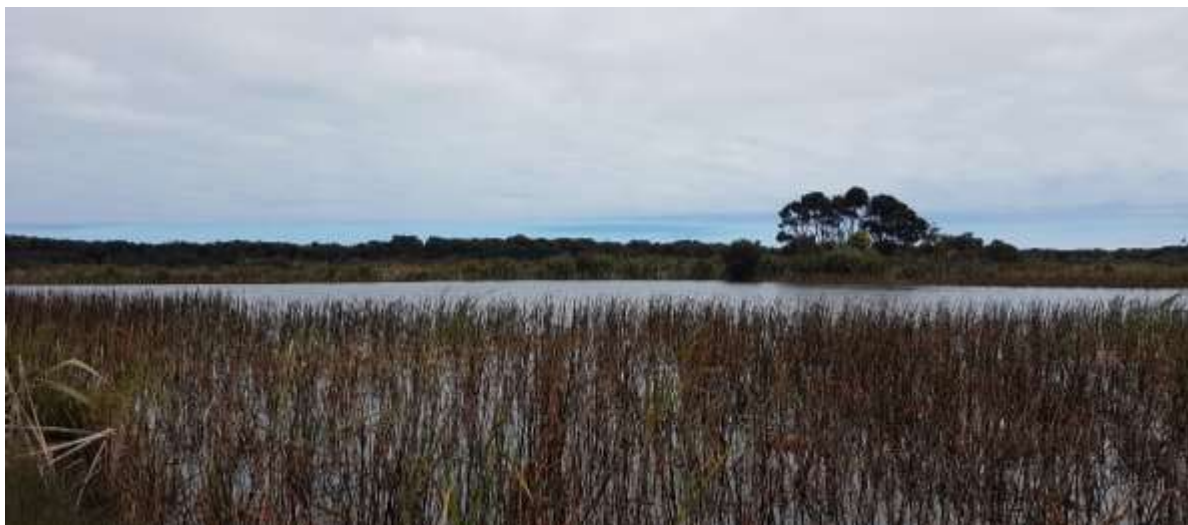
**Figure 3-14: Lake Otapuiti.** Photo taken from the eastern shore, with dense emergent band of kuta (*Eleocharis sphacelata*). (Photo: Paul Champion 20 September 2018).

The dominant emergent species was kuta (*Eleocharis sphacelata*), which formed a 25 m wide zone, extending to depths of 2 m, with occasional raupo (*Typha orientalis*) and rare invasive *Utricularia gibba*. Surrounding this emergent zone was a diverse wetland with *Carex secta*, *Machaerina articulata*, *M. juncea*, *M. arthropphylla*, *M. rubiginosa*, manuka (*Leptospermum scoparium*), harakeke (*Phormium tenax*), ti kouka (*Cordyline australis*), *Thelypteris confluens*, *Isachne globosa* and *Hydrocotyle pterocarpa*.

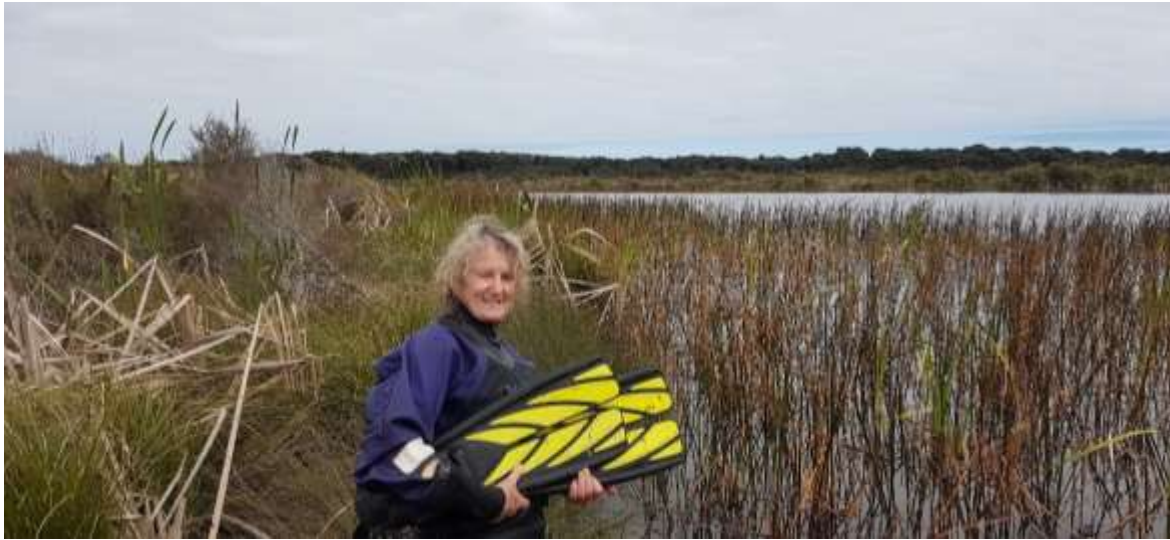
**Figure 3-15: Wetland and emergent vegetation on the margin of Lake Otapuiti.** (Photo: Paul Champion 20 September 2018)

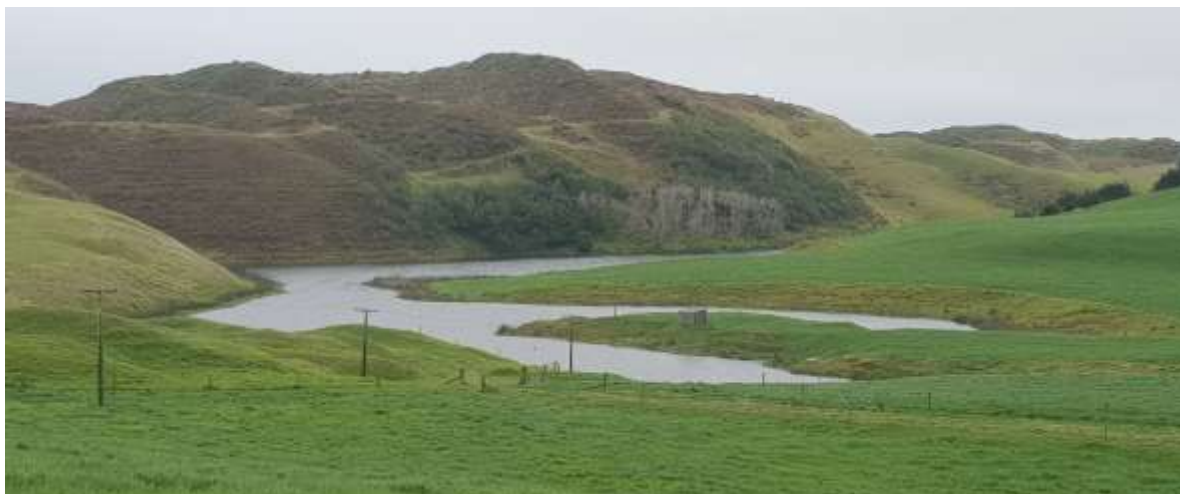
**Figure 3-16: Lake Parawanui.** Photo from Southern end of lake showing the fenced pasture margins and re-establishing marginal vegetation. (Photo: Tracey Burton 18 September 2018).

Summary Lake Parawanui	
<b>Surveyed:</b>	2001, 2016 and 2018.
<b>Overall ranking:</b>	<b>Moderate:</b> A degraded lake, with poor water quality, but fencing has prevented grazing from most of the lake margins permitting the re-establishment of an emergent vegetation band around the lake. Submerged vegetation appears to be well established around the margins despite the presence of pest fish.
<b>Threats:</b>	Pest fish (rudd, koi carp, orfe) have been introduced into this lake. Nutrient enrichment and algal blooms continuing despite fencing. The lake is fished for eels providing an introduction pathway for additional pest fish and pest plants.
<b>Management recommendations:</b>	Advocate the establishment of wetlands to mitigate impacts of the nutrients transported to the lake from the inlet. Advocate the closing of this lake to eel fishing. Five yearly surveillance for pest plants and lake native biodiversity value monitoring.

Poor water quality remains a concern and continuation of restoration initiatives are advocated, especially the interception of nutrients from inflows, possibly by planting wetlands. The risk of new pests through contaminated fyke nets used for eel fishing is high and the recommendation to close this lake to eel fishing should be advocated to the landowner. Five-yearly monitoring is recommended.

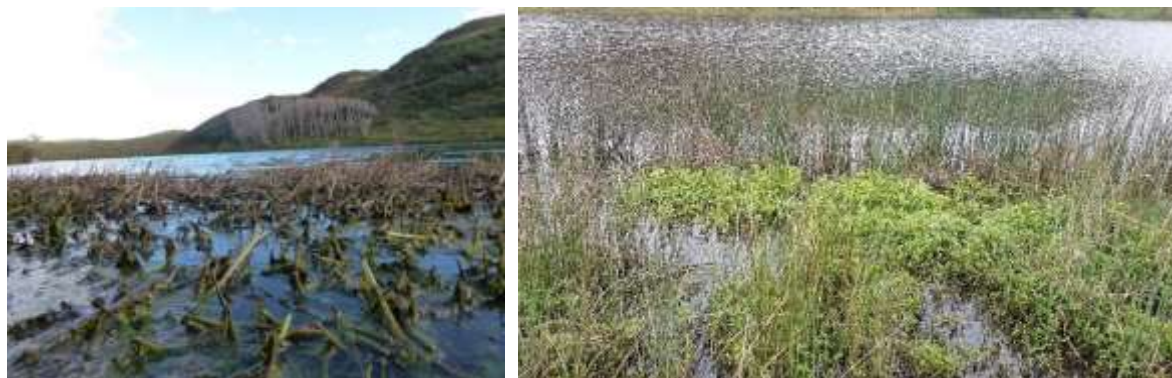
were noted spreading out from the lake edge in 2018. This showed the heavy browsing by the biocontrol agent *Agasicles hygrophila* seen in 2016 only provided temporary control (Figure 3-17). The turf community lining the southern margin of the lake, previously reported as containing the locally rare *Fimbristylis velata*, was submerged during the 2018 survey and this plant was not recorded.

**Figure 3-17: Alligator weed on the margin of Lake Parawanui.** Photo on left shows Alligator weed in autumn 2016 (defoliated by alligator weed flea beetle) and on right, in spring 2018 (healthy). (Photos: Paul Champion March 2016 and September 2018).

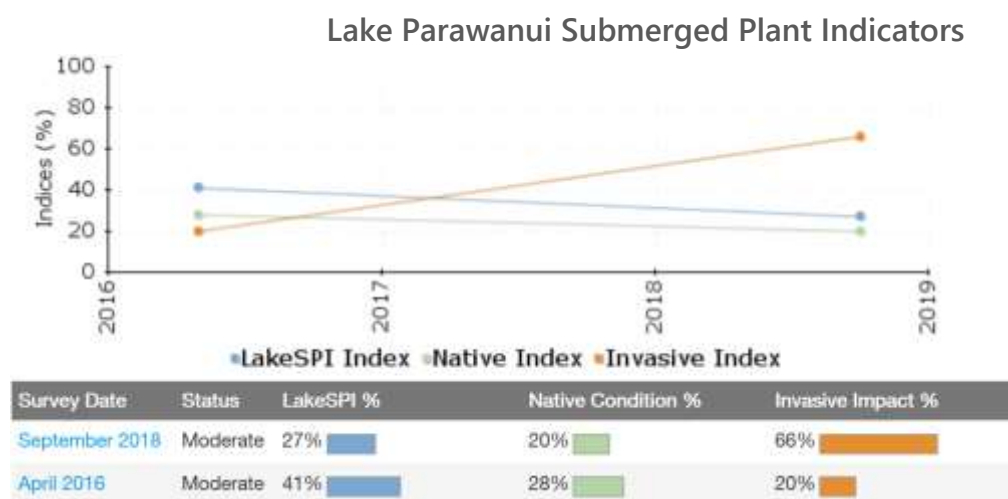
**Figure 3-18: LakeSPI results for Lake Parawanui.** LakeSPI Indices expressed as a percentage of lake maximum potential.

Lake Parawanui is categorised as being in moderate ecological condition with a LakeSPI Index of 27%.

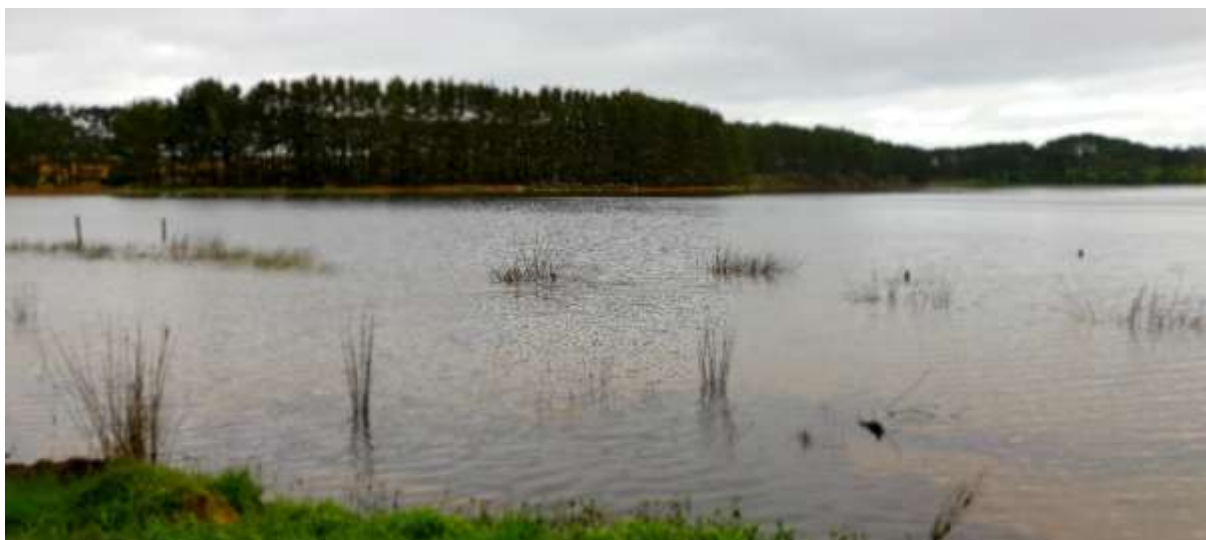
**Figure 3-19: Lake Rotokawau.** Photo from entry point on western margin looking over at a line of pine trees on the northern margin. (Photo: Tracey Burton 19 September 2018).

Summary Lake Rotokawau	
<b>Surveyed:</b>	2001, 2005, 2007, 2012, 2015 and 2018.
<b>Overall ranking:</b>	<b>Outstanding:</b> All submerged vegetation has declined significantly since 2015, charophyte meadows were absent and only low covers were recorded in depths greater than 0.6 m. This includes the continued decline of the invasive weed <i>Egeria densa</i> since 2007. These changes indicate a major deterioration in water quality. However, an outstanding ranking is maintained, as the lake still supports extensive turf communities dominated by the Nationally Critical <i>Trithuria inconspicua</i> and extensive beds of freshwater mussels.
<b>Threats:</b>	Presumably eel fishing nets were the mode of introduction of egeria and pose a threat for future introductions of pest species. Water quality has declined since 2015, with nutrient enrichment most likely relating to farming activities in the catchment. This deterioration could potentially lead to the loss of submerged vegetation, including the last Pouto population of <i>Trithuria inconspicua</i> .

Understanding the drivers for the water quality decline is critical to sustaining the outstanding ecology of this lake. Mitigating water quality deterioration in the lake should take priority over the planned management of *Egeria densa* in Lake Rotokawau. Lake ecological assessment should be carried out every 3 years.

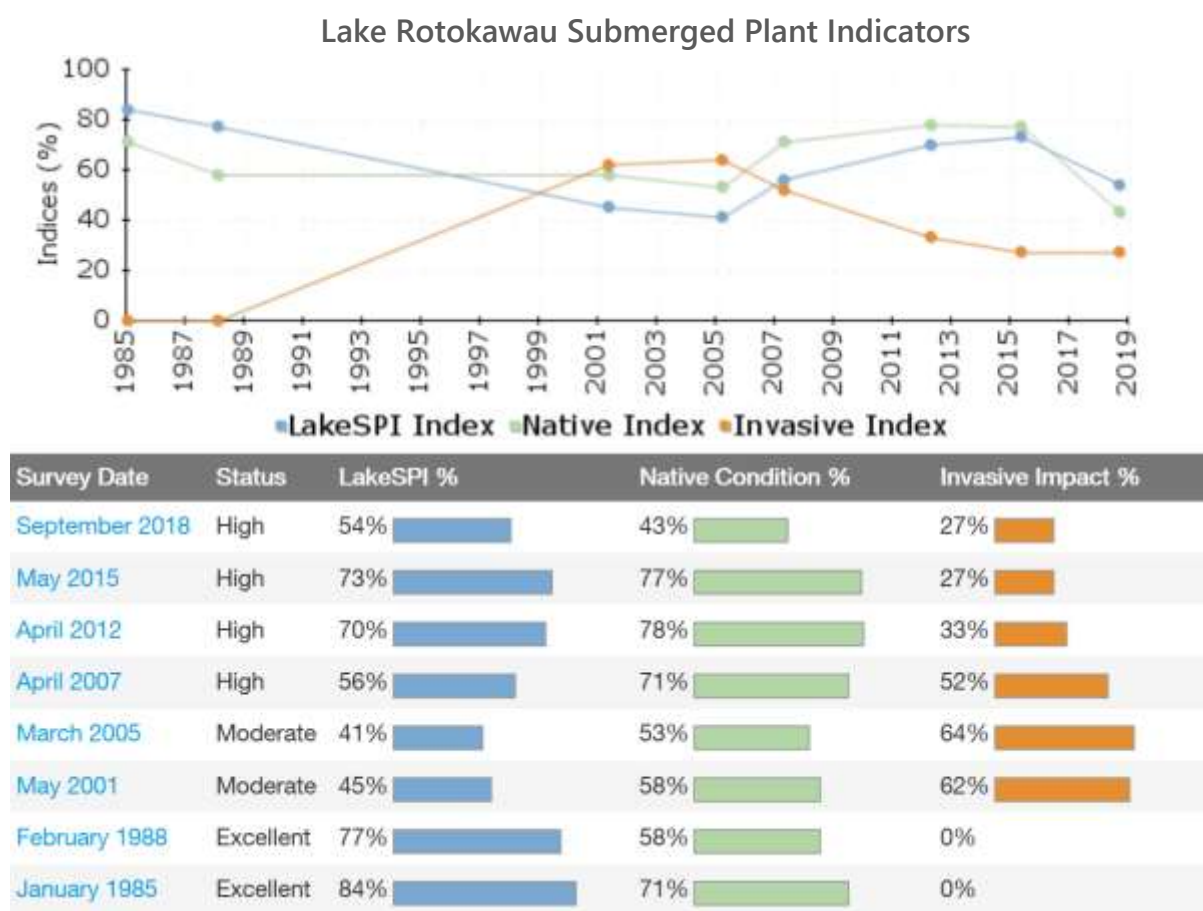
**Figure 3-20: LakeSPI results for Lake Rotokawau.** LakeSPI Indices expressed as a percentage of lake maximum potential.

Lake Rotokawau is categorised as being in high ecological condition with a LakeSPI Index of 54%. LakeSPI had declined from 73% in 2015, reflecting a large decrease in the Native Condition Index, from 77% in 2015 to 43% in 2018 (Figure 3-20). With no further increase in the Invasive Impact Index, LakeSPI scores had declined as a result of water quality issues and not further invasive impact.

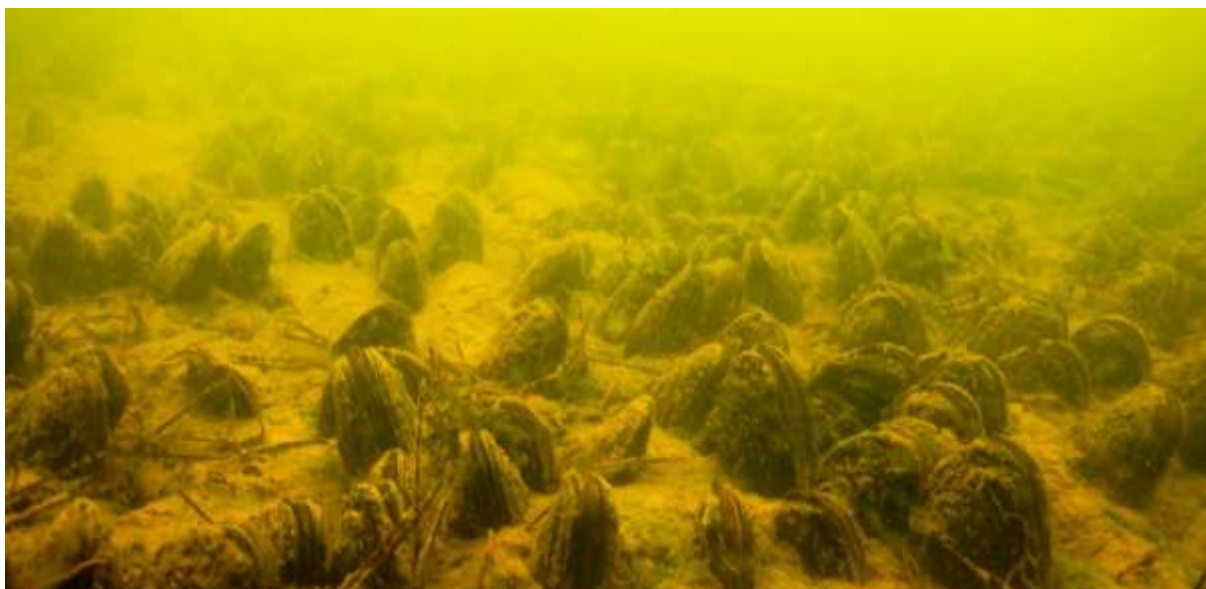
Freshwater mussels (*Echyridella menziesii*) were abundant in the 2018 survey (Figure 3-21). Leeches (*Richardsonianus mauianus*), and *Potamopyrgus antipodarum* snails were noted in some surveys but not in 2018.

**Figure 3-21: Freshwater mussels in Lake Rotokawau.** (Photo: Tracey Burton, 19 September 2018).

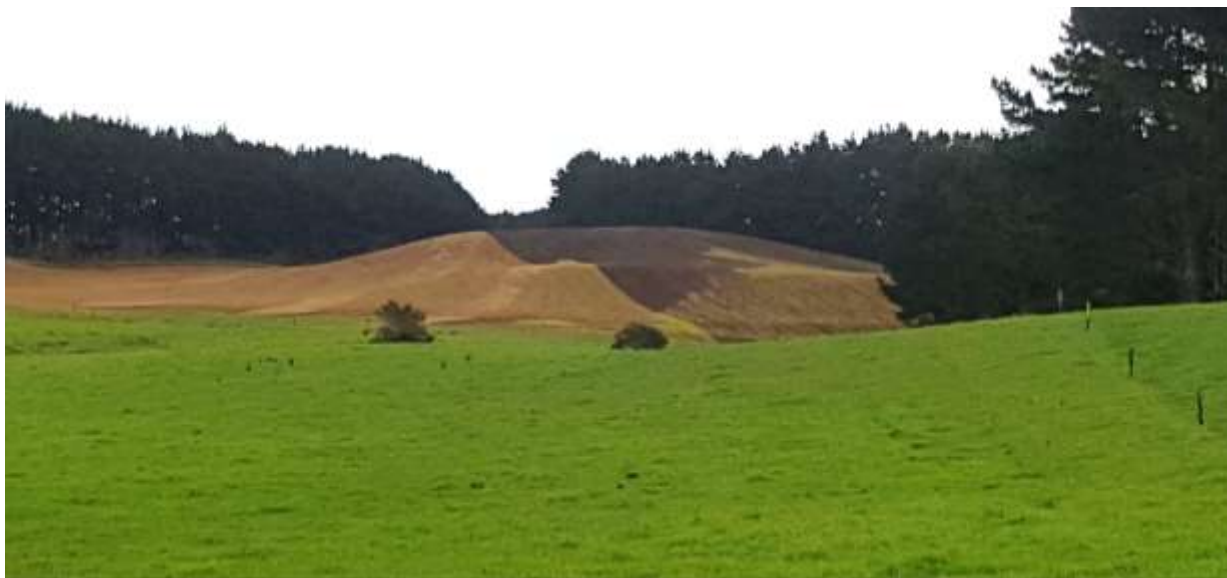
Of the utmost concern is the apparent collapse of submerged vegetation. Water quality has declined since 2015, with nutrient enrichment and algal blooms most likely relating to farming activities in the catchment. A paddock adjacent to the lake was devegetated at the time of the 2018 survey (Figure 3-22) and fertiliser application may have contributed additional nutrients to Lake Rotokawau (L. Forester, NRC, pers. comm.).

**Figure 3-22: Paddock adjacent to Lake Rotokawau (to the north (right)).** Run off from the bare earth is likely to run into the lake, contributing to phosphorus loading and stimulating algal blooms. (Photo: Paul Champion 19 September 2018).

Livestock access to parts of this lake could also affect water quality through direct nutrient addition, and damage to emergent and wetland vegetation that currently buffer the northern part of the lake from land-based nutrient sources.

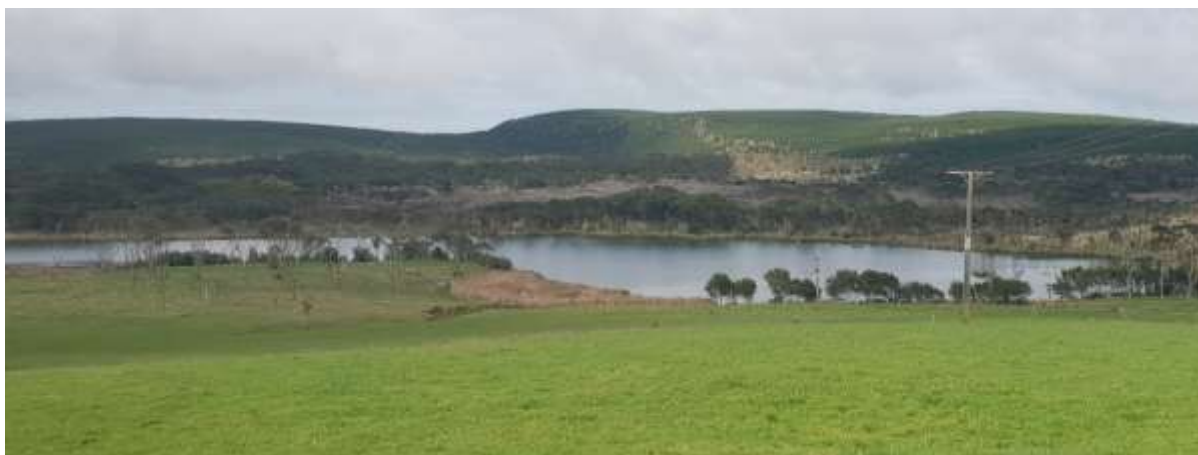
**Figure 3-23: Lake Rotopouua.** Photo showing the pasture catchment to the east (foreground) with native scrub and pine forest to the east. (Photo: Tracey Burton 21 September 2018).

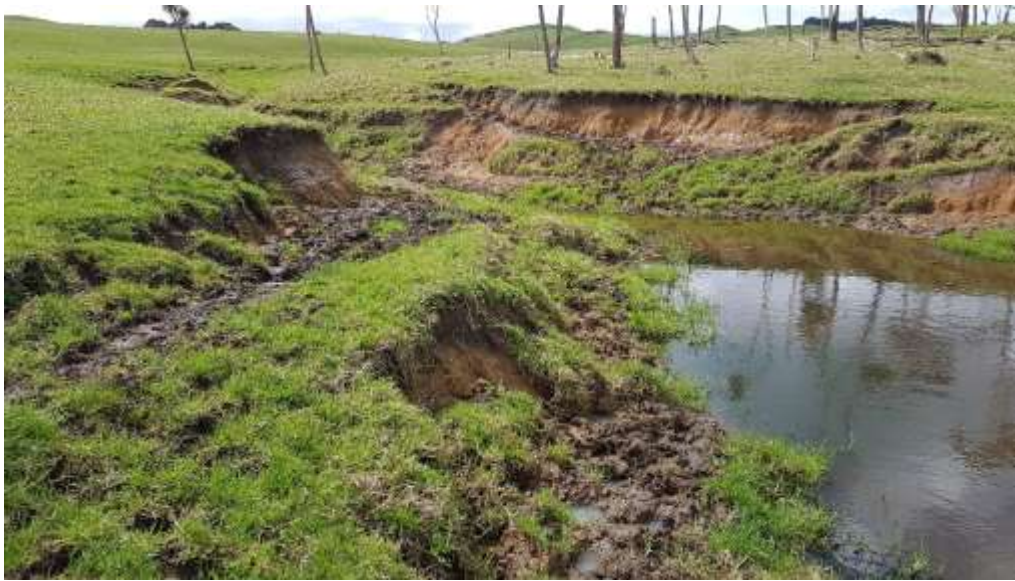
Water quality continues to be poorer than expected, considering the intact submerged vegetation present in the lake. The heavy rainfall prior to and during the 2018 survey allowed investigation of point sources of nutrients running off from farmland. Several extensive pugged wetland areas were noted on the northern side of the lake (Figure 3-25) that would contribute to deteriorating water quality. These were compared with a fenced inlet at the western end of the lake which was completely vegetated (Figure 3-26) allowing processing of nutrients.

**Figure 3-25: Unfenced inflow to Lake Rotopouua.** (Photo: Paul Champion 21 September 2018).

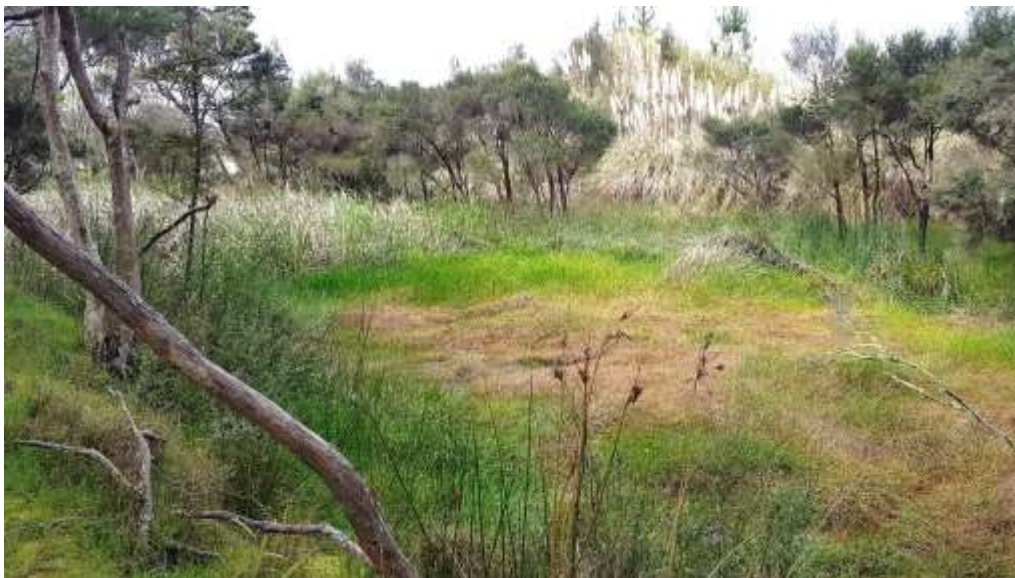
**Figure 3-26: Fenced inflow into lake Rotopouua.** (Photo: Paul Champion 21 September 2018).

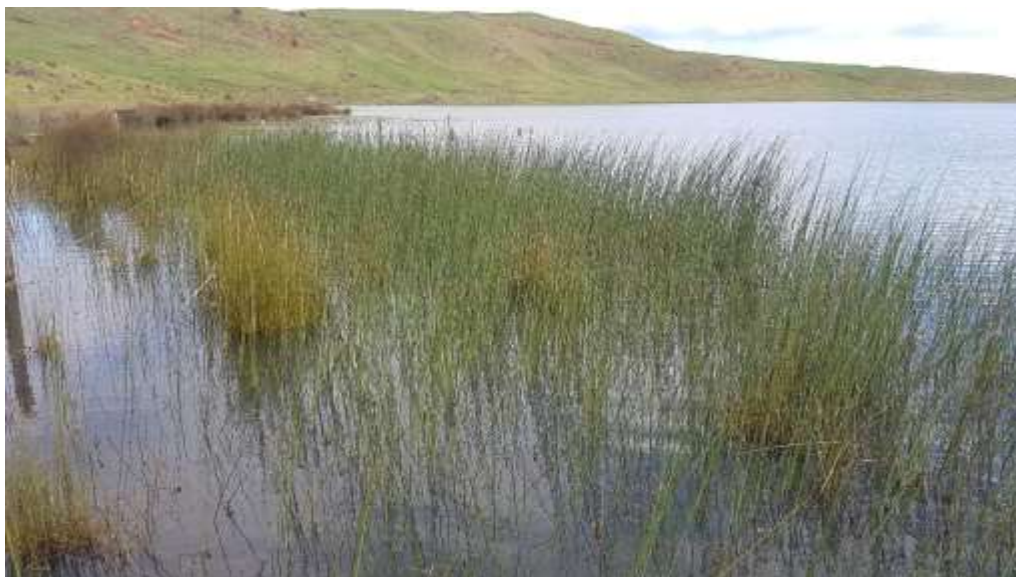
**Figure 3-27: Lake Waingata.** Photo showing the re-establishment of emergent vegetation within the fenced area (Photo: Paul Champion 19 September 2018).

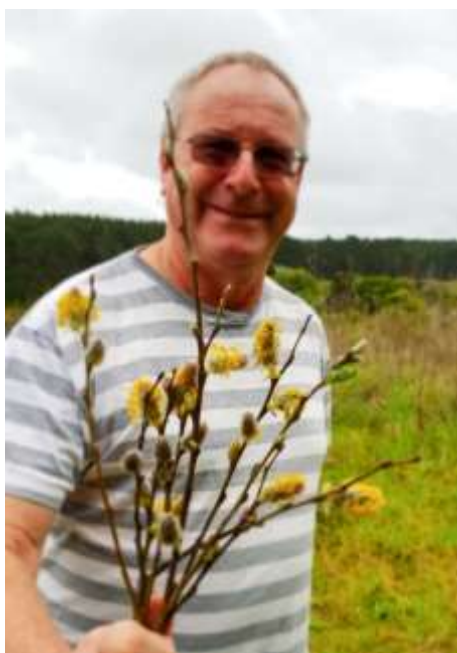
Plants that seemed to be identical to grey willow were noted in a wetland near Kaihu and on the margin of Lake Rototuna in the Spring 2018 report (Champion 2018). These plants were flowering in September and samples were taken from both sites and several other plants seen on the road between Dargaville and Kaihu. Subsequently this plant has been found elsewhere in Northland. All material is male (Figure 3-28), the flowers and bark corresponding to specimens collected in the vicinity of Hamilton, where grey willow is abundant. Herbarium material has been collected from those sites.

**Figure 3-28: Male flowers of grey willow (*Salix cinerea*) collected from the margin of Lake Rototuna.** (Photo: Tracey Burton 19 September 2018).

Despite the absence of female plants (seed are wind dispersed), an eradication programme is advocated at sites where this plant is spread vegetatively, as seen in the Kaihu wetland.
