Te Hiku

Lake Waiporohita (Karikari), NRC Lake No. 99.

Summary	Waiporohita
Surveyed:	2004, 2006, 2005, 2011, 2014, 2017, 2019, 2021 and 2022.
Overall ranking:	High: Indigenous submerged vegetation almost carpets this shallow lake. The first New Zealand records for four vagrant Australian plants have been made at this lake. Water quality has been poor in the past with the lake in a supertrophic state. However, despite frequent algal blooms, water quality appears to be improving and is now regarded as being eutrophic.
Threats:	Significant potential for pest plant and fish impacts. Nutrient enrichment and algal blooms can result in reduced water clarity.
Management recommendations:	Nutrient enrichment and consequent planktonic algal blooms threaten this lake. The sources of nutrients should be investigated, with possible control of the very large numbers of birds (particularly Canada geese). Annual pest plant surveillance monitoring is recommended as well as lake native biodiversity value assessment monitoring every 5 years.

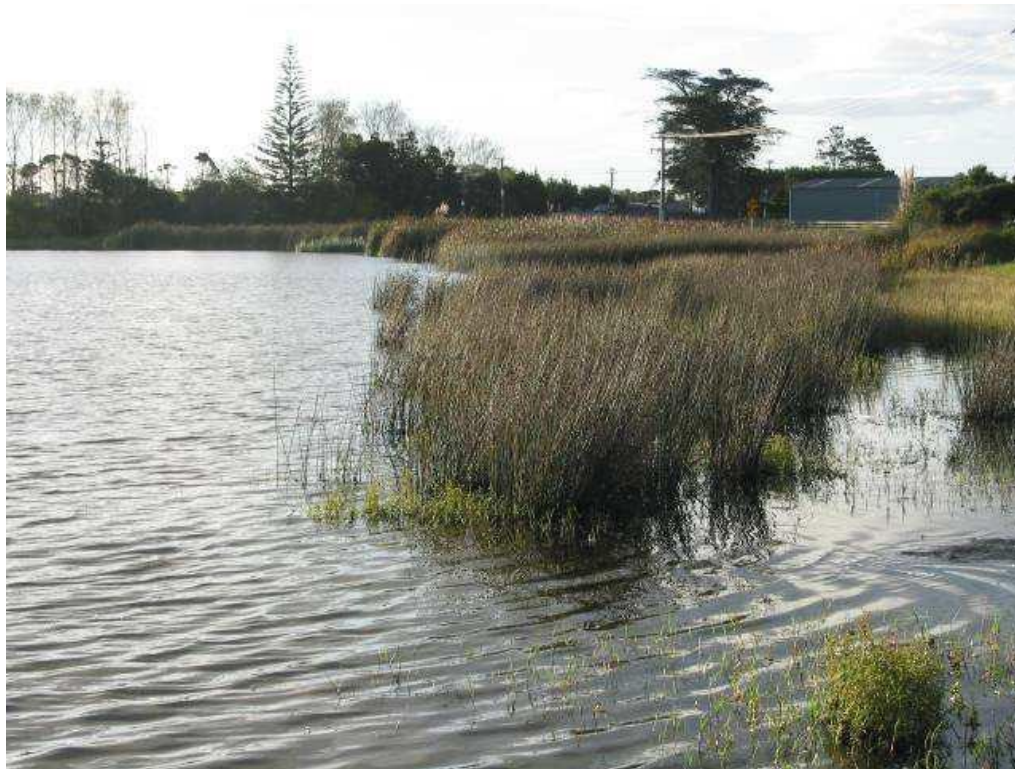
Lake Waiporohita. Image shows emergent plant communities on the east side of the lake accessible from the road.

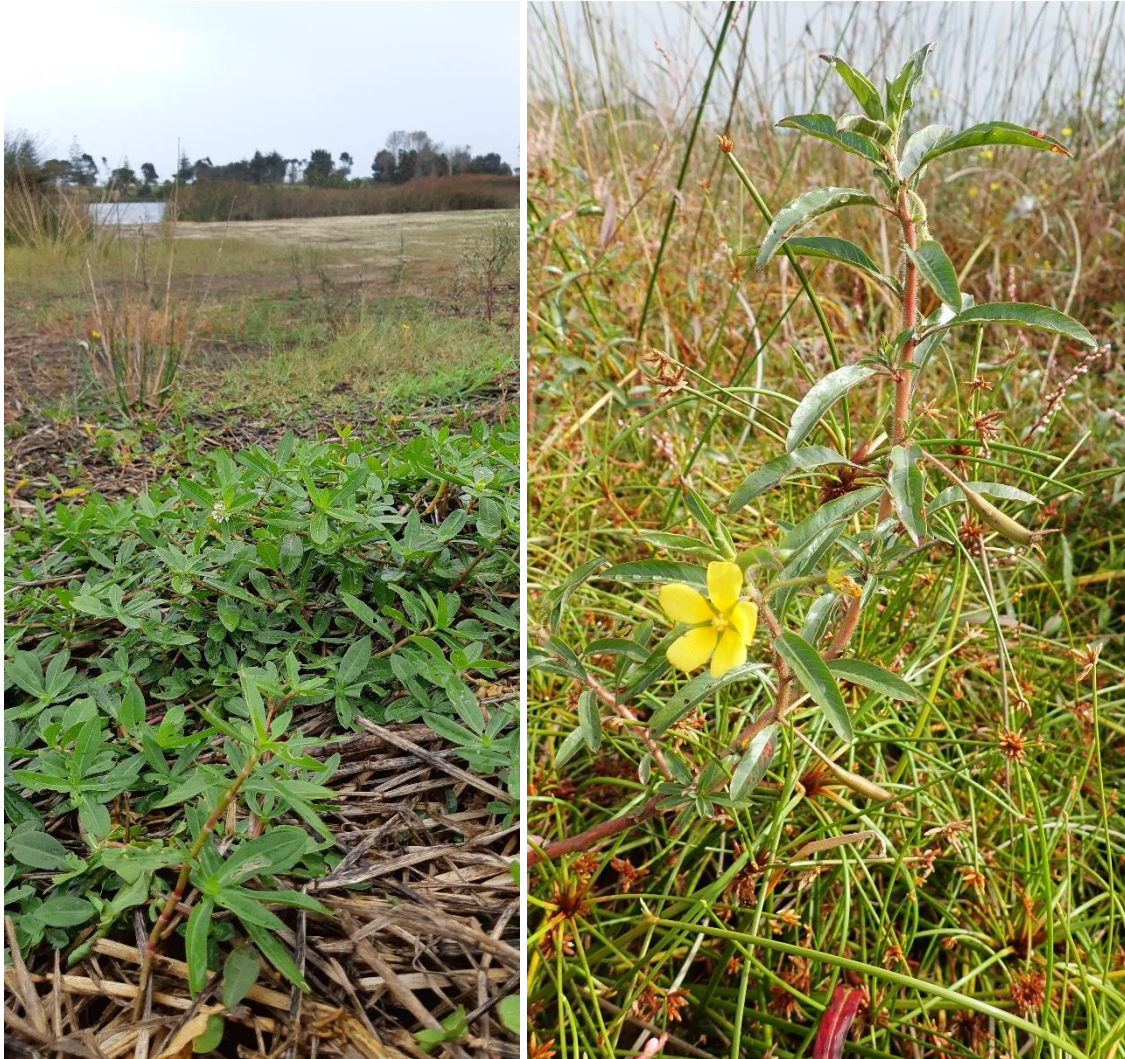
A 2 m² patch of alligator weed (*Alternanthera philoxeroides*) was noted in 2005 at the north end access point. This species has increased and was found amongst much of the marginal emergent vegetation. The introduced weed, primrose willow (*Ludwigia peploides* var. *montevidensis*), was also recorded. Both species are now widespread in the margins of Lake Waiporohita.

Alligator weed (left) and primrose willow (right) in marginal vegetation of Lake Waiporohita (Daniel Clements 2019).

Alligator weed and primrose willow have now spread around the lake in the marginal vegetation but do not seem to be having a major impact on other marginal species.

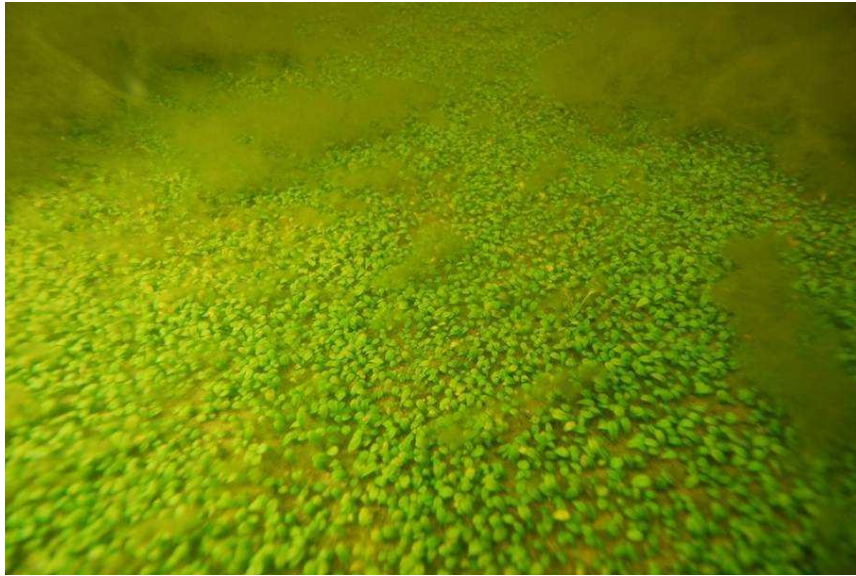
Turf communities were conspicuous in many areas of the lake with *Glossostigma elatinooides*, *Lilaeopsis novae-zelandiae*, *Myriophyllum propinquum*, the exotic *Ludwigia palustris* and at one site *Gratiola pedunculata* extending from the shore to ~ 1 m deep. *Potamogeton ochreatus* and *Chara australis* dominated deep vegetation extending to 2.9 m (the bottom) in 2017.

Submerged turfs in Lake Waiporohita. *Glossostigma elatinoides* was the most common turf species.

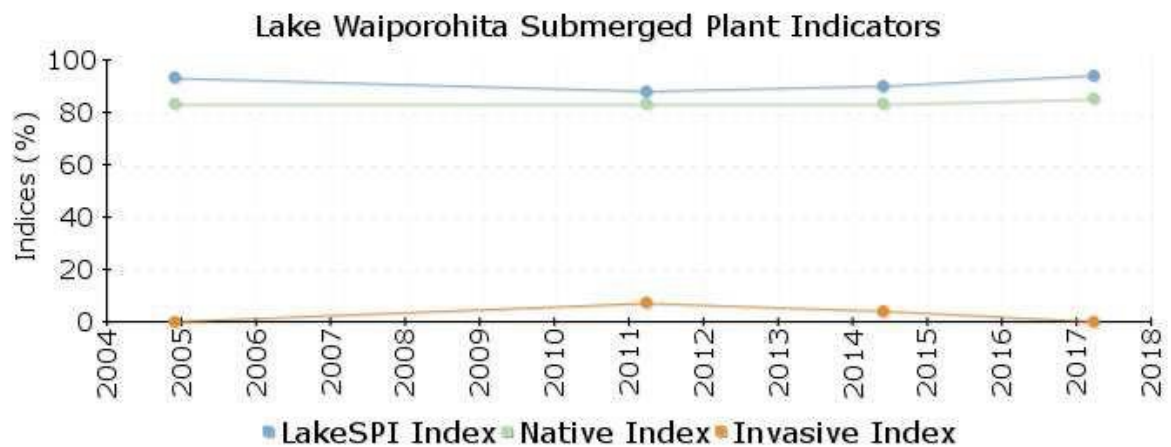
The excellent LakeSPI scores of 88 - 94% reflects the extent of the native vegetation, with limited influence of invasive exotic species.

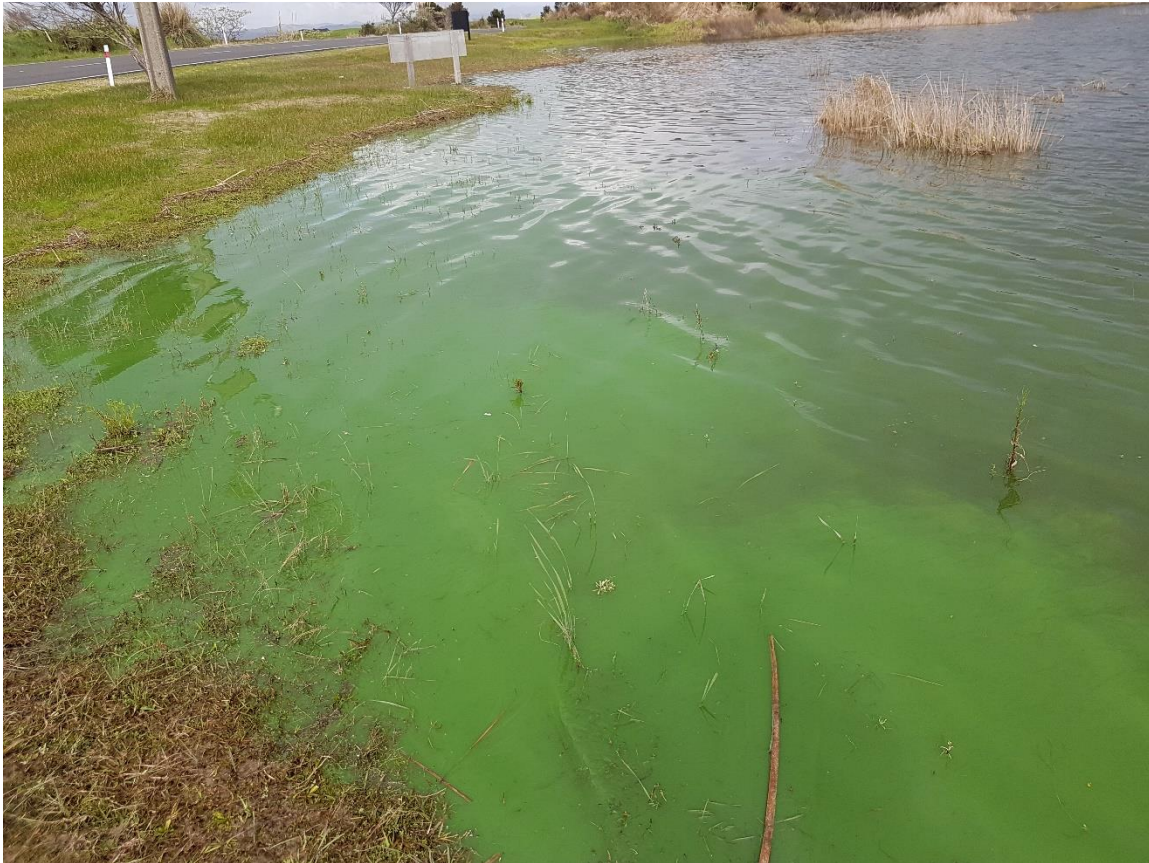
Lake Waiporohita has an ecological value rating of “High” with a score of 11. The condition of the lake has improved and was fully vegetated. Water quality trends showed improvement in TLI indicating eutrophic status (10-year median of 4.96) in 2019, improving from supertrophic status prior to then. Water levels were very high in August 2022, with flooding of much of the grass verge between the lake and Inland Road. A large planktonic cyanobacterial bloom prevented any investigation of submerged ecology of Lake Waiporohita on that occasion.

Lake Waiporohita, showing the flooded grass verge and cyanobacterial bloom (Paul Champion, 9 August 2022).

The lake was improving in clarity and plant health but dense cyanobacterial blooms are commonly encountered. Sources of nutrients need to be considered carefully and managed.

Nutrient management, including Canadian geese control, is advocated. It would be advisable to explore the relative importance of waterfowl and catchment as nutrient sources.
