8 COASTAL WATER QUALITY

8.1 Introduction

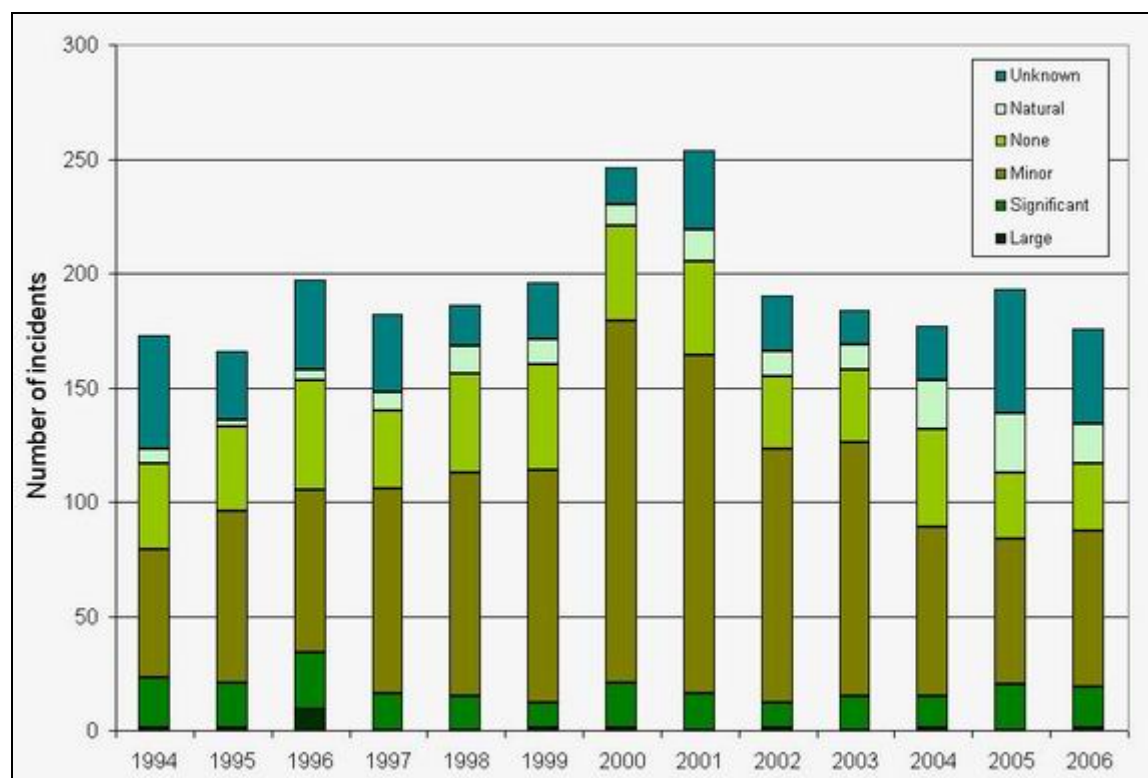
Figure 1: Number of coastal incidents reported to the Regional Council from January 1994 to December 2006 and their impact on the environment.

Since the environmental hotline started in 1993 there has been over 160 coastal incidents reported to the council every year. The number of incidents peaked in 2000 and 2001 with 246 and 254 coastal incidents respectively, as shown in figure 1 (below).

Over the 13-year period from January 1994 to December 2006 there has been approximately 2500 coastal incidents reported to the council, of which only 16 were reported as having a large effect on the environment as shown in figure 1 (above). A further 220 incidents (8% of the total) were reported as having a significant effect on the environment.

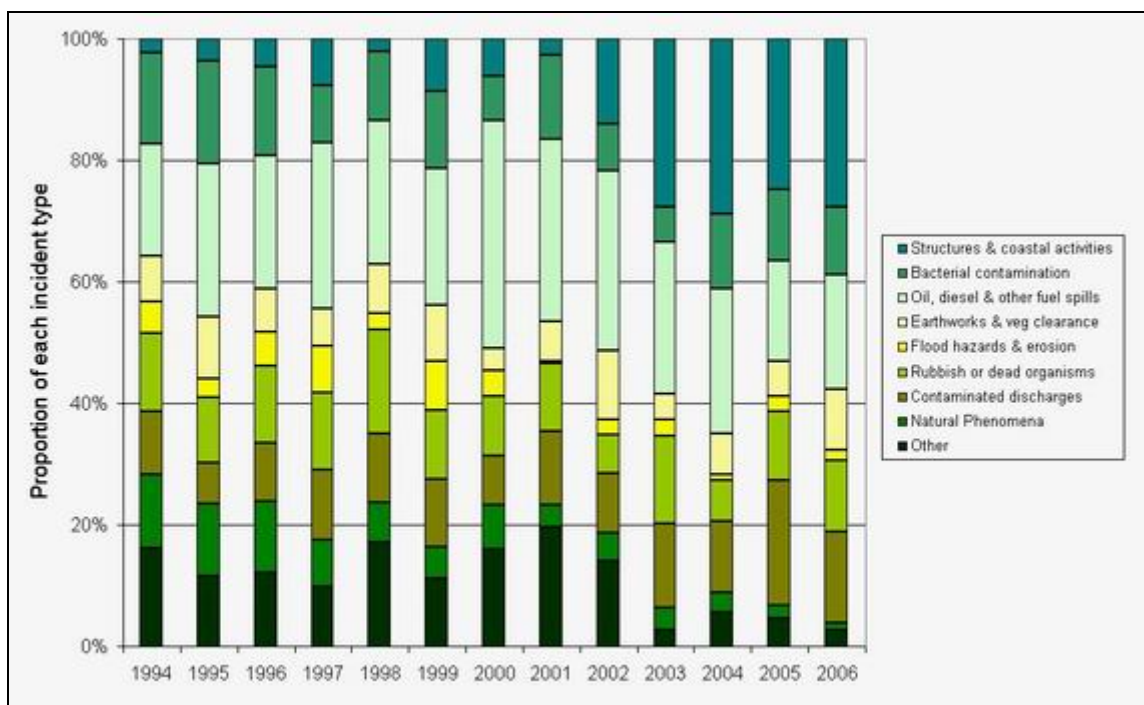
Figure 2: Different types of coastal incidents reported to the Council between January 1994 and December 2006.

Oil, diesel and other fuel spills are the most common type of coastal incident reported to the council since 1994 as shown in figure 2 (below). More recently the number of incidents relating to structures and other coastal activities has increased. However there has been a subsequent drop in the number of incidents recorded as miscellaneous (shown in the 'other' category in figure 2). This is likely to be as a result of a change in recording from 'miscellaneous' to 'other coastal activities', which was added to the database system as an incident type in 2002.

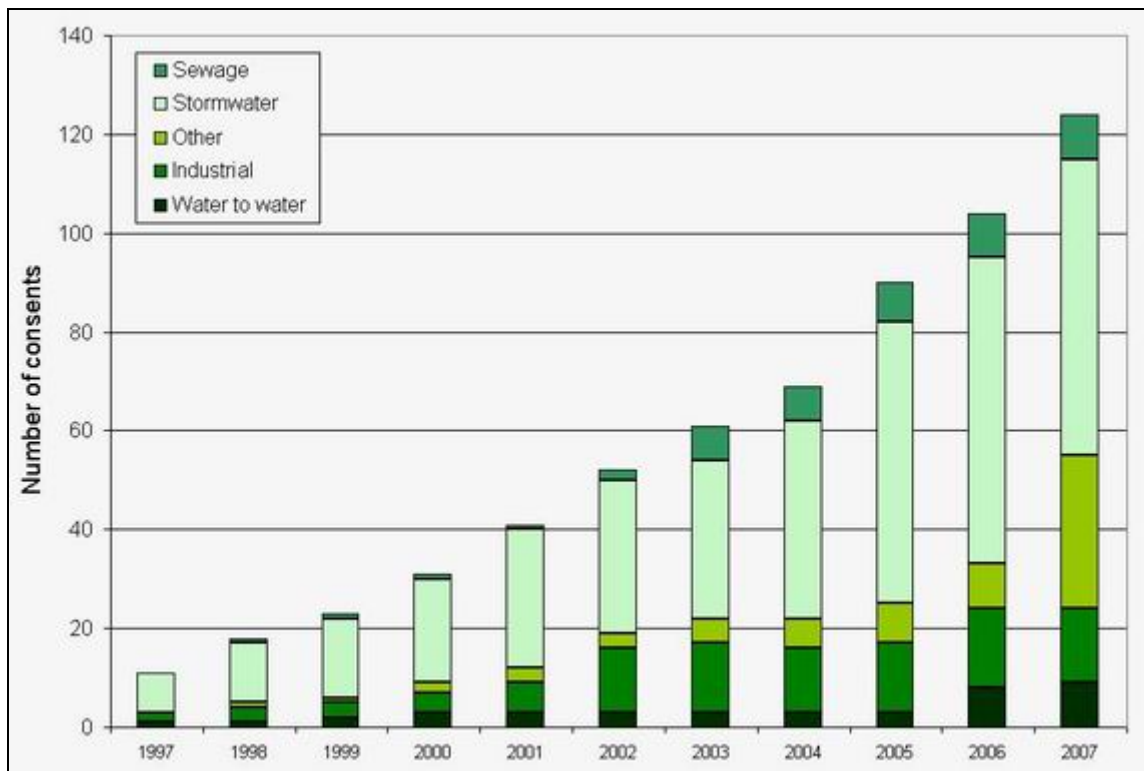
Figure 3: Number of coastal discharge consents at 1 January of each year for 1997 to 2007.

There has been a steady increase in the number of coastal discharge consents from 1997 to 2007 as shown in figure 3 (below). Stormwater discharges are the most common. More recently there has been an increase in the number of 'other' discharge consents. The majority of these are for chemical use to remove algae from boat ramps within consent conditions.

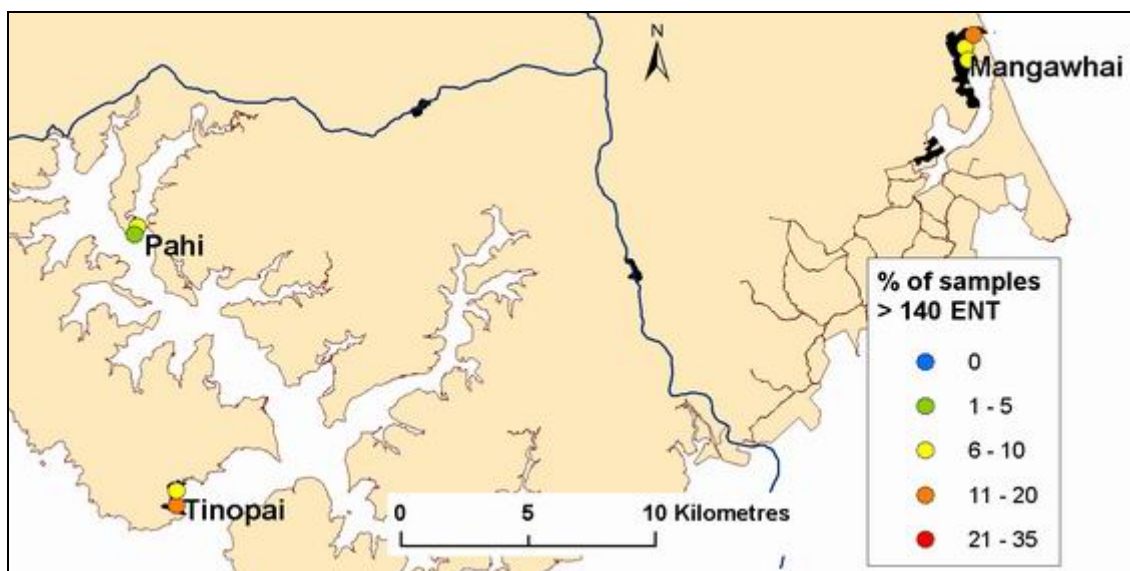
Figure 5: Percentage of samples between 2002 and 2007 that are greater than 140 enterococci per 100ml for sites in the Kaipara District

Of the seven sites in the Kaipara District all comply with the guideline of 140 Enterococci per 100ml on at least 80% of sampling occasions, as shown in figure 5 (below). However none of these sites had 100% of their samples comply with the guideline.

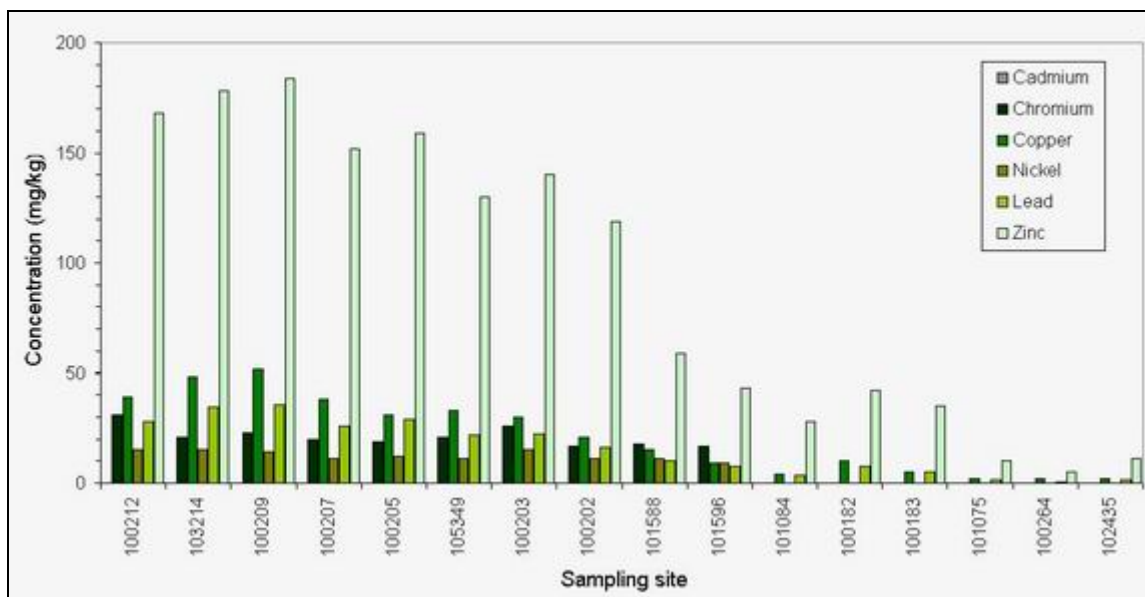
Figure 14: Metal concentrations (mg/kg) in sediment samples for all Whangarei Harbour sites sampled in 2002.

In 2002 zinc was found in the highest concentrations, generally followed by copper, lead, chromium and then nickel as shown in figure 14 (below). Cadmium was found in the lowest concentration, in fact so low it does not show on figure 14.

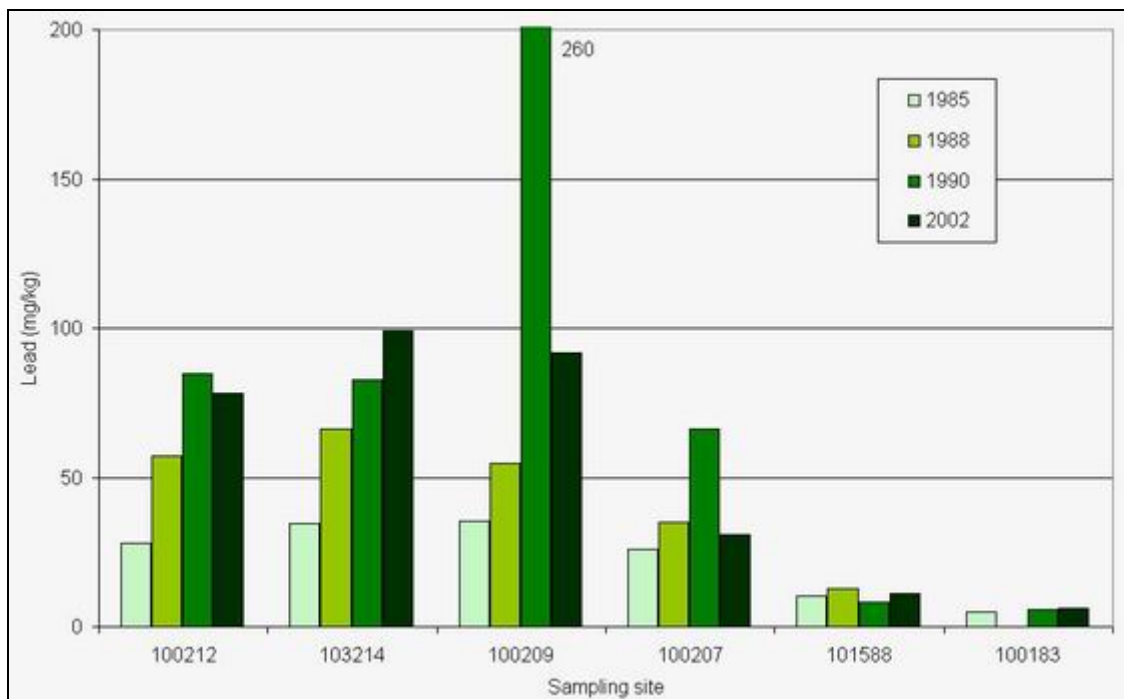
Figure 18: Lead concentrations (mg/kg) in sediments samples from several sites in the upper Whangarei Harbour in 1985, 1988, 1990 and 2002.

Lead is showing a slightly increasing trend at two sites (100212 and 103214) but has had a significant decrease at some of the other sites between 1990 and 2002 (figure 18). Although chromium has not decreased much between 1990 and 2002, since 1985 there has been an overall reduction in chromium concentrations in sediments from the upper Whangarei Harbour (figure 20).

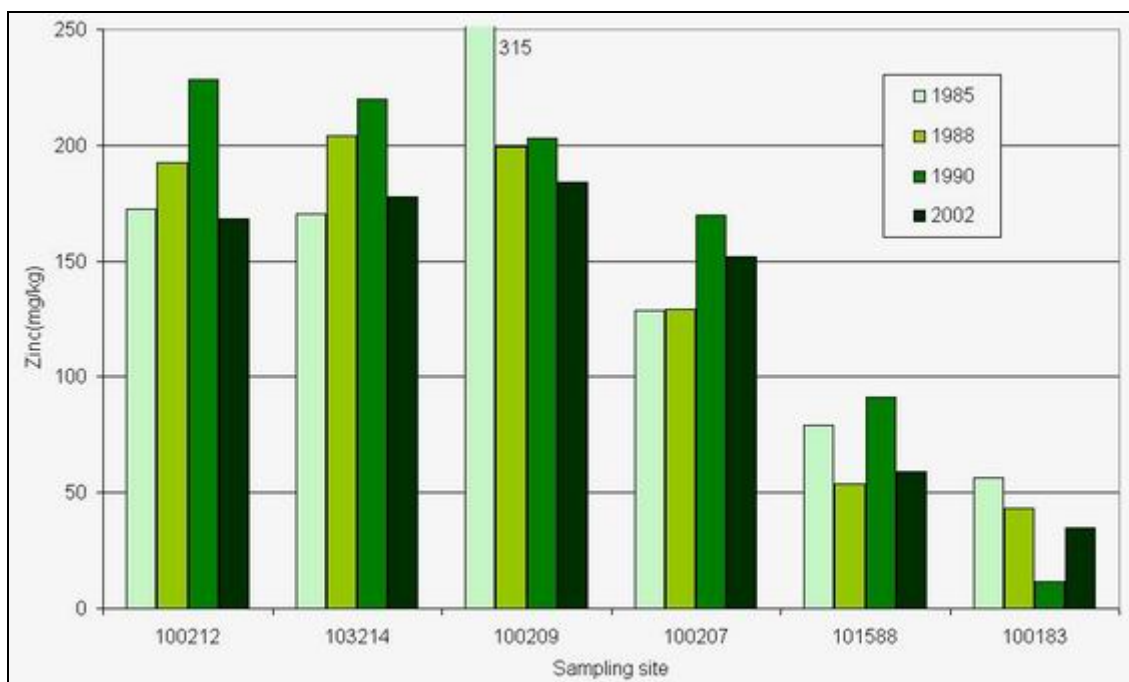
Figure 19: Zinc concentrations (mg/kg) in sediments samples from several sites in the upper Whangarei Harbour in 1985, 1988, 1990 and 2002.

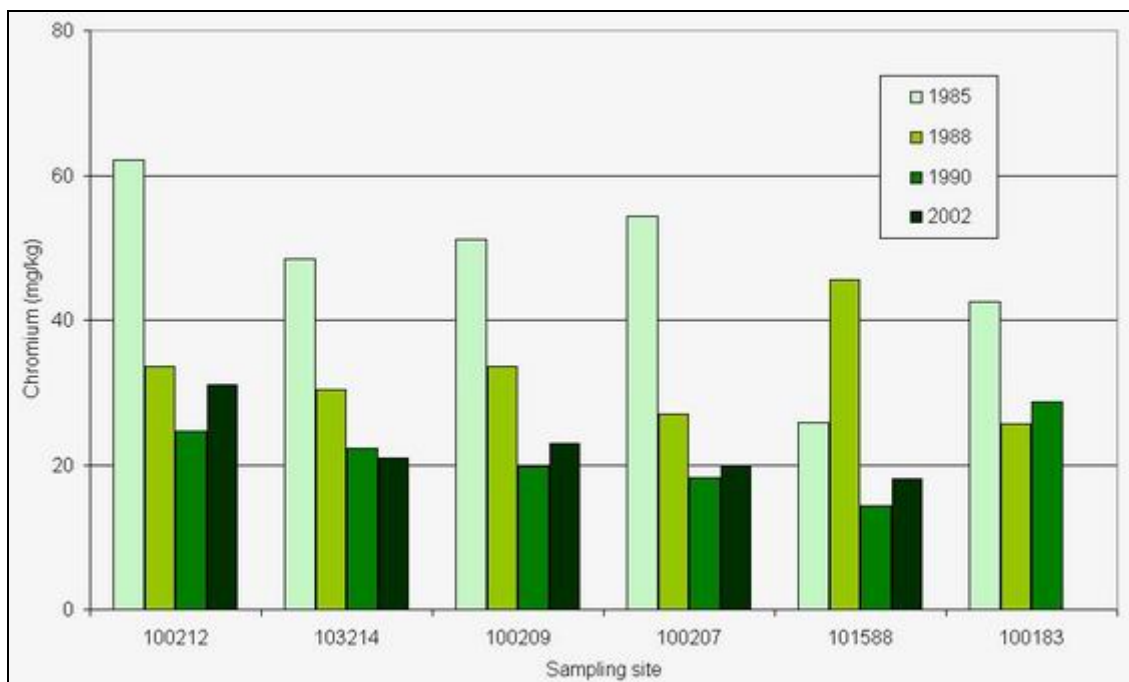
Figure 20: Chromium concentrations (mg/kg) in sediments samples from several sites in the upper Whangarei Harbour in 1985, 1988, 1990 and 2002.

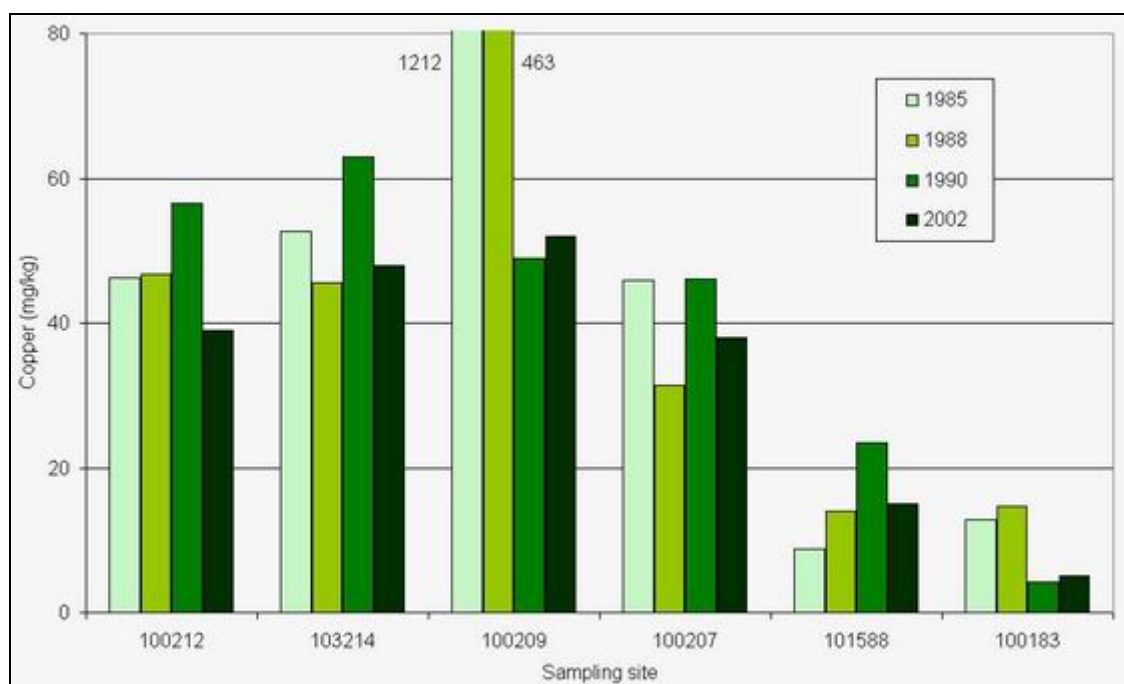
Figure 21: Copper concentrations (mg/kg) in sediments samples from several sites in the upper Whangarei Harbour in 1985, 1988, 1990 and 2002.

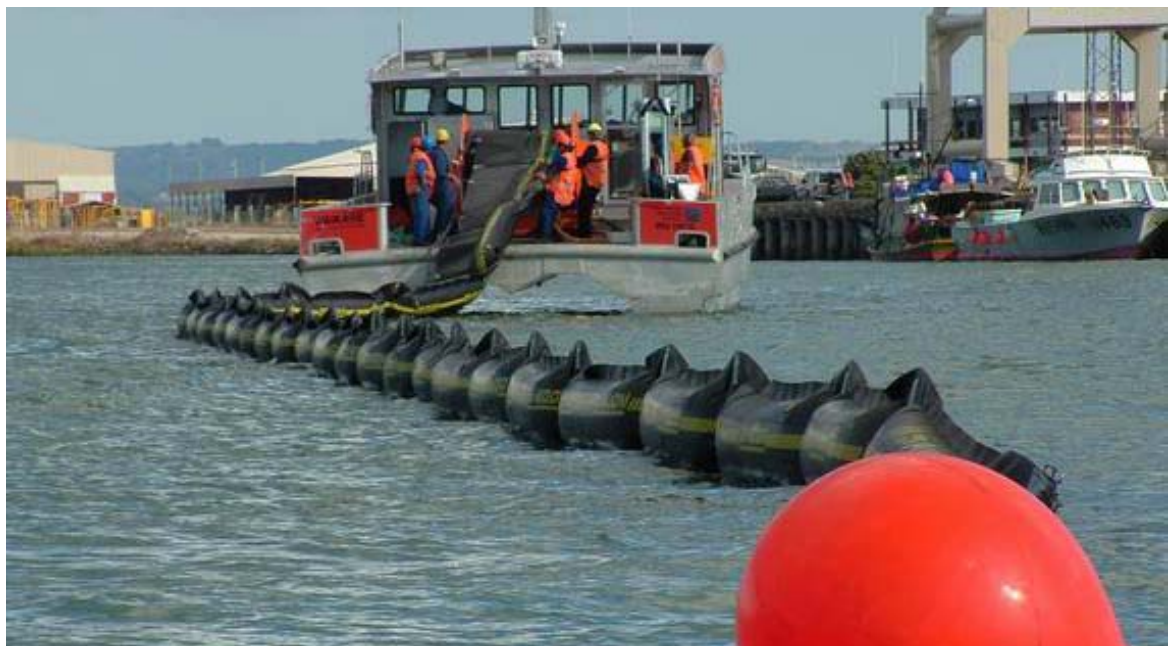
Deploying the Ro-boom from the Waikare in an oil spill response exercise.

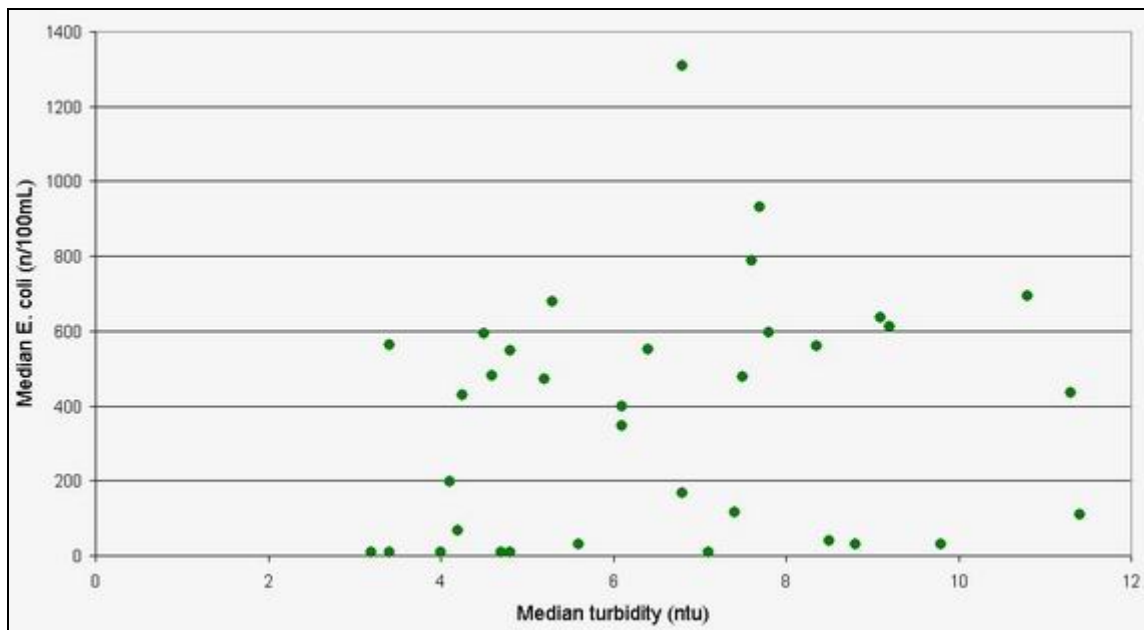
Figure 25: Median turbidity (ntu) against median E. coli (n/100ml) for all Whangaroa Harbour study sampling sites.

An analysis was carried out to see if there was any relationship between turbidity or salinity and E. coli levels. No relationship was found between turbidity and E. coli as shown in figure 25 (below).

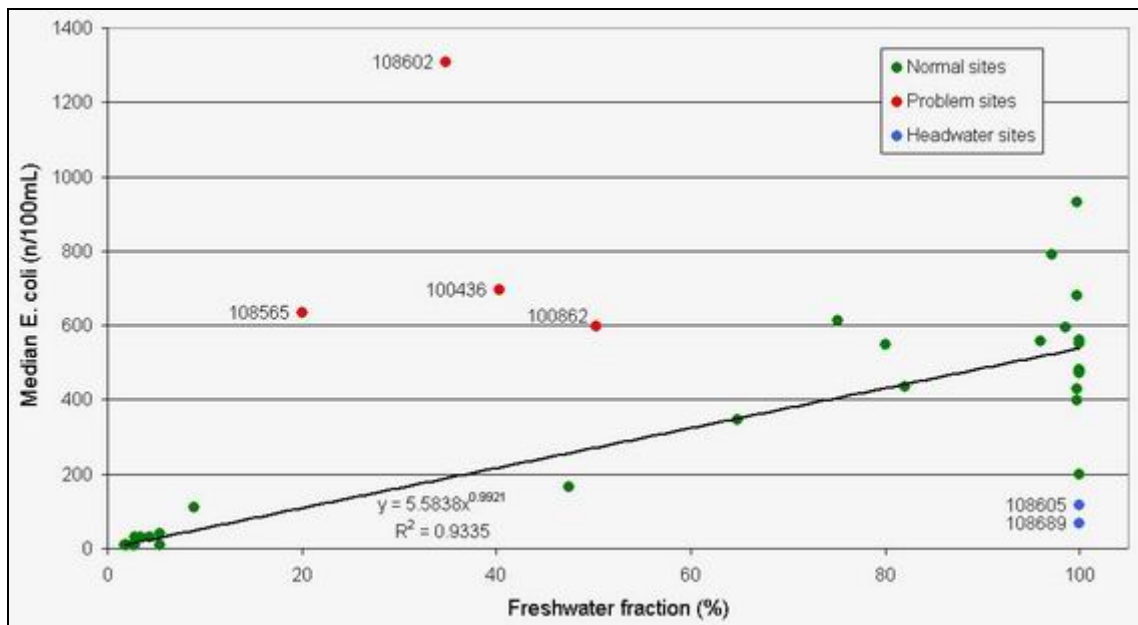
Figure 26: Median freshwater fraction (%) against median E. coli (n/100ml) for all Whangaroa Harbour study sampling sites.

At the other end of the scale, the sites shown in red have relatively high E. coli levels considering the low proportion of freshwater at these sites. This includes the unnamed tributary that flows into the upper Whangaroa Harbour by Weber Road (sites 108602 and 100436), Waitapu Creek (site 100862) and an unnamed tributary in Totara North (site 108565).
