Engineering Works
Roading Typical Cross Sections

189 Three Mile Bush Road, Kamo, Whangarei

Three Waters Design Report

Stormwater Ponds
189 &131 Three Mile Bush Road
Whangarei

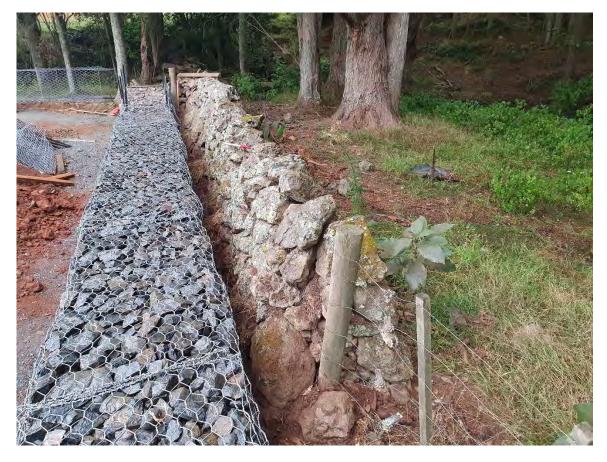
Figure 42: Section of wall in fair condition along northern boundary.

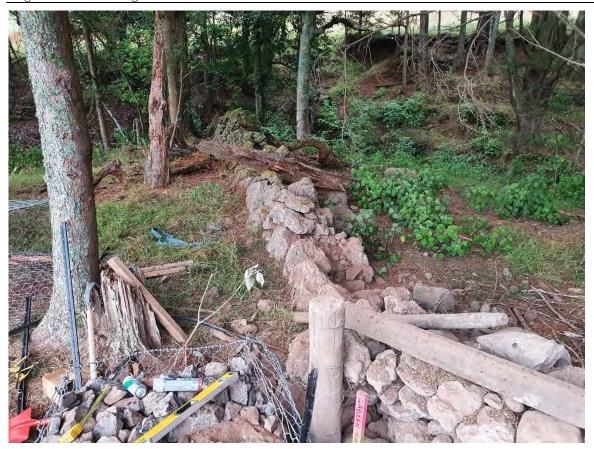
Figure 43: Section of stone wall in poor condition on northern boundary.

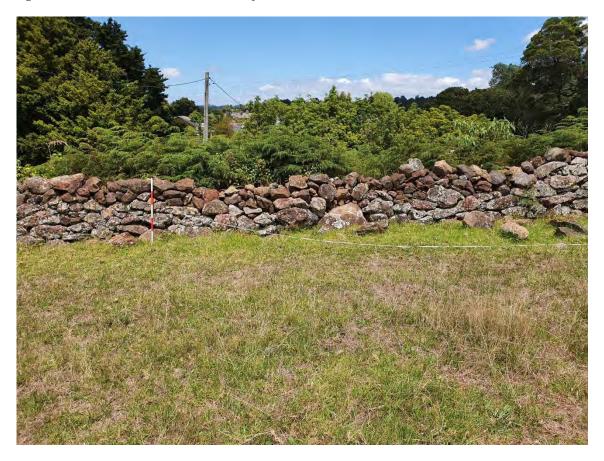
Figure 51; Poorly repaired section of Three Mile Bush Road boundary wall.

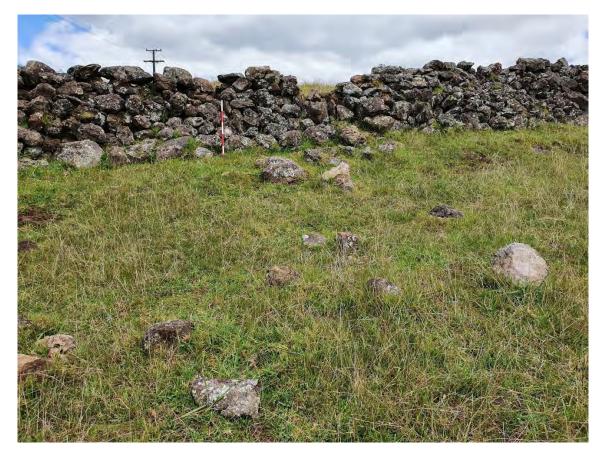
Figure 53: Section of wall in poor condition.

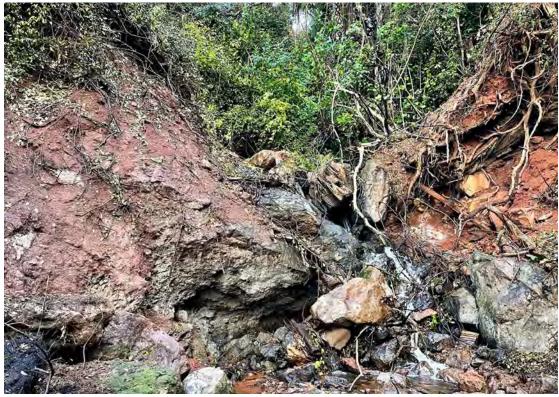
Figure 3: View west from the gully floor towards the gully head, showing basalt exposed beneath red tephra soils at the base of the gully slopes.

Several exposures of large basalt boulders are noted around the crest at the western end of the gully. Several areas of tephra soils are exposures through the mid-section of the steeper slopes. The gully floor is covered by cobble to boulder sizes clasts of loose basalt, with some possibly in situ basalt at the base of the gully head.

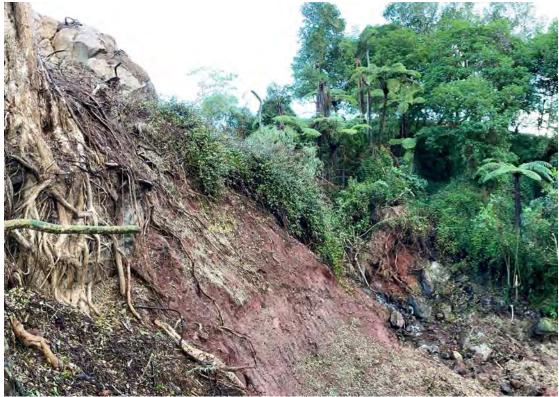
Figure 4: View west across the southern gully slope, showing large basalt promontory at crest of slope (top left), tephra soils immediately below, and boulders of basalt over the gully floor.

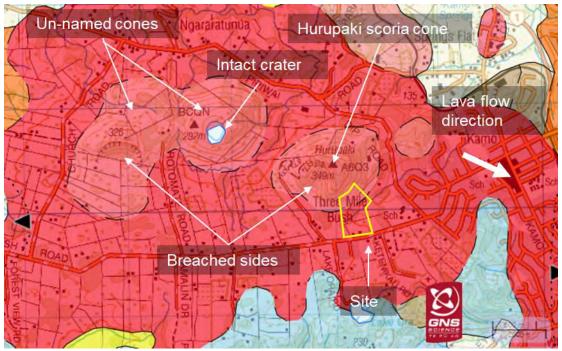
Figure 5: Clip of the NZ Geology Web Map, showing the mapped geological units in the vicinity of the site (outlined yellow). Dark red indicates lava flows, light red indicates scoria cones. Blue to the south indicates greywacke bedrock of the Pukunui Forest, confining the lava flow.

The volcanic field in the vicinity of the subject site comprises broad flat to gently east-ward sloping lava fields, forming elevated plateaus of the Kamo and Three Mile Bush suburbs, punctuated by a series of three scoria cones aligned west to east, of which Hurupaki is the eastern and largest. The central scoria cone (Rawhitiroa) has an in-tact crater lake, while Hurupaki and the western most scoria cone (Ngararatunua) appear to both have breached craters, indicated by arcuate depressions in the side of the otherwise conical form (Figure 3). The local volcanic field is confined to the south by the greywacke bedrock hills of the Pukenui Forest, and to the north by an older Pleistocene age rhyolite/dacite volcanic dome (Parakiore).

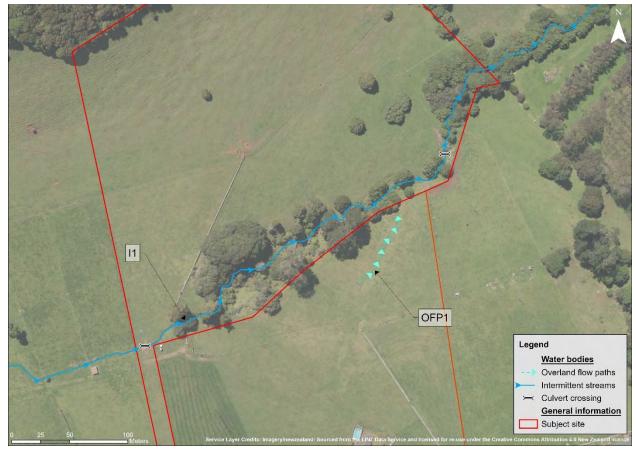
Figure 22: Showing the general hydrology of the subject site

The subject site provides for an interesting study of hydrology and ecology. A section of the Waitaua Stream flows along the southern boundary of Lot 3, flowing through the natural depression in the land within the remnant bush area which was historically formed by volcanic activity and lava flows. The section of the Waitaua Stream, while flowing through the subject site, is best described as an intermittent stream (I1). An overland flow path (OFP1) was noted on Lot 2. The watercourses on the subject site were delineated using a handheld GPS, while the wider stream systems were obtained from LINZ Data Service. A basic overview of the hydrological features on the site is provided below in (Figure 22). No wetland habitats (as defined under the Resource Management Act 1991 (RMA) and National Policy Statement for Freshwater Management 2020 (NPSFM) were identified on site during the field surveys.

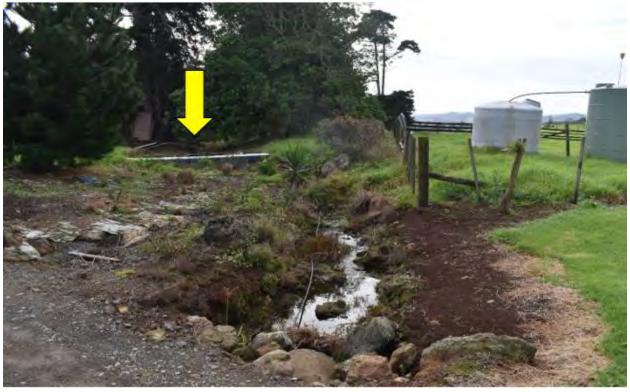
Figure 24: Showing the existing stream crossing associated stream and where stream seeps into soil and drops for about 10-15m (yellow arrow)

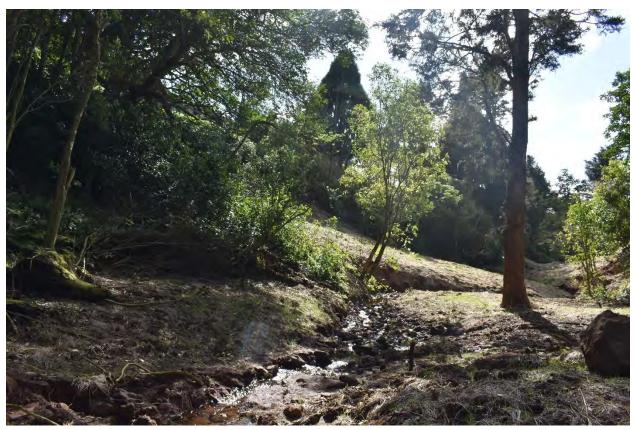
Figure 25: Showing general stream morphology in the eastern extent during a repeat site visit in August 2021

The mid-section of the stream was observed to have a scoria gravel substrate with occasional large rocks, no free-flowing surface water (at the time of survey visit in April 2021), but there was evidence of debris and streambank erosion to suggest heavy flows in rain events (as observed during a repeat site visit in August 2021). The eastern extent of the stream consisted of a basalt stream bed. The stream channel is approx. 1.5m-3m in width with a series of small waterfall and associated pools (>0.4m) with bank height averaging approximately >5m (Figure 25).

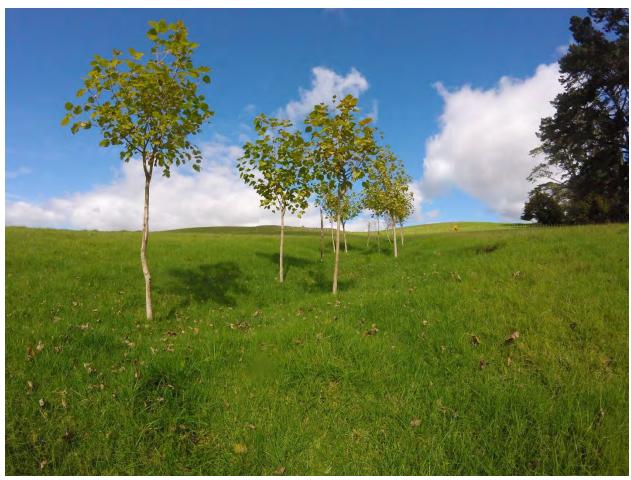
Figure 26: Showing the overland flow path (OFP1) observed on site

A small overland flow path (OFP1) was observed within the northern aspect of Lot 2 near the Waitaua Stream (Figure 26). The overland flow path follows a small natural depression in the land and was completely dry at the time of the site visit. It is anticipated that in high rainfall events some overland surface water flows may occur. Currently the flow path is part of the open pastoral area dominated by kikuyu with sparse buttercup (*Ranuculus repens*) and has been more recently planted with poplar (*Populus* sp.).

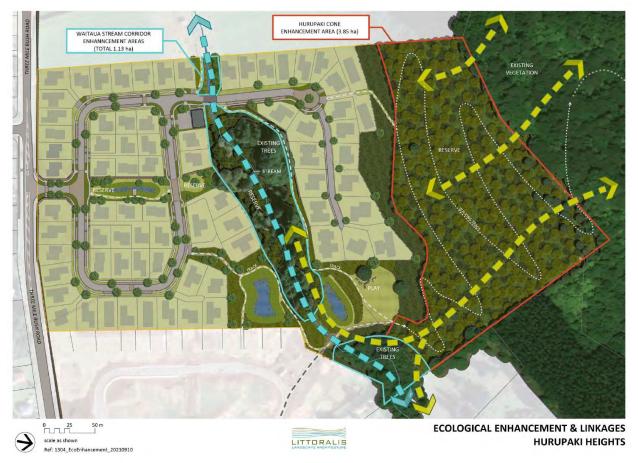
Figure 29: Showing the proposed Waitaua Stream Corridor Enhancement Area and Hurupaki Cone Enhancement Area (plan prepared by Littoralis Landscape Architecture)

It is proposed a standalone document such as an Ecological and Landscape Enhancement Plan, that sets out delineation of ecological planting requirements, as well as overall management of these areas, is to be conditioned as a part of the Resource Consent.
