Poutō Peninsula

Rototuna (Poutō), NRC Lake No. 328.

Summary

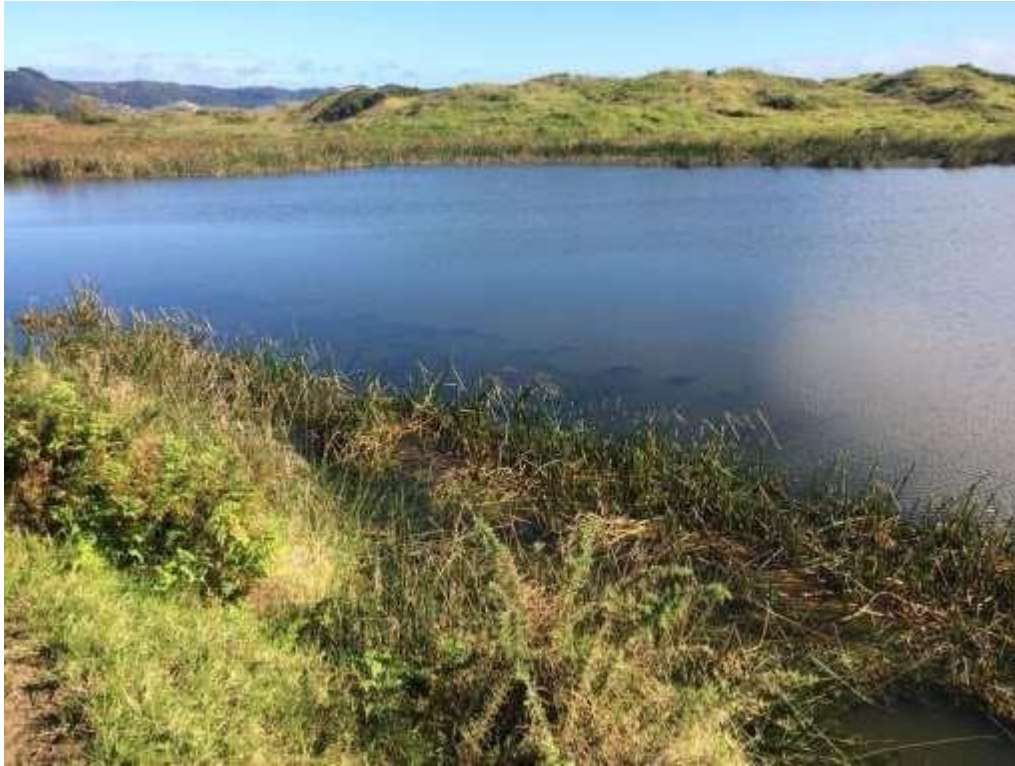
Rototuna. Viewed from the south. Photo: Lisa Forester, NRC (4 May 2018).

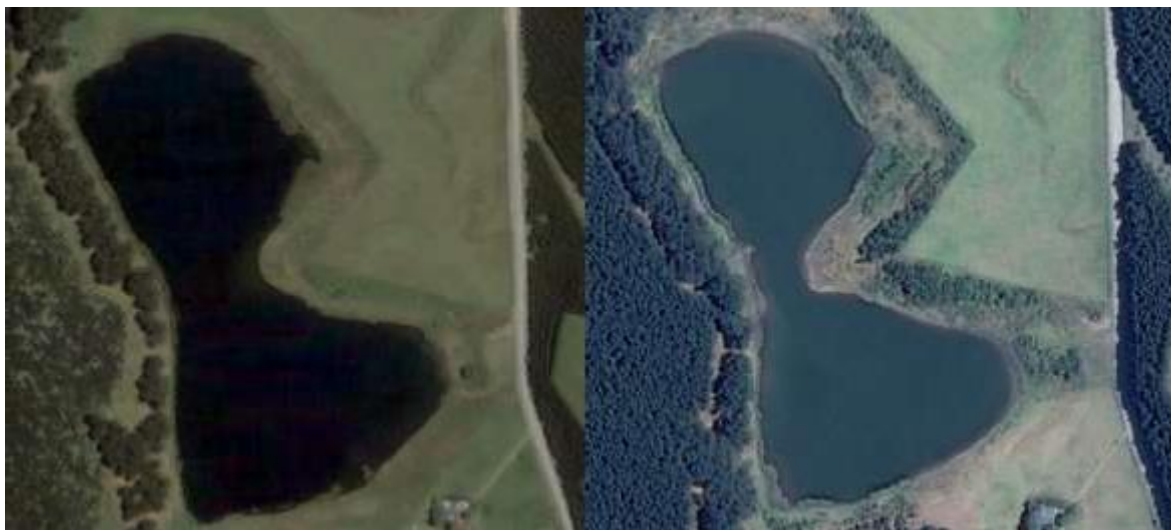
Google Earth images of Rototuna in 2004 and 2017. Note the establishment of native vegetation in the catchment and increased emergent vegetation.

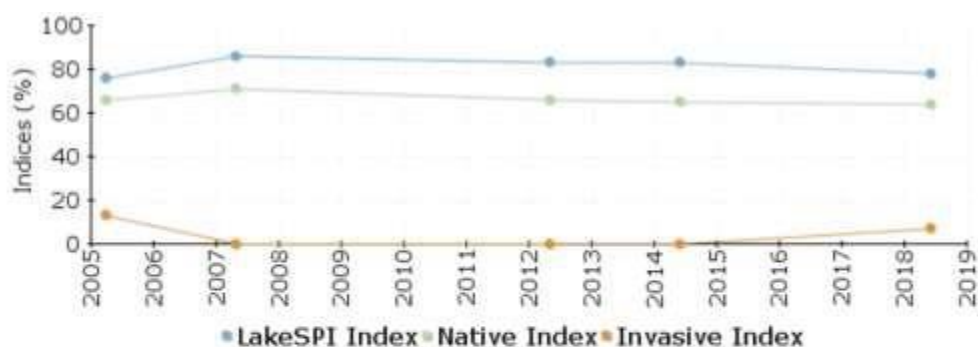
Lake Rototuna Submerged Plant Indicators

Survey Date	Status	LakeSPI %	Native Condition %	Invasive Impact %
May 2018	Excellent	78%	64%	7%
May 2014	Excellent	83%	65%	0%
April 2012	Excellent	83%	66%	0%
April 2007	Excellent	86%	71%	0%
March 2005	Excellent	76%	66%	13%

Rototuna is categorised as being in 'Excellent' condition with a LakeSPI index of 78%. LakeSPI values for this lake have remained stable since surveys began in 2001 with only a small change noted in the invasive impact scores during the 2001 and 2005 surveys on account of *Potamogeton crispus* and *Juncus bulbosus* being present at that time and the minor impact of *U. gibba* in 2018.
