DUNE RESTORATION STRATEGY FOR THE OMAPERE-OPONONI SHORELINE

A strategy for the restoration of the Omapere-Opononi shoreline and dunes as a means of mitigating the effects of coastal erosion on property and infrastructure and enhancing the amenity and biodiversity of the shoreline.

Hokianga Harbour Foreshore Restoration Society

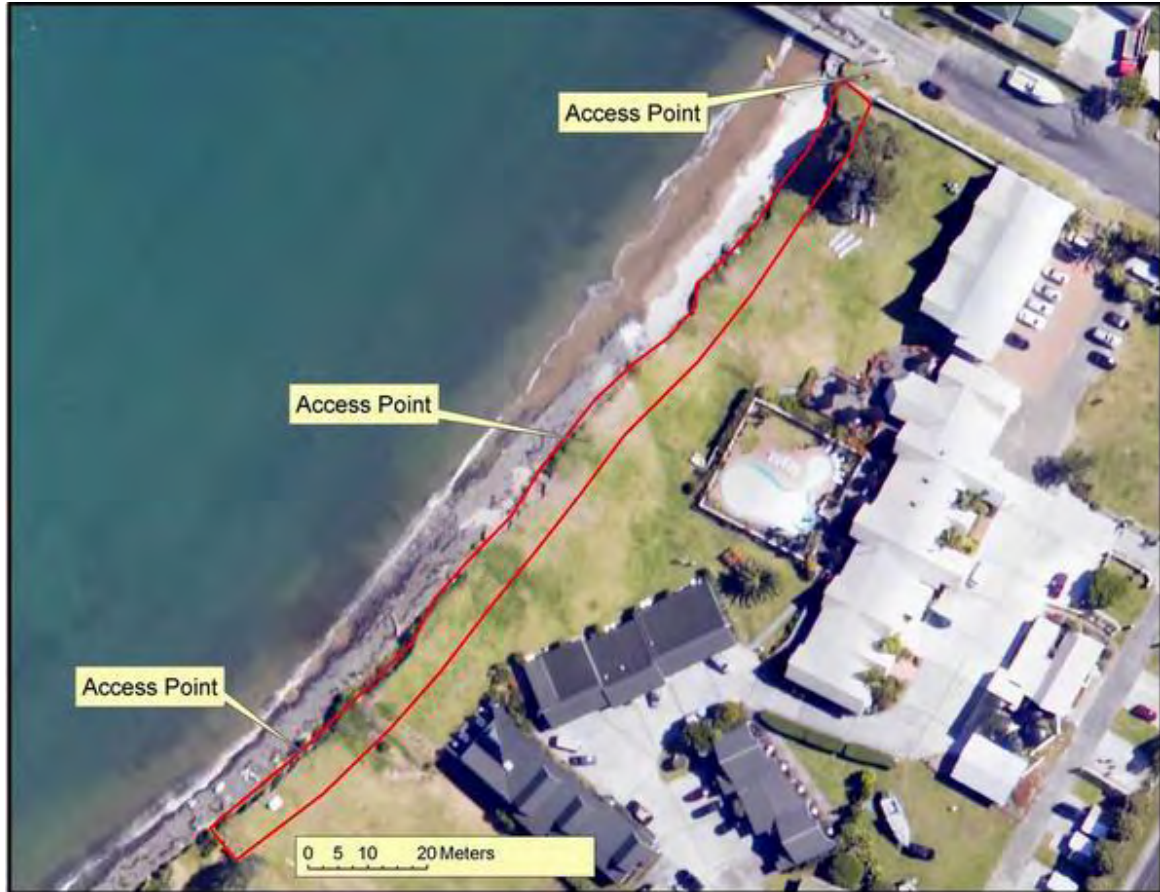
Site 1: Site diagram indicating approximate area and extent where restoration is proposed and suggested location of access points.

<i>Priority ranking</i>	3 rd priority as restoration of this bank will stabilise foreshore reserve in front of Copthorne. Stabilisation of foreshore in this area will enable any future management of the Wharf Road boat ramp to be done in a manner that has less impact on this site (to reduce the extent of sediment bypassing in the lee of the structure).
<i>Shoreline length and area for restoration</i>	160 metres (from pohutakawa trees to Wharf Road boat ramp) & 1200 m ² .
<i>Minimum shoreline setback from development</i>	15 metres from Copthorne chalets.
<i>Recommended restoration</i>	Retire a minimum of 7 metres of foreshore reserve/land for dune vegetation to provide a sufficient erosion buffer. Remove non-sand material and non-native plants. Reshape first 1 – 3 metres of shoreline bank to bring slope of dune face back to 25 – 30 degrees. Plant first 7 metres of reshaped area with spinifex/pingao mix. Low growing shrubs/trees can be planted landward of fenced off area if desired.

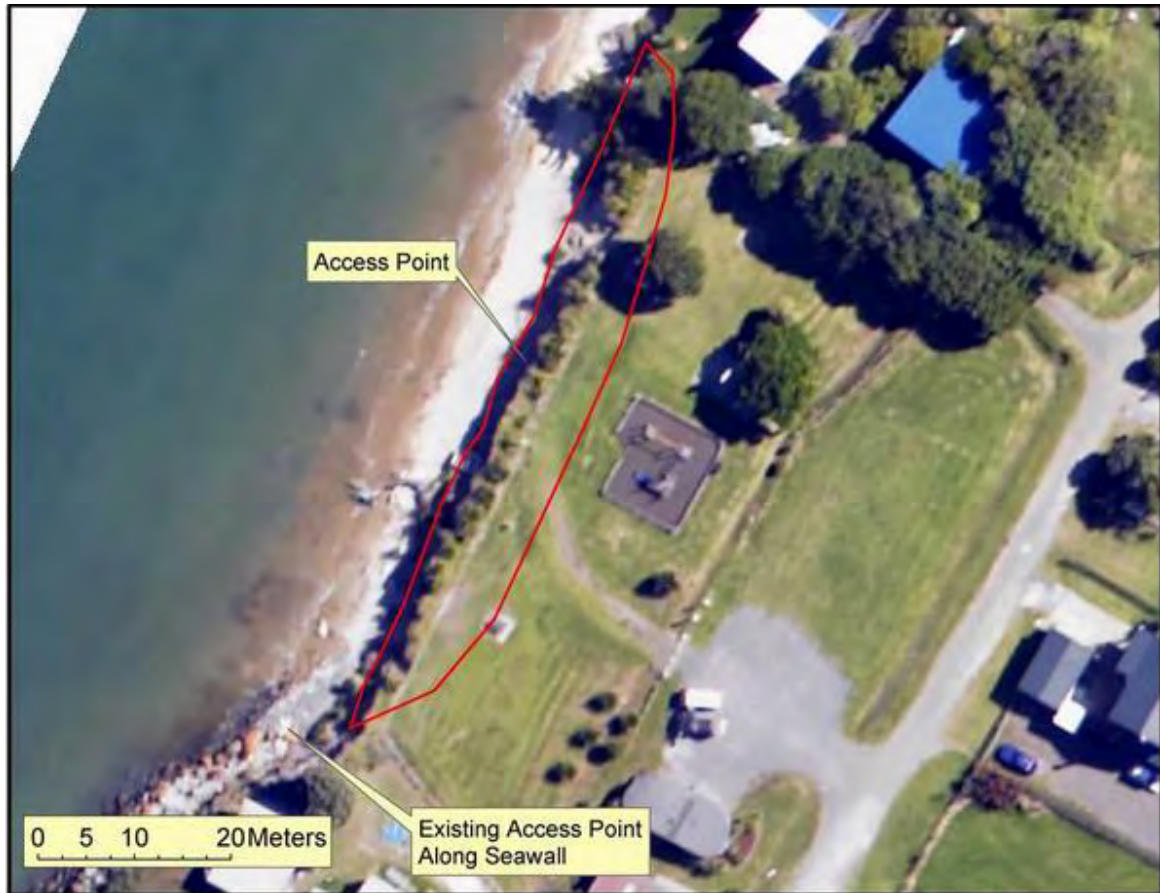
Site 2: Site diagram indicating approximate area and extent where restoration is proposed and suggested location of access point.

<i>Priority ranking</i>	2 nd priority. Restoration of this bank will aid in stabilisation of foreshore reserve by reducing failure of over steep bank face. Public access will also be enhanced through Freese Park to the beach. Management of potential erosion adjacent to the seawall will also be enhanced.
<i>Shoreline length and area for restoration</i>	72 metres (from seawall to end of park) & 620 m ² .
<i>Minimum shoreline setback from development</i>	27 metres from public toilets, 12 metres from playground
<i>Recommended restoration</i>	Retire a minimum 10 metre margin of foreshore reserve for dune vegetation to provide a sufficient buffer. Reshape the first 6 – 8 metres of bank to bring slope of dune face back to 26 – 33 degrees. Reshaping should focus on the upper profile whilst leaving a toe buttress of the cemented sandstone to resist toe erosion. Care should be taken during any reshaping to minimise disturbance of the lowest 2 metres of bank. Plant first 10 metres of reshaped area with spinifex/pingao mix. Low growing shrubs/trees can be planted landward of fenced off area if desired.

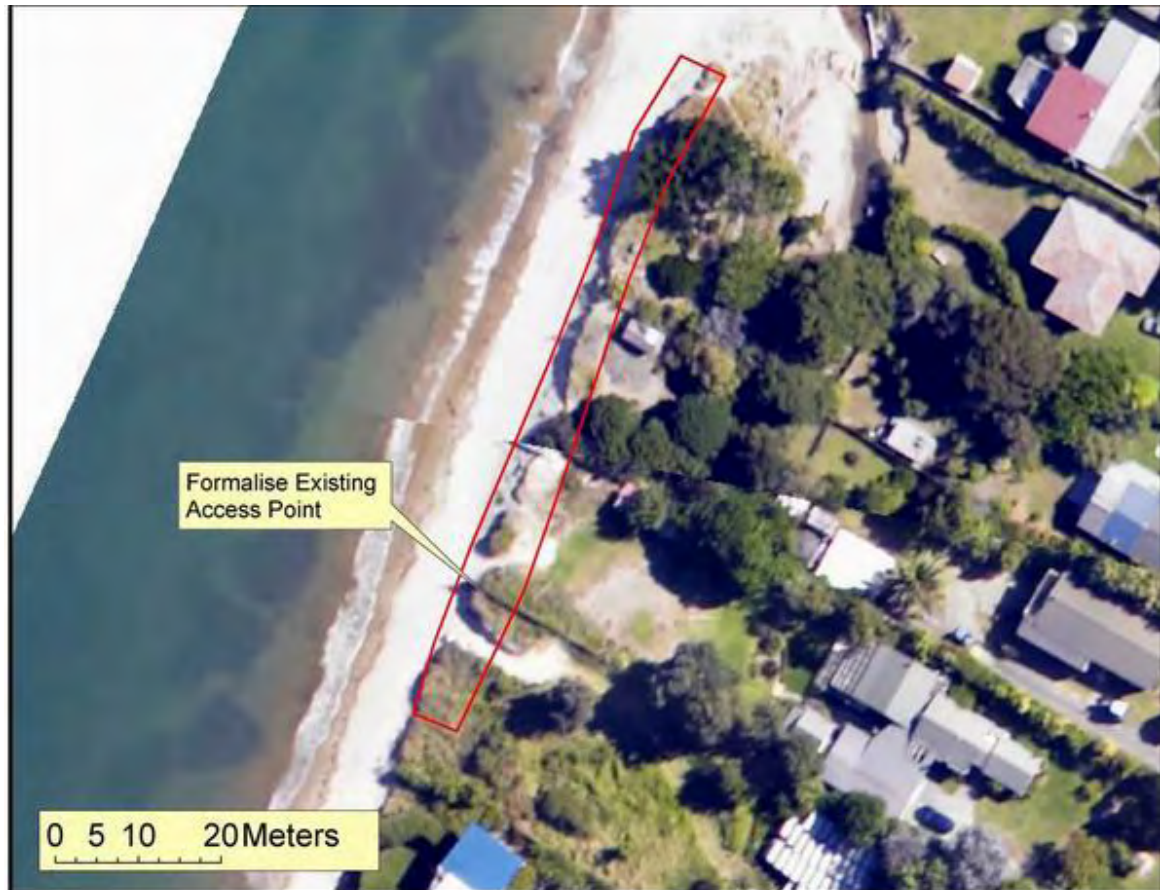
Site 4: Site diagram indicating approximate area and extent where restoration is proposed and suggested location of access point.

<i>Priority ranking</i>	5th priority. Restoration of this bank will stabilise foreshore and allow for continuation of restoration works. Public access will also be enhanced.
<i>Shoreline length and area for restoration</i>	85 metres & 550 m ² .
<i>Minimum shoreline setback from development</i>	4 - 10 metres from garden sheds.
<i>Recommended restoration</i>	Reshape first 3 - 5 metres of bank to bring slope of dune face back to 26 – 33 degrees & smooth out the contour of dune profile. Remove non-native vegetation including pine trees. Plant first 5 metres of reshaped area with spinifex/pingao mix. Care should be taken to minimise disturbance of areas of dune already vegetated with spinifex & pingao.
<i>Provision of public access</i>	Provision of one sand ladder access structure adjacent to the existing foreshore access point.
<i>Fencing</i>	Temporary fencing (post & wire) at the base of restored area only (foot traffic should not be too heavy through private property) and along access point.

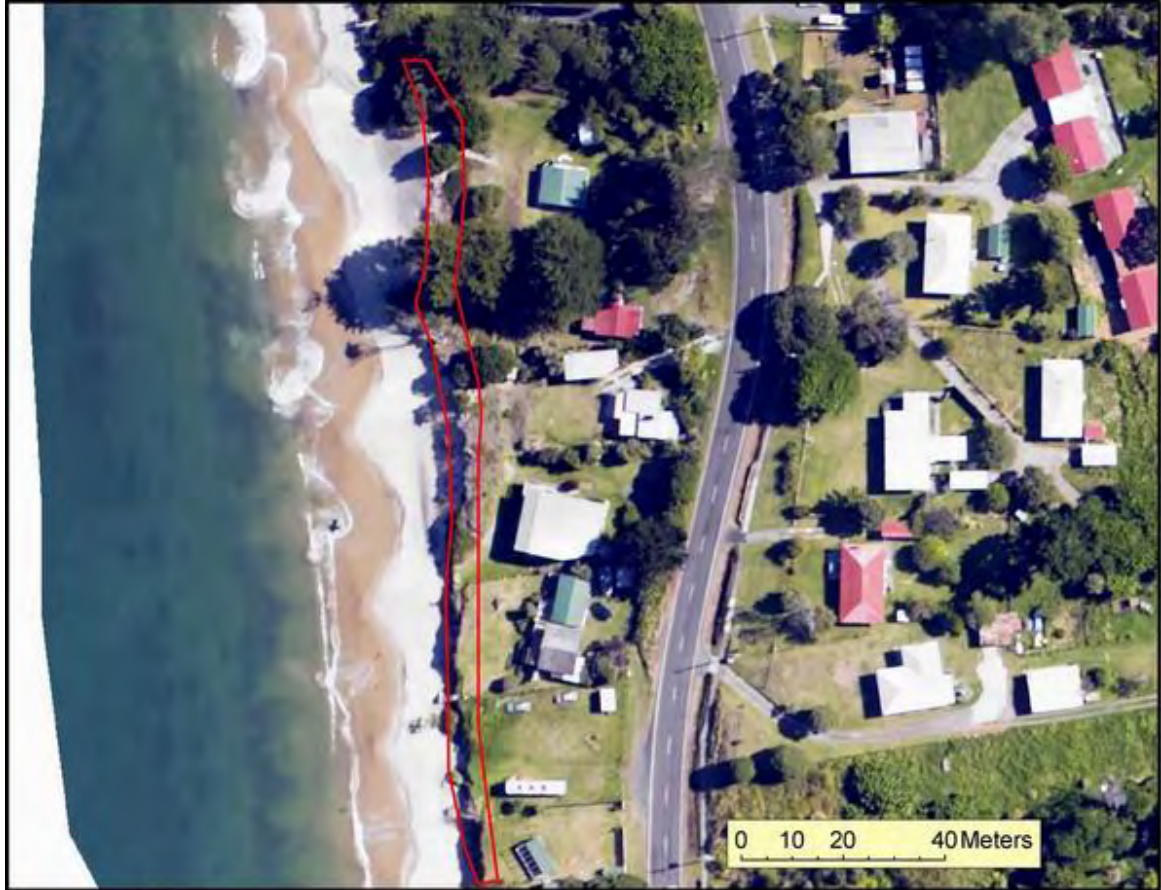
Site 8: Site diagram indicating approximate area and extent where restoration is proposed.

<i>Priority ranking</i>	1st priority. Restoration of this bank will stabilise foreshore. The restoration will enable any erosion adjacent to the seawall to be managed.
<i>Shoreline length and area for restoration</i>	160 metres (from seawall to end of park) & 1000 m ² .
<i>Minimum shoreline setback from development</i>	10 metres from closest dwelling.
<i>Recommended restoration</i>	Reshape first 2- 4 metres of bank to bring slope of dune face back to 26 – 33 degrees & smooth contour of dune profile. This is not required in some parts where existing profile slope is sufficient. Plant first 10 metres of reshaped area with spinifex/pingao mix. Care should be taken to minimise disturbance of areas of dune already vegetated with spinifex & pingao.
<i>Provision of public access</i>	Provision of two sand ladder access structures adjacent to existing foreshore access point for access to private properties. The location of these needs to be determined by the residents at this is mostly private title with no public access.

<i>Fencing</i>	Temporary fencing (post & wire) at the base of restored area only (foot traffic should not be too heavy through private property) and along access point.
<i>Cost estimates (note assumes volunteer labour costs for planting, fencing and construction of access structures) Costs will be lower as work has begun on this project.</i>	Access structures ~ \$1,500 Fence ~ \$800 Plants ~ \$5,000 Machinery ~ \$2,000 Other miscellaneous ~ \$500 Sum of costs ~ \$9,800
<i>Land ownership</i>	Private title with one part FNDC reserve.
<i>Notes</i>	The area contains some spinifex and pingao that should be maintained. Work has already begun on this project: <ul style="list-style-type: none"> • Post and wire fence erected along the toe of the dune along a portion of this area (see photos 1-3 below). • Spinifex and pingao planted on areas of the dune suitable for planting without reshaping.

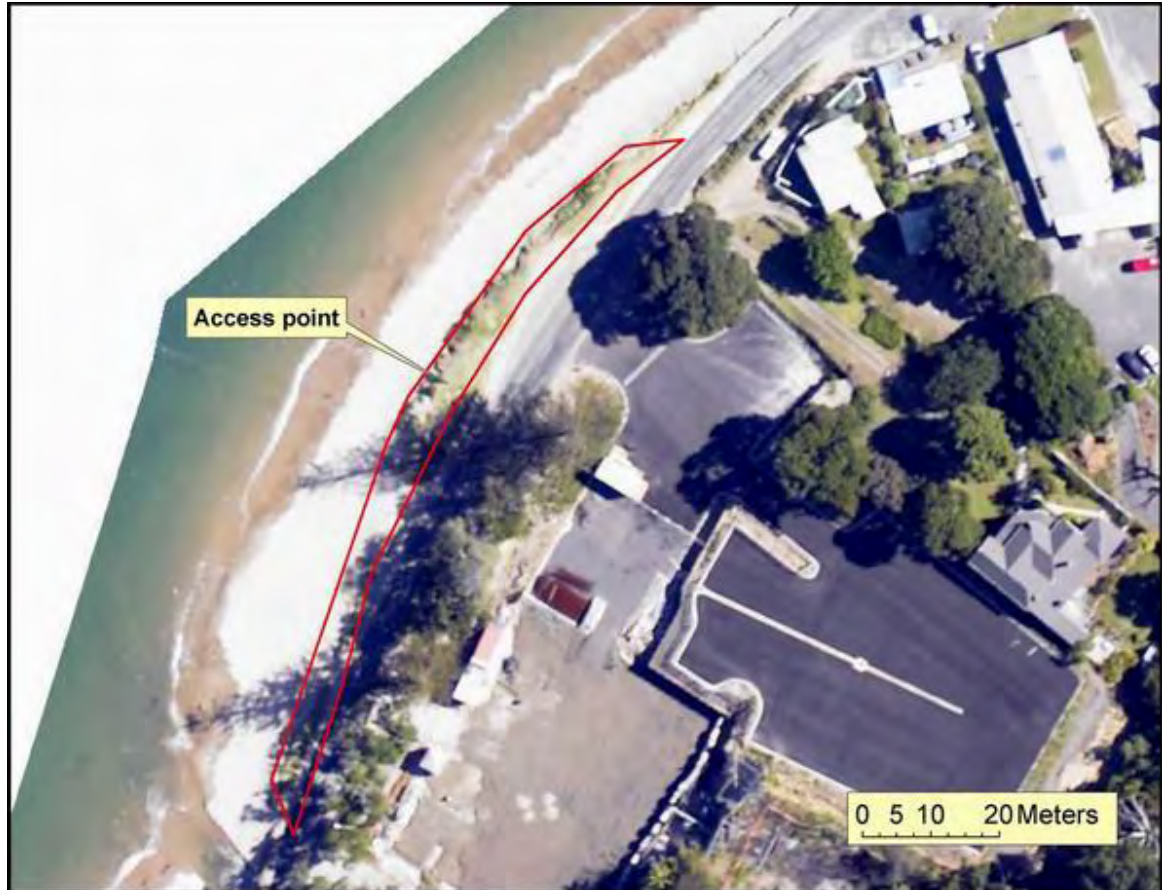
Site 12a: Site diagram indicating approximate area and extent where restoration is proposed and suggested location for an access structure.

<i>Priority ranking</i>	4th priority. Restoration of this bank will stabilise foreshore and minimise risk of erosion to the road and the need for future protection works.
<i>Shoreline length and area for restoration</i>	110 metres (from seawall to end of park) & 600 m ² .
<i>Minimum shoreline setback from development</i>	2 – 5 metres from road.
<i>Recommended restoration</i>	Reshape first 2- 3 metres of bank to bring slope of dune face back to 26 – 33 degrees & smooth contour of dune profile. Remove existing marram grass and other non-native vegetation. Plant reshaped area with spinifex/pingao mix.
<i>Provision of public access</i>	Provision of one access structure to enable access through fenced area. This should be placed opposite the new carpark/shopping centre area to enable/encourage use of the access structure. It is critical that public access through these proposed restoration areas is provided in a manner that enables clear and easy access through to the beach.

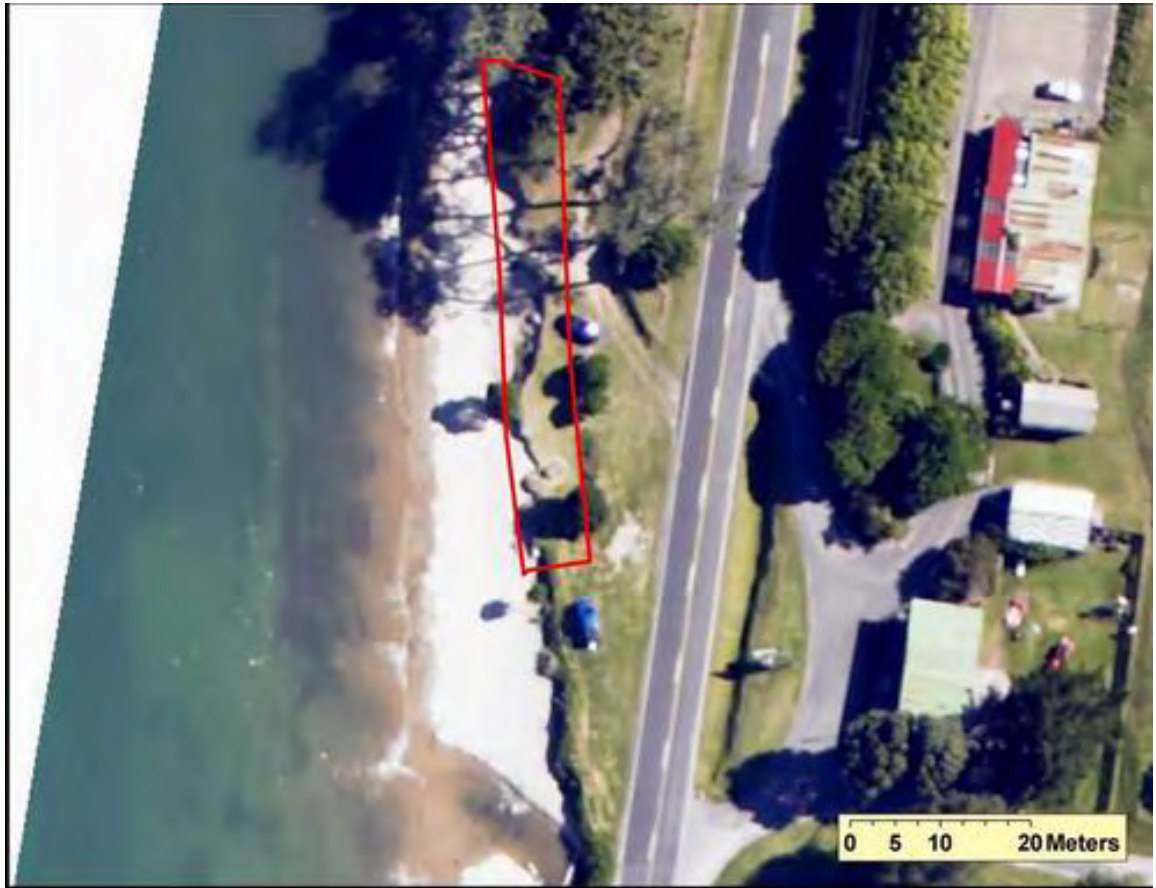
Site 12b: Site diagram indicating approximate area and extent where restoration is proposed.

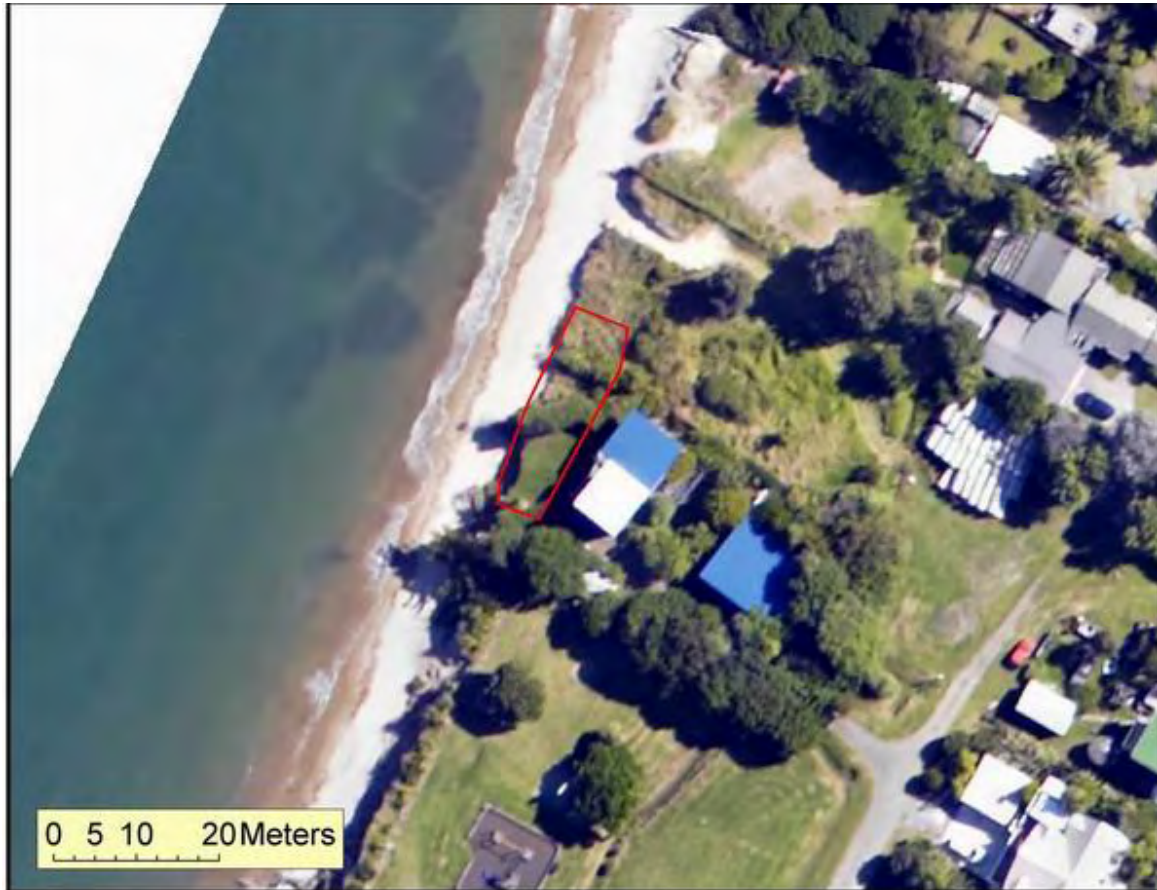
Site 3: Site location diagram.

This area is located immediately north of Freese Park. There is insufficient setback from the dwelling to the shoreline to enable restoration of the dune. The dune also contains soil fill that would require removal.

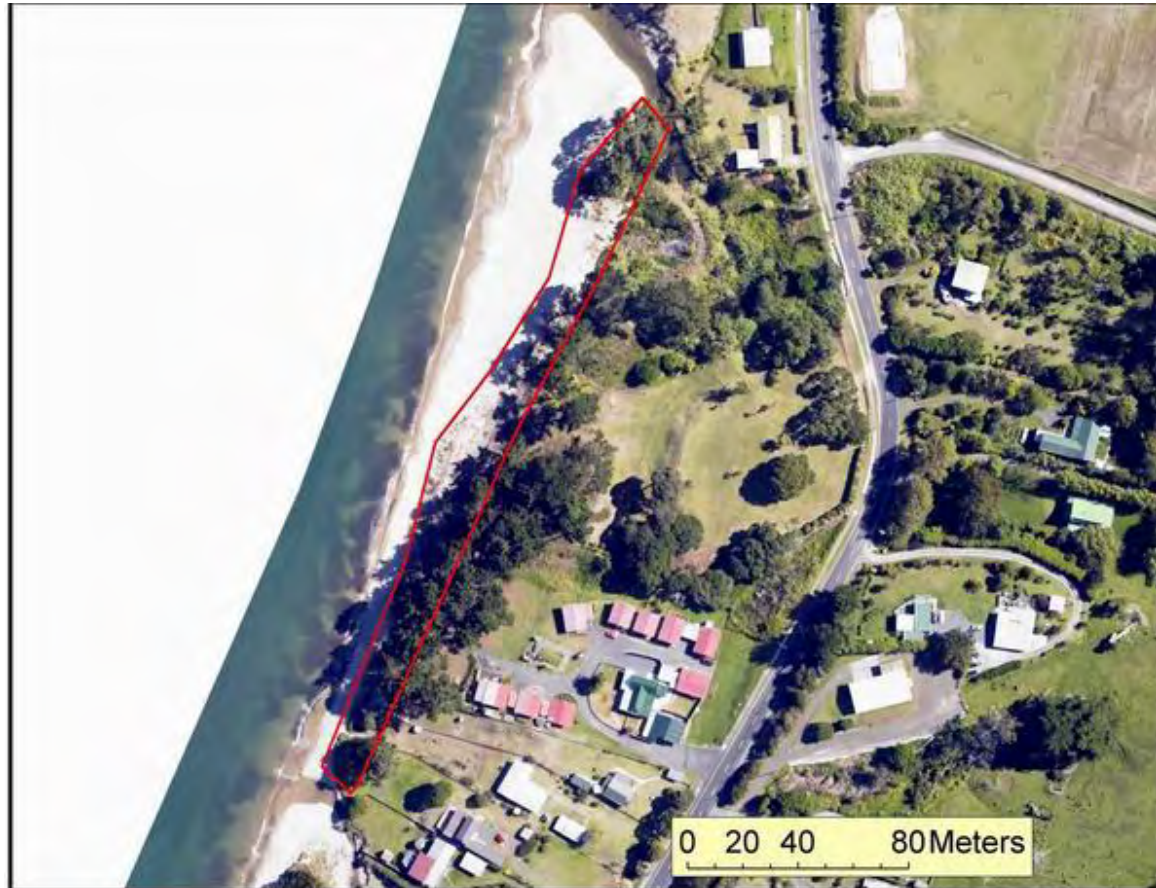
Site 5: Site location diagram.

Whilst restoration would benefit this site, this is considered a low priority as there is sufficient setback of dwellings from the shoreline to buffer effects of erosion. Furthermore, the dune in this area appears healthy and well accreted, not requiring any intervention in the form of reshaping, replanting or fencing. As such, restoration in this area is not recommended. However, this area would benefit from some occasional maintenance (weeding and fertilising of spinifex/pingao) to encourage strong growth of the dune.

The south extent of this section could benefit from some reshaping and restoration, which would aid in the continuity of the dune complex at this site. This is in the area immediately north of the first stream. In this area the dune complex has been removed and capped with soil to create a gently sloping lawn. This land is slowly eroding, due to the combined effects of the stream outlet migration and coastal erosion. Removal of the soil and existing non-native vegetation and replanting with spinifex and pingao would aid in the stability of this area. This would only be necessary in a small section that is approximately 20 metres in length (refer to Site 5 photos 5 & 6). This subsection of Site 5 could be afforded priority status for restoration, particularly if done in conjunction with other works to stabilise the right bank of the stream (as discussed below).

Erosion of the right (north) stream bank at this site is of concern to at least one adjacent property owner. This bank has eroded due to combined coastal and river processes cutting into the toe of the bank causing this to erode. Dune restoration is not recommended at this stream bank, due to the river processes and lack of sediment supply to the right bank. However, a small rock revetment seawall structure (designed in accordance with professional engineering standards) could be implemented to address erosion of the stream bank. This will likely only have minor adverse effects on coastal processes, the main being potential for increased erosion where the structure terminates. This activity would require a coastal permit, obtained prior to commencing work.

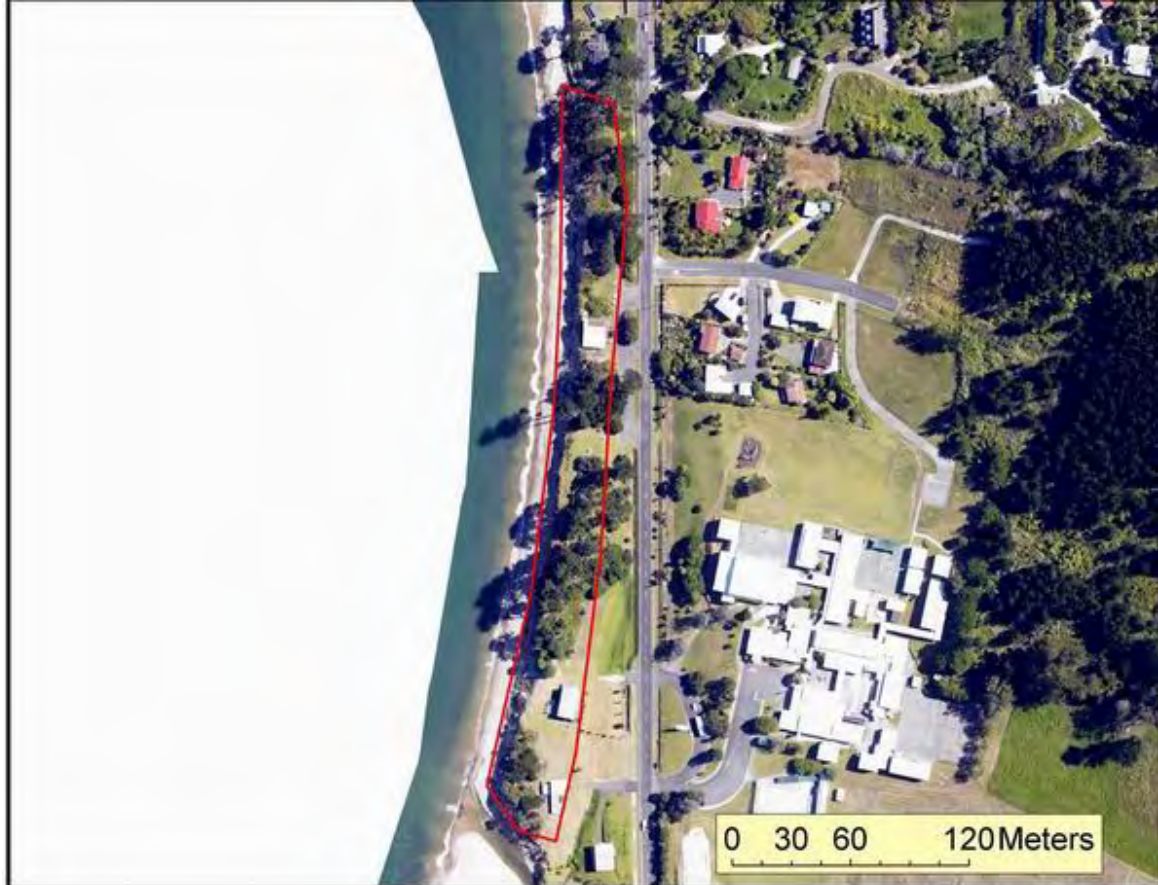
Site 6: Site location diagram.

Wholesale reshaping of the bank/dune is not recommended for the majority of this site, given the high elevation of the bank (approx 5 – 6 metres from toe to crest) and steep face (greater than 50 degrees). To sufficiently correct the over steep profile, some 9 – 12 metres of bank, extending from the shoreline landwards, would need to be reshaped to bring the profile face back towards 26 – 33 degrees.

Whilst replanting with spinifex and pingao is to be encouraged by property owners, as this will reduce the rate of erosion in this area, the over steep profile and steep face will continue to erode as the toe of the bank is undercut and the upper profile slumps and fails. However, spinifex and pingao establishment will aid in retention of sand at the toe of the bank and will aid in mitigating the rate of undercutting and failure and should be undertaken where this is a concern.

Some vegetation removal and minor reshaping could be undertaken near the top of the bank profile in parts of this site, to enable a clear area and gentle slope for planting with pingao and spinifex. In any case, the sandstone of the lower 2 – 3 metres of the bank profile should not be disturbed as this offers some resistance to erosion in areas where spinifex and pingao establishment is difficult.

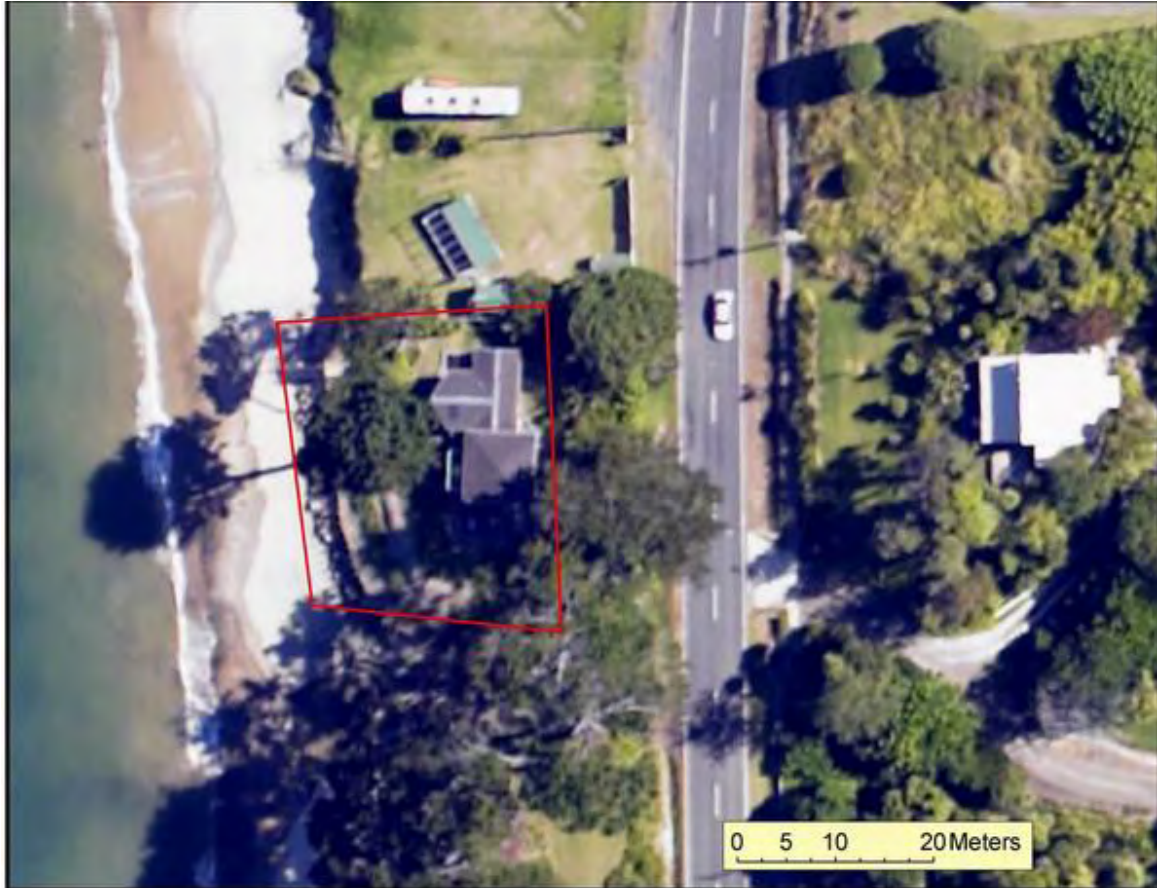
Site 7: Site location diagram.

This site is protected with a seawall, hence there is no requirement for dune restoration.

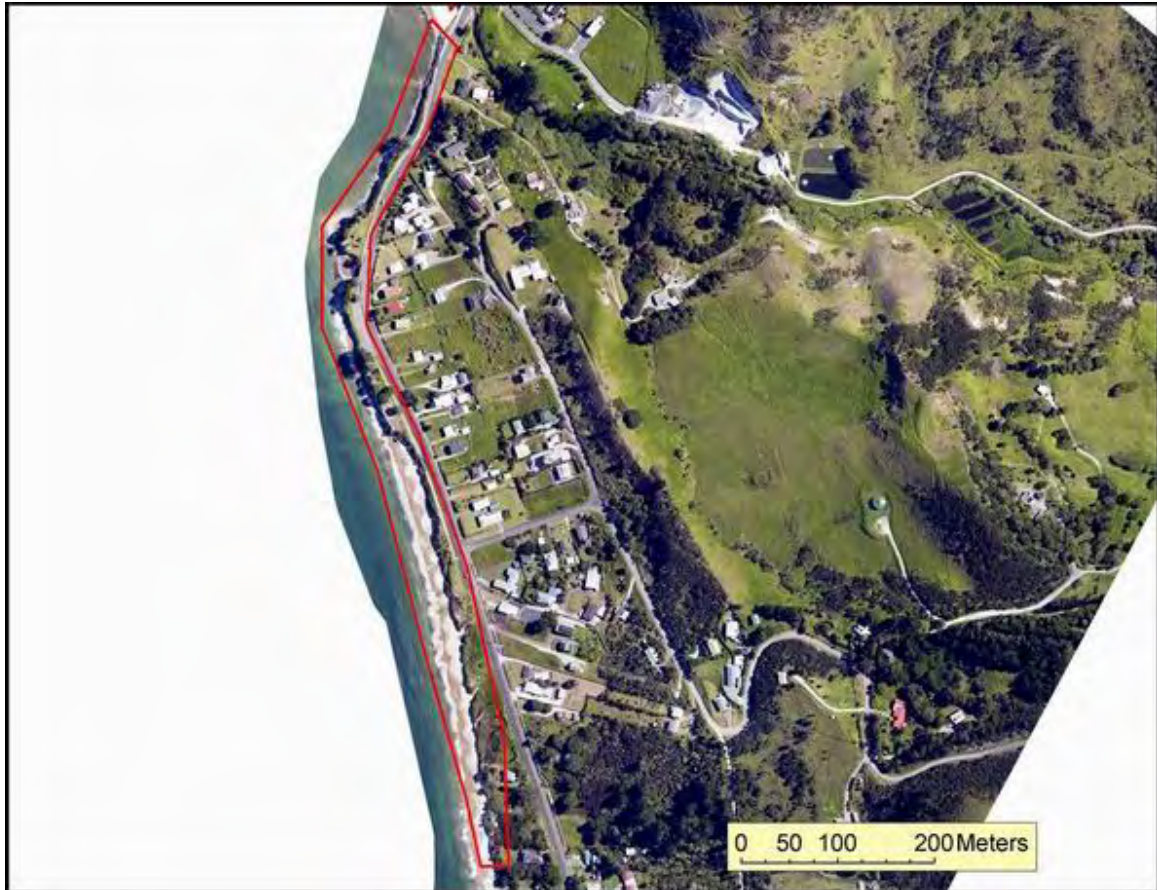
Site 9: Site location diagram.

This area of foreshore is comprised of three distinct geomorphologies. The northern half of the site is comprised of mudstone cliffs and a shore platform that with a transient sand veneer, no restoration works are feasible in this part (Refer Site 9 images 1-2). Parts of the area are also protected with seawalls.

The southern quarter of this site appears to be mostly comprised of dune sands, however patches of mudstone were apparent which would need to be investigated further prior to proceeding with any restoration in this area (Refer Site 9 image 5). Nevertheless, restoration of this southern area could be undertaken in the form of reshaping and planting with pingao and spinifex and should be considered in the future to enable continuation of the dune restoration recommended for site 8.

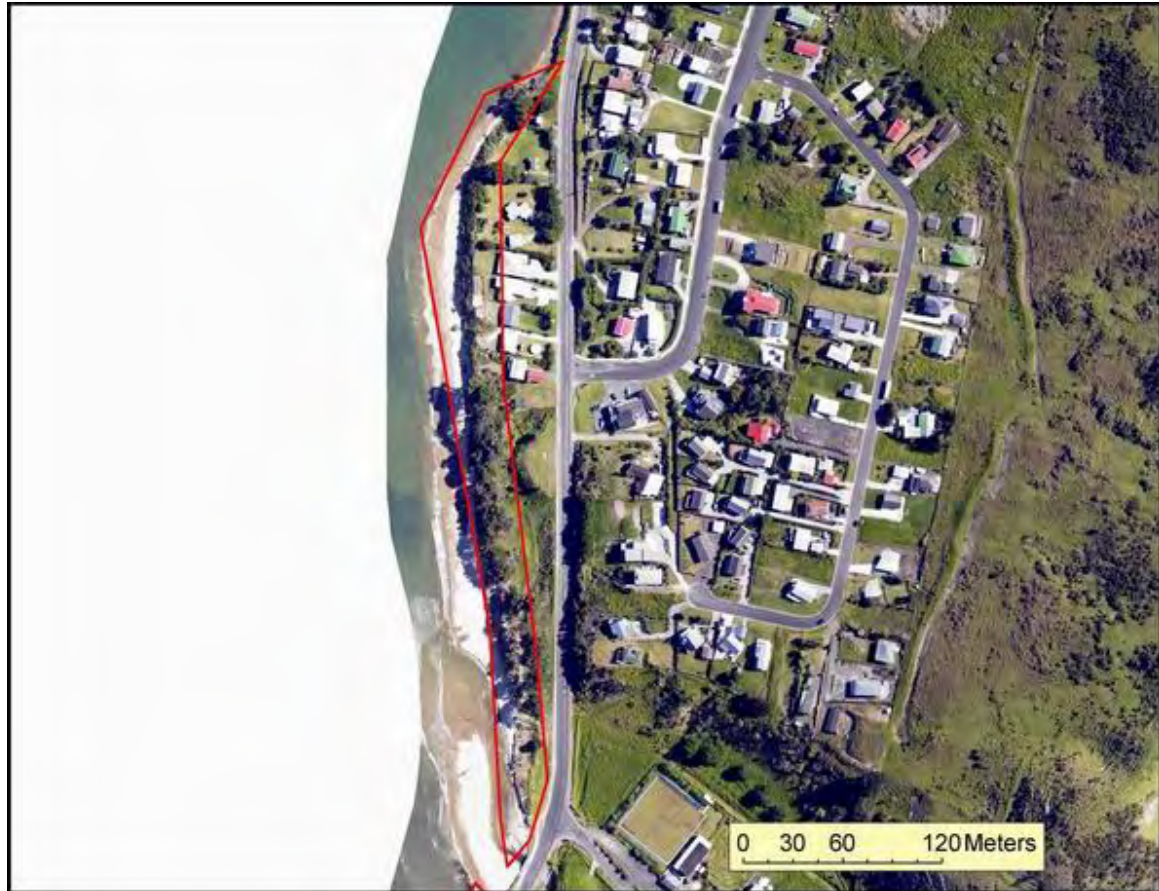
Site 10: Site location diagram.

The stability of the foreshore in the south half of this site is predominantly influenced by the Waiarohia Stream outlet, which meanders northwards on occasions causing erosion of the shoreline and dune and impacting on sediment supply to the north half of the site. Restoration is not recommended in the south half of this site due to the influence of the Waiarohia Stream and the fact that no dwellings or infrastructure are at immediate risk if the area erodes. However, removal of the pine trees and enhancement of the back dune area by replanting with spinifex and pingao would aid in enabling dune recovery following episodes of erosion.

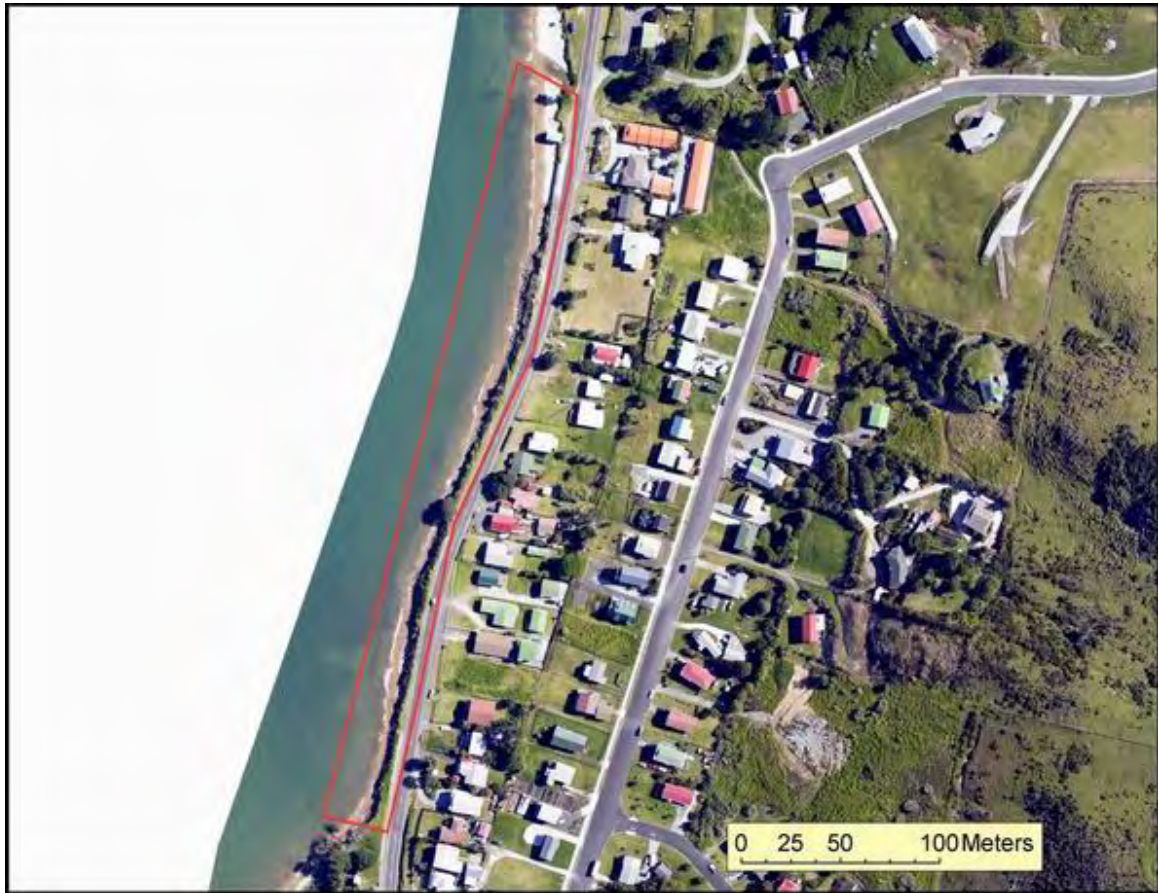
Site 11: Site location diagram.

The shoreline in this site is located in close proximity to the road, and is for the most part protected with rock sea walls. No restoration works are recommended for this area of shoreline.

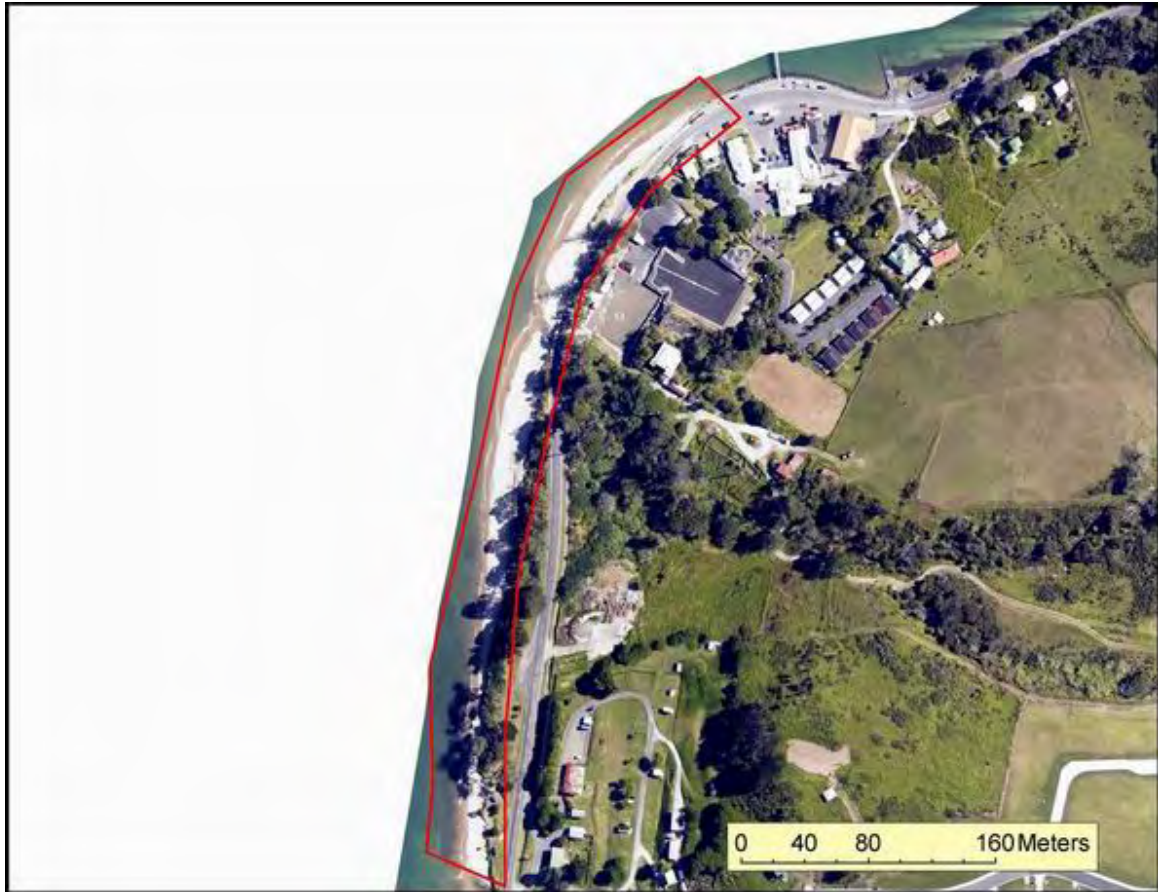
Site 12: Site location diagram.

The mid-south extent of this site features a well vegetated incipient dune and no restoration is recommended in this part of the site. Restoration could be undertaken at the very southern extent of this site and would require reshaping of the eroded bank and revegetation of the first 2 – 4 metres of the bank with pingao and spinifex. However, as no infrastructure or dwellings are immediately at risk from erosion in this area, this is not seen as an immediate priority for restoration.

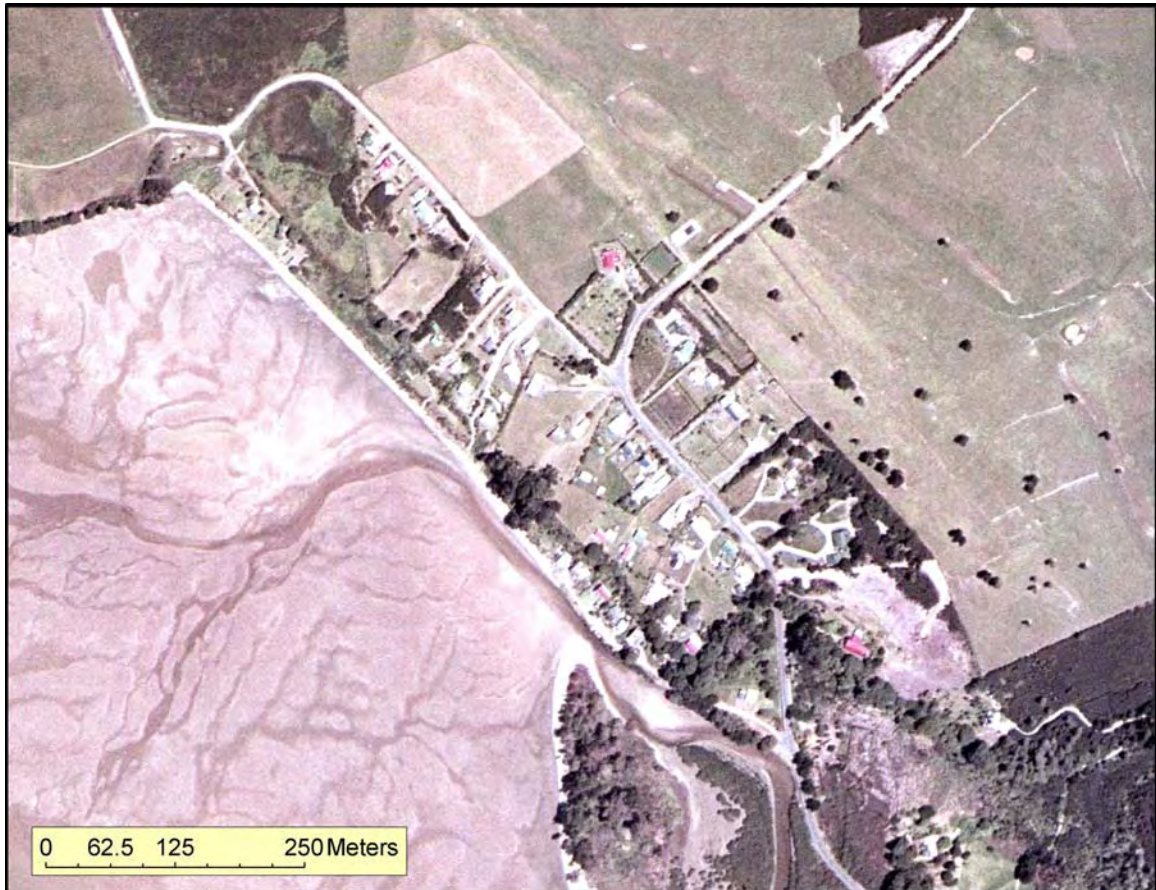
Site 13: Site location diagram.

The Koutu shoreline is comprised of two distinct geomorphologies. In the area north of the Koutu estuary the shoreline is comprised of a weakly cemented mudstone or soil backed by mixed vegetation. No restoration is recommended in this area as there is insufficient sand or suitable dune relict. The area within the estuary is similar in character and a derelict seawall is located between the road and the dwellings. The estuary spit is comprised of sand, and whilst restoration may be feasible in this location, it is not recommended as the area is currently grazed by cattle and there appears to be little risk, if any, to dwellings (although one dwelling appears to be located close to the shoreline).
