# Poplar windthrow following Cyclone Gabrielle

Date: 1 April 2023 Author: John Ballinger, Dean Satchell, Simon Webb

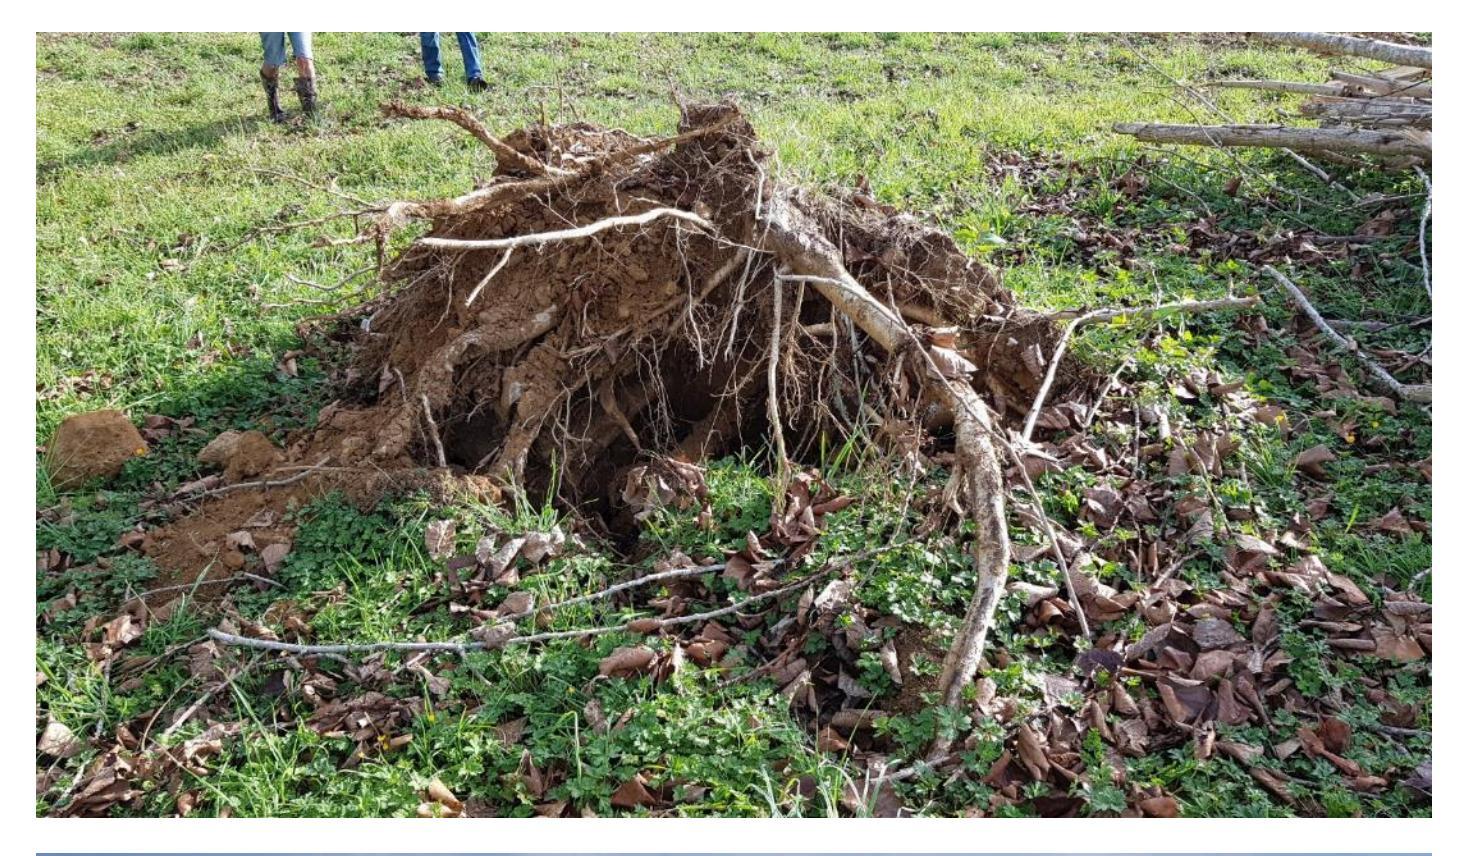
This Kawa poplar plantation suffered extensive toppling with 180 of the 220 planted blowing over (82% loss). The initial SE wind toppled 12 trees, then when it switched to the SW the rest of the trees came down. Even though the soil type is well drained, it was saturated during the cyclone. It was noted that poplars with poor form and of unknown parentage growing on the same soil on a neighbouring property did not suffer from windthrow. However, this could be a result of variations in wind tumbling/turbulence rather than a difference between clones.

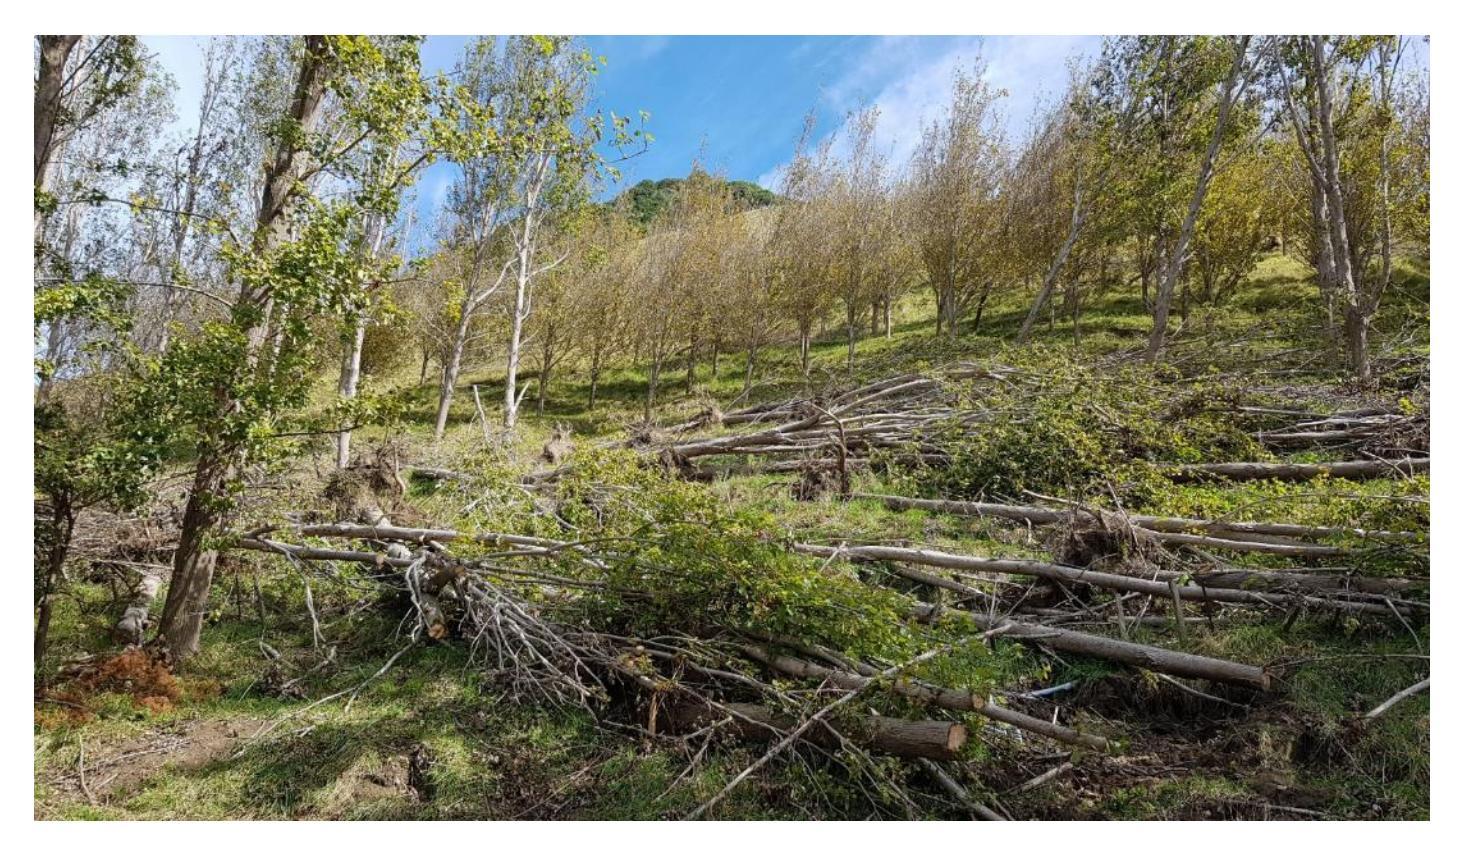
Situated on the flanks of Mt Houto in an extremely exposed location. Soil type Takitu gravelly clay loam, a young semi volcanic soil that is naturally fertile, but particularly prone to shallow and deep-seated slipping. Two clones of poplar were planted on an active slip above the road. Kawa were planted at 7-8m spacing at the base of the slip and grew tall and toppled. Another clone, possibly Veronese *P. x euramericana* was planted at the top and adjacent to the slip and remarkably suffered little windthrow, although they were smaller than the Kawa. It's estimated the trees were planted 20 years ago.

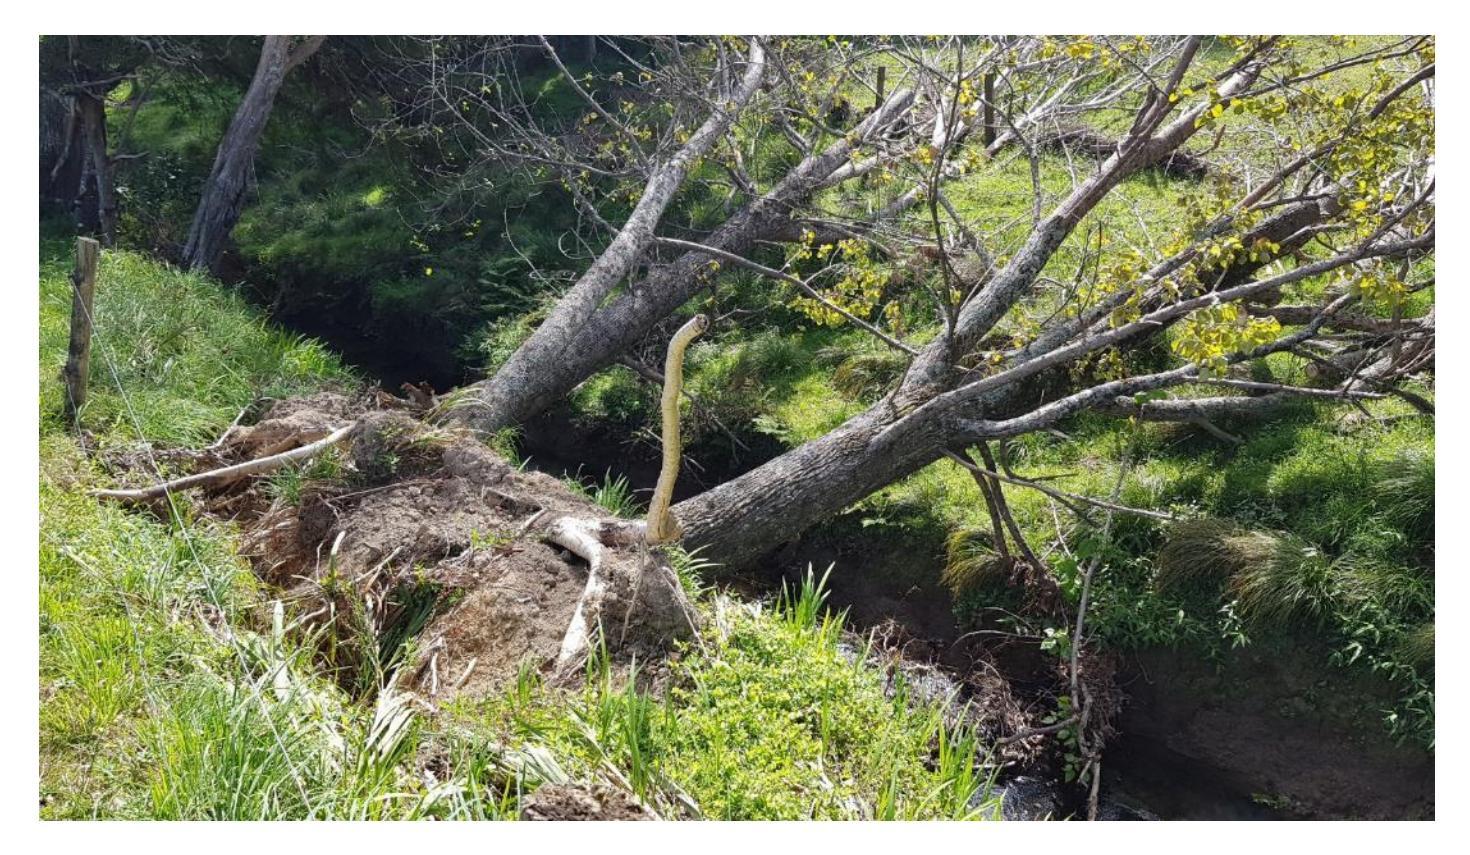
On this farm there was a small amount of toppling along streambanks and drains. The soil type is Kara sandy loam with pan, a very old podzol known colloquially as gumland or pipe clay that is very prone to gullying. Along a streambank a handful of mature Kawa (estimate 30 years old) were planted too close to the river edge on an eroding bend. A combination of stream bank undermining and extreme wind gusts pulled up the root plates, generating sediment. The big strong roots of these trees had been doing an excellent job of holding the steep bank together but ideally would have been shifted back beyond the bank full capacity.
