Preliminary Geotechnical Investigation for Proposed Service Centre at 47 Millbrook Road, Waipu

Job No. NL220045

**PRELIMINARY GEOTECHNICAL INVESTIGATION
FOR PROPOSED SERVICE CENTRE AT
47 MILLBROOK ROAD, WAIPU**

Job Number:	NL220045
Name of Project:	47 Millbrook Road, Waipu
Client:	Vaco Investments (Waipu) Limited
Author	Ben Young, Senior Engineering Geologist, MEngNZ
Reviewer: / Authoriser:	Bruce Green, Principal Geotechnical Engineer, CMEngNZ, CPEng
Document Version:	A
Printed:	28 November 2022
Author Signature:	
Reviewer: / Authoriser:

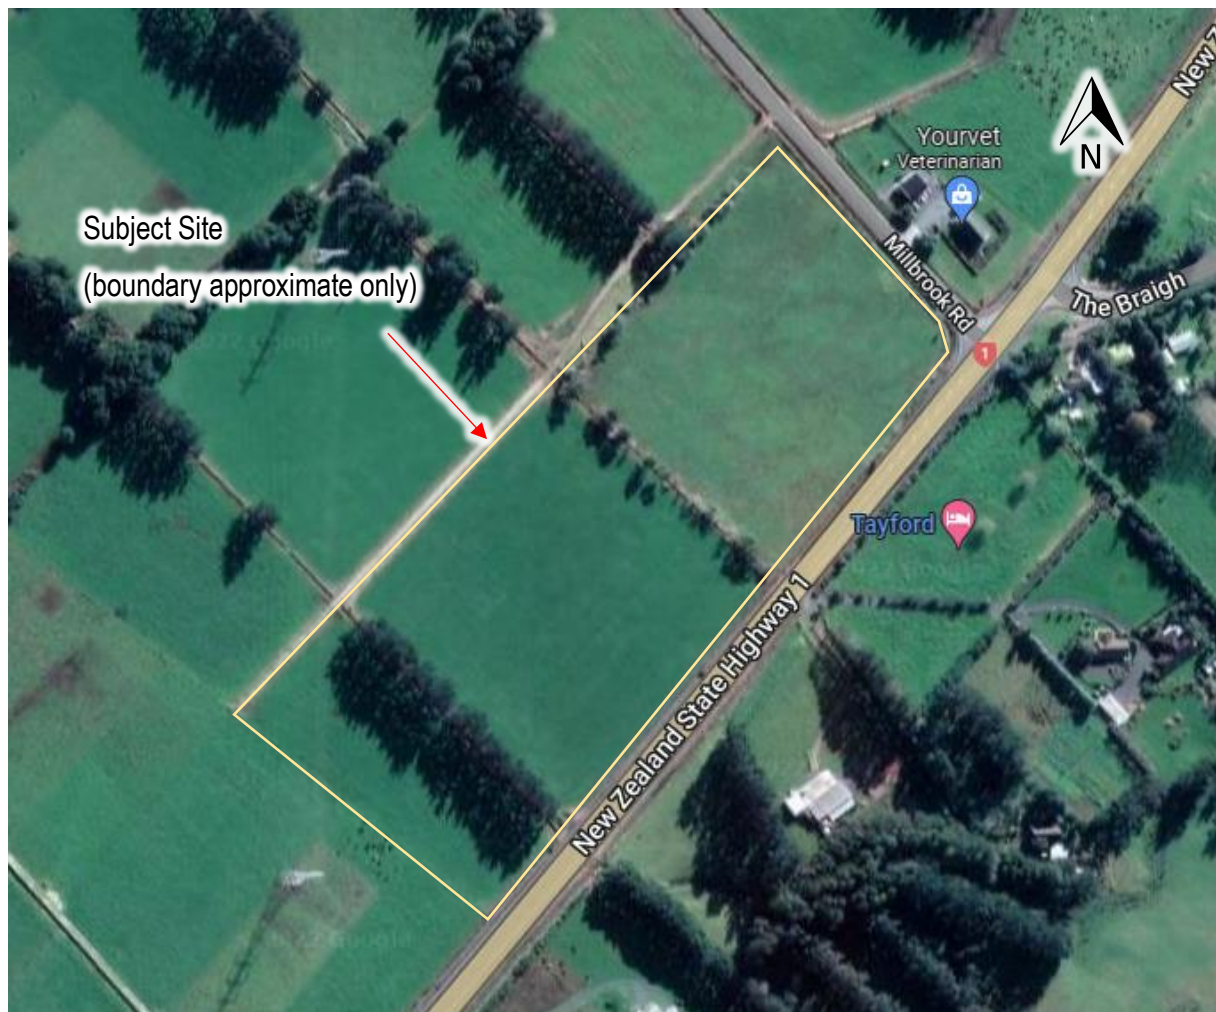
Figure 1: Site Plan (Source of background image: Northland Regional Council)

The subject site is located at the corner of Millbrook Road and State Highway 1 and is legally described as Part Lot 1 DP 44163. The site is irregular in shape (see Figure 1). The site and its neighbouring properties comprise rural farmland and are near level.

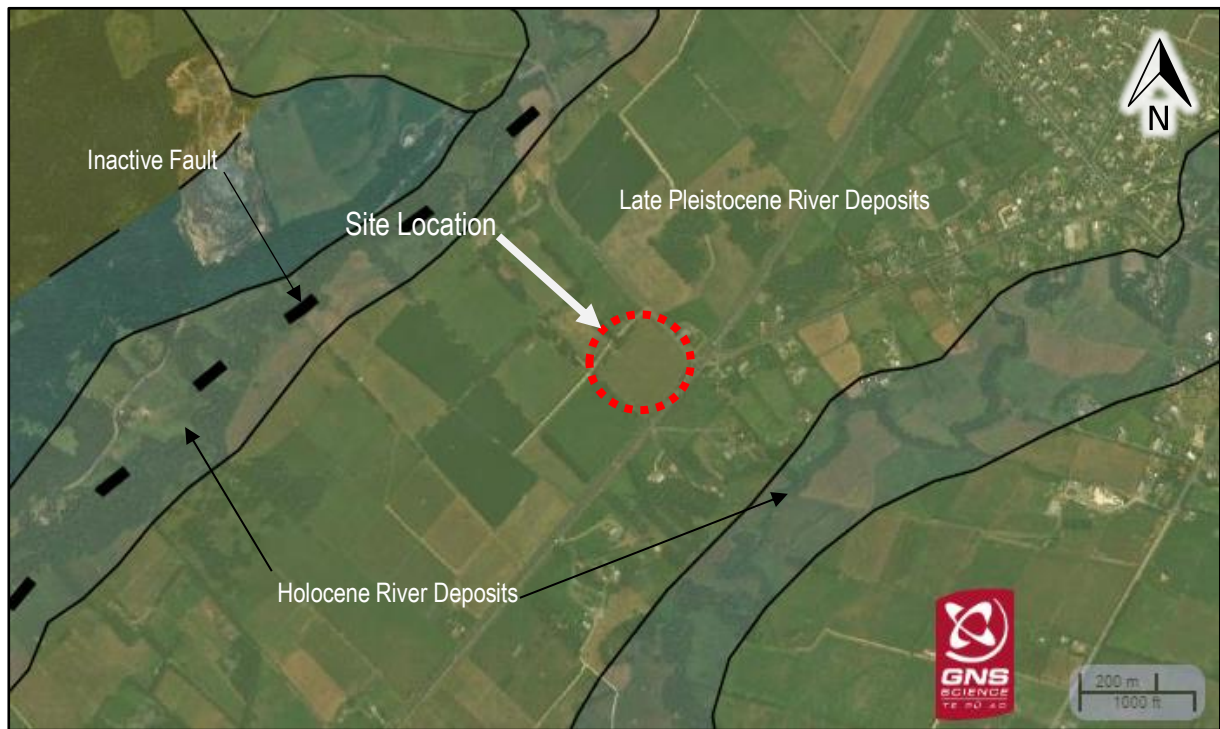
Figure 1 Geological Map (Source: GNS WebMaps Website)

A geological map of the area² indicates that the site is underlain by Late Pleistocene River Deposits of the Tauranga group (refer to Figure 1). These materials generally comprise poorly consolidated mud, sand, gravel, and peat deposits of alluvial, swamp and estuarine origins.

Alluvial soils are inherently variable and can change in both strength and composition over short vertical and lateral distances.

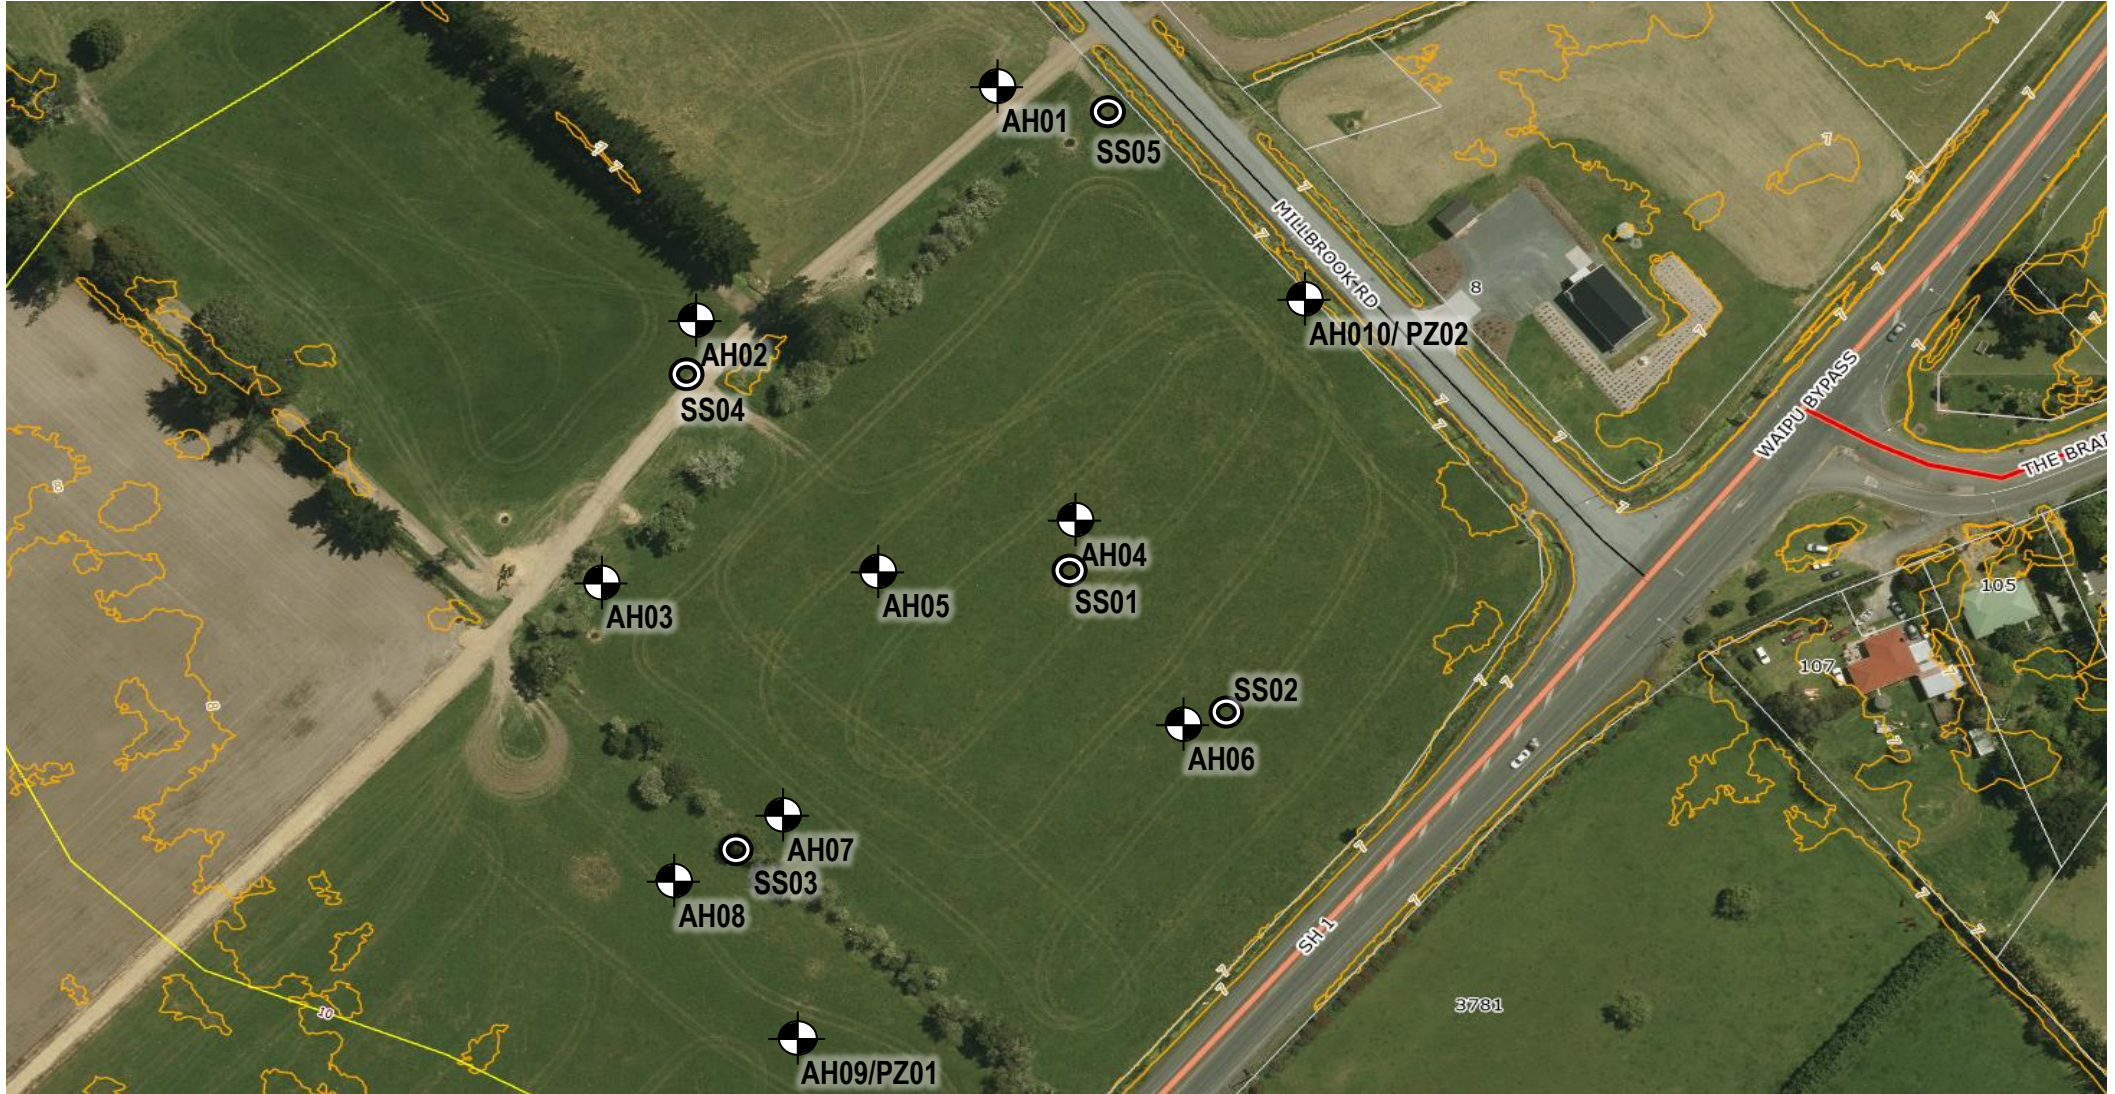
DRAWING NO:	NL220045 /1
DATE:	June 2022
DRAWN:	NB
SCALE:	NTS

Investigation Plans

Aerial Photo from Auckland Council GeoMaps Webservice

- Visual appraisal of the site
- Drilling of ten (10) hand augerholes (AH01 – AH10 inclusive)
- Retrieval and laboratory testing of five (5) soil expansivity samples (SS01 – SS05)
- Installation of standpipe piezometers within 2 of the augerholes (PZ01 within AH09 and PZ02 with AH10).
- Carrying out ten shallow Scala penetrometer tests to 1.0 m to assess near surface conditions for pavement design (SC01 to SC10).
- Soil sampling for acid sulphate analysis (10 sample location with 4 samples per location)

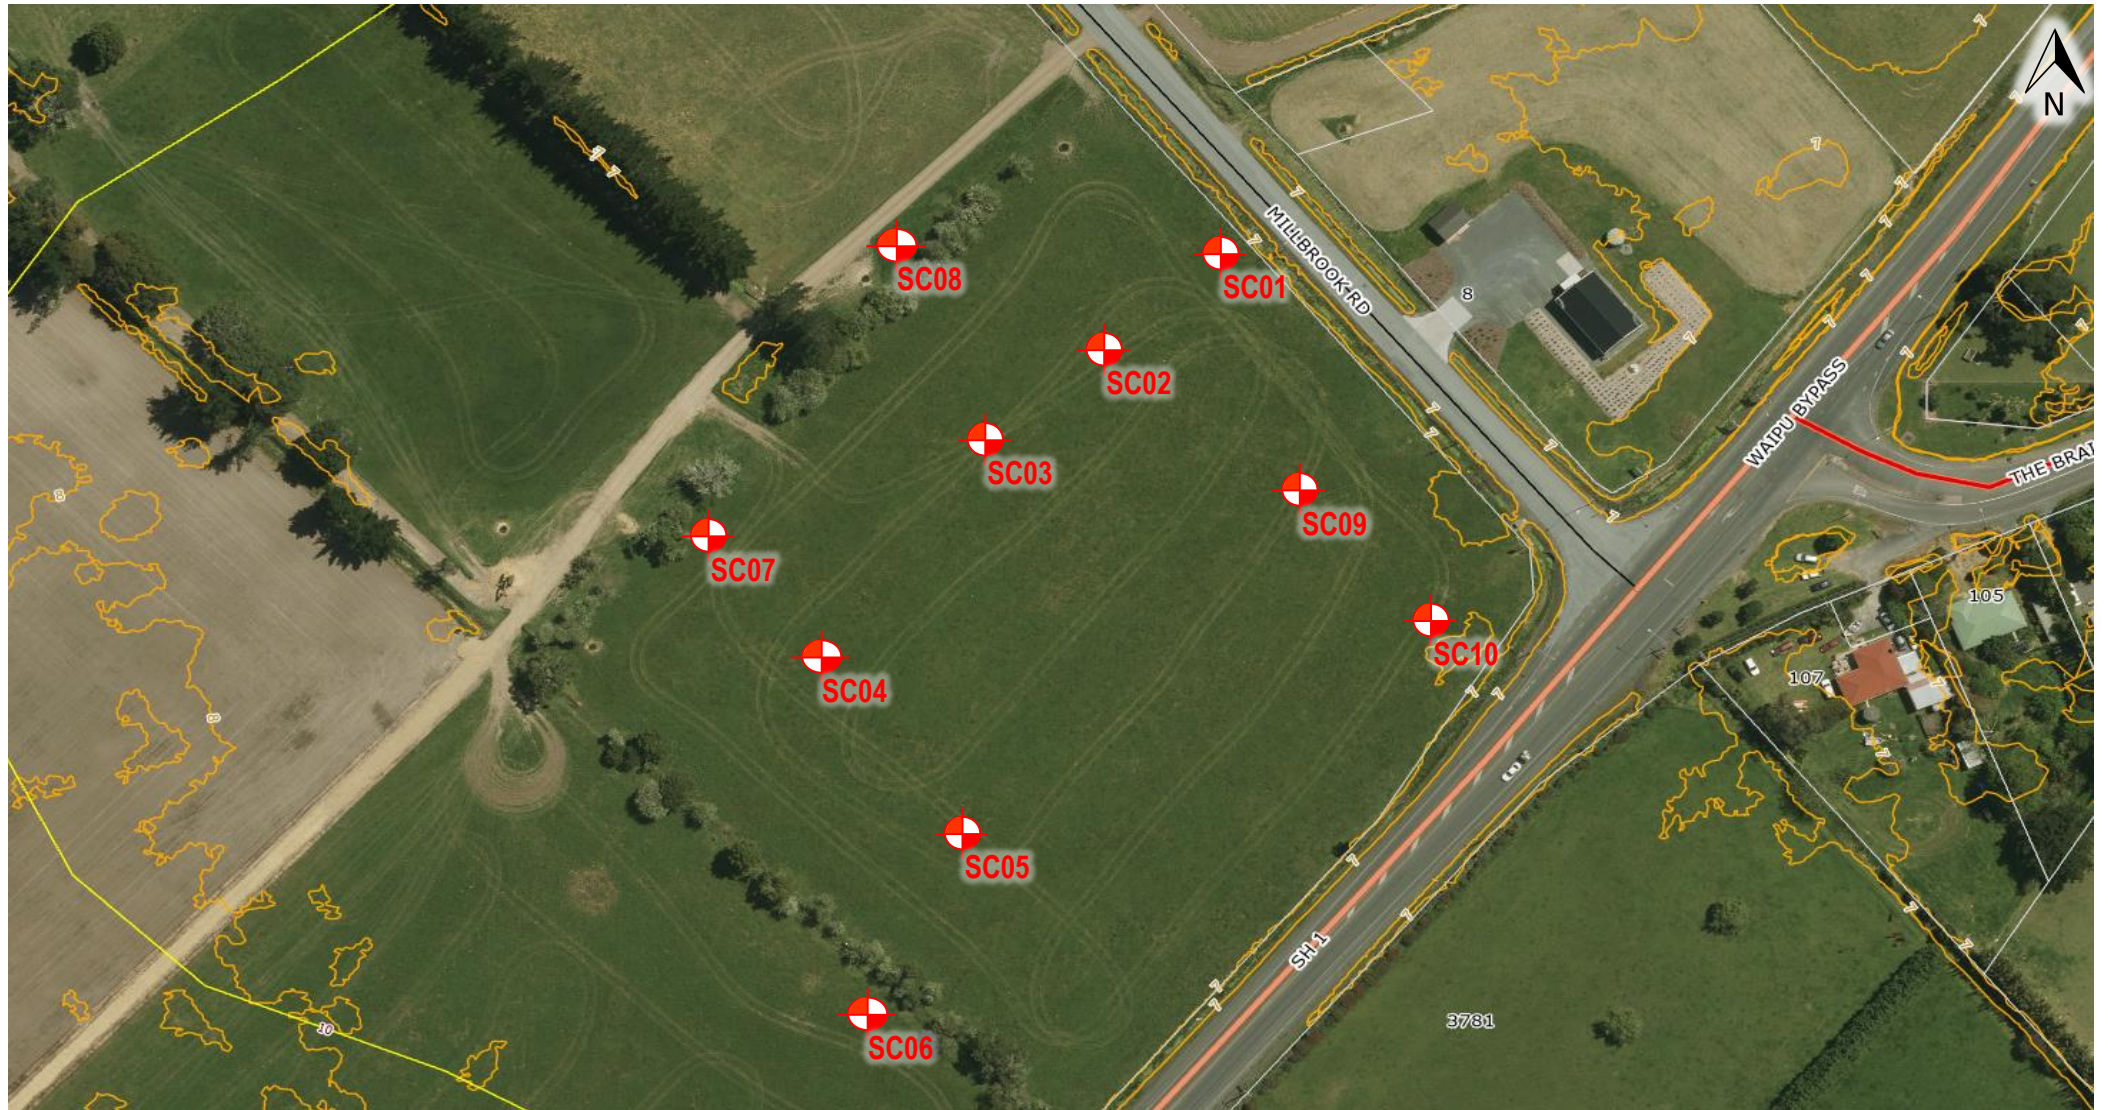
PZ	S&RC Piezometer Locations 06 Apr 2022

Aerial Photo from Auckland Council GeoMaps Webservice

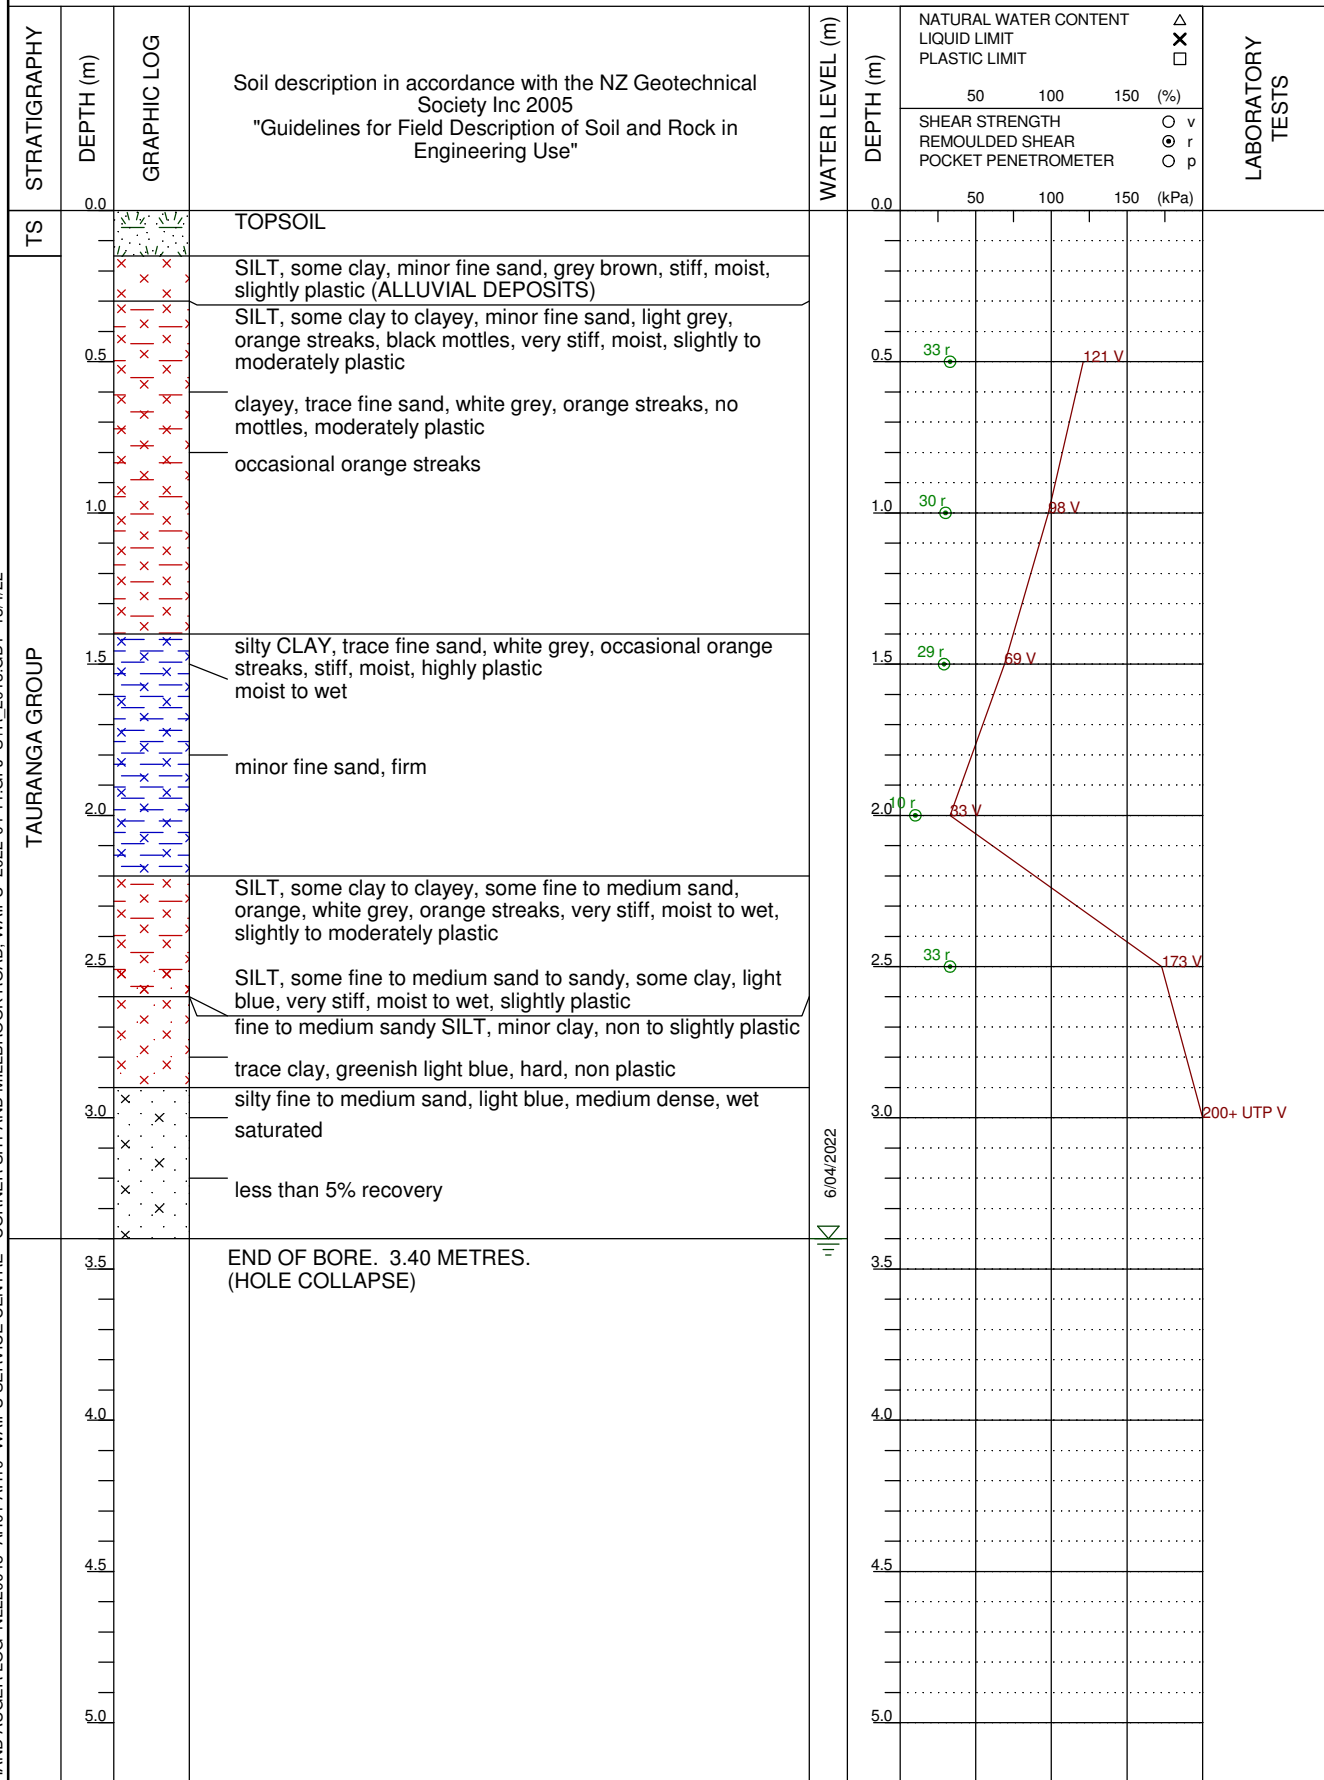
Drill Type: 50mmØ Hand Auger Project No: NL220045 Logged By: RH
 Drilled By: RH Coordinates: Shear Vane No - Calibration Date: GEO119 - 10/03/2021
 Date Started: 6/4/22 Ground Elevation: Surface Conditions: Near Level, Grass
 Date Finished: 6/4/22 Water Level: 3.4m 6/04/2022

HAND AUGER LOG NL220045-AH01-AH10-WAIPU SERVICE CENTRE - CORNER SH1 AND MILLBROOK ROAD, WAIPU- 2022-04-11.GPJ S+R 2013.GDT 13/4/22

A thin layer of topsoil was found underlain by alluvial deposits of Tauranga Group soils. An outline of the soil conditions and investigation results is given below and summarised in Table 1. Detailed descriptions of the soils are given on the attached logs (Appendix B).

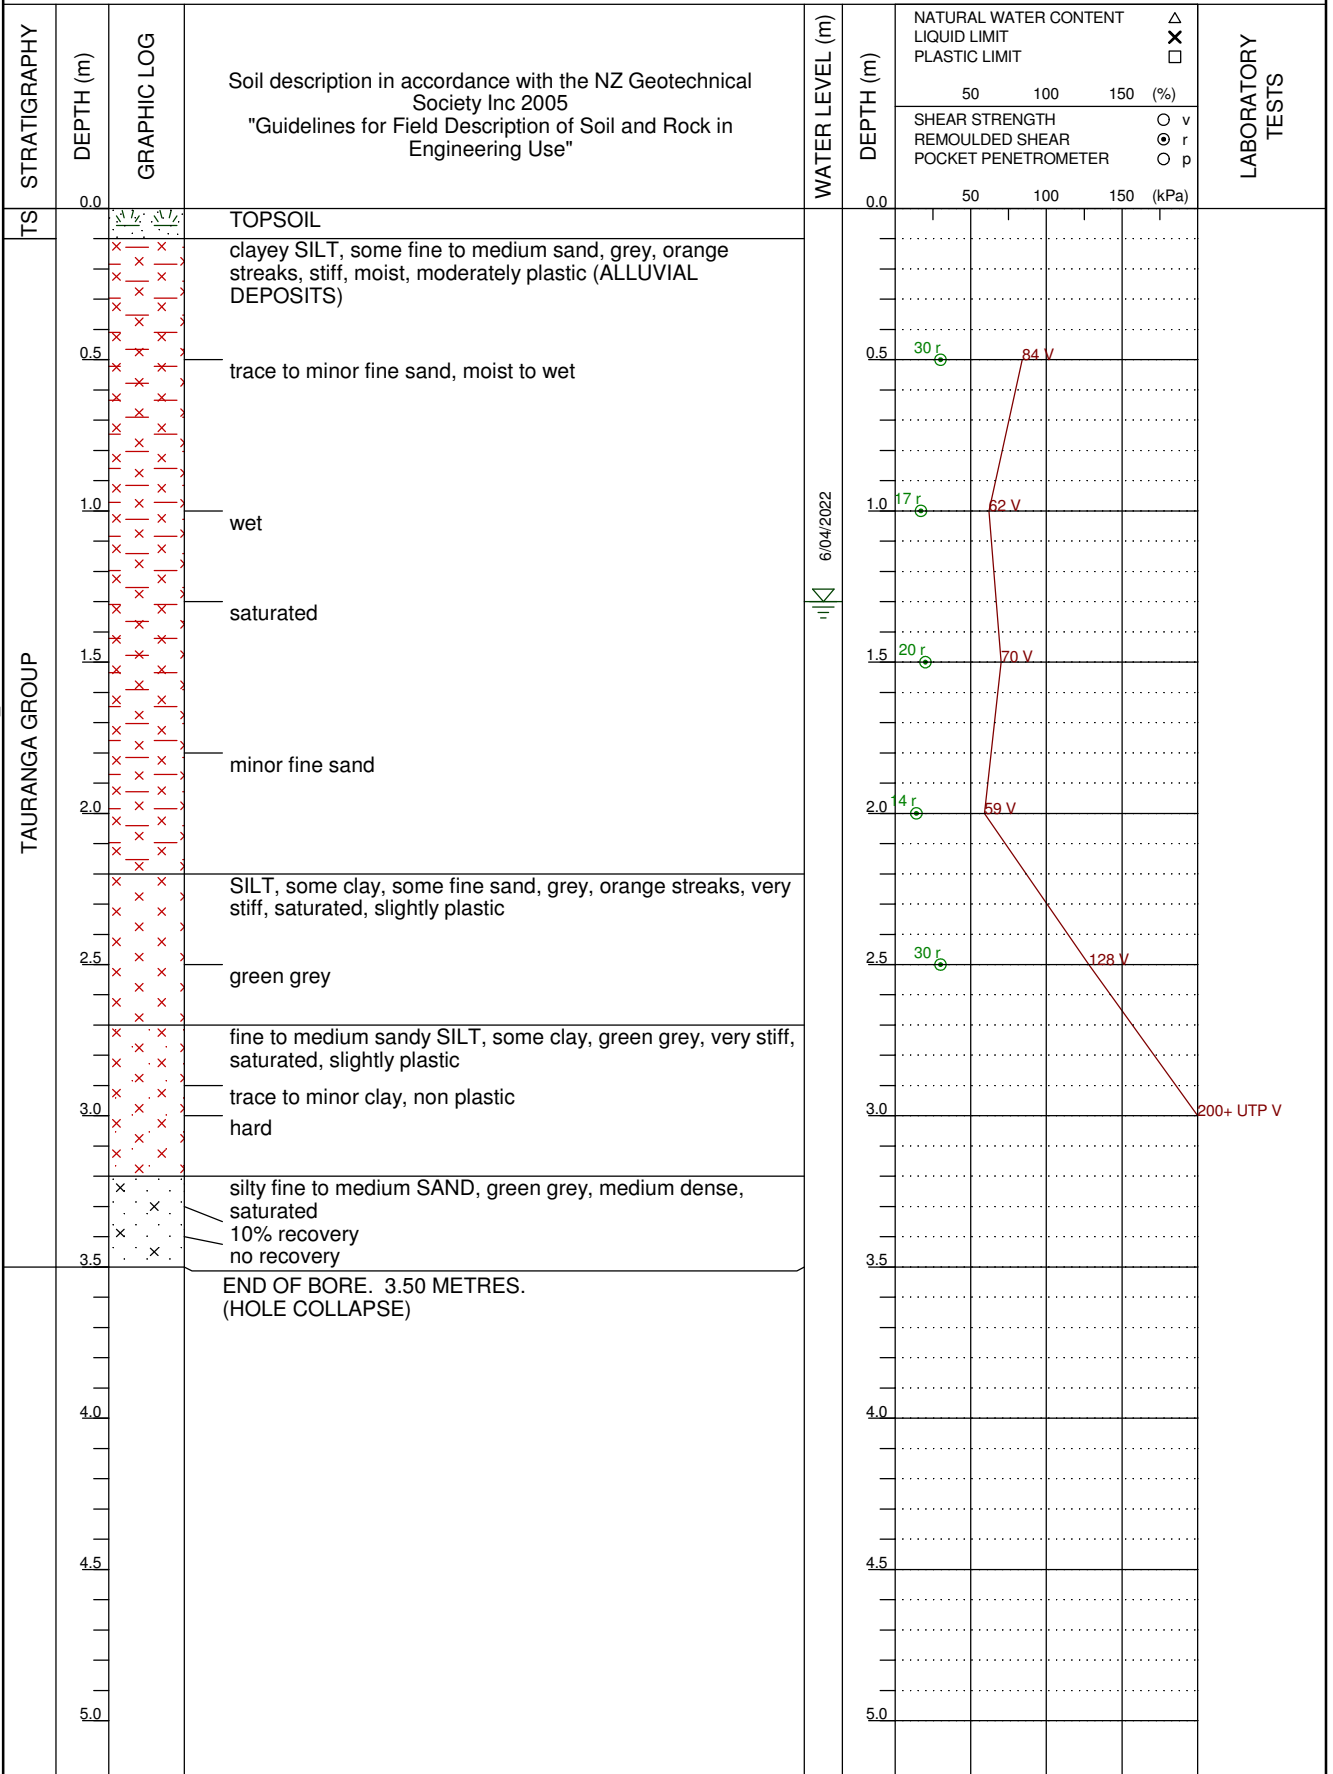
Drill Type: 50mmØ Hand Auger Project No: NL220045 Logged By: JT
 Drilled By: JT Coordinates: Shear Vane No - Calibration Date: GEO740 - 3/02/2022
 Date Started: 6/4/22 Ground Elevation: Surface Conditions: Near Level, Grass
 Date Finished: 6/4/22 Water Level: 1.3m 6/04/2022

HAND AUGER LOG NL220045-AH01-AH10- WAIPU SERVICE CENTRE - CORNER SH1 AND MILLBROOK ROAD, WAIPU- 2022-04-11.GPJ S+R_2013.GDT 13/4/22

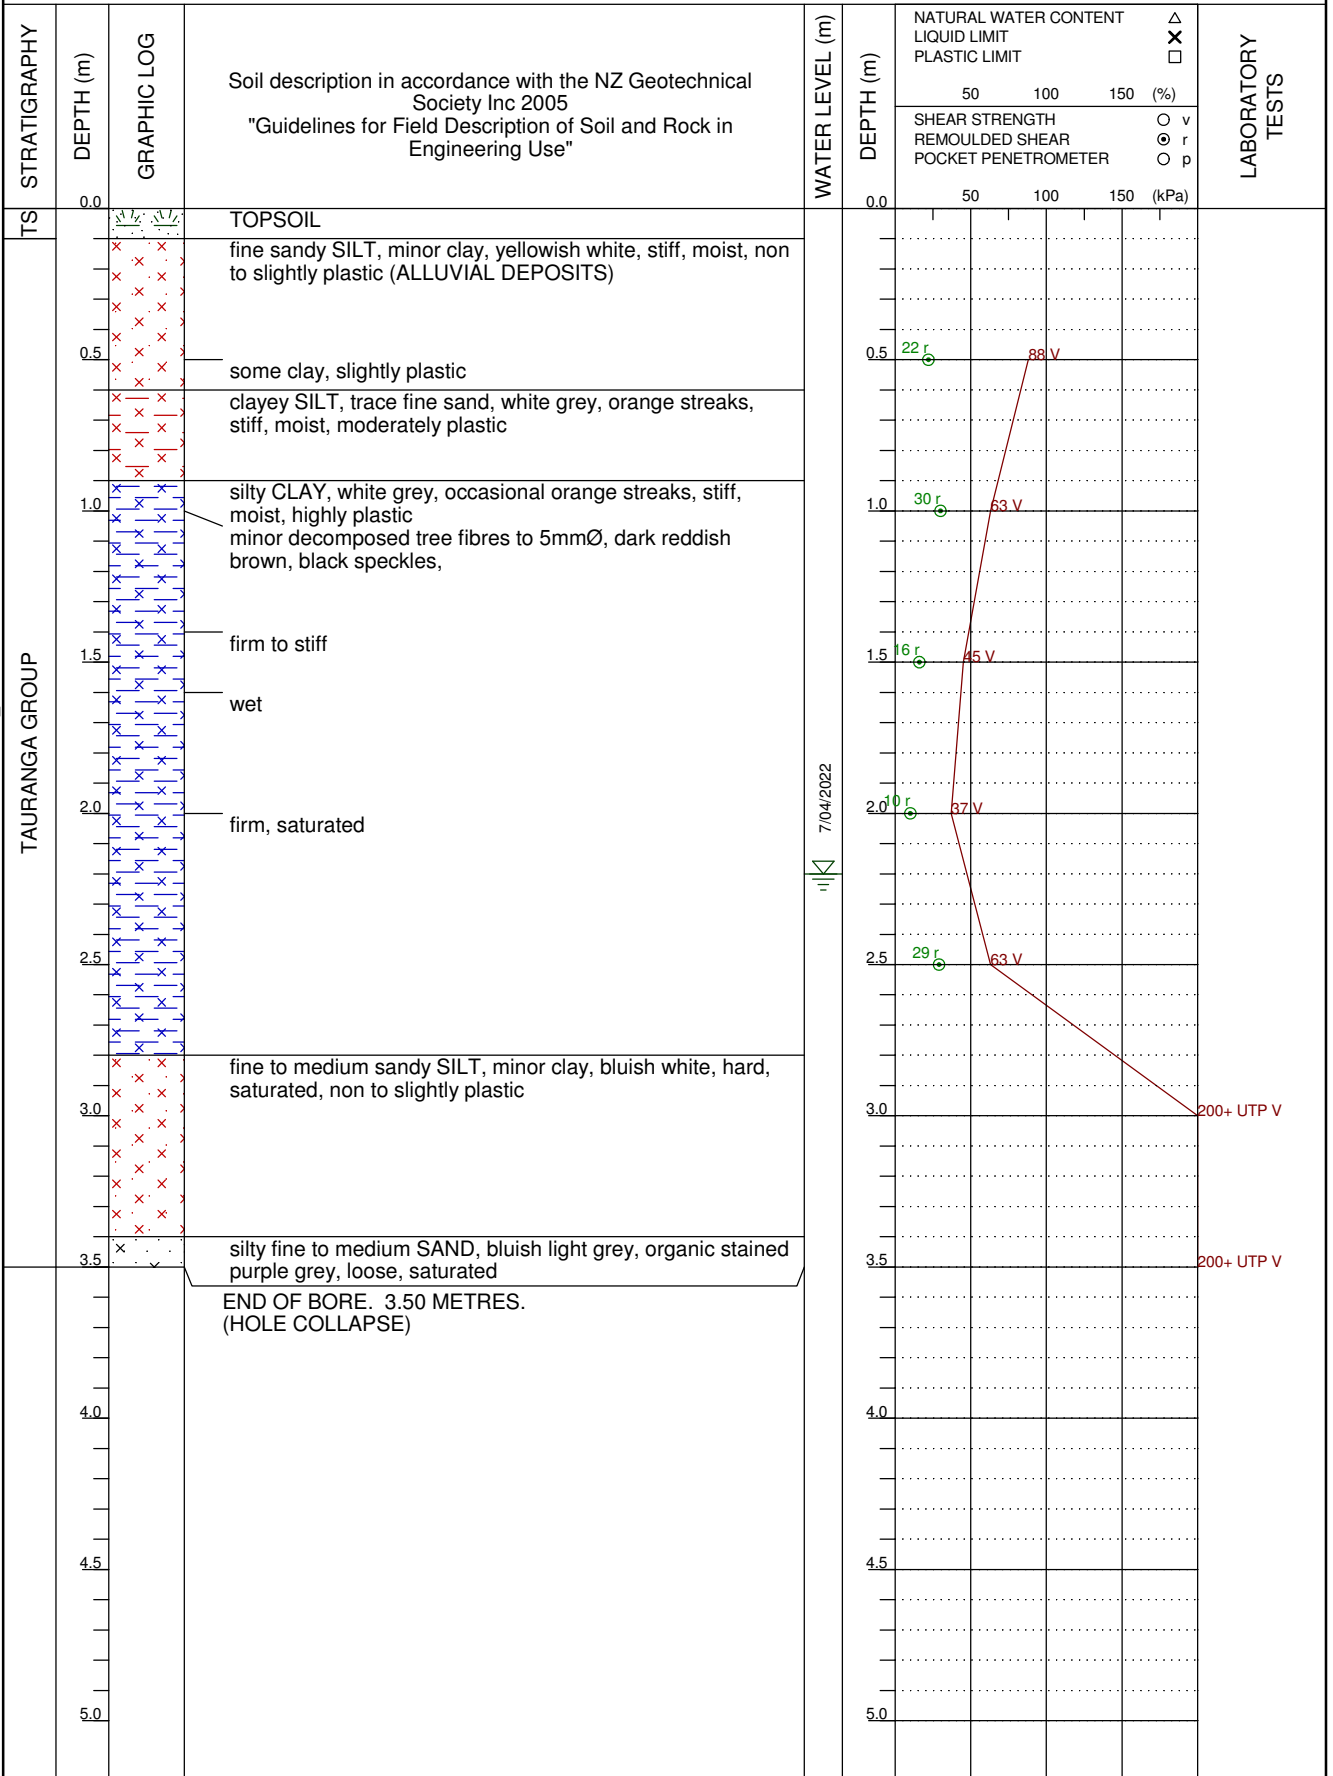
Drill Type: 50mmØ Hand Auger Project No: NL220045 Logged By: RH
 Drilled By: RH Coordinates: Shear Vane No - Calibration Date: GEO119 - 10/03/2021
 Date Started: 7/4/22 Ground Elevation: Surface Conditions: Near Level, Grass
 Date Finished: 7/4/22 Water Level: 2.2m 7/04/2022

HAND AUGER LOG NL220045-AH01-AH10- WAIPU SERVICE CENTRE - CORNER SH1 AND MILLBROOK ROAD, WAIPU - 2022-04-11.GPJ S+R 2019.GDT 13/4/22

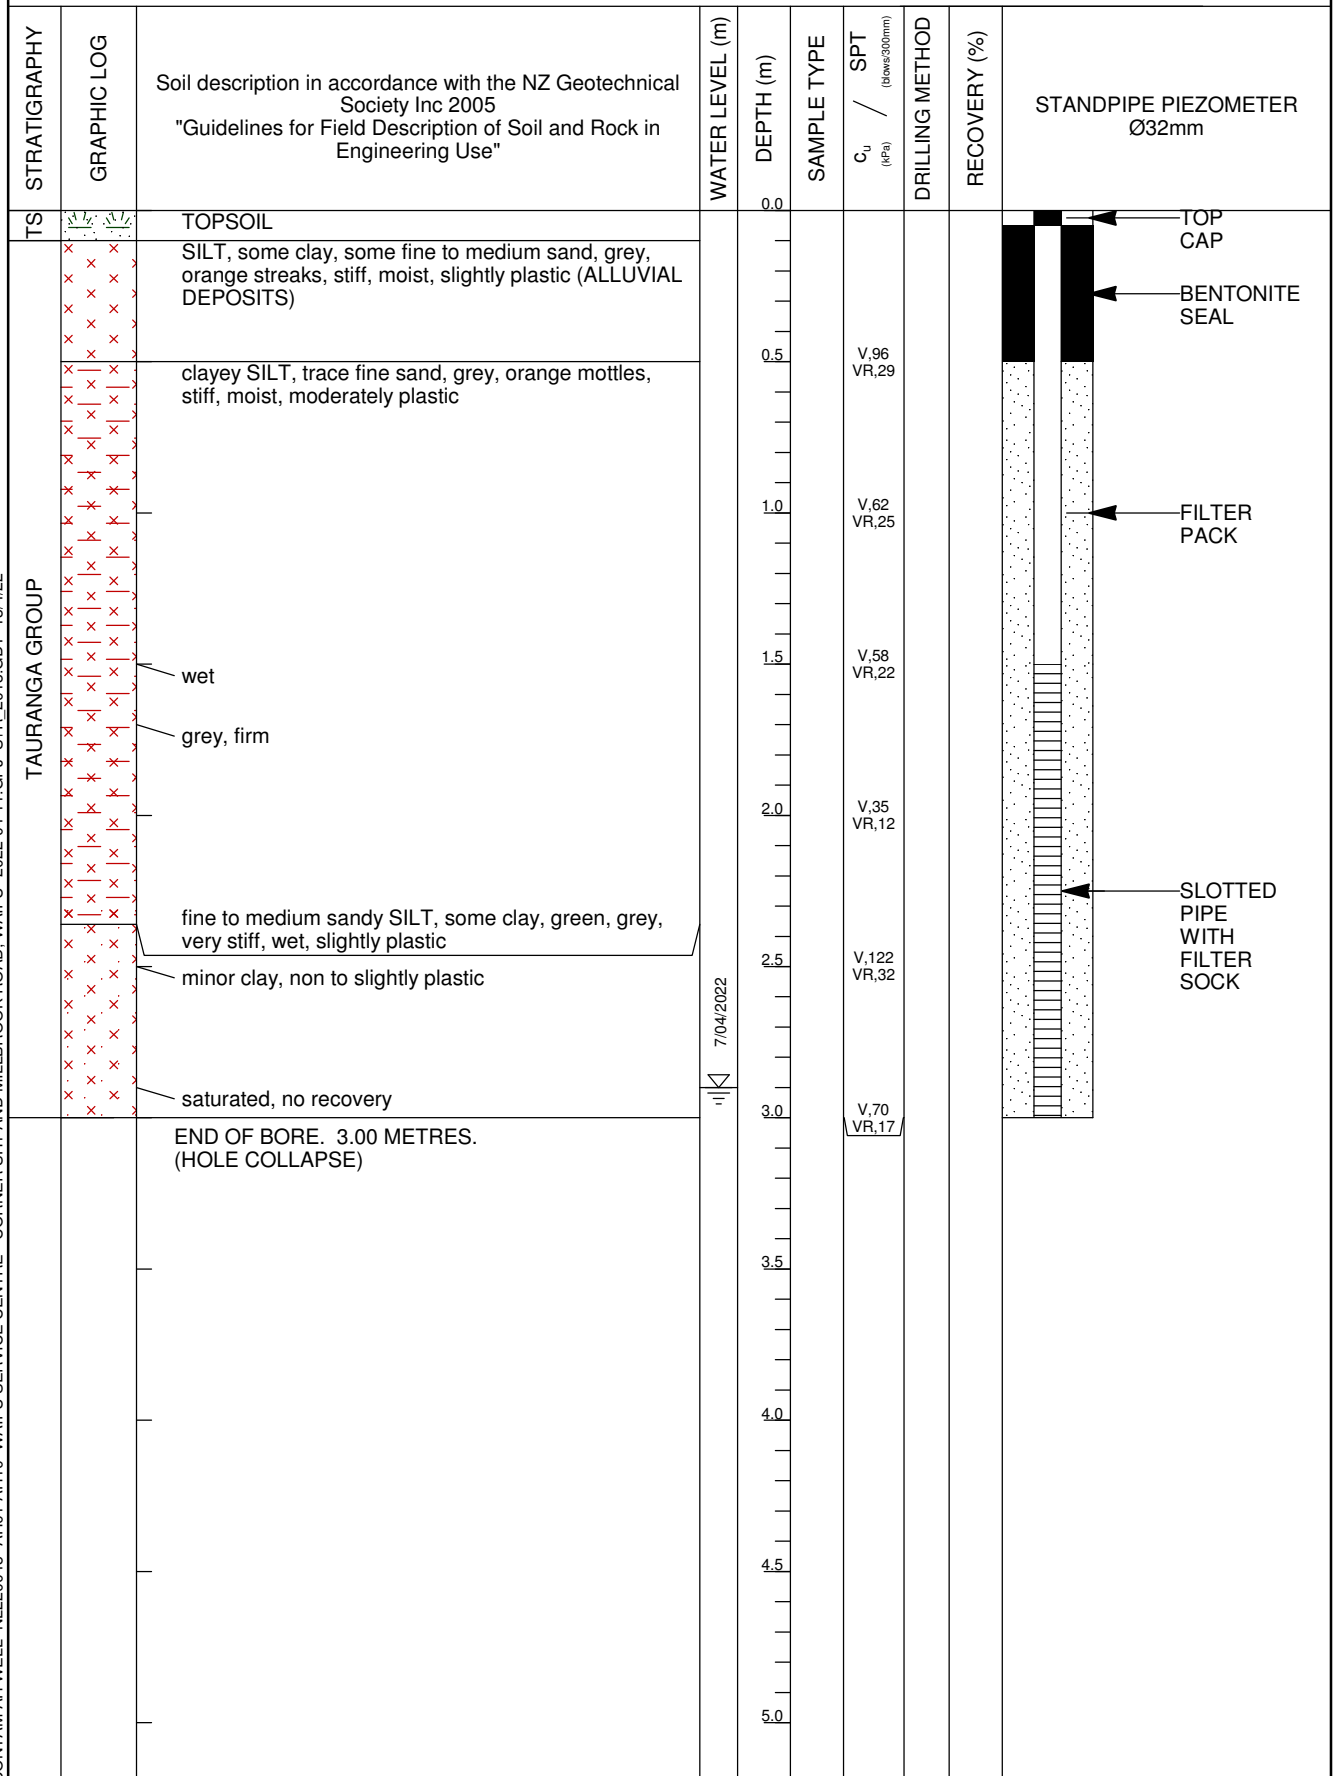
Drill Type: 75mmØ Hand Auger Project No: NL220045 Logged By: JT
 Drilled By: JT Coordinates: Shear Vane No - Calibration Date: GEO740 - 3/02/2022
 Date Started: 7/4/22 Ground Elevation: Surface Conditions: Near Level, Grass
 Date Finished: 7/4/22 Water Level: 2.9m 7/04/2022

CONTAM AH WELL NL220045-AH01-AH10-WAIPU SERVICE CENTRE - CORNER SH1 AND MILLBROOK ROAD, WAIPU - 2022-04-11.GPJ S+R 2013.GDT 13/4/22

Groundwater levels measured within piezometers across subsequent visits are more representative of actual conditions. The results of the groundwater monitoring are summarised in Table 2.

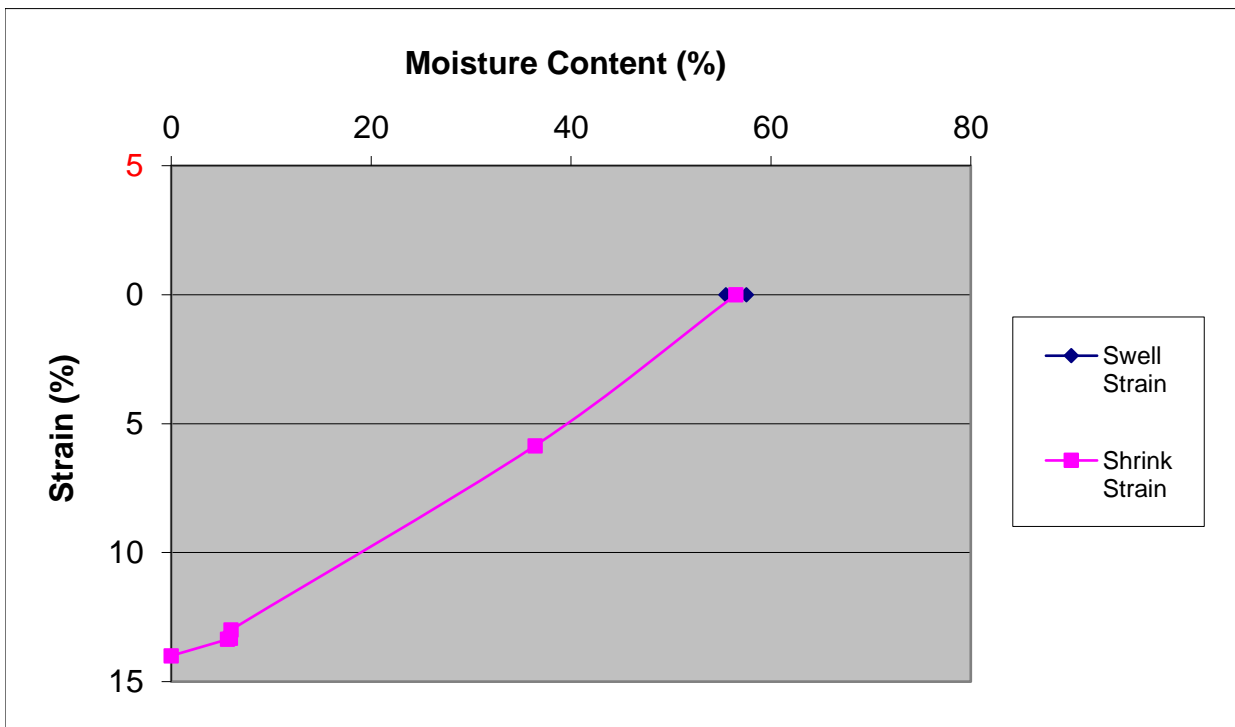
Swell Test

ϵ_{sw} = Magnitude of the swelling strain (%) =	-0.2
(Note: The ϵ_{sw} value is negative if the sample has undergone consolidation)		
	Initial moisture content (%) =	55.5
	Final moisture content (%) =	57.6

Shrink-Swell index

Iss = **7.8** Strain per ΔpF (%)

We recommend that Class H soil expansivity is assumed for design purposes. B1/AS1 states that Class E soils experience surface movements of up to 90 mm and foundation design should take account of this classification. Laboratory test results are presented in Appendix C.

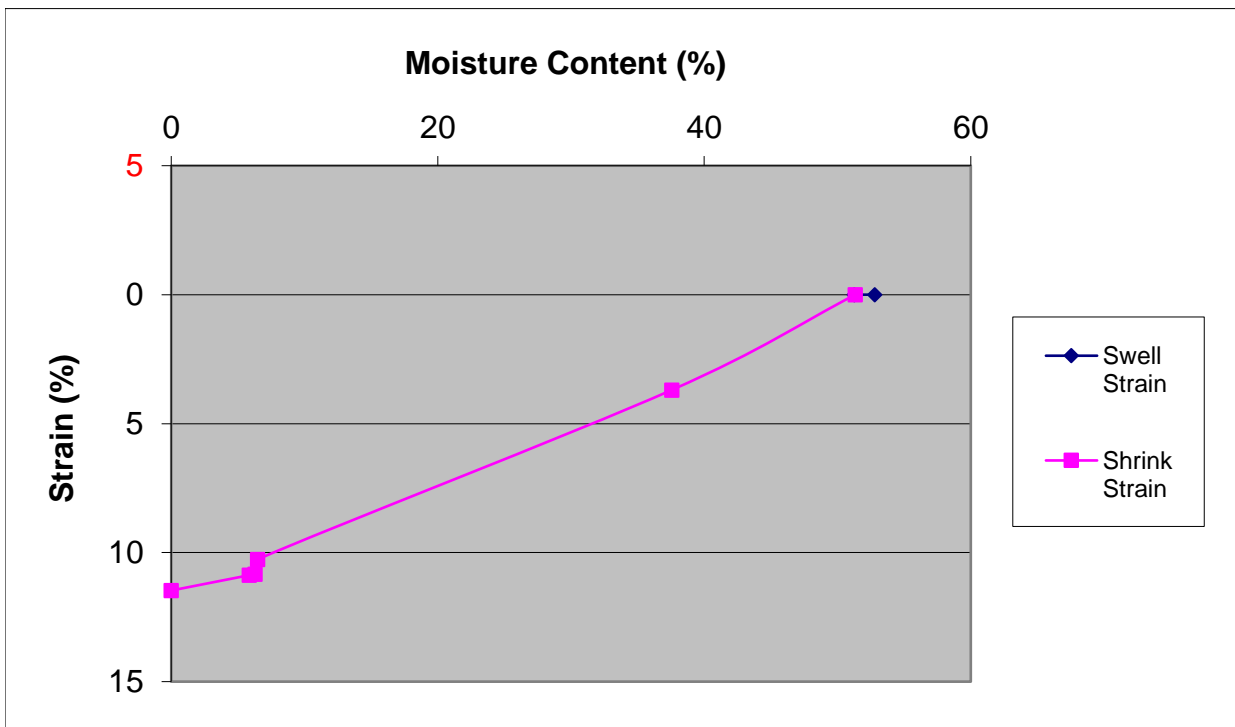
Swell Test

ϵ_{sw} = Magnitude of the swelling strain (%) =	-0.5
(Note: The ϵ_{sw} value is negative if the sample has undergone consolidation)		
	Initial moisture content (%) =	51.3
	Final moisture content (%) =	52.8

Shrink-Swell index $I_{ss} = \boxed{6.4}$ Strain per ΔpF (%)

Testing Method: AS1289.7.1.1 - 2003 Soil reactivity tests

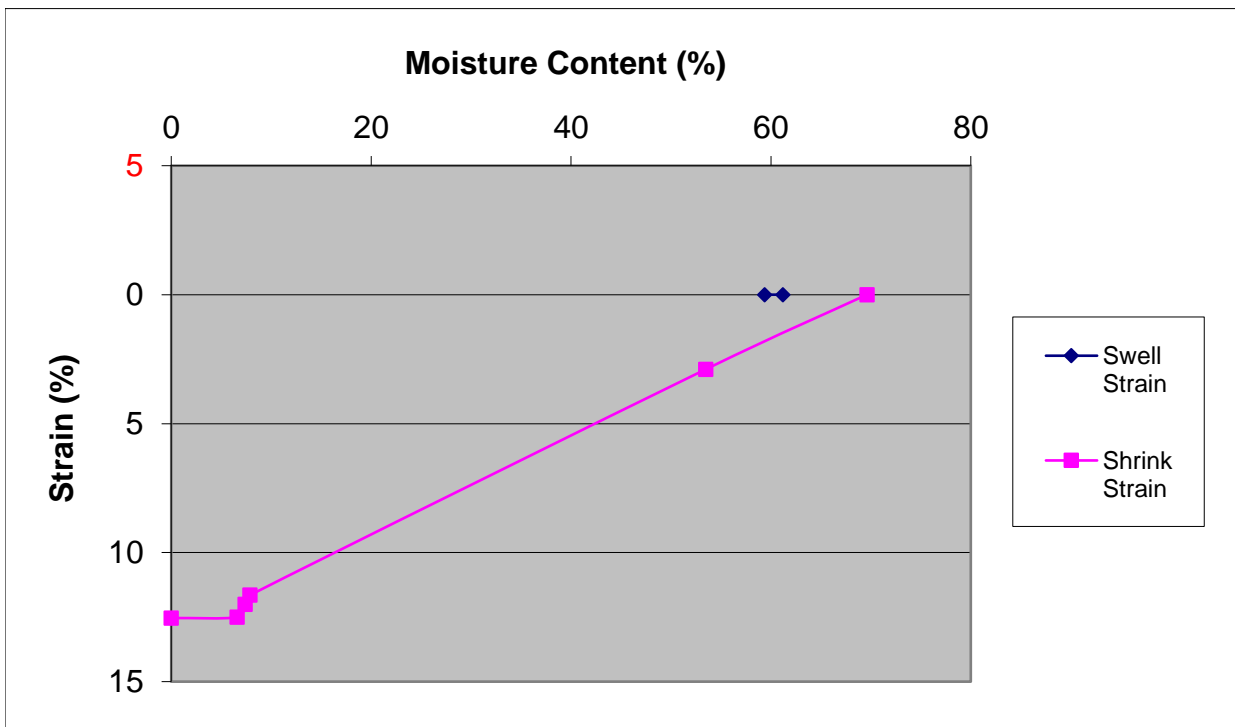
Swell Test

ϵ_{sw} = Magnitude of the swelling strain (%) =	-0.7
(Note: The ϵ_{sw} value is negative if the sample has undergone consolidation)		
	Initial moisture content (%) =	61.2
	Final moisture content (%) =	59.4

Shrink-Swell index

Iss = **7.0** Strain per ΔpF (%)

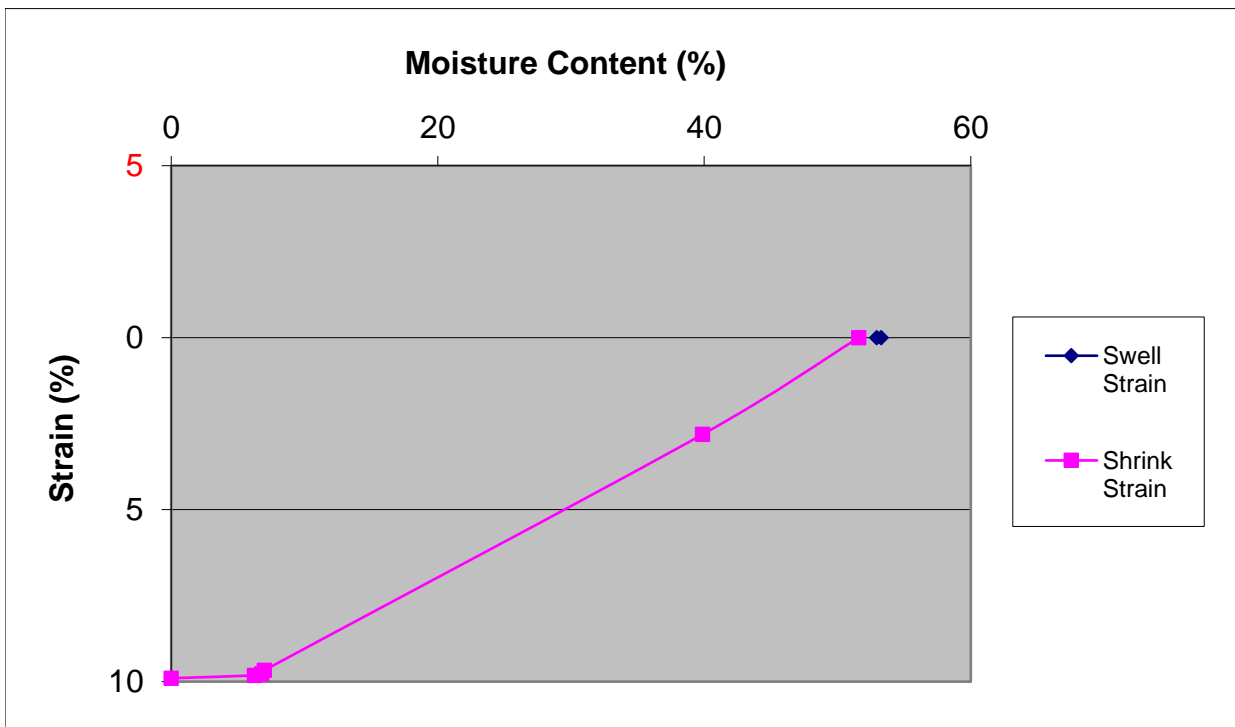
Swell Test

ϵ_{sw} = Magnitude of the swelling strain (%) =	-0.1
(Note: The ϵ_{sw} value is negative if the sample has undergone consolidation)		
	Initial moisture content (%) =	53.3
	Final moisture content (%) =	52.9

Shrink-Swell index

Iss = **5.5** Strain per ΔpF (%)

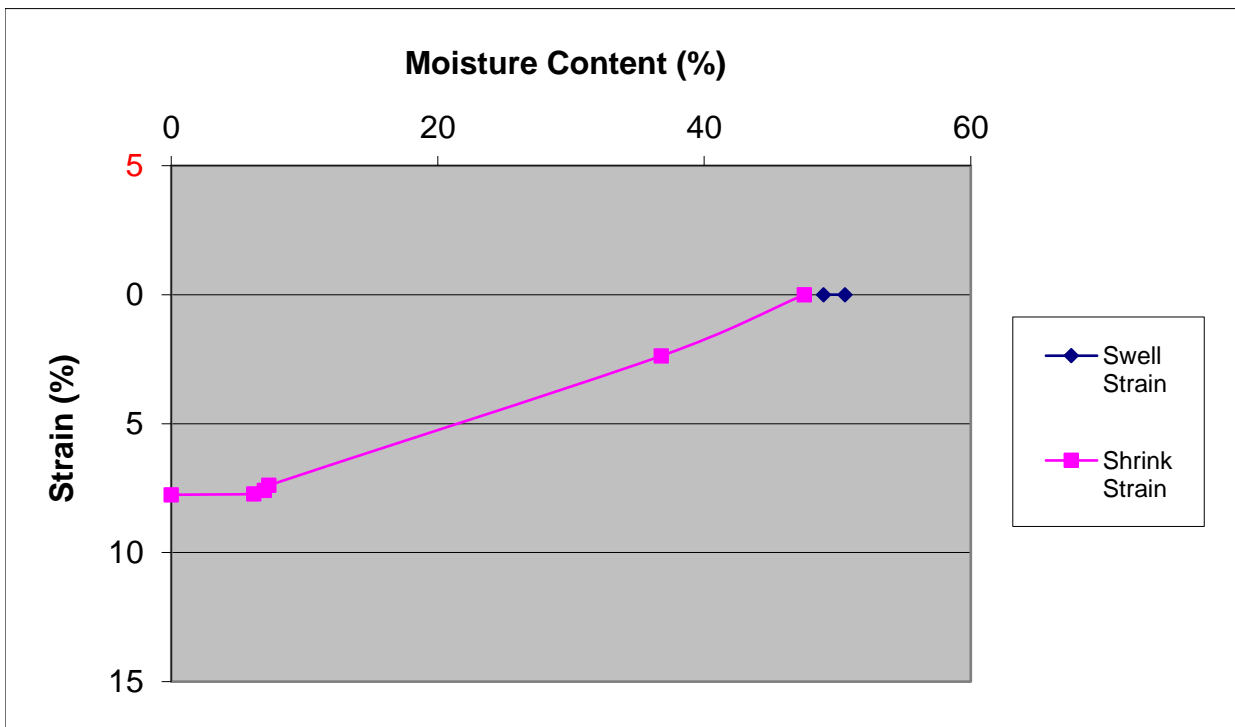
Swell Test

ϵ_{sw} = Magnitude of the swelling strain (%) =	0.0
(Note: The ϵ_{sw} value is negative if the sample has undergone consolidation)		
	Initial moisture content (%) =	49.0
	Final moisture content (%) =	50.6

Shrink-Swell index

Iss = **4.3** Strain per ΔpF (%)
