AND an application by Doug's Opuā Boatyard for
resource consents relating to the redevelopment of
the boatyard located at 1 Richardson Street, Opuā.

**STATEMENT OF EVIDENCE OF DR PETER STANLEY WILSON ON
BEHALF OF DOUG'S OPUA BOATYARD (DOBY)**

Appendix PSW3

Appendix PSW4

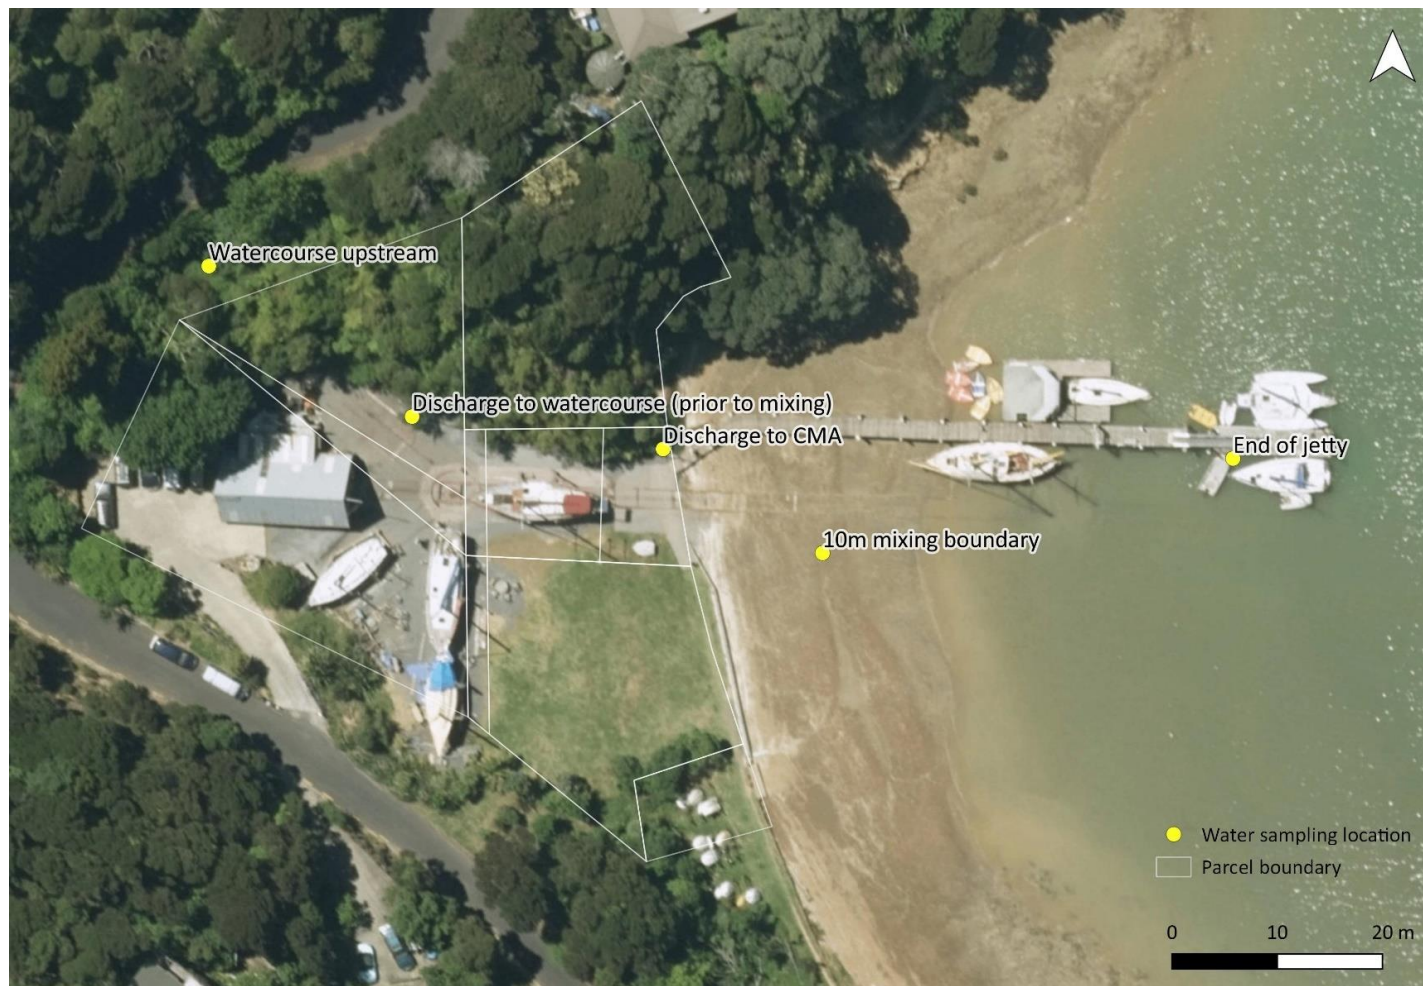
Northland Regional Council consent compliance water quality monitoring locations

Figure: Aerial image of Doug's Opua Boatyard and the nearby CMA. Yellow circles show locations where Northland Regional Council have collected water samples over multiple years for consent compliance monitoring relating to the stormwater discharge from Doug's Opua Boatyard into the CMA.

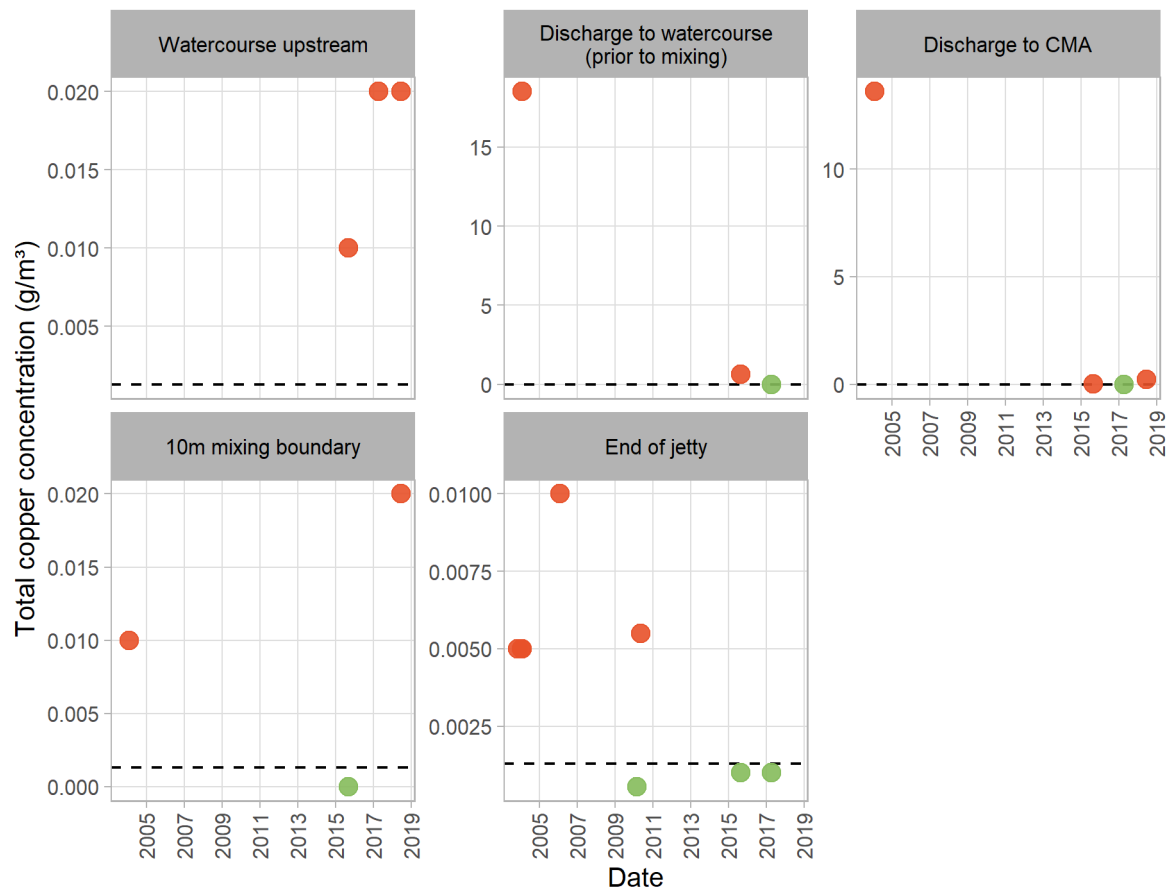
Figure 1: Total copper concentrations in samples collected by Northland Regional Council for consent compliance monitoring relating to the stormwater discharge from Doug's Opua Boatyard into the CMA. The dashed, horizontal line denotes the ANZECC water quality guideline value (0.0013 g/m³), which is also the consent requirement at the 10m mixing boundary. Note the difference scale on the y-axis for each plot.

DGV (Appendix PSW3 Figures 1 to 3; plots titled "Watercourse upstream"). The quality of the water at this location is not influenced by activities being undertaken at DOBY.

39. NRC monitoring data suggests zinc and lead at the 10m mixing zone have been below the DGVs (and the consent conditions) since the infrastructure improvements in 2012. Although, the most recent copper measurement was an order of magnitude greater than the DGV at the 10m mixing zone boundary, this was still slightly lower than the concentration of copper in the watercourse entering the property.

40. My Figure 1 in Appendix PSW3 also indicates that copper concentrations were below the DGV at the jetty location, as would be expected with increased distance from the discharge point and, therefore, a greater mixing volume.

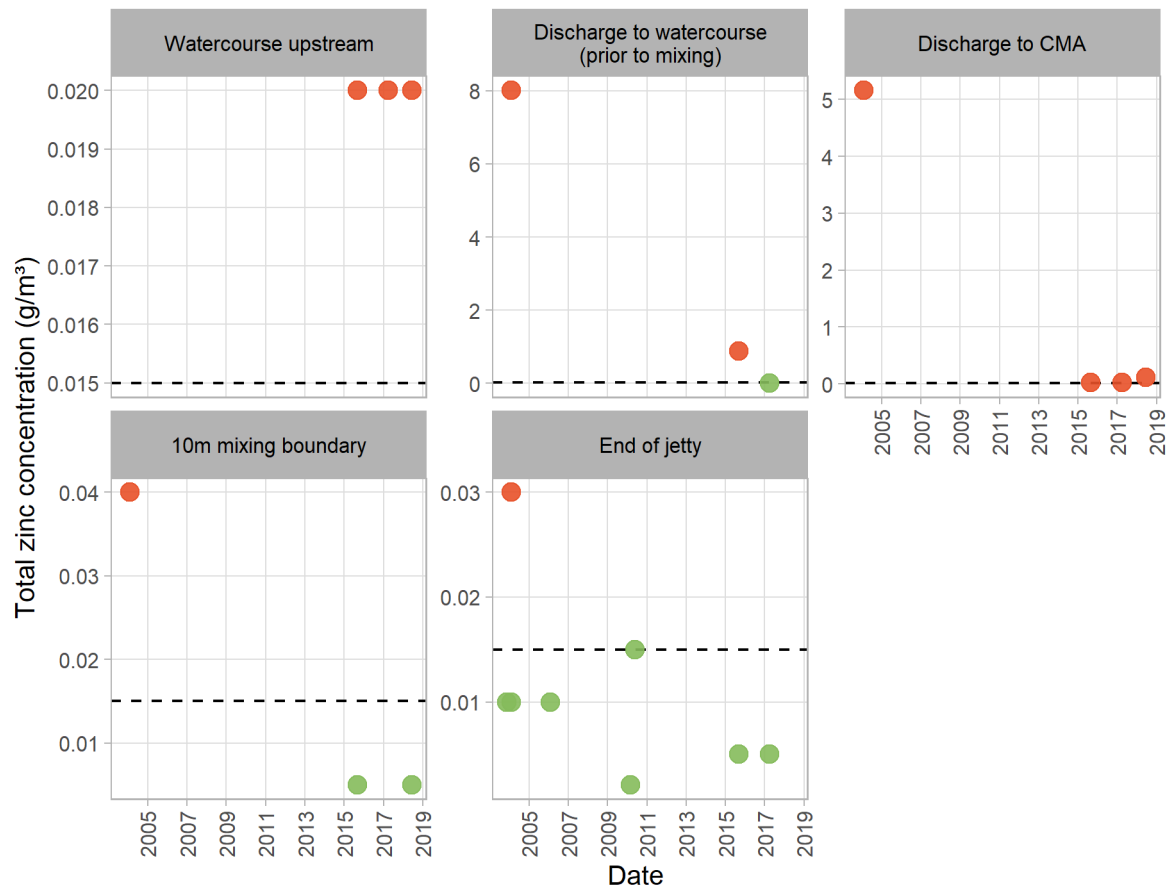
Figure 2: Total zinc concentrations in samples collected by Northland Regional Council for consent compliance monitoring relating to the stormwater discharge from Doug's Opua Boatyard into the CMA. The dashed, horizontal line denotes the ANZECC water quality guideline value (0.015 g/m^3), which is also the consent requirement at the 10m mixing boundary. Note the difference scale on the y-axis for each plot.

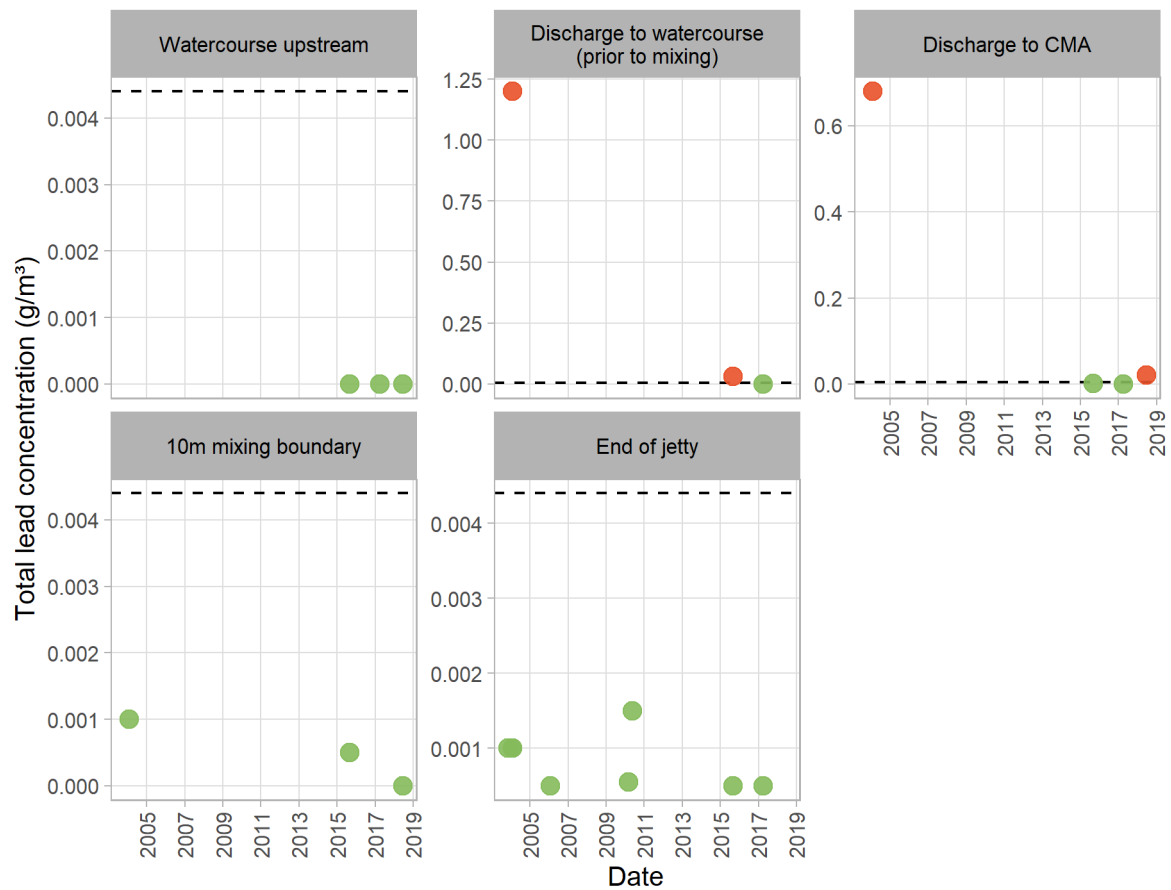
Figure 3: Total lead concentrations in samples collected by Northland Regional Council for consent compliance monitoring relating to the stormwater discharge from Doug's Opua Boatyard into the CMA. The dashed, horizontal line denotes the ANZECC water quality guideline value (0.0044 g/m³), which is also the consent requirement at the 10m mixing boundary. Note the difference scale on the y-axis for each plot.
