## ECOLOGICAL ASSESSMENT OF THE COMPLIANCE POINT FOR THE TAIPA WASTEWATER TREATMENT PLANT DISCHARGE, TAIPA

## **Contract Report No. 3458**

April 2015

Far North District Council Private Bag 752 Kaikohe 0440

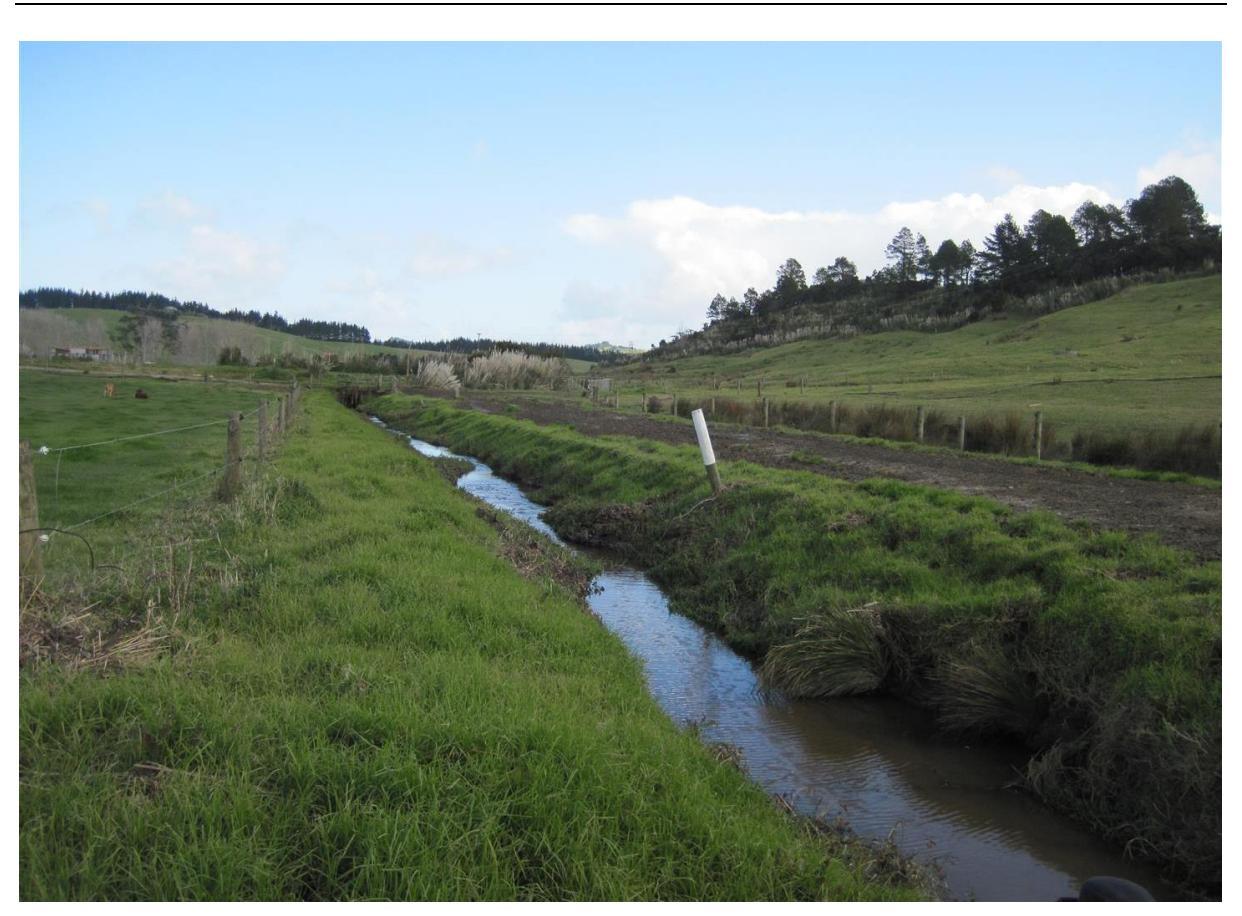
The existing compliance point for the Taipa WWTP discharge, Parapara Stream catchment.

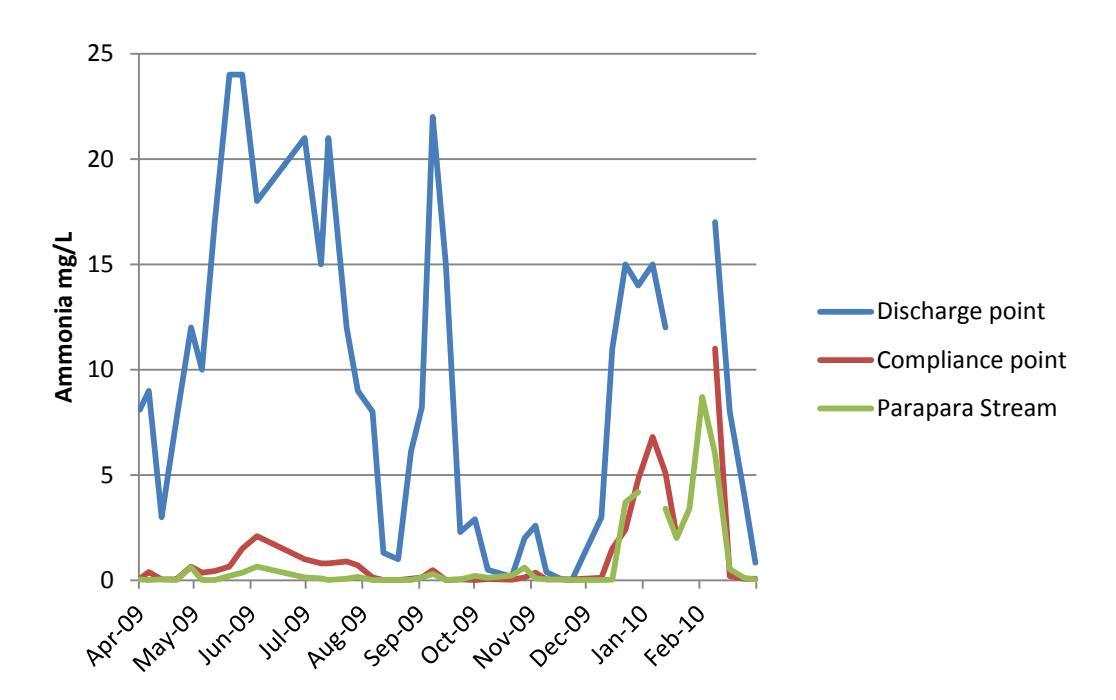
- Figure 2: Ammonia concentrations (mg/L) for the discharge point, compliance point, and upstream where the Parapara Stream flows through the settlement of Parapara, April 2009-March 2010.
- Table 1:Lethal concentration of ammonia (mg/L) for three freshwater fish species<br/>present at the compliance point. Data sourced from Richardson (1997).

Ammonia concentrations for the compliance point, for the period April 2009-March 2010, averaged 1.1 mg/L. In comparison, ammonia concentrations of up to 0.4 mg/L are common for lowland streams which pass through agricultural land (Richardson 1997). A dairy shed oxidation pond is located c.200 m downstream of the compliance point and when effluent is being discharged from the pond, ammonia concentrations are likely to be much higher in the stream as effluent ammonia can frequently exceed 360 mg/L (Hickey and Vickers 1994). Below the dairy shed oxidation pond, aquatic life in the watercourse may be limited by ammonia toxicity from both the discharge from the wastewater treatment plant and the dairy oxidation ponds.

Background levels of ammonia are also monitored at the settlement of Parapara, upstream of where the discharge tributary meets the Parapara Stream. Trends and peaks in ammonia concentration appear to be closely correlated with concentration at the compliance point (Figure 2). However, the similarity in trends between the compliance point and the Parapara Stream upstream of the discharge, are likely to be caused ammonia being concentrated during low flow conditions throughout the catchment. Upstream at Parapara, this may possibly be caused by inflows from septic tanks within the settlement. Whilst the discharge is a significant source of ammonia, the Parapara Stream receives ammonia from multiple sources other than the wastewater treatment plant.

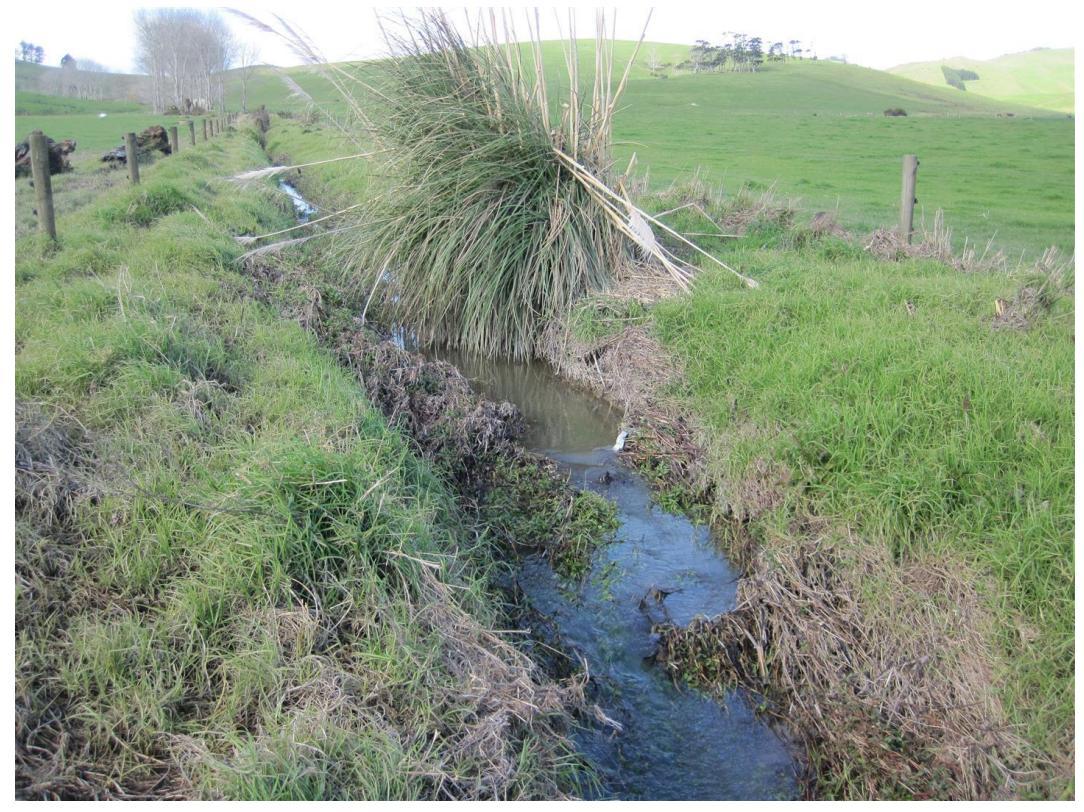
Plate 1: The discharge flow path during winter high-flow conditions. The channel is partly shaded by macrophytes, overhanging grasses, and, further upstream, by steep banks. 25 July 2014.

On 25 July 2014, the discharge flow path comprised runs, riffles, and pools with slow to moderate water flow. Average wetted width was *c*.1 m, and water depth was 0.2-0.8 m (Appendix 1: Plate 1). The substrate was fine mud and silt. Where the adjacent stream banks were steep, short sections were undercut. The exotic macrophyte water pepper (*Persicaria hydropiper*) was common, forming dense patches along the channel edges. The discharge flow path supported an abundant population of inanga (*Galaxias maculatus*) (Appendix 1: Plate 2) and common bully (*Gobiomorphus cotidianus*) (Appendix 1: Plate 3), with up to seven inanga and 12 common bullies caught within each 4-5 m reach. One large longfin eel (*Anguilla dieffenbachii*), *c*.1.5 m in length, was caught several metres upstream of the confluence within the farm drain (Appendix 1: Plate 4).

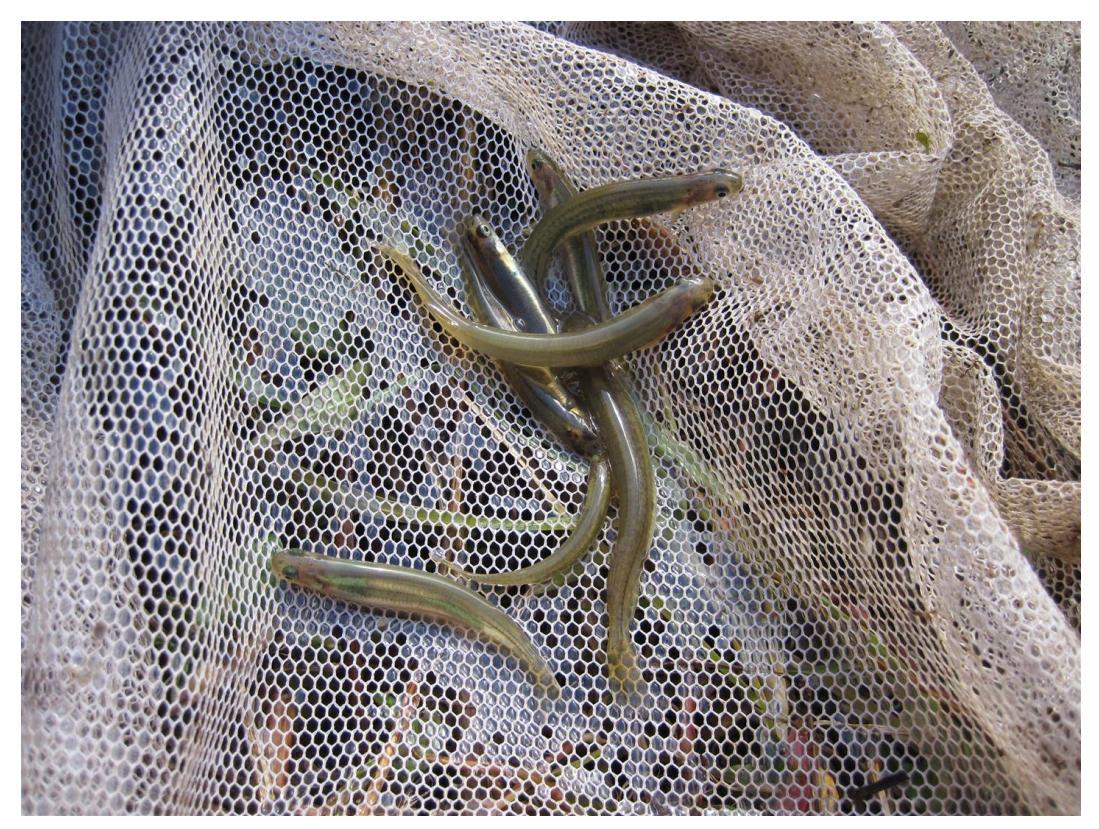
Plate 2: Inanga caught in the discharge flow path. 25 July 2014.

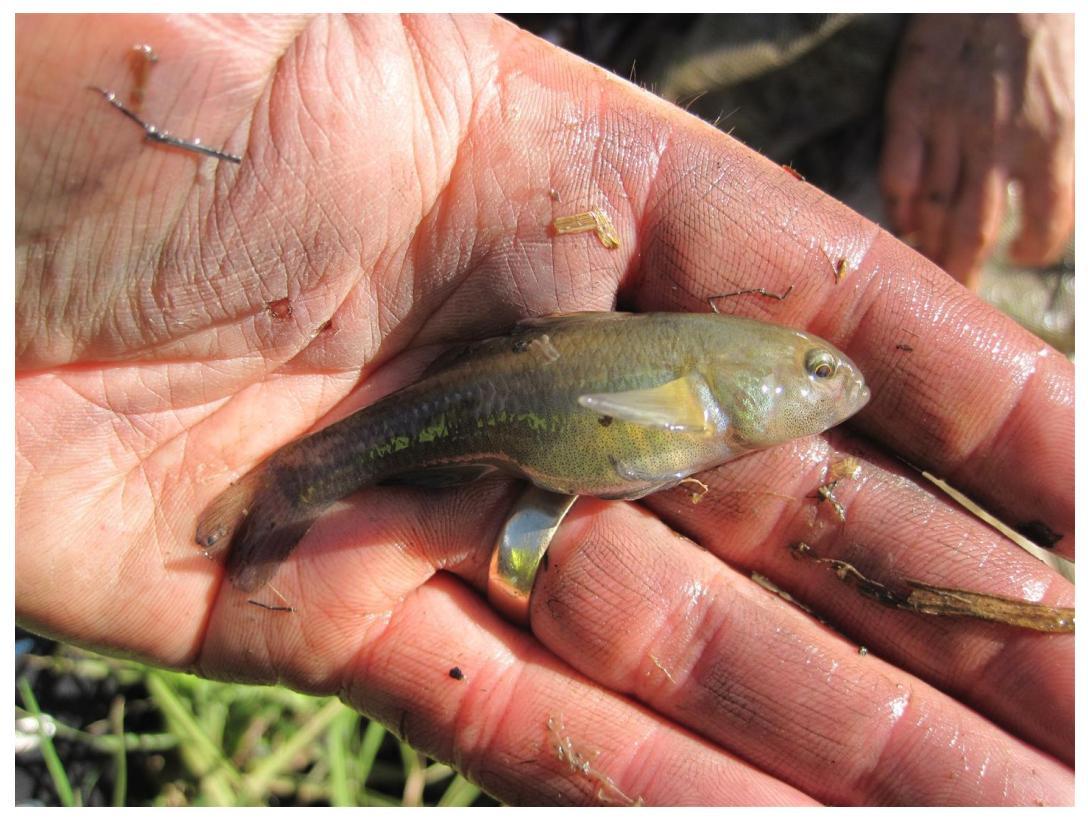
Plate 3: Common bully caught in the discharge flow path. 25 July 2014.

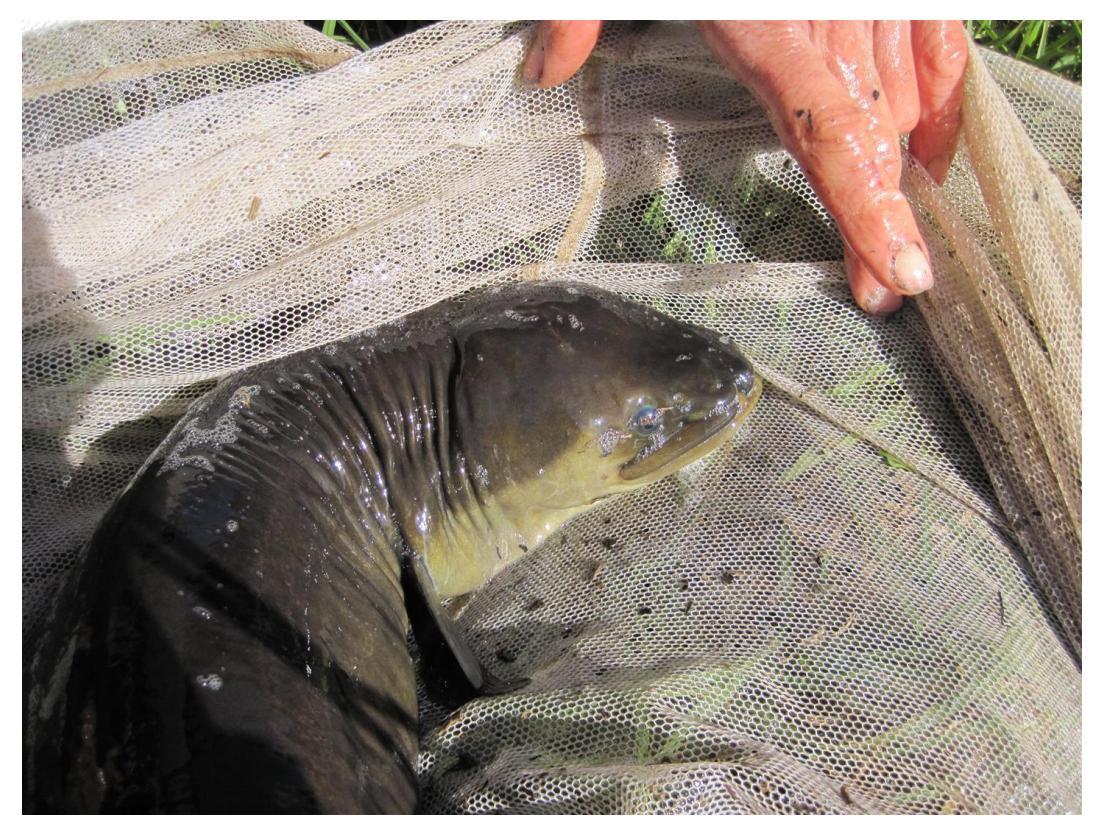
Plate 4: Adult longfin eel caught in the discharge flow path. 25 July 2014.

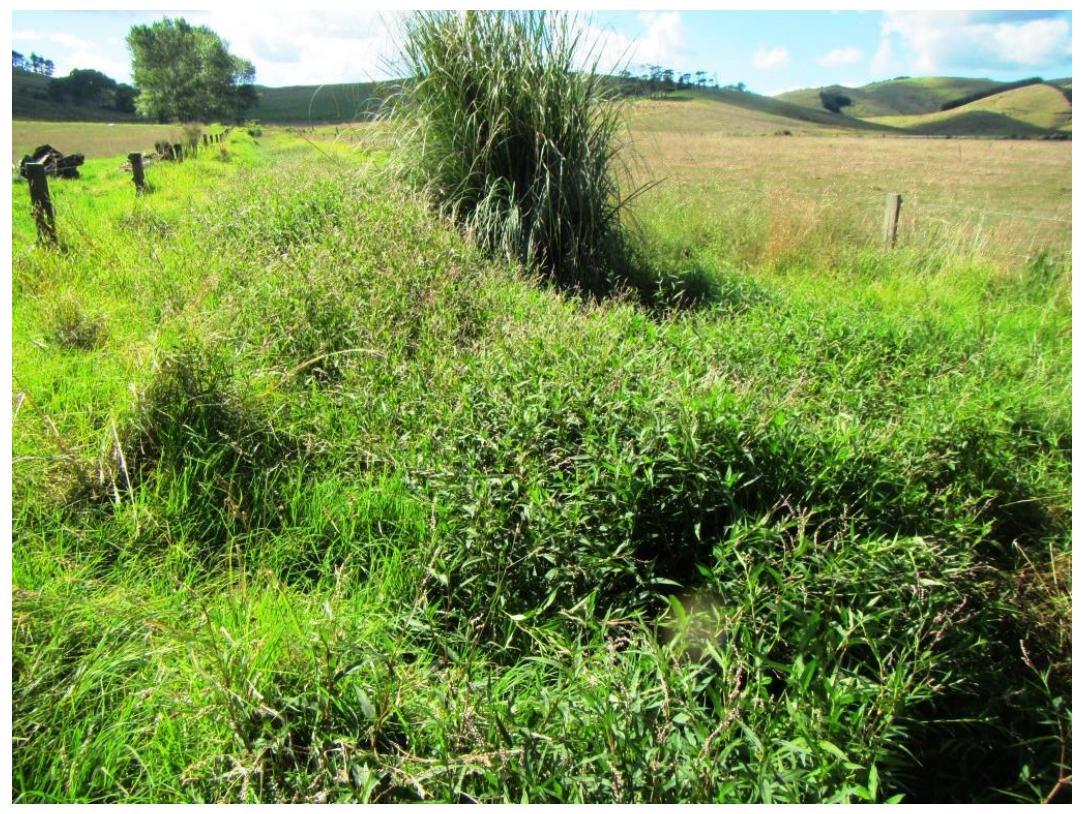
Plate 5: The discharge flow path during summer low-flow conditions, viewed looking upstream from near its confluence with the drain. The channel is densely covered with water pepper. 25 July 2014.

The discharge flow path, immediately upstream of the compliance point, flows across a wide valley floor (Appendix 1: Plate 5). At this location, there is the opportunity to create additional treatment wetlands, and these could be constructed within the bounds of the existing riparian margin from which livestock are excluded. Earthmoving machinery could be used to construct a series of bunded wetlands so that the wetted width, which is as little as 0.5 m during low flows, is increased to 3-5 m. If the bunds were created so that they formed wetlands 0.3-0.5 m deep, these wetlands could be planted with indigenous reeds (e.g. raupo (*Typha orientalis*) and sedges (*Carex* species)). Planting would not need to occur across all of the wetland area, but instead be limited to introducing the desired species into the system, and then allow for natural spread to achieve dense wetland vegetation. During low-flow conditions, when ammonia levels peak, filtering of the discharge through these wetlands could be implemented for approximately \$12,000 GST exclusive<sup>1</sup>.

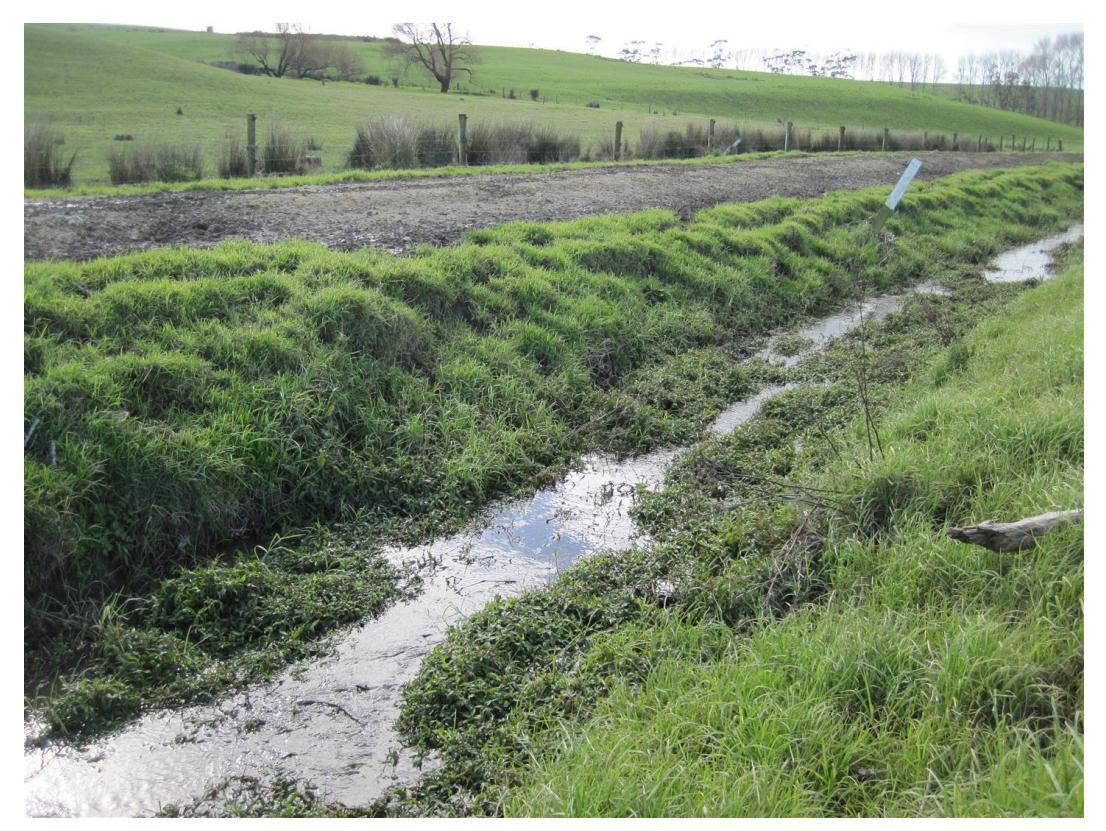
Plate 6: Drain immediately upstream of its confluence with the discharge flow path during high-flow conditions. Woody debris and pools are absent from this reach. 25 July 2014.

On 25 July 2014, the channel immediately upstream of the confluence with the discharge flow path had low to moderate flow and included runs and riffles. Wetted width was 1-2 m, with a water depth of 0.2-0.6 m (Appendix 1: Plate 6). The channel was partly shaded by patches of water pepper. This section of the drain provided habitat for inanga and common bully. Fewer fish were caught than in the discharge flow path, which may be due to the absence of pools. Eels (*Anguilla* sp.) are also likely to be present, at least during higher winter and spring flows.

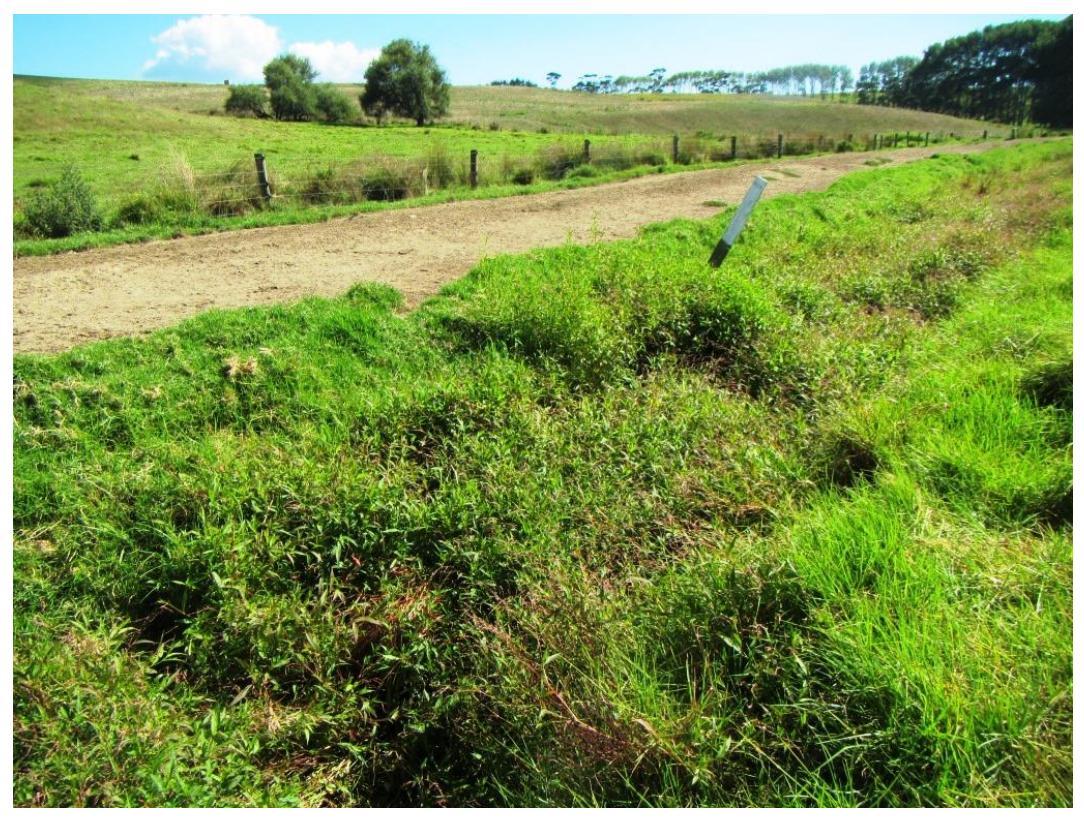
Plate 7: Drain immediately upstream of its confluence with the discharge flow path during low-flow conditions. 20 February 2015.

On 20 February 2015, surface water in the drain above the confluence was restricted to a few shallow pools 2-5 cm deep. The channel bed was choked with dense growth of water pepper (Appendix 1: Plate 7). No fish were recorded and macroinvertebrates were not sampled.

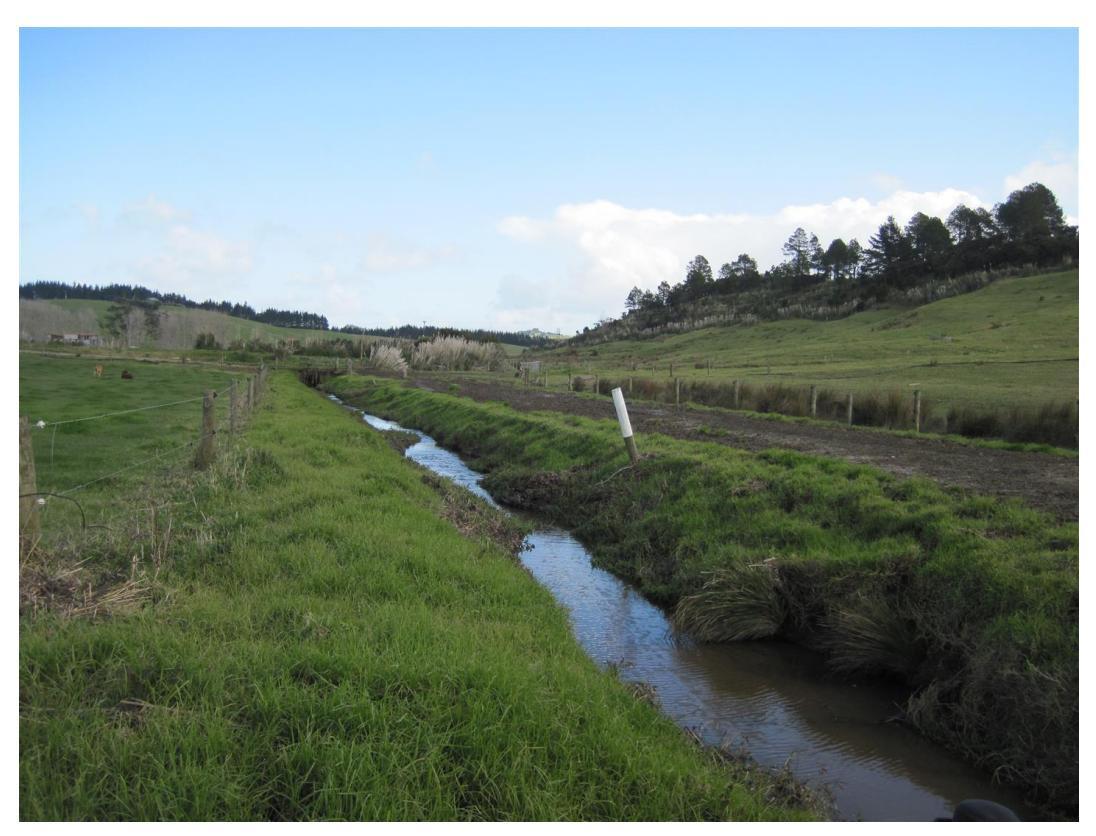
Plate 8: Drain immediately downstream of its confluence with the discharge flow path during high-flow conditions. 25 July 2014.

On 25 July 2014, the channel had slow to moderate flow and included pools and riffles. Wetted width was 1-2 m with a water depth of 0.3-1.0 m (Appendix 1: Plate 8). Water pepper covered 0.5-1.0 m of the width of the stream channel.

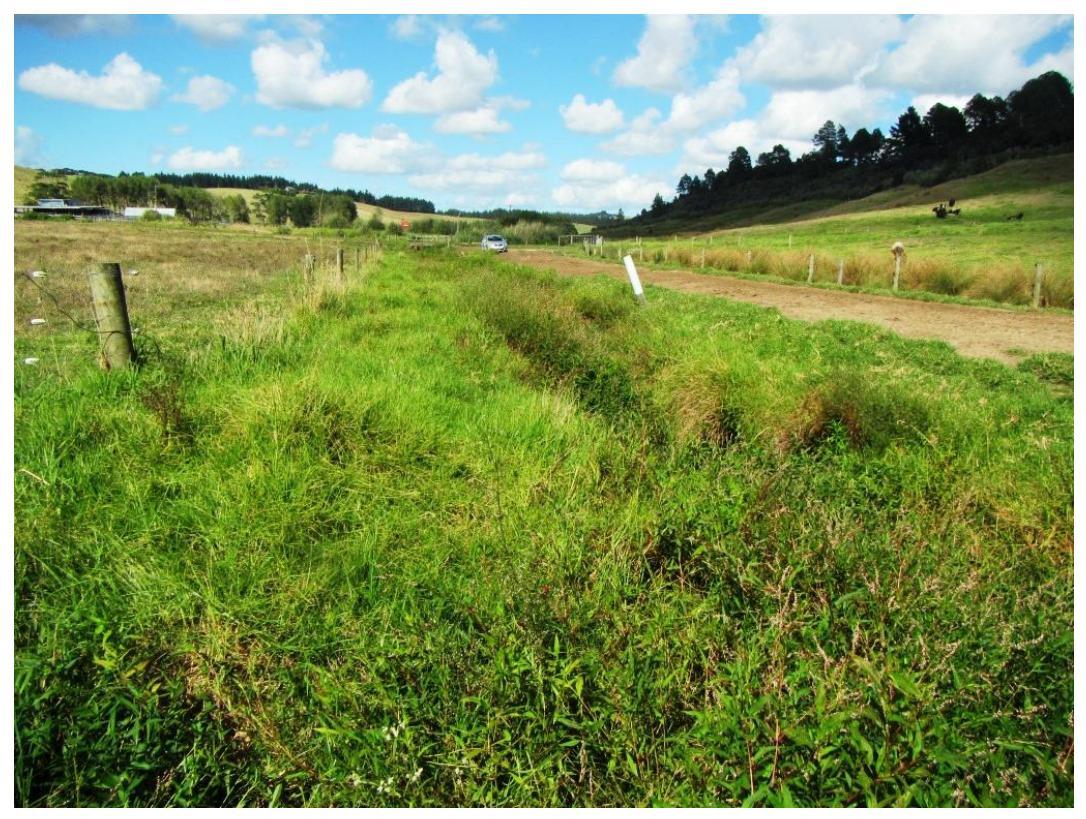
Plate 9: Drain immediately downstream of its confluence with the discharge flow path during low-flow conditions. 20 February 2014.

On 20 February 2015, the channel had very low flow and included runs and pools. Wetted width was 1-2 m with a water depth of 0.1-1.0 m. Water pepper covered the entire channel except for the deepest pools (Appendix 1: Plate 9). Gambusia (mosquitofish; *Gambusia affinis*) were abundant in the pools, and inanga were present in the pools in low numbers. One inanga was caught in one of the three Gee minnow traps. The MCI score was 80.0, indicative of fair water quality, or "probable moderate pollution".

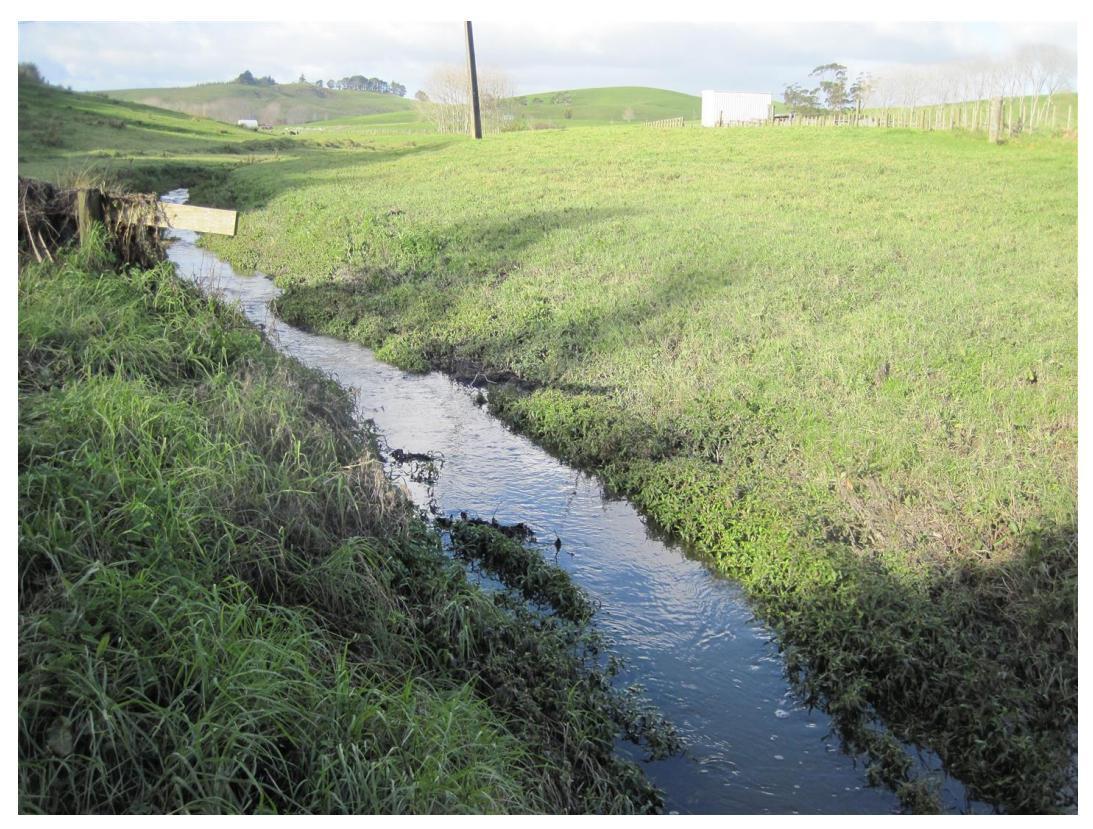
Plate 10: Stream immediately upstream of Parapara Road bridge. 25 July 2014.

On 25 July 2014, the stream included runs, riffles, and pools (Appendix 1: Plate 10). Flow was detectable in the shallow runs and riffles, but not in the pools. Upstream of the bridge, where the stream flows through pasture, wetted width was 1-3 m, water depth was 0.3-1.0 m, and water pepper covered 0.5-1.0 m of the stream width. Under the Parapara Road bridge and further downstream, livestock are excluded from both banks. The stream is shaded by overhanging vegetation and steep banks, and there are several pools of unknown depth.

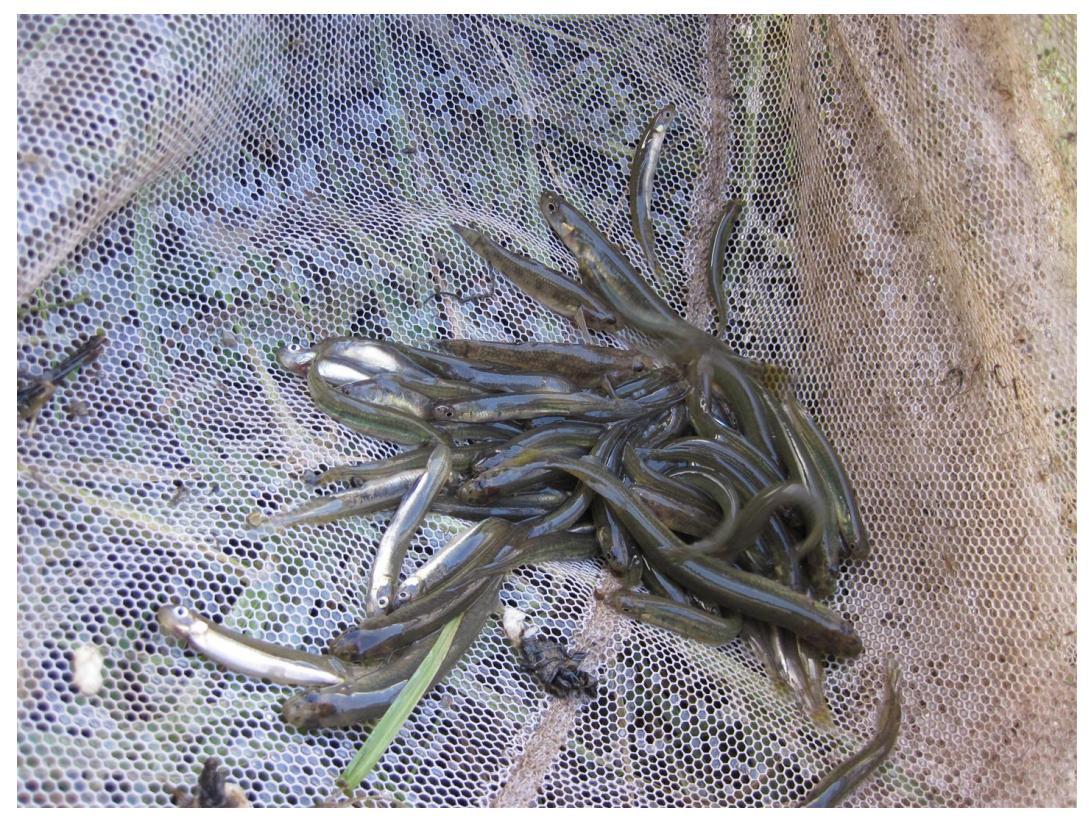
Plate 11: Inanga caught in one Gee minnow trap set by Parapara Road bridge. 25 July 2014.

The stream at this location supported an abundant population of inanga, and common bully. All Gee minnow traps caught numerous inanga (Appendix 1: Plate 11), and eels are also likely to be present. This stream is likely to also act as a migration pathway for other species of fish such as banded kokopu (*Galaxias fasciatus*) whose larvae hatch in freshwater, are swept out to sea with the downstream current and tide, and return to rivers and streams in spring.

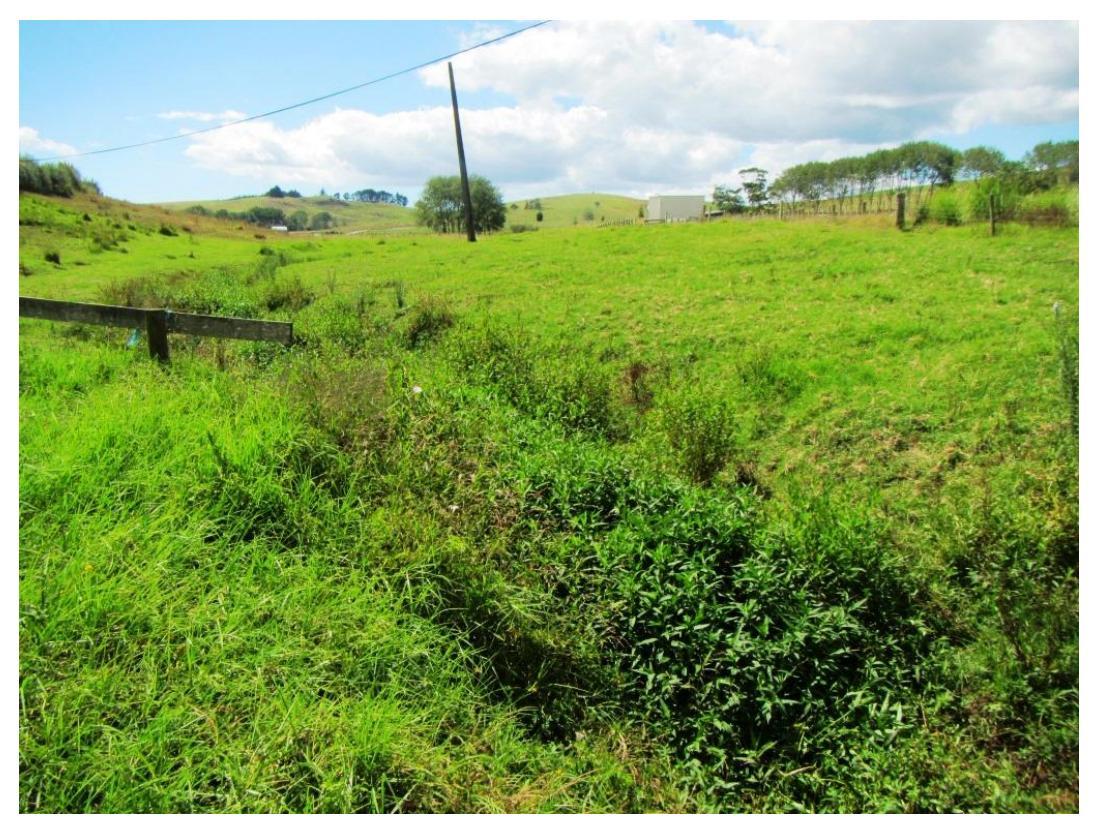
Plate 12: Stream immediately above the Parapara Road bridge during low-flow conditions. 20 February 2015.

On 20 February 2015, the stream included shallow runs and pools with low flow. Wetted width was 1-3 m, water depth was 0.2-1.0 m, and except for the deepest pools. water pepper covered the entire channel (Appendix 1: Plate 12). Inanga, mosquitofish, and koi carp (*Cyprinus carpio*) were present in the pool under the Parapara Road bridge. The MCI score was 50.5, the lowest of the three MCI sites, and indicative of poor water quality, or "probable severe pollution".
