3.28 Lake Waimimiha South (Aupouri), NRC Lake No. 137; surveyed in 2005

3.29 Lake Waipara / Dead Lake (Aupouri), NRC Lake No. 25; surveyed in 2005

3.30 Lake Waiparera (Aupouri), NRC Lake No. 102; surveyed in 2005 and 2010

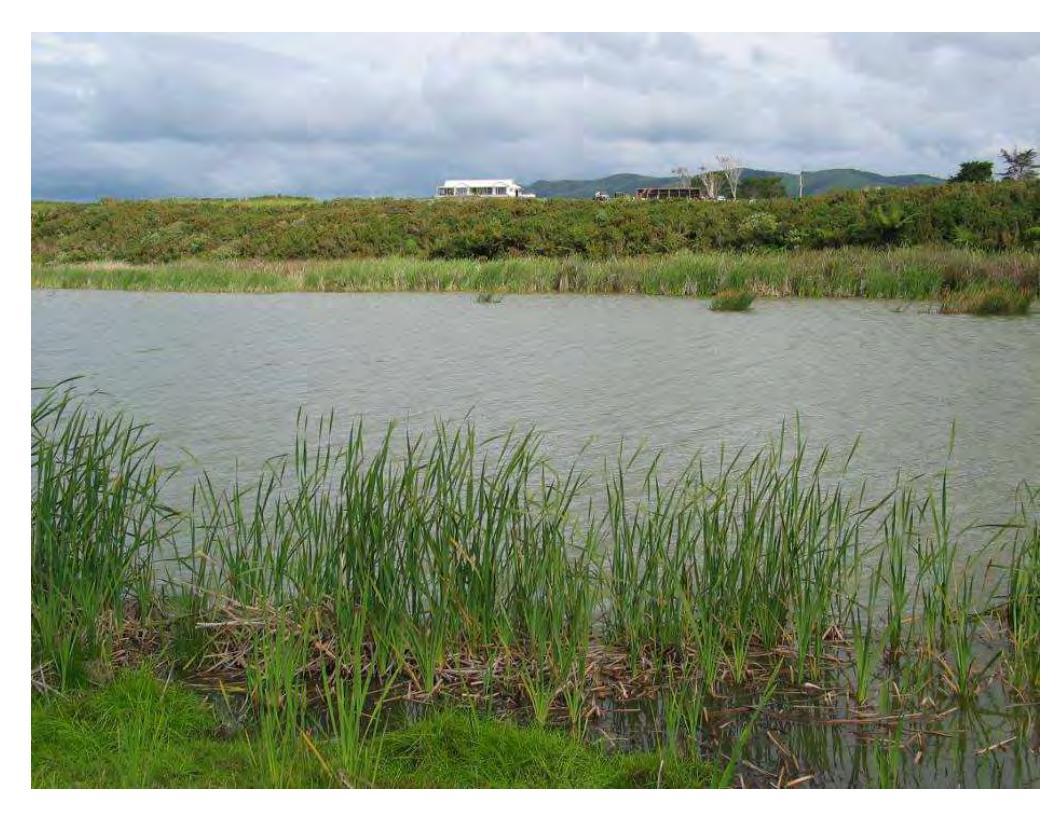
Plate: Lake Waimimiha South showing margin of emergent vegetation. Note the green tinge to the water indicating an algal bloom.

There is a dense fringe of emergent vegetation up to 10 m across comprised predominantly of *Typha orientalis*, with occasional clumps of *Eleocharis sphacelata* in deeper water. No investigation of depth of vegetation was attempted due to possibly toxic algal blooms. The problem weed *Glyceria maxima* was collected from this lake in 1988, but not seen on the reconnaissance visit.

No investigation of submerged vegetation was attempted due to possibly toxic algal blooms, however development of plants with such restricted clarity is unlikely.

No monitoring recommended.

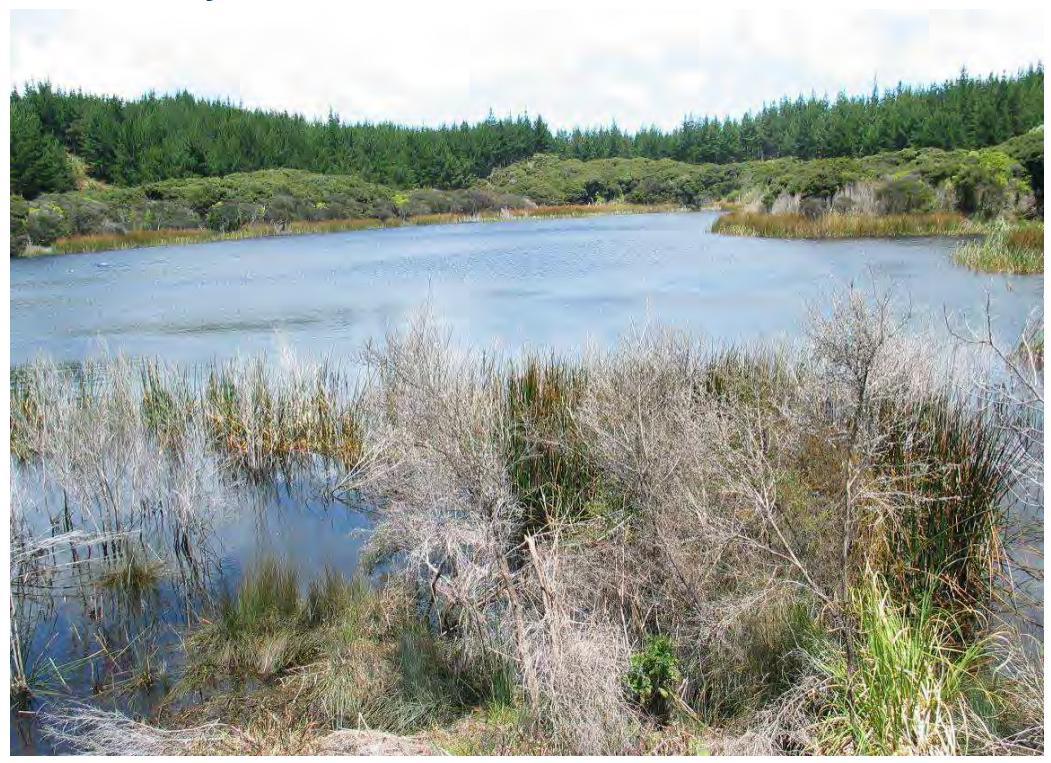
Plate: Lake Waipara showing the margin of scrub vegetation with pine forestry behind this. Note the narrow emergent zone.

The lake was ringed by a narrow (2 to 5 m wide) emergent band of *Baumea articulata* (edge to 0.5 m deep) and *Eleocharis sphacelata* (0.5 to 2 m deep).

Lake native biodiversity value monitoring every 5 years.

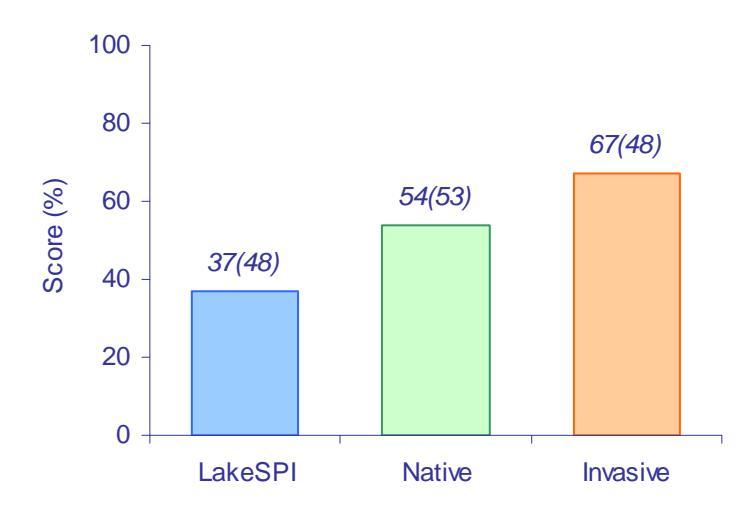
Figure: 2010 LakeSPI Index as % of potential score, Native Condition Index, and Invasive Impact Index (from left to right). 2005 score in brackets.

The low LakeSPI score of 37% reflects the increased impact (deeper growing) of the invasive alien species *E. densa* and *L. major* in 2010 compared to 2005.

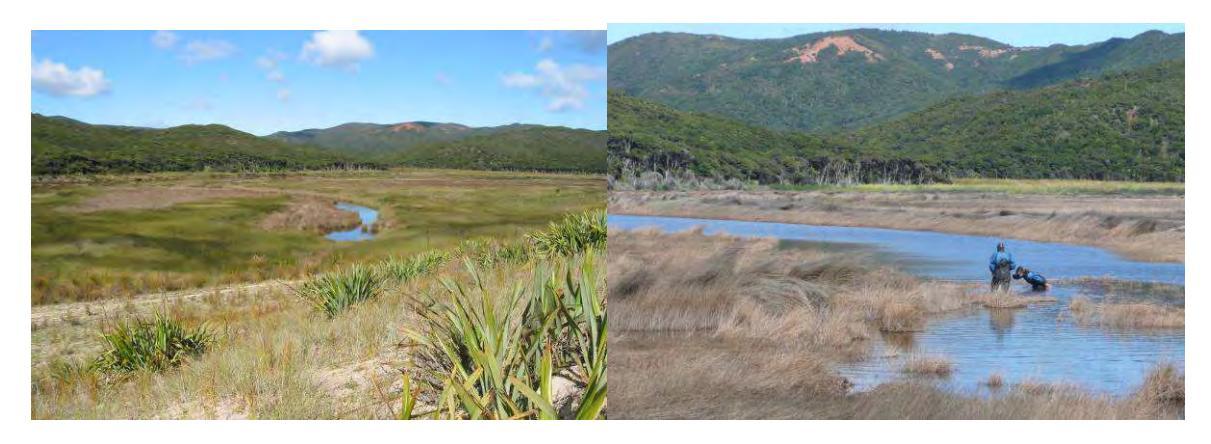
Plate 1: LEFT 2007 showing the east end of Waitahora Lagoon, showing a saline influenced wetland dominated by the green oioi (*Apodasmia similis*) and brown sea rush (*Juncus kraussii* var. *australiensis*). RIGHT 2009 showing a closer of the same area but with the oioi impacted by saltwater intrusion.

Most of the lagoon was saline with no submerged vegetation. However, some sparse vegetation (5-25% cover) was noted in 2007 in the upper channels (as shown in Plate 1). Species present included *Ruppia polycarpa, Triglochin striata, Mimulus repens* and a charophyte in the genus *Lamprothamnium*. All these species are typical from brackish areas, although the first of these plants is also relatively common in freshwater lakes. Prior to the 2007 survey one species of *Lamprothamnium* (*L. macropogon*) was recorded from the southern North Island, the South Island and Chatham (Rekohu) Island, with the northernmost record from the Whakaki Lagoon near Wairoa (Hawkes Bay). The Waitahora Lagoon plant appears to be a different species (M. de Winton pers. comm.) and has been planted to grow on to enable its identification. In 2009 the *Lamprothamnium* site had recently been affected by a saline intrusion and no submerged plants were found and surrounding rushes / sedges were brown. A channel closer to the freshwater wetland supported *Utricularia australis* growing over dead rushes / sedges.

Carry out 5 - year ecological condition monitoring.

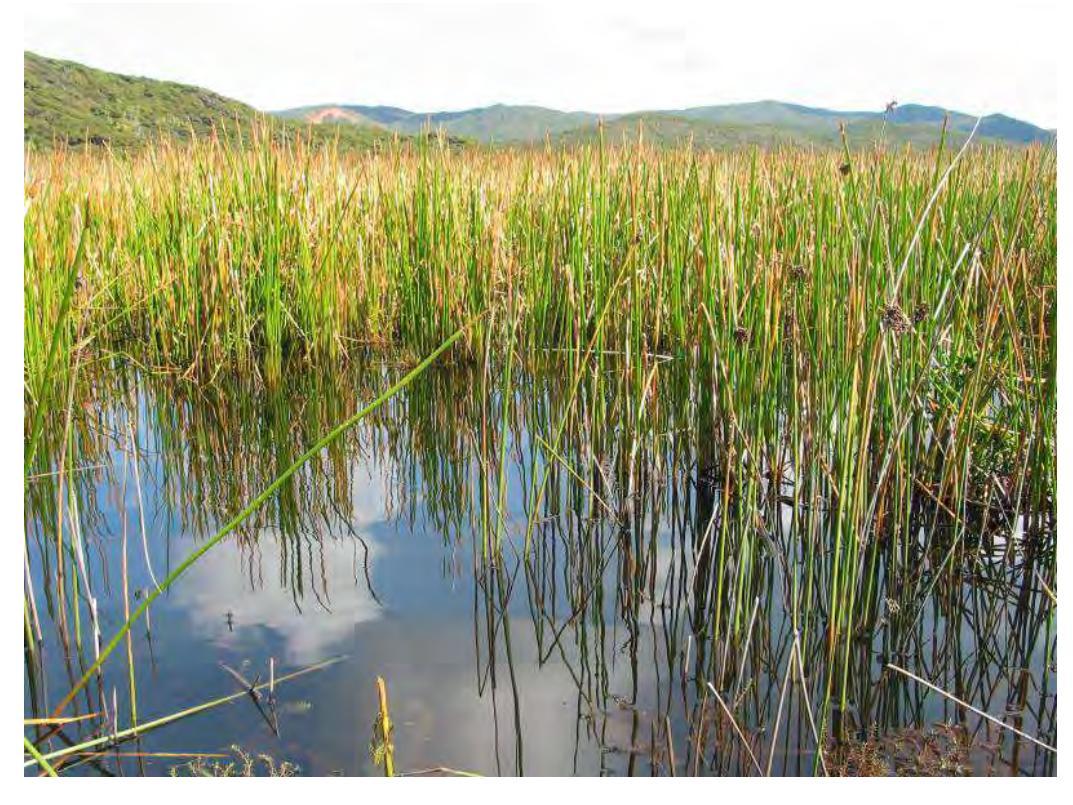
Plate 2: Freshwater lake, east of Waitahora Lagoon dominated by Eleocharis sphacelata.

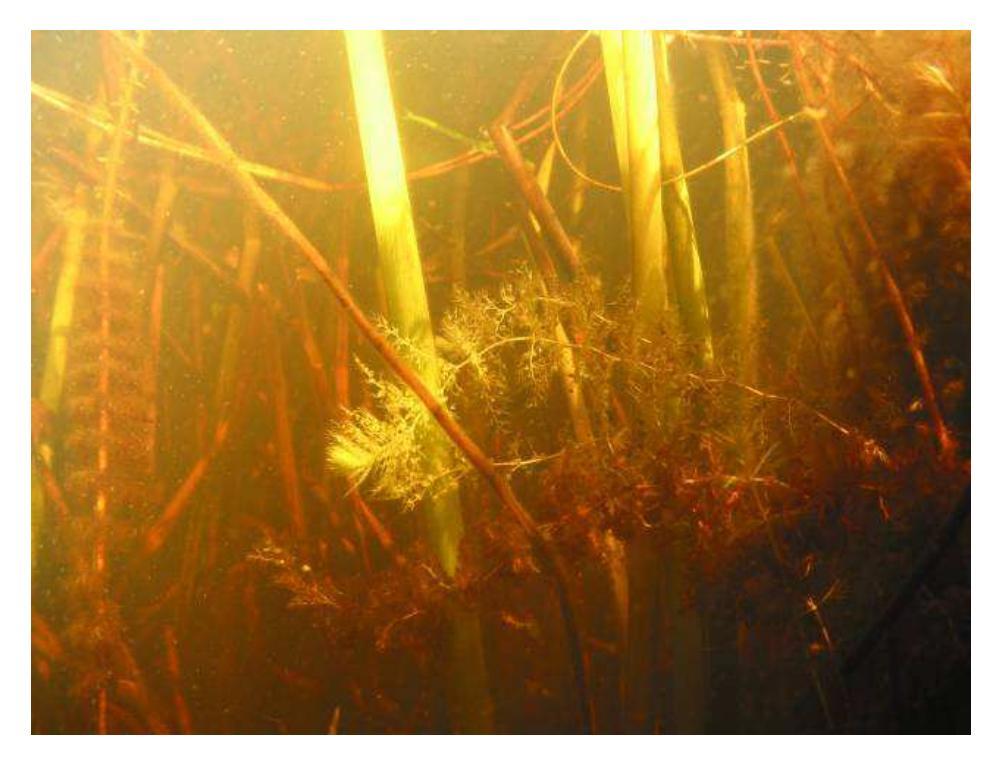
lakes. Water was tea-stained indicating high humic content (Plate 3). The lakes are accessed from the Cape Reinga Walkway some 5.5 km west of the Kapowairua Camp Ground.

Plate 3: Freshwater lake east of Waitahora Lagoon with the endangered bladderwort (*Utricularia australis* – centre) and the milfoil *Myriophyllum propinquum* (left and right) in open water amongst the culms of *Eleocharis sphacelata* (centre background).

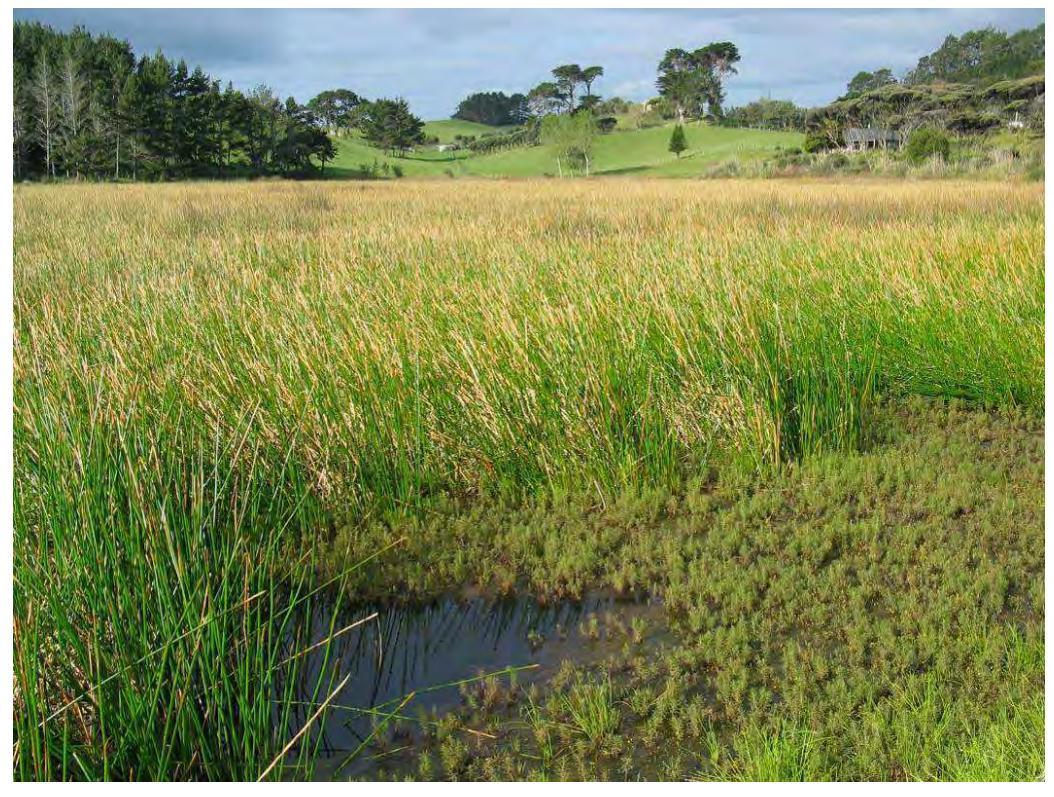
Plate: West Coast Road Lake showing emergent dominated water body with the endangered *Myriophyllum robustum* (bottom right) 2005. However (without disturbance spraying) emergents have taken over the whole lake and there is no open water and no *M. robustum* was seen in 2010.

Approximately 90% of the lake was covered with dense emergent vegetation dominated by *Eleocharis sphacelata* with local patches of the taller *Baumea articulata*. In the early 1990's *Salvinnia molesta* covered the water surface. An aerial spray programme to eradicate the *S. molesta* also reduced the cover of *E. spacelata* providing areas of open water. In 2005 the nationally endangered *Myriophyllum robustum*, a sprawling emergent species, was restricted to areas of open water amongst the taller sedges (see plate). However when visited in 2007 these plants could not be found and sedges occupied its former habitat. In 2010 the whole lake had been colonised by *E. sphacelata*.

Control some areas of *E. sphacelata* with glyphosate to provide open water habitat for growth of the endangered *M. robustum*.

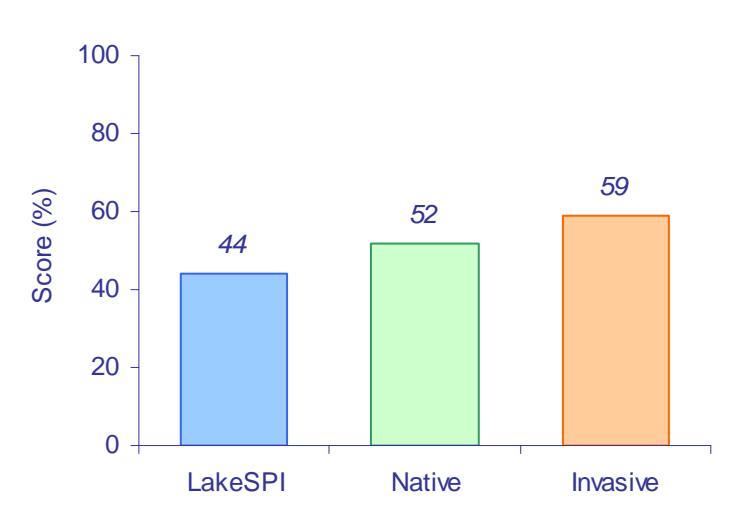
Figure: LakeSPI Index as % of potential score, Native Condition Index, and Invasive Impact Index (from left to right).

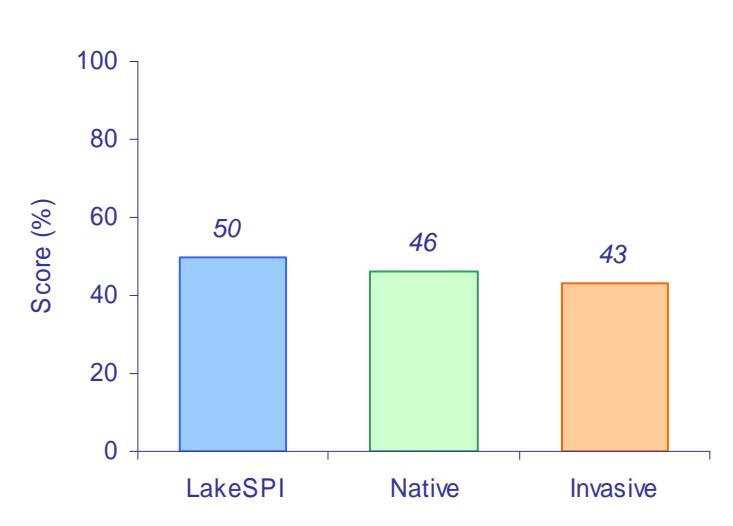
Figure: LakeSPI condition as % of potential score, native index, and invasive index (from left to right).

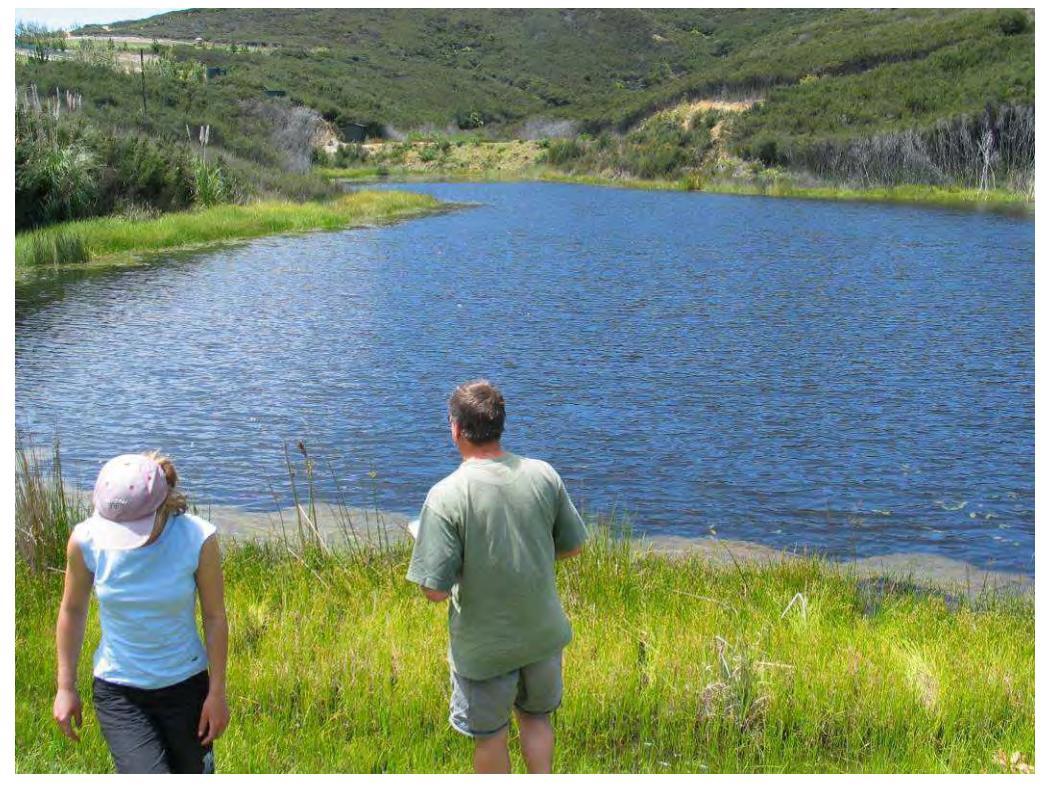
Plate: Roadside pond at Matai, note the sprawling *Isolepis prolifera* margin (light green), contiguous mat floating mats of *Utricularia gibba* around the pond (pale brown) and floating leaves of swamp lily (*Ottelia ovalifolia*).

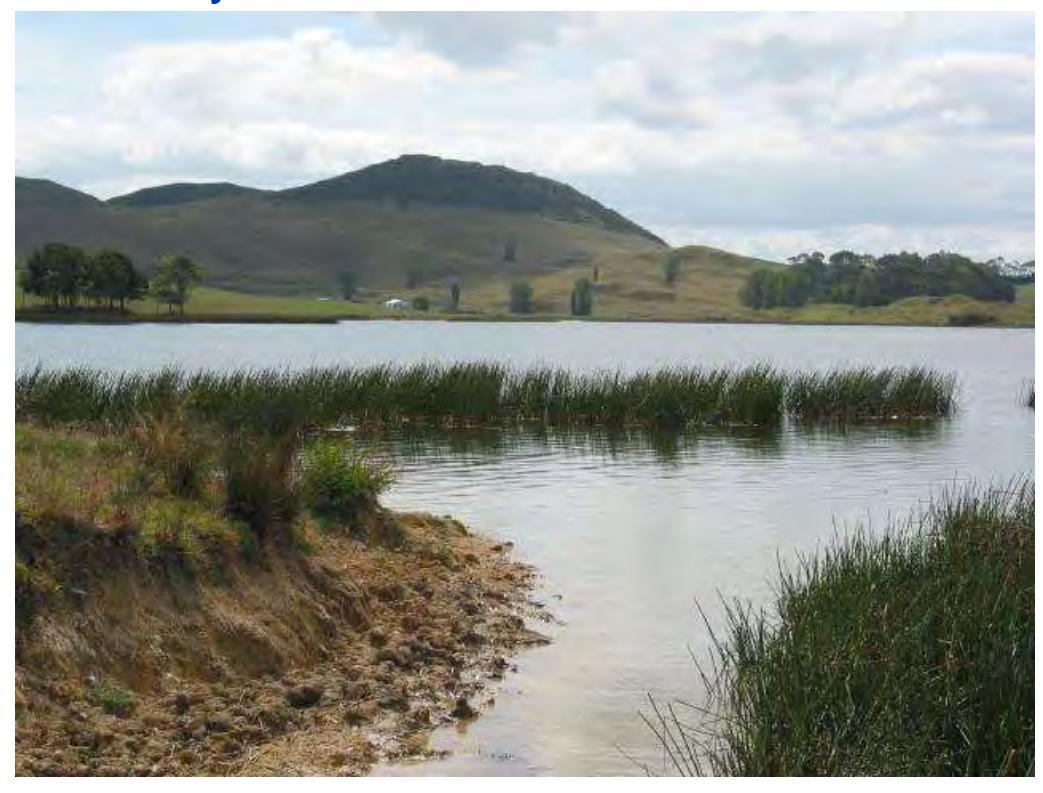
Plate: Lake Owhareiti margin showing pasture margins and emergent beds of *Eleocharis sphacelata*.

The submerged vegetation was dominated by tall beds of the exotic *Egeria densa* growing from the emergent vegetation zone to 4 m, with scattered plants to 5 m deep.

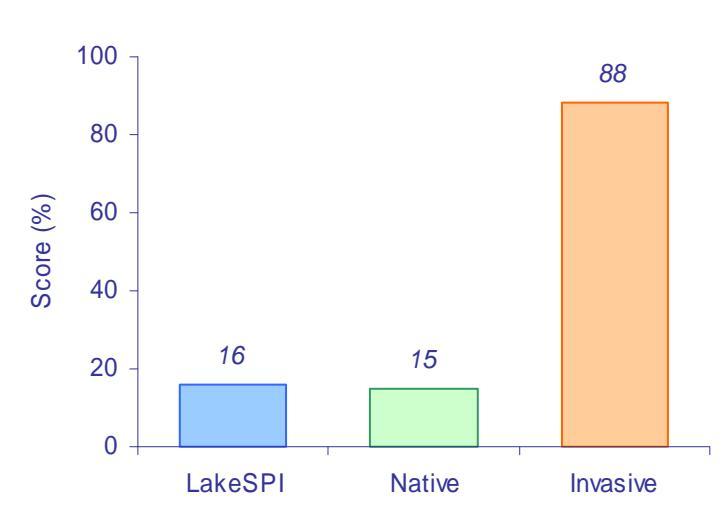
Figure: LakeSPI condition as % of potential score, native index, and invasive index (from left to right).

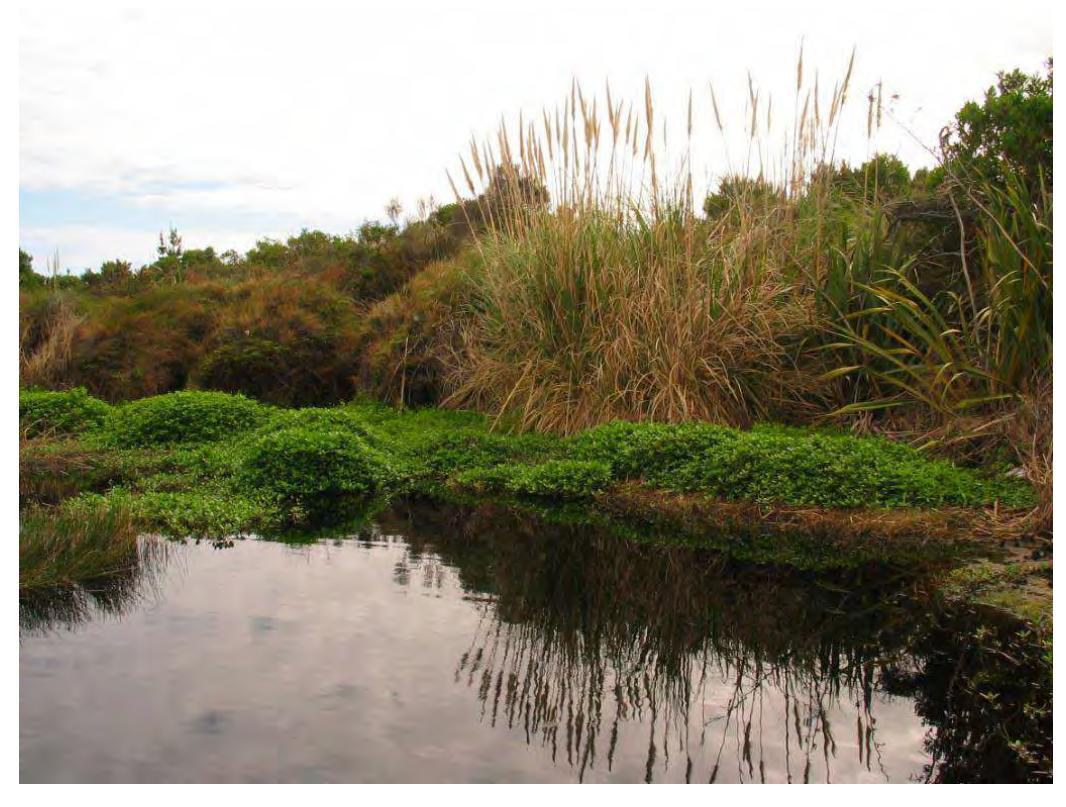
Plate: Margin of Lake Rotokawau East showing floating mats of the pest plant alligator weed (*Alternanthera philoxeroides*) with clumps of wire rush (*Empodisma minus*) (left), pampas (*Cortederia selloana*) (mid-right) and flax (*Phormium tenax*) (right) in the marginal vegetation behind this. Note the humic-stained water.

There was a narrow fringe of emergent vegetation around much of the lake, mostly < 5 m across. Large floating rafts of the exotic alligator weed (*Alternanthera philoxeroides*) were noted around the access point. These were interspersed with clumps of *Eleocharis acuta, Baumea juncea, Schoenoplectus tabernaemontani, Typha orientalis, E. sphacelata* and *Phormium tenax.* Immediately adjacent to this was bog/heath vegetation dominated by the regionally significant *Empodisma minus, Gleichenia dicarpa, Schoenus brevifolius* and the scrub weeds, gorse and pampas. The endangered ferns and fern ally, *Todea barbara, Cyclosorus interuptus* and *Lycopodiella serpentina* were reported from this marginal area.

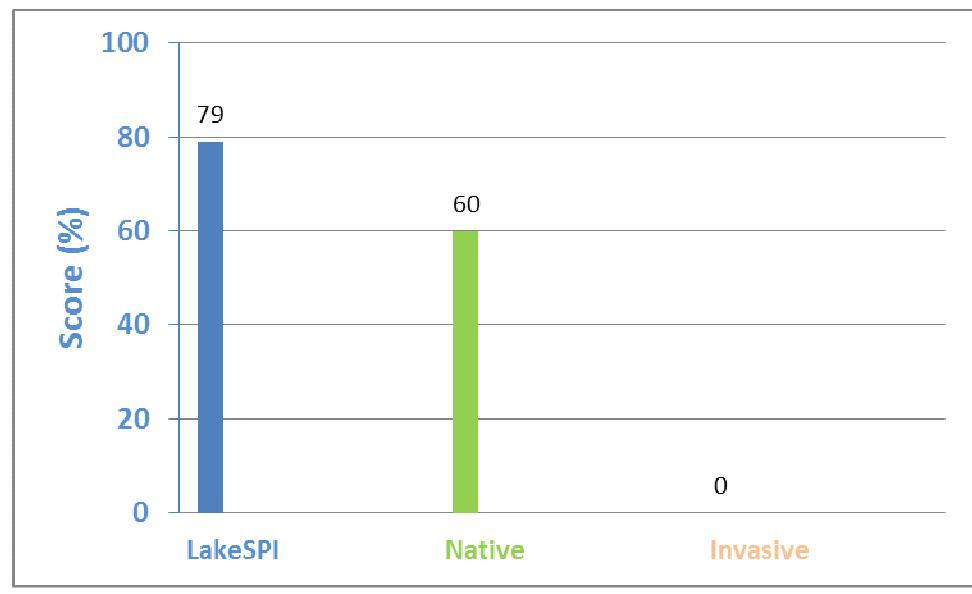
Figure: LakeSPI Index for Lake Tauanui as % of potential score, Native Condition Index, and Invasive Impact Index (from left to right).
