Northland Lakes Annual Report 2018

Prepared for Northland Regional Council

NIWA CLIENT REPORT No:	2018220HN
Report date:	July 2018
NIWA Project:	NRC18203

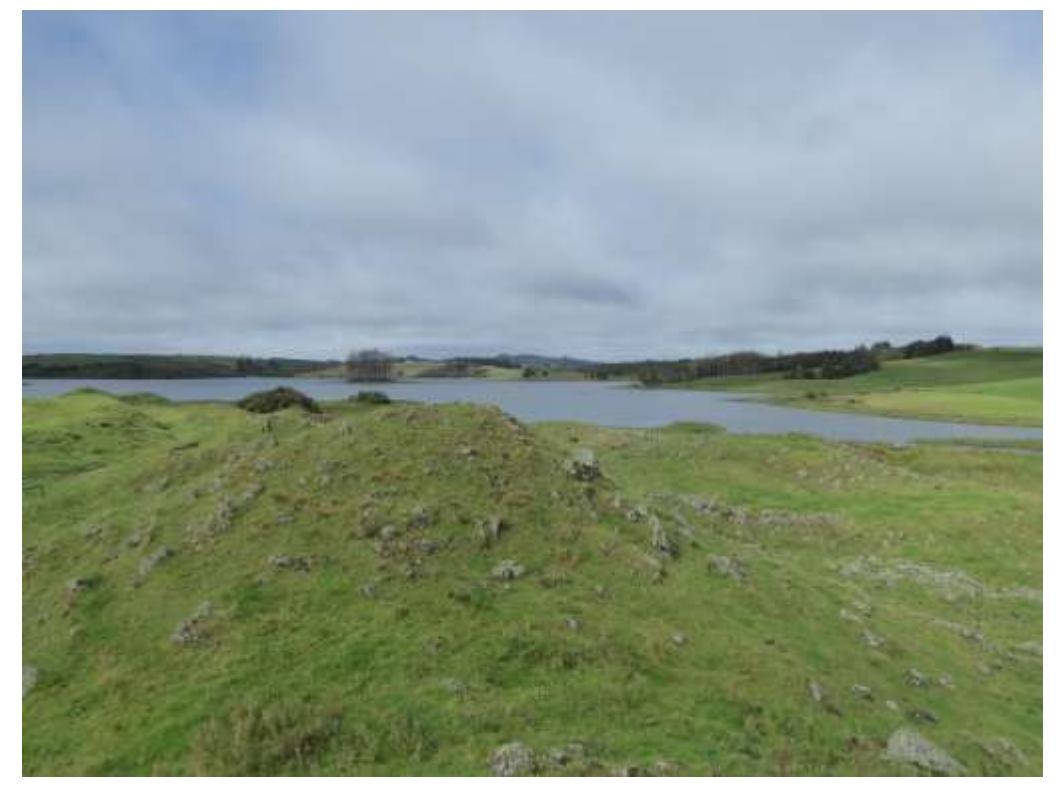
Figure 3-2: Lake Owhareiti. Photo taken from the north to show the main basin and pastoral catchment on volcanic soils. (Photo: Paul Champion 30 April 2018)

There was a fringe of emergent vegetation around much of the lake, 5-10 m across to 2.5 m deep. It was dominated by *Eleocharis sphacelata* with lesser amounts of *Machaerina articulata* and *Schoenoplectus tabernaemontani* (first recorded in 2018). There was cattle access to much of the lake, with several fences collapsed or broken.

No monitoring is recommended.

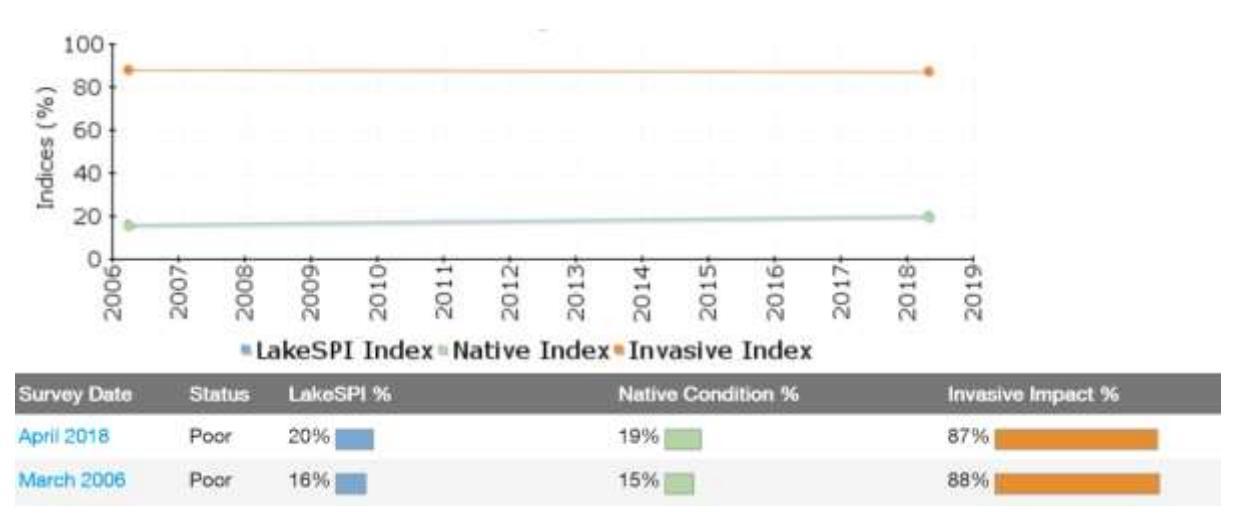
Lake Owhareiti Submerged Plant Indicators

Egeria also was the dominant submerged species in 2018, growing to a maximum depth of 6.1 m. Scattered native plants included *Potamogeton ochreatus, P. cheesemanii, Myriophyllum propinquum* and *Chara australis,* along with the invasive *Utricularia gibba,* with the turf species *Gratiola sexdentata, Glossostigma elatinoides* and *Lilaeopsis novae-zelandiae* found in areas lacking tall emergent vegetation.

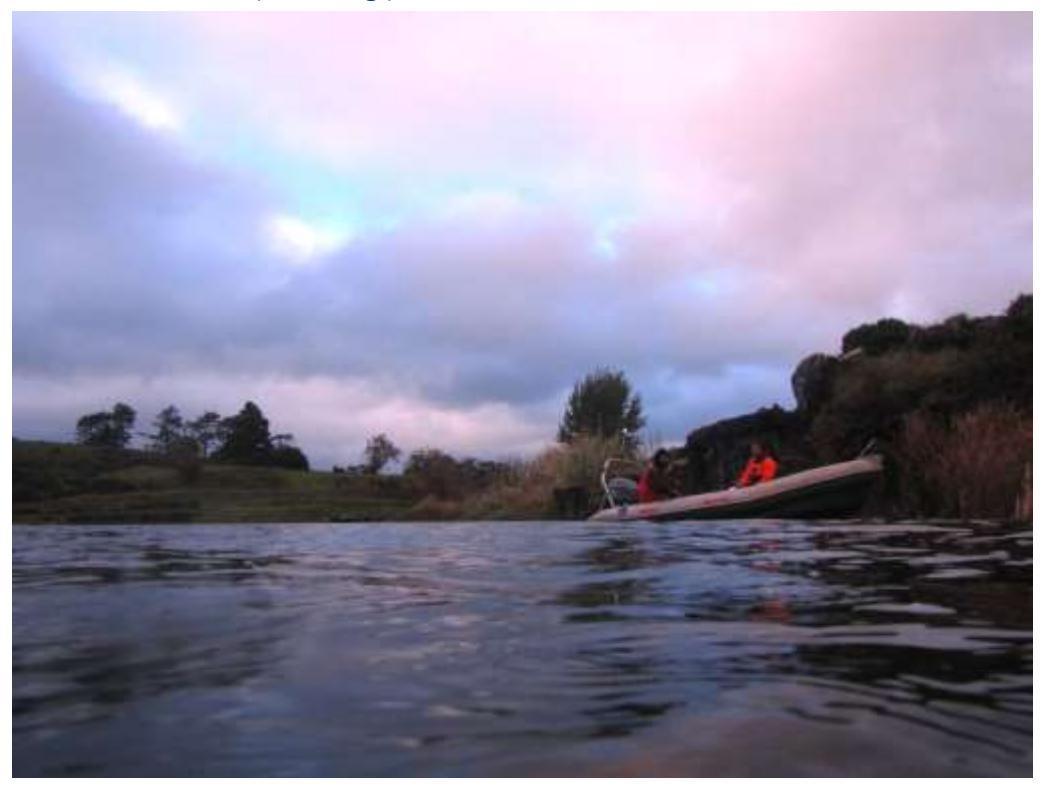
Figure 3-3: Lake Waro. A lake frequently used for contact recreation, particularly swimming. (Photo: Aleki Taumoepeau 30 April 2018)

In 2018, vegetation had recolonised to 6.4 m at one transect and over 5 m in the others. *Egeria densa* dominated throughout the depth range, with *Potamogeton cheesemanii* and *Myriophyllum propinquum* at each profile, with scattered *Potamogeton ochreatus* and a deep water bed of *Nitella* sp. aff. *cristata*, at one site. *Utricularia gibba* had declined in range and abundance, and was only noted at one transect with low covers from the emergent zone to 3.1 m deep.

Water quality is threatened by stratification and anoxic bottom waters releasing nutrients from sediments. Dense growths of *E. densa* will add more organic matter to the lake increasing BOD. There may also be other significant catchment sources of nutrients to the lake that require investigation. The ease of access to this lake gives it a relatively high likelihood of additional submerged weed transfer. Species such as hornwort would drastically impact the lake. Alligator weed would also spread and dominate marginal vegetation. Further nutrient enrichment could render the lake a health hazard to swimmers and dense beds of egeria pose a drowning risk.

This lake has moderate to low ecological value and is not recommended for regular ecological health monitoring. However, the lake is becoming more degraded and may require management if the lake is still to be recommended for recreational uses. Perhaps control of submerged weeds could be contemplated using grass carp and water quality and *E. coli* level monitoring continued to assess potential human health hazards.

Remove the Arundo donax before it dominates the riparian margins of this lake.

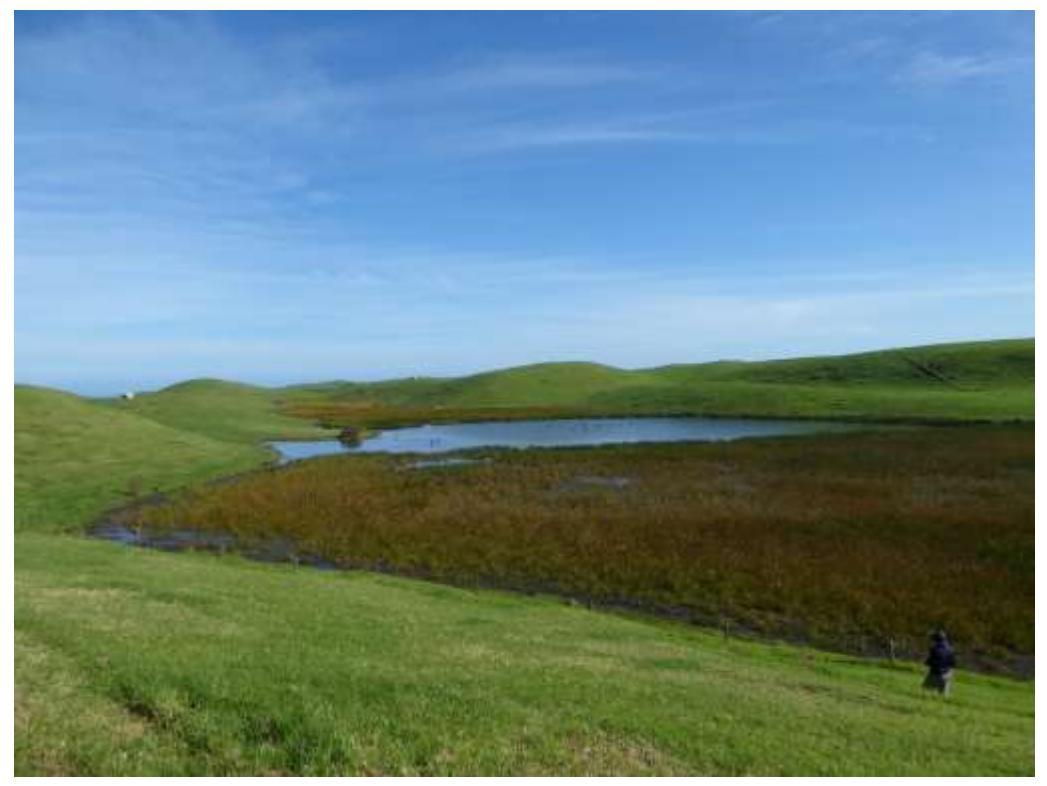
Figure 3-4: Freidrich's Lake. Photo shows the artificially maintained area of open water evidenced by the straight line of emergent kuta (Photo: Paul Champion 4 May 2018).

Kuta (*Eleocharis sphacelata*) was the dominant emergent vegetation and would entirely fill the lake if the owner did not maintain open water, presumably for duck shooting. Biodiversity has been enhanced by this action as it creates habitat for submerged species. The invasive alligator weed (*Alternanthera philoxeroides*) was well established amongst marginal kikuyu (*Cenchrus clandestinum*). The introduced spike sedge *Eleocharis* sp., previously noted on the floodplains of the Northern Wairoa and Kaihu Rivers, was found here for the first time in 2018.

No regular monitoring for lake native biodiversity value required.

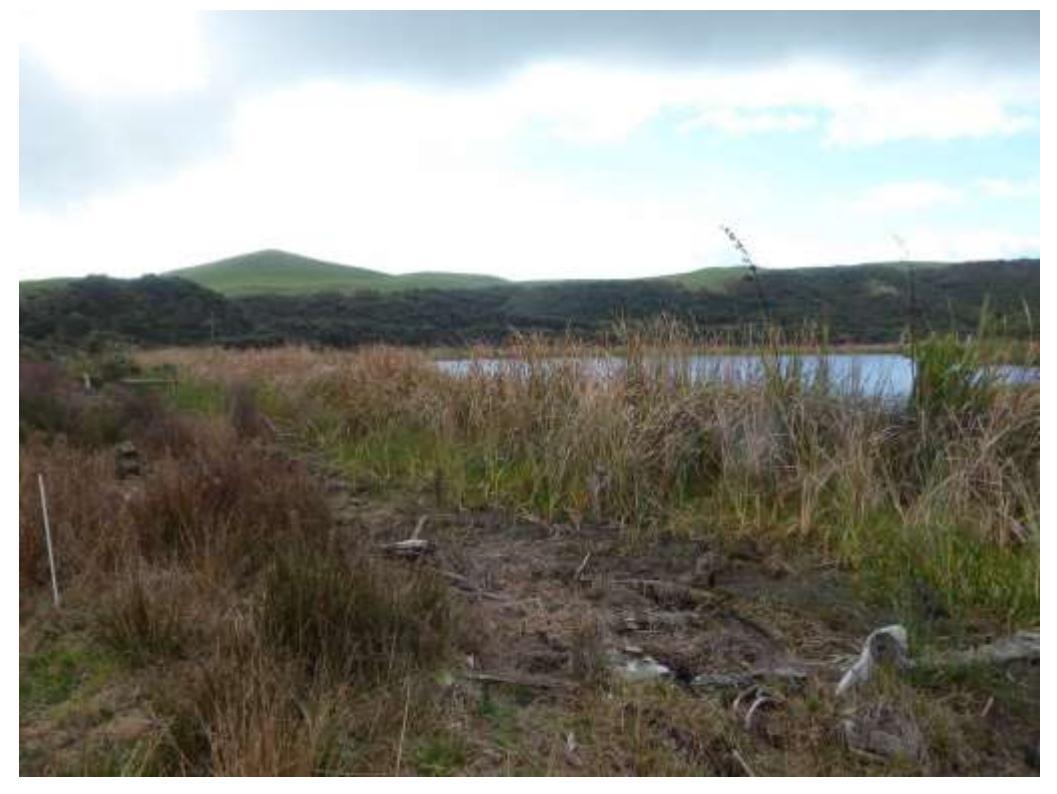
Figure 3-5: Greer's Lake. Photo shows the entire emergent margin and regenerating forest within the catchment (Photo: Paul Champion 2 May 2018).

Raupo (*Typha orientalis*) was the dominant emergent vegetation, with associated harakeke (*Phormium tenax*), *Machaerina rubiginosa, Isolepis prolifera, Persicaria decipiens, Ranunculus amphitrichus* and *Isachne globosa*. This vegetation formed a complete almost 20 m band surrounding the lake, to a depth of 1.5 m. The wetland further away from the emergent vegetation was dominated by *Juncus* rushland, with four species noted including *Juncus pauciflorus*.

Conduct a full ecological assessment, with fish surveys (targeting mudfish) and assessment of water quality is also advocated.

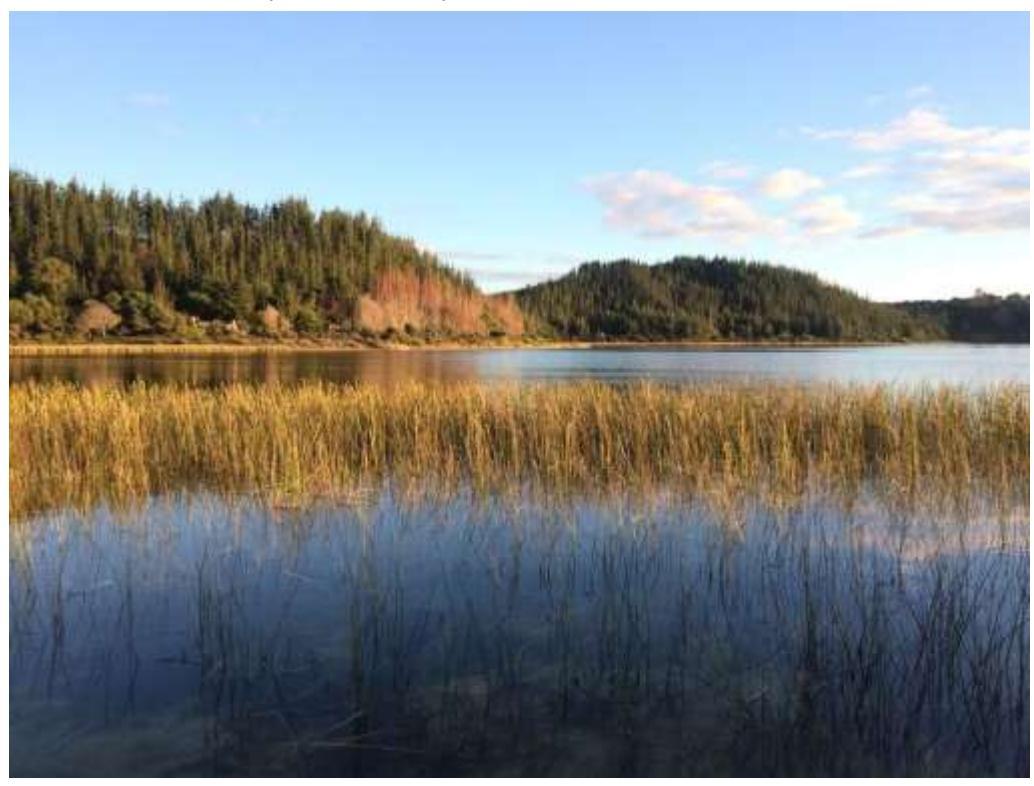
Figure 3-6: Lake Kai-lwi. with emergent *Machaerina arthrophylla* in the immediate foreground, then a zone of kuta (*Eleocharis sphacelata*) (Photo: Lisa Forester, NRC 2 May 2018).

Most of the lake had a 3 - 10 m wide margin of emergent vegetation, with dense oioi (*Apodasmia similis*) and occasional *Schoenus brevifolius* closest to the terrestrial margin and *Machaerina arthrophylla* (especially on the exposed eastern shore). *Machaerina articulata* and *M. juncea* were common in shallow water up to 0.7 m deep and an outer zone of *Eleocharis sphacelata* extended up to 2.6 m deep on one transect. One patch of raupo (*Typha orientalis*) was noted for the first time in 2014. This could indicate a local source of nutrient enrichment. Small saplings of the conifer pond cypress (*Taxodium distichum* var. *imbricarium* (syn. *T. ascendens*)) were noted amongst the oioi on the eastern shoreline. This is the first known naturalised record of this plant.

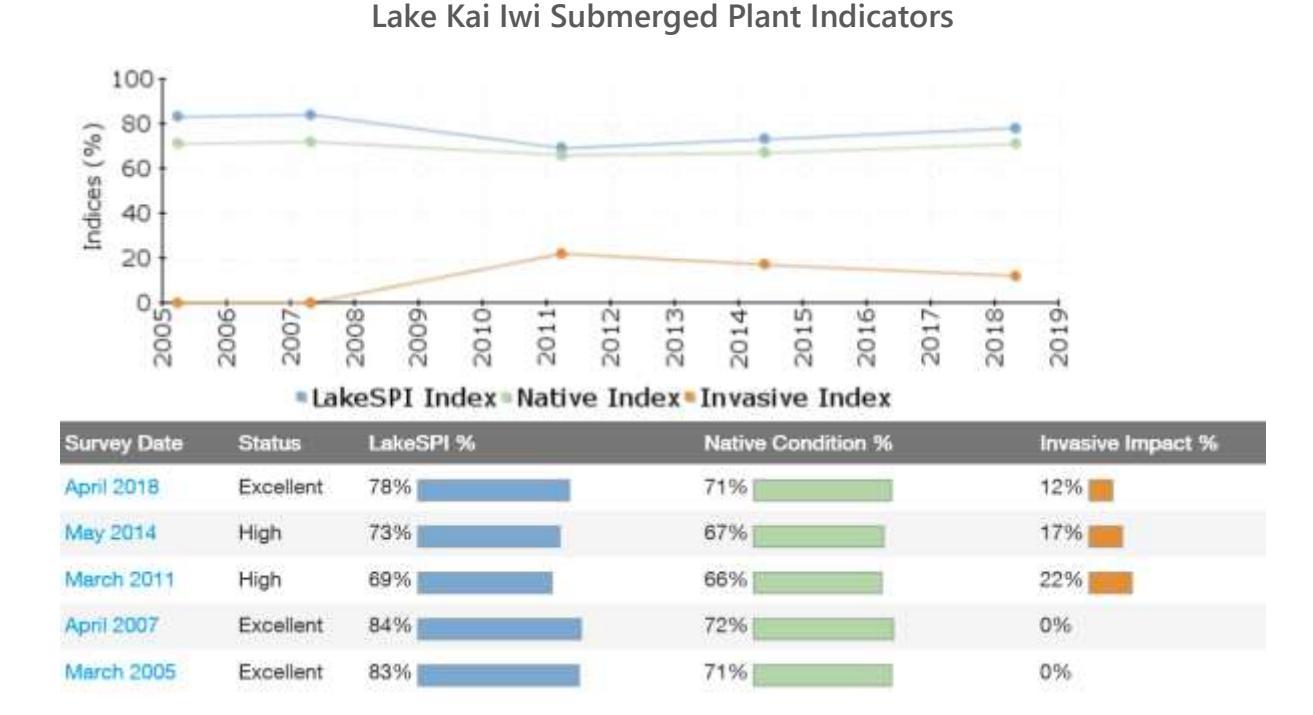
The 2018 LakeSPI score saw a return to the 'Excellent' status after two subsequent monitoring occasions with 'High' status. This increase in status reflected the increased extent of charophyte vegetation and apparently reduced *U. gibba* presence and impact (reduced from 22% in 2011 to 17% in 2014 to 12% in 2018).

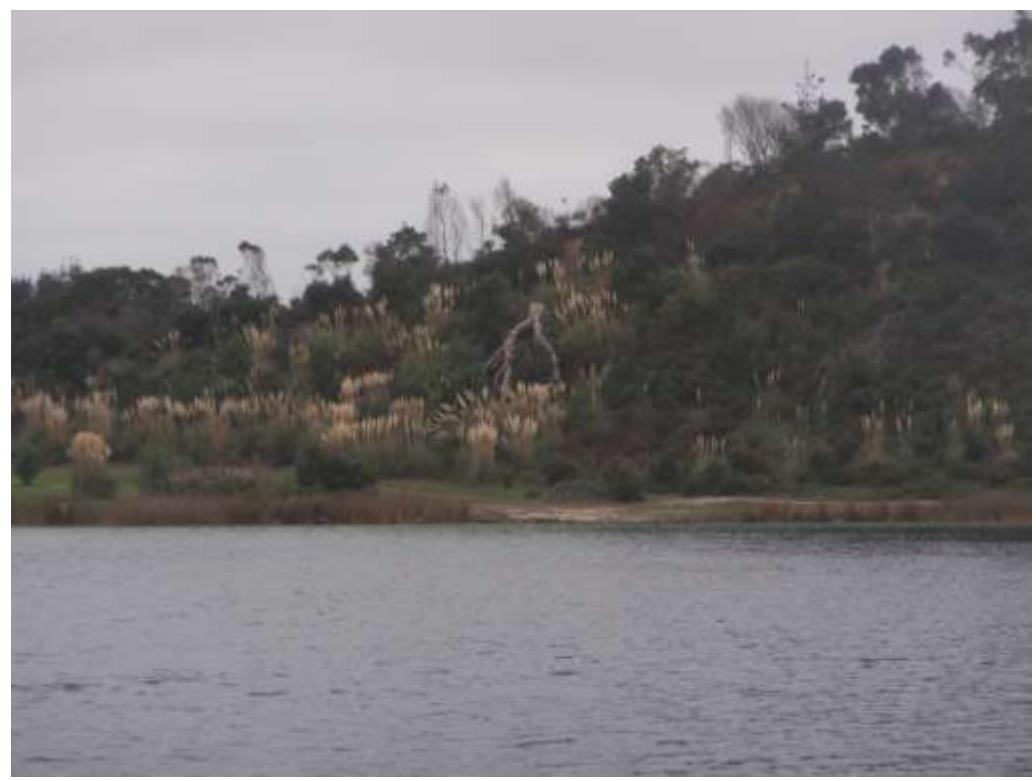
Figure 3-7: Southern shoreline of Lake Taharoa. The photo shows oioi (*Apodasmia similis*) on the shoreline and pampas (*Cortaderia selloana*) in the area previously under pine plantation forest (Photo: Aleki Taumoepeau 2 May 2018).

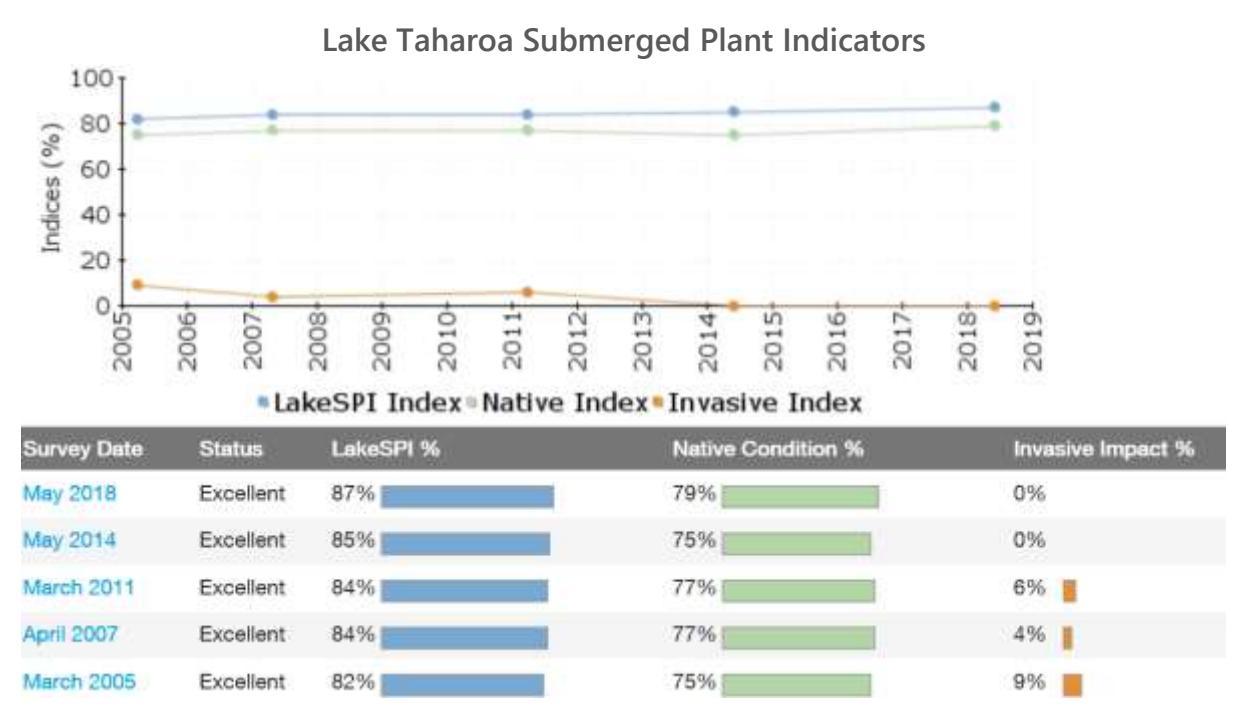
An 'Excellent' LakeSPI score of 87% reflects the depth extent of vegetation, the predominance of the native charophyte community and lack of impact by invasive exotic plants. LakeSPI condition remains very stable.

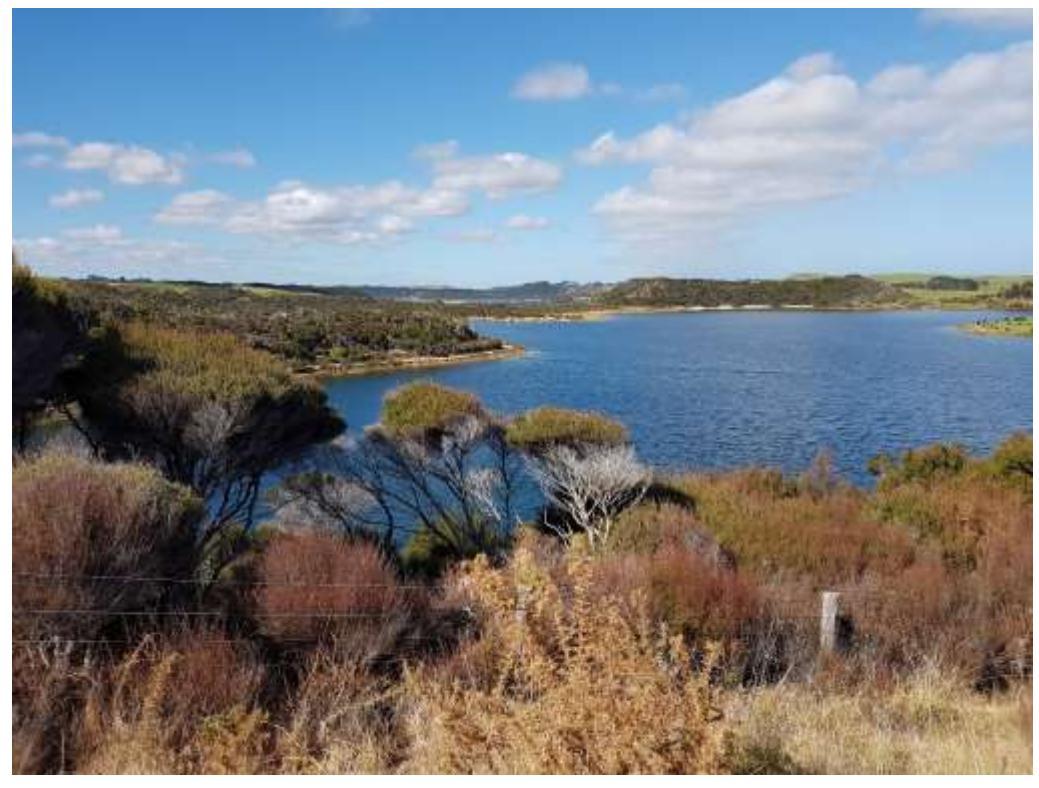
Figure 3-8: Lake Waikare. Photo taken from the ridge between this and Greer's Lake to the west (Photo: Paul Champion 2 May 2018).

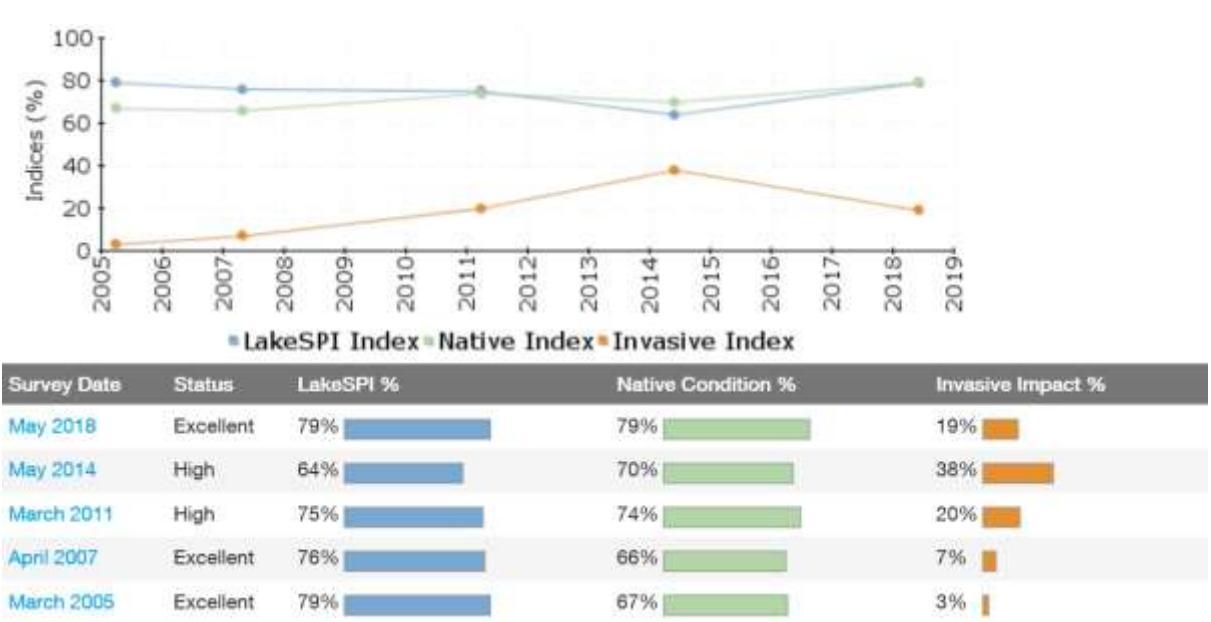
Lake Waikare Submerged Plant Indicators

The 2018 LakeSPI score saw a return to the 'Excellent' status after two subsequent monitoring occasions seeing this reduce to 'High' status. This increase in status reflected the increased extent of charophyte vegetation and loss of the high cover, deep-water *U. gibba* mats, with Invasive Impact Index reduced from 38% in 2014 to 19% in 2018. Native Condition and LakeSPI indices have increased to scores seen in the early 2000's.

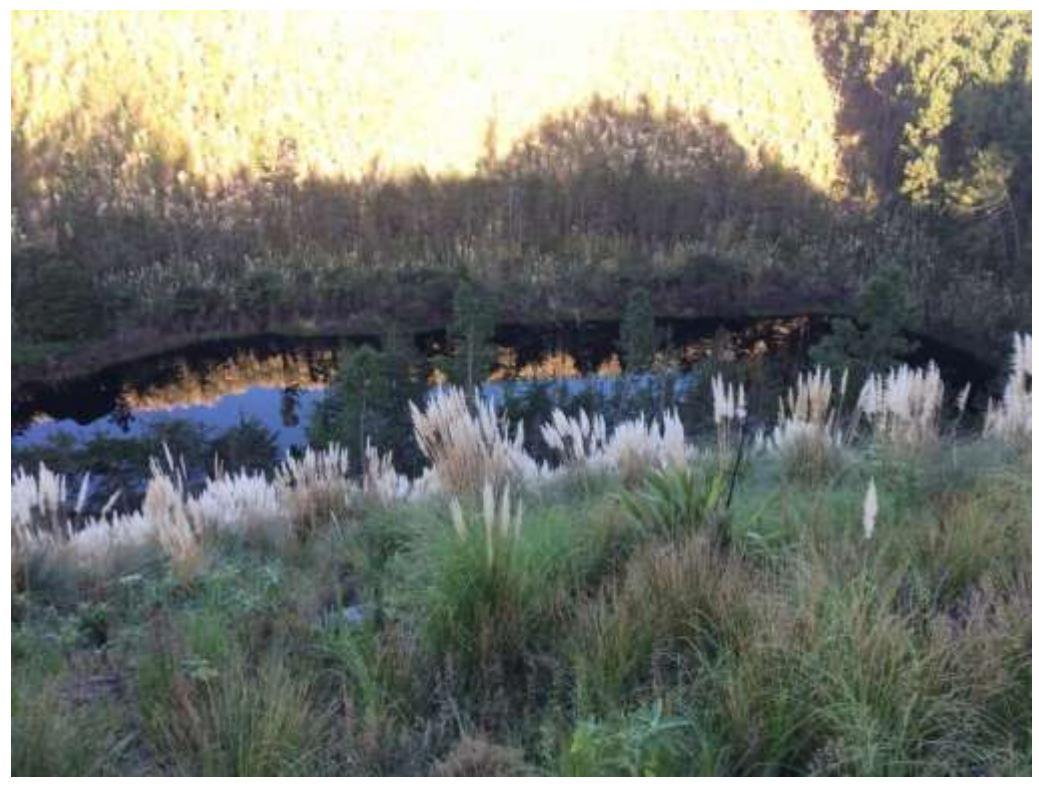
Figure 3-9: Lake Waingata. Photo from the west, showing the steep, pampas dominated catchment (Photo: Lisa Forester, NRC 3 May 2018).

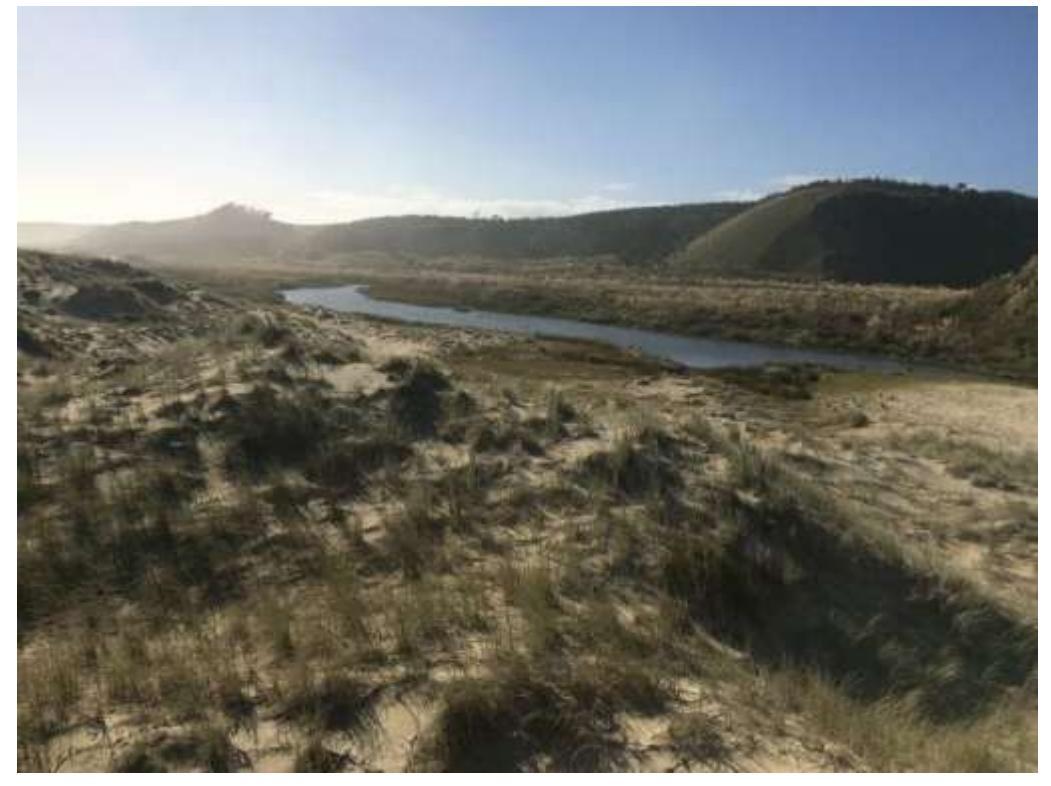
Figure 3-10: Waipoua Lagoon South. Photo taken from the southern end (Photo: Lisa Forester, NRC 3 May 2018).

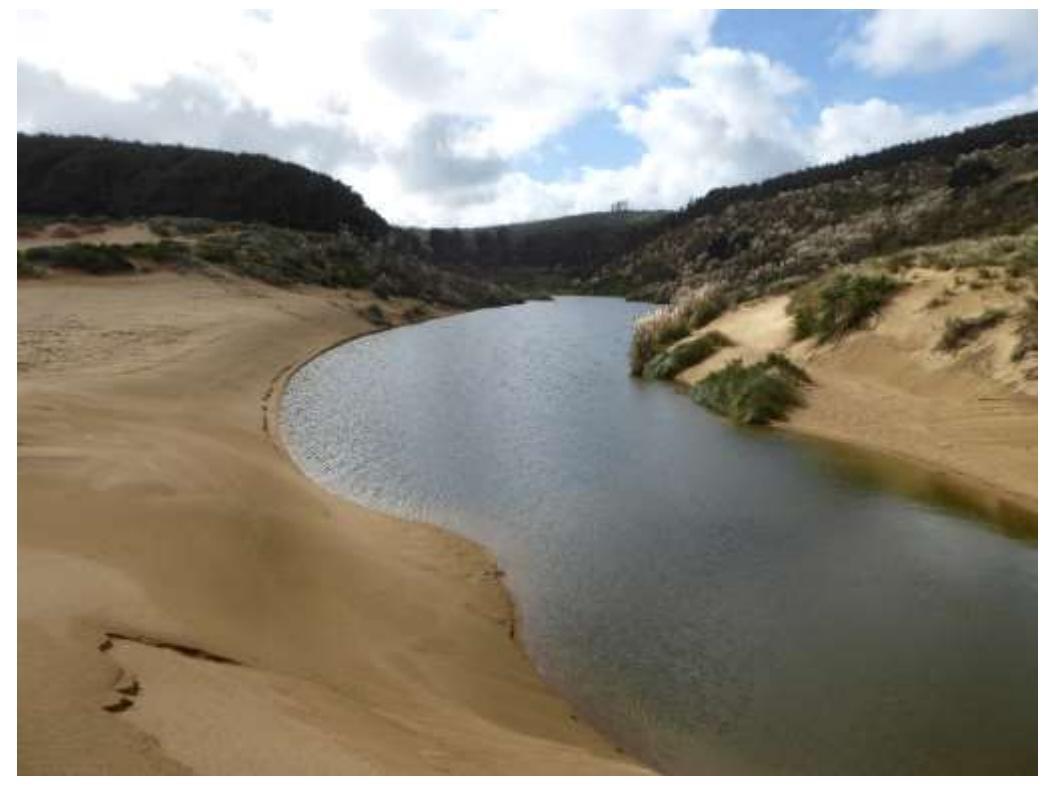
Figure 3-11: Waipuna Lake. Viewed from the west, note mobile dunes at the western end and scrub vegetation further east (Photo: Paul Champion 1 May 2018).

An isolated lake that is difficult to access, but further information on biota and water quality is required to assign a full ecological condition score. Five yearly monitoring is recommended.

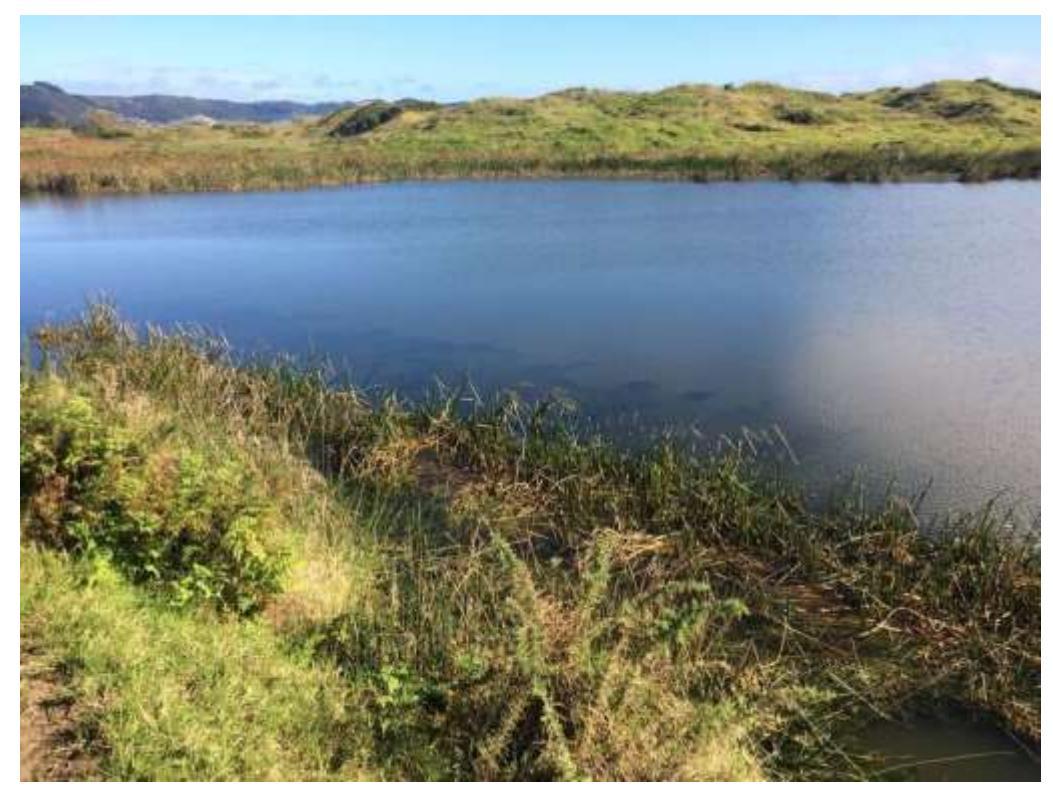
Figure 3-12: Lake Rototuna. Viewed from the south (Photo: Lisa Forester, NRC 4 May 2018).

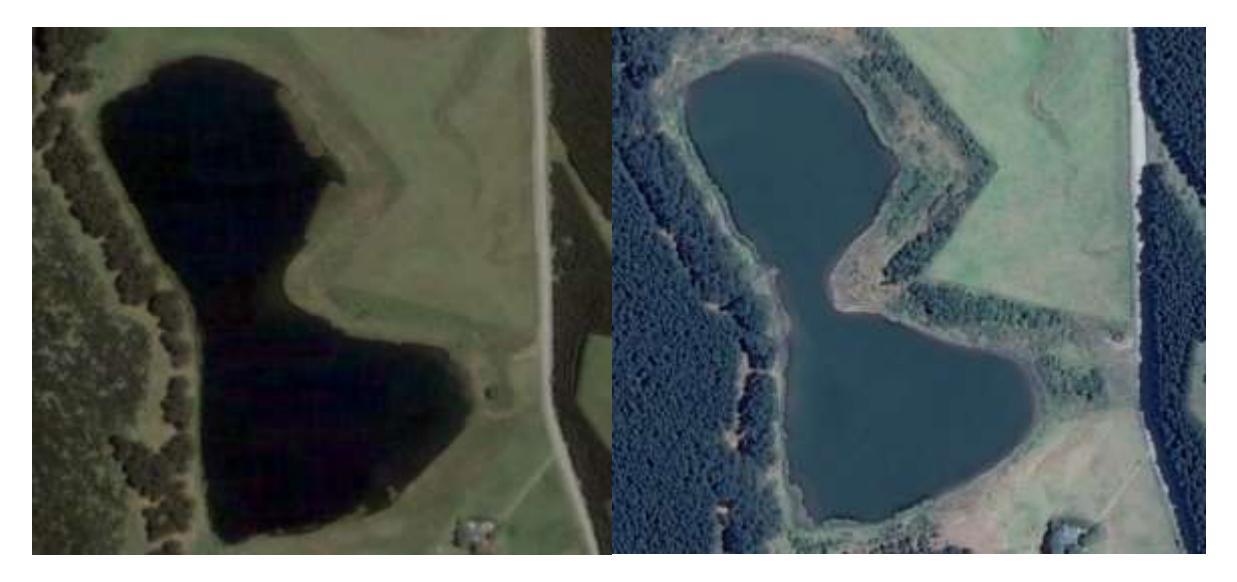
Figure 3-13: Google Earth images of Lake Rototuna in 2004 and 2017. Note the establishment of native vegetation in the catchment and increased emergent vegetation.

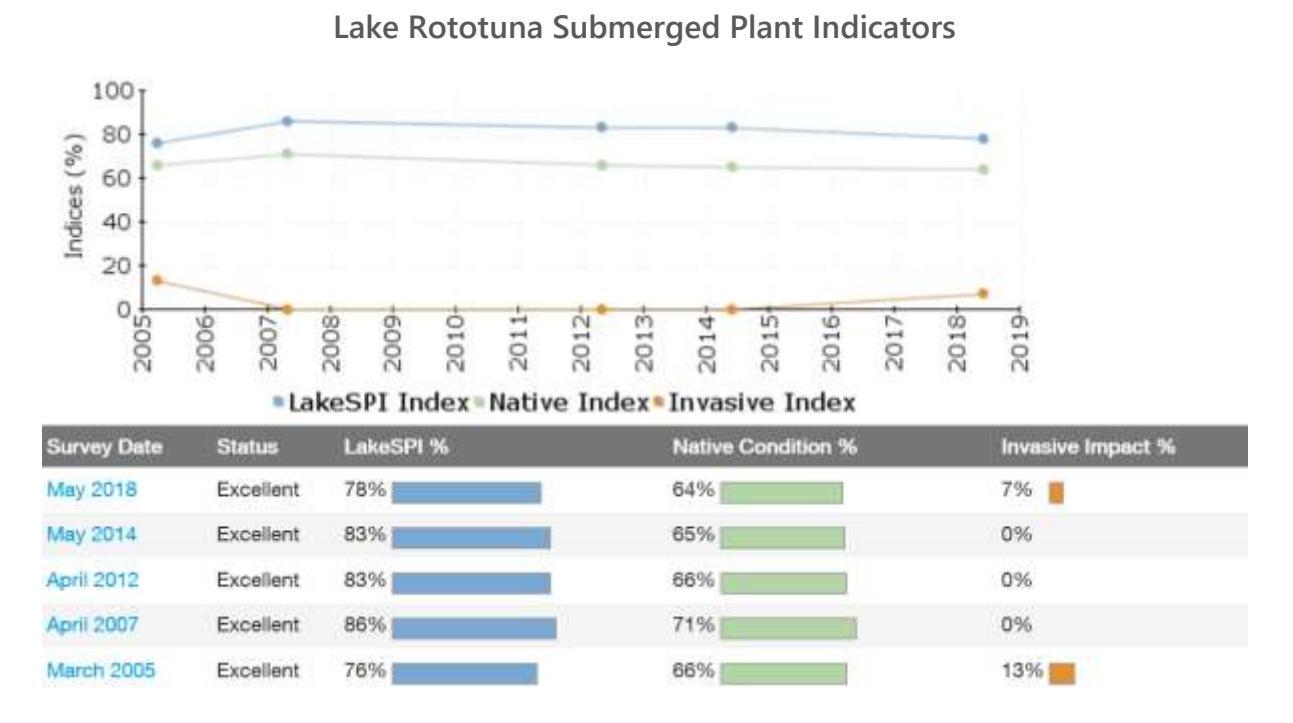
Lake Rototuna is categorised as being in 'High to Moderate' status with a LakeSPI index of 78%. LakeSPI values for this lake have remained stable since surveys began in 2001 with only a small change noted in the invasive impact scores during the 2001 and 2005 surveys on account of *Potamogeton crispus* and *Juncus bulbosus* being present at that time and the minor impact of *U. gibba* in 2018.

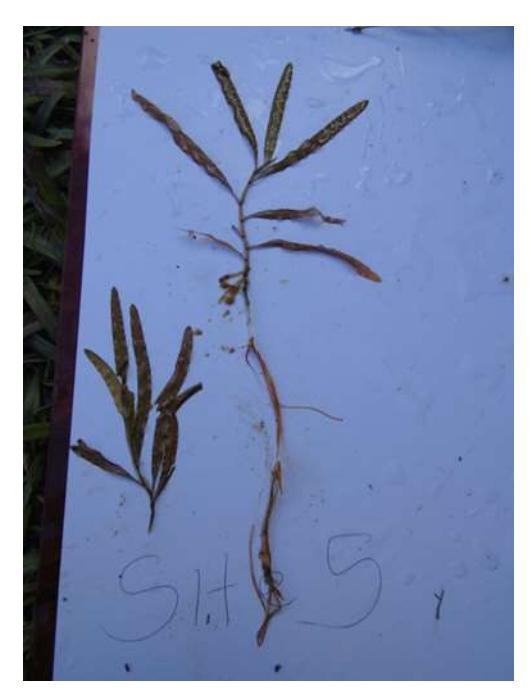
No submerged weeds were detected in Lakes Kai-Iwi, Taharoa or Waikare during the 2018 surveillance programme. The introduced minor submerged weed *Potamogeton crispus* was recorded near the boat ramp at Lake Waikare in 2017 (Figure 3-14) as part of a dune galaxias survey (Alisha Frost, NorthTec pers. comm.). The plant was removed and was not seen in the 2018 survey.

Figure 3-14: Specimens of *Potamogeton crispus* collected from Lake Waikare. Photo: A. Frost, NorthTec 17 August 2017.

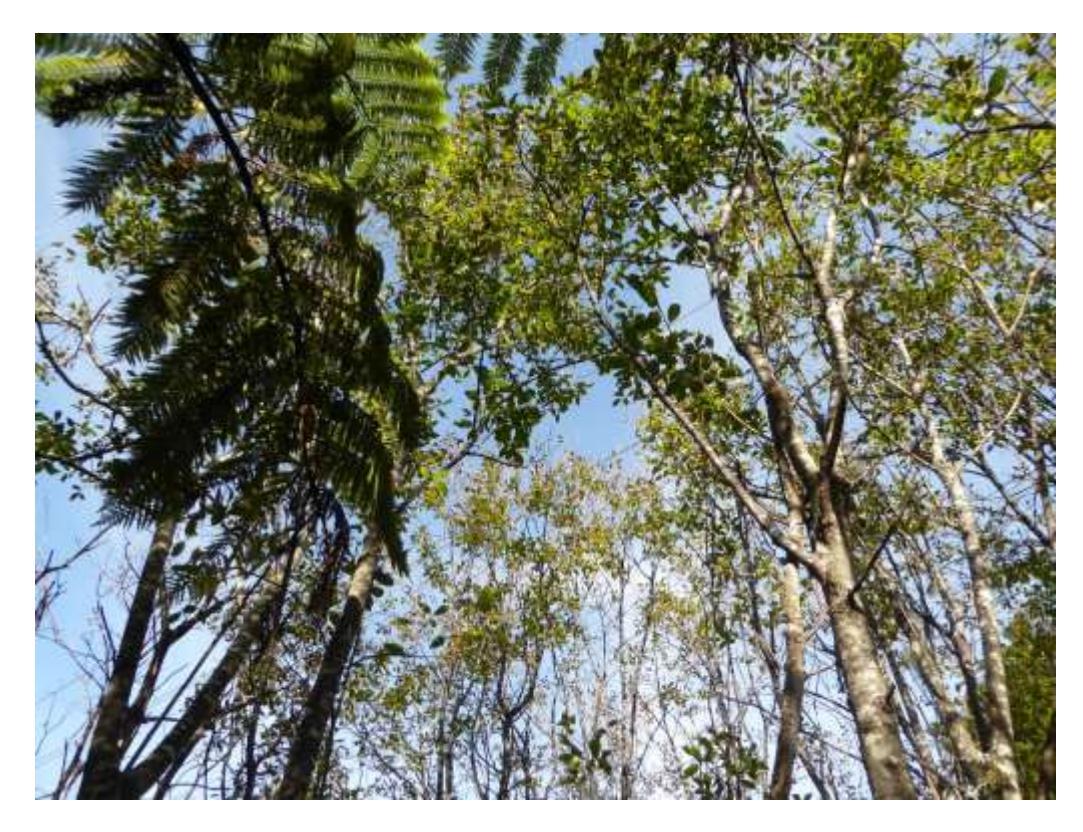
Grey willow (*Salix cinerea*) is regarded as New Zealand's worst wetland weed. It is found in most parts of New Zealand, but was thought to be absent from Northland. On 3 May 2018, investigation of a suspect tree in a wetland on the roadside of SH 12 just north of Kaihu (1660995E, 6041885N) revealed a small clump of this tree, around 2.5 m tall (Figure 3-15). As described in Section 3.1.12, small trees were also found adjacent to Lake Rototuna the following day. All efforts must be made to delimit the infestations of this species. If both sexes are present, then seed set and dispersal of wind-adapted seed could spread this plant to suitable sites (wetlands or even disturbed bare soils, e.g., road cutting cropping areas, gardens) down wind. Fortunately seed have limited viability. Eradication of all trees should be undertaken.

Figure 3-15: Grey willow (Salix cinerea), Kaihu. A small stand of saplings in a roadside wetland.
