CONDITION OF STRUCTURES

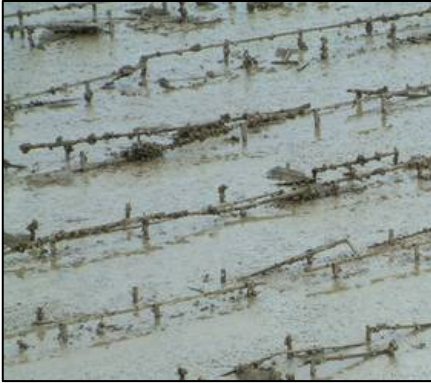
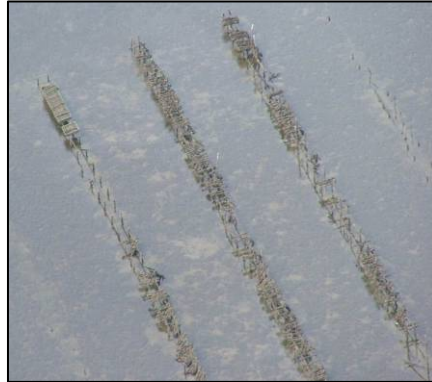
Significant Non-Compliance (= CL6)

More than minor areas of the farm structures appear in disrepair and are becoming or likely to become detached and result in either debris generation and/or give rise to objects that may become potential navigation hazards.

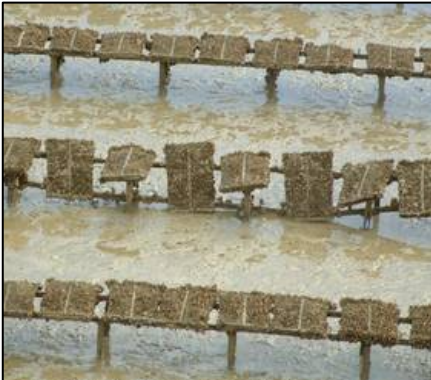
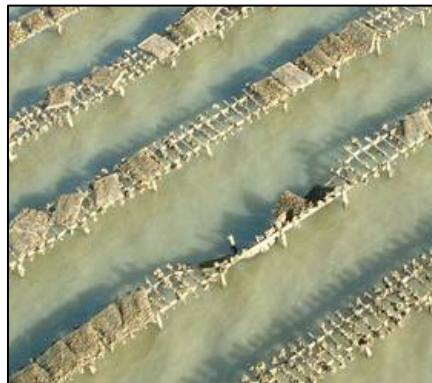
Minor Non-Compliance (= CL3)

Localised minor small areas of farm structures appear in disrepair and are becoming or likely to become detached and result in either debris generation and/or give rise to objects that may become potential navigation hazards and/or excessive cropping likely to cause failure of farm structures.

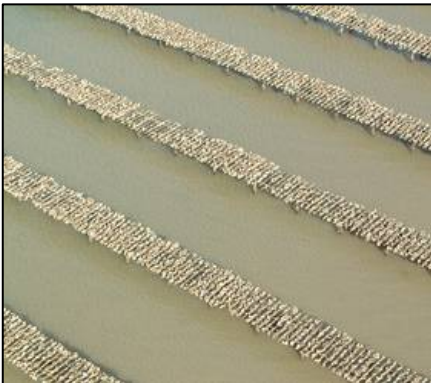
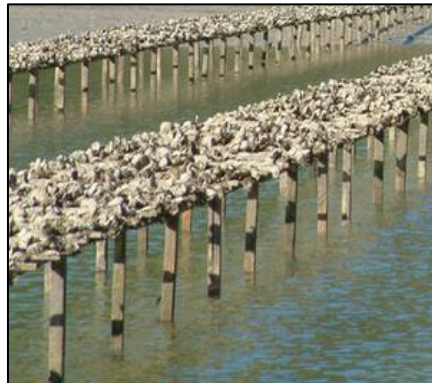
Full Compliance (= CL1)

All structures associated with the marine farm appear in good condition.

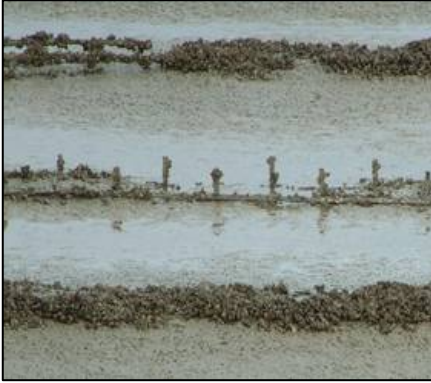
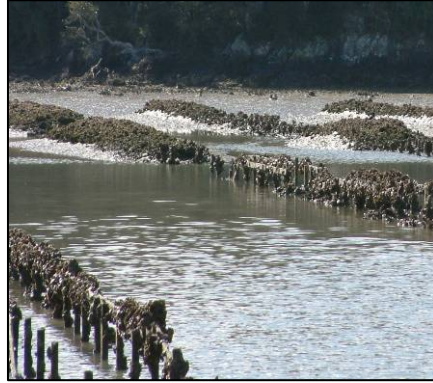
Significant Non-Compliance (CL6)

More than minor sediment and shell accumulation visually apparent under farm structures causing 'windrow' formation of sediment mounds.

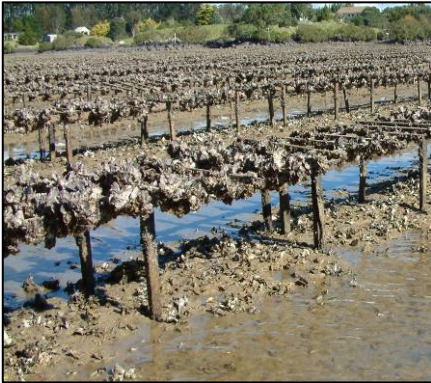
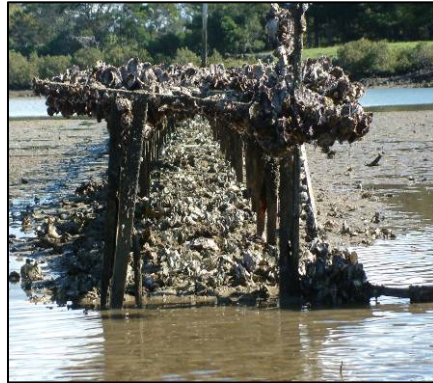
Minor Non-Compliance (= CL3)

Minor accumulation of shell material beneath farm structures readily apparent, although no 'windrow' formation of sediment mounds apparent.

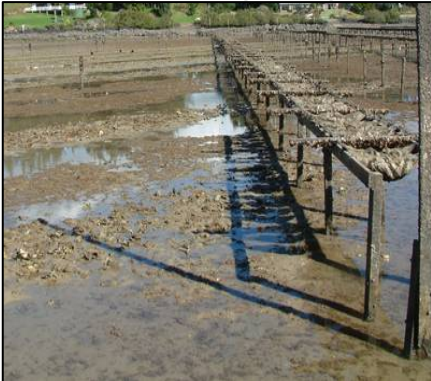
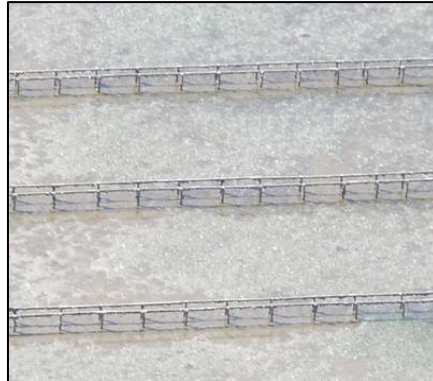
Full Compliance (= CL1)

Less than minor accumulation of shell material beneath farm structures and no 'windrow' formation of sediment mounds apparent.

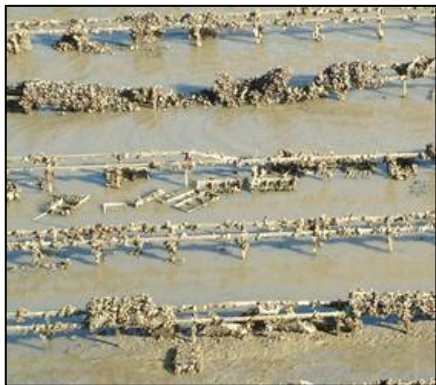
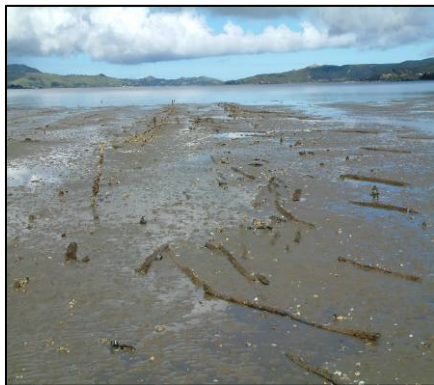
Significant Non-Compliance (CL6)

More than minor amount of debris present and/or potential for debris generation from failed or failure of farm structures or materials associated with farming activities.

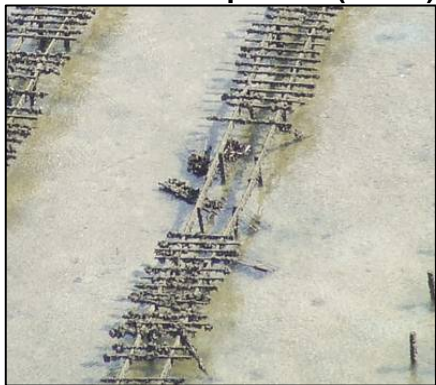
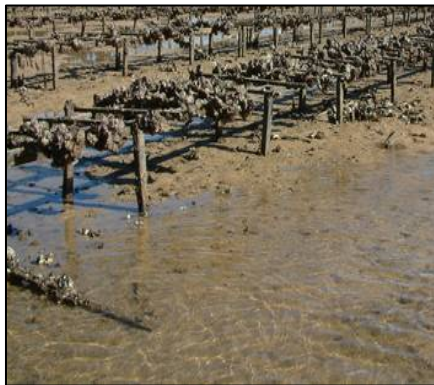
Minor Non-Compliance (= CL3)

Minor amount of debris present from failed farm structures or materials associated with farming activities.

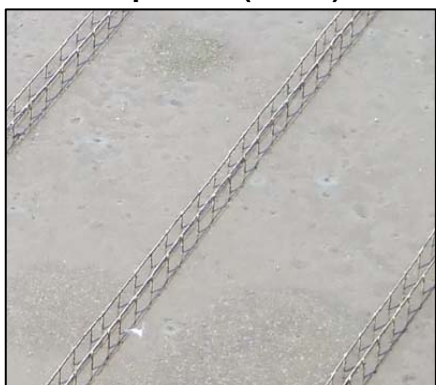
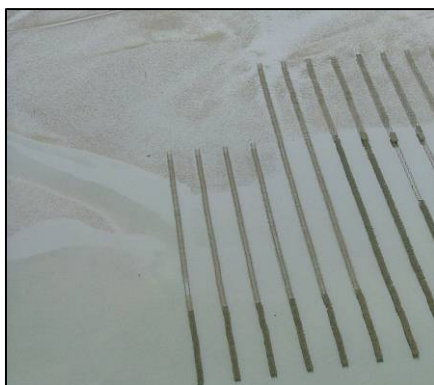
Full Compliance (= CL1)

No debris apparent.

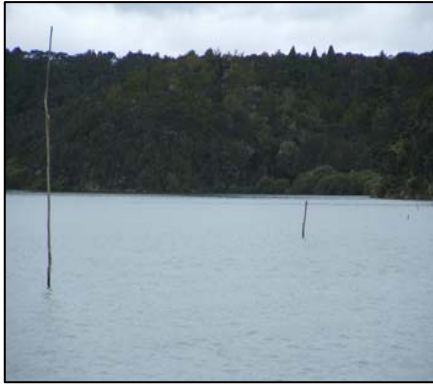
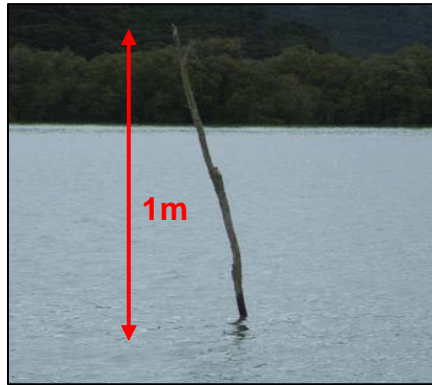
Significant Non-Compliance (CL6)

Markers absent from one or more location and/or showing less than 1m above MHWS, not showing white, or are not placed at correct spacing, which are likely to cause a navigational hazard to other marine users.

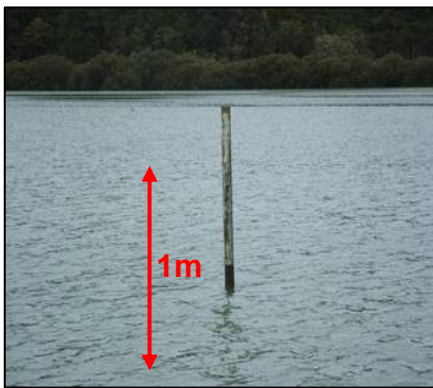
Minor Non Compliance (= CL3)

Markers missing from one or more locations however are not likely to be a navigational hazard to other marine users, or marker suitable however not adequately maintained (i.e. white painting faded).

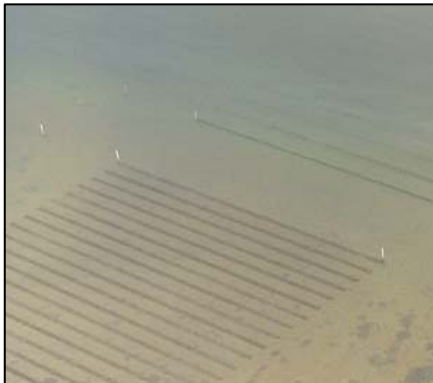
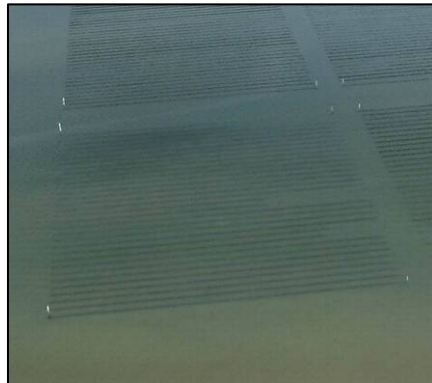
Full Compliance (= CL1)

Markers present at required locations, showing at least 1m above MHWS and well maintained.
