Taita Stream right bank and Kaihu right bank Maitahi to Bottleneck (survey RB4)

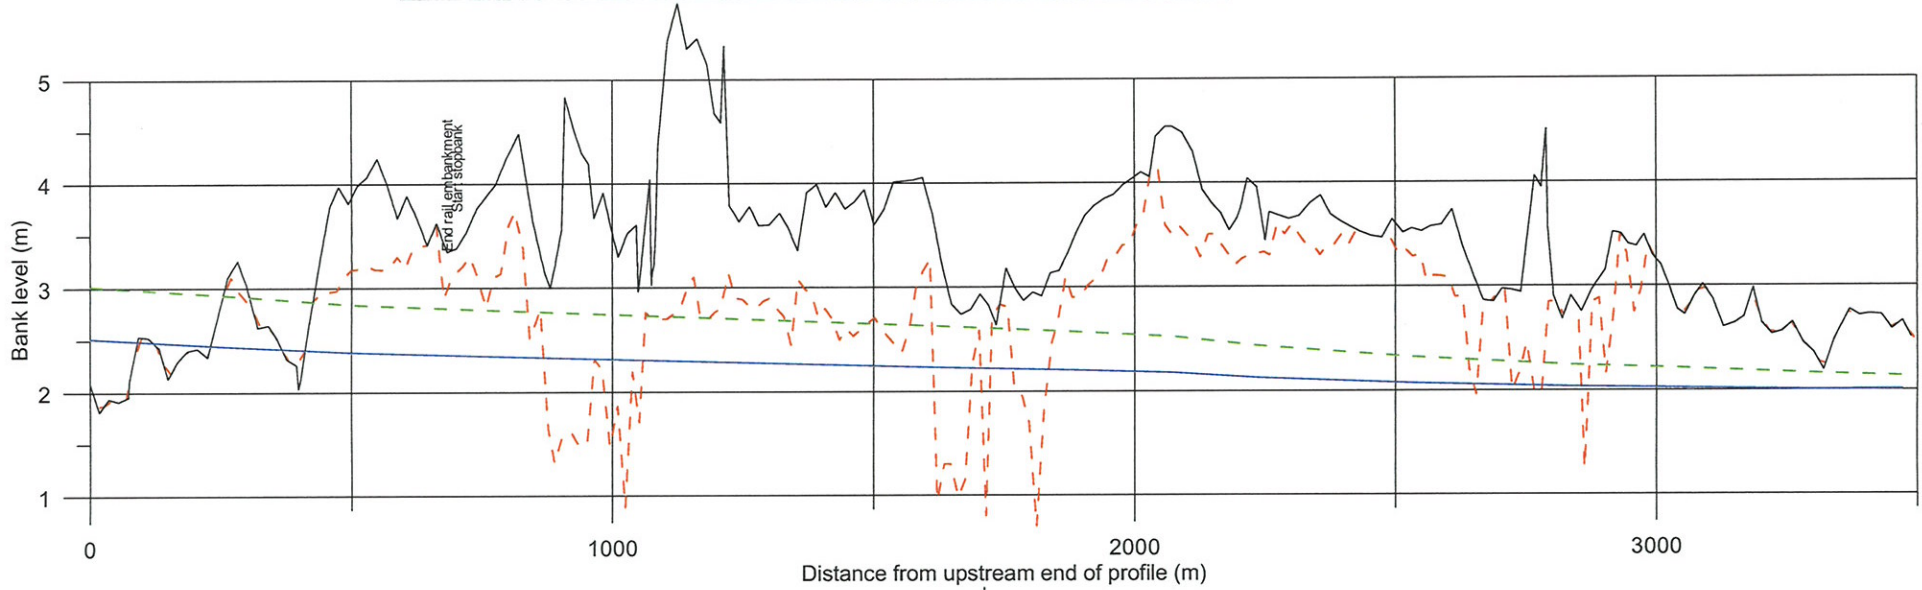
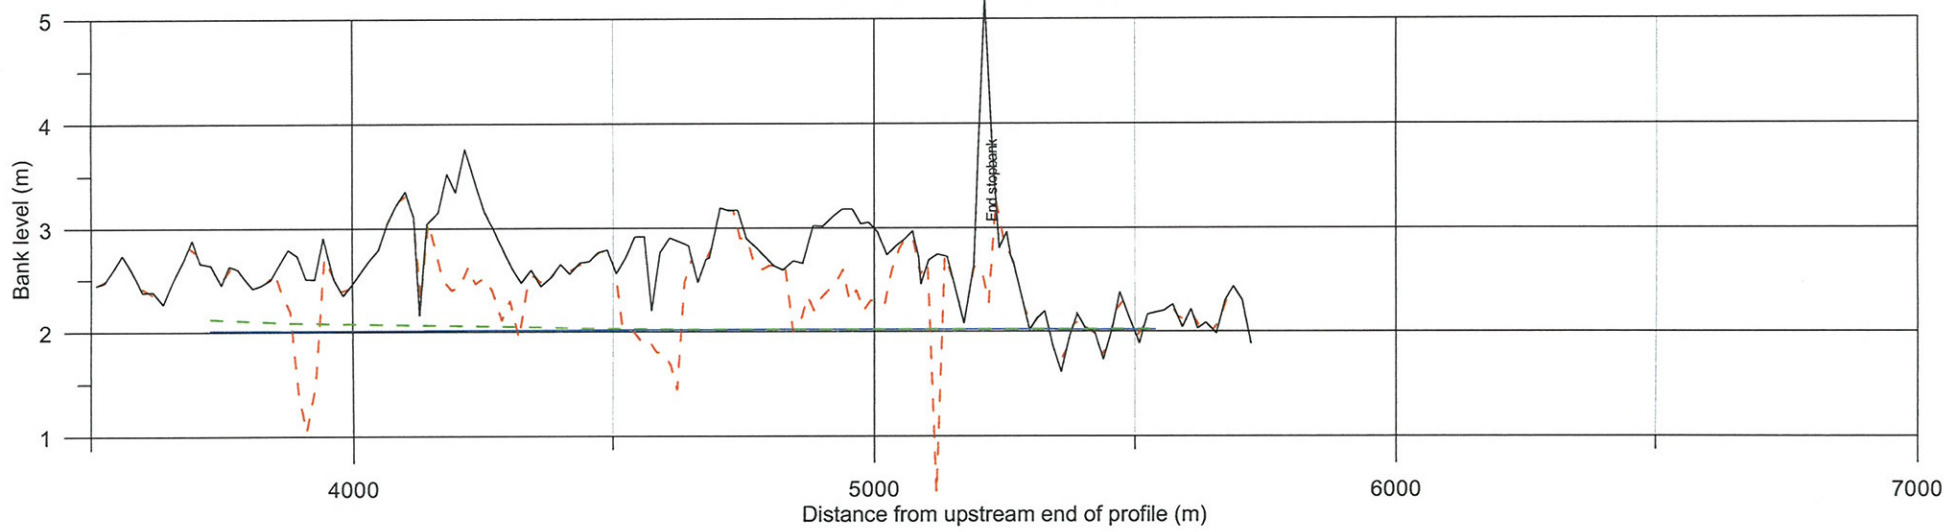
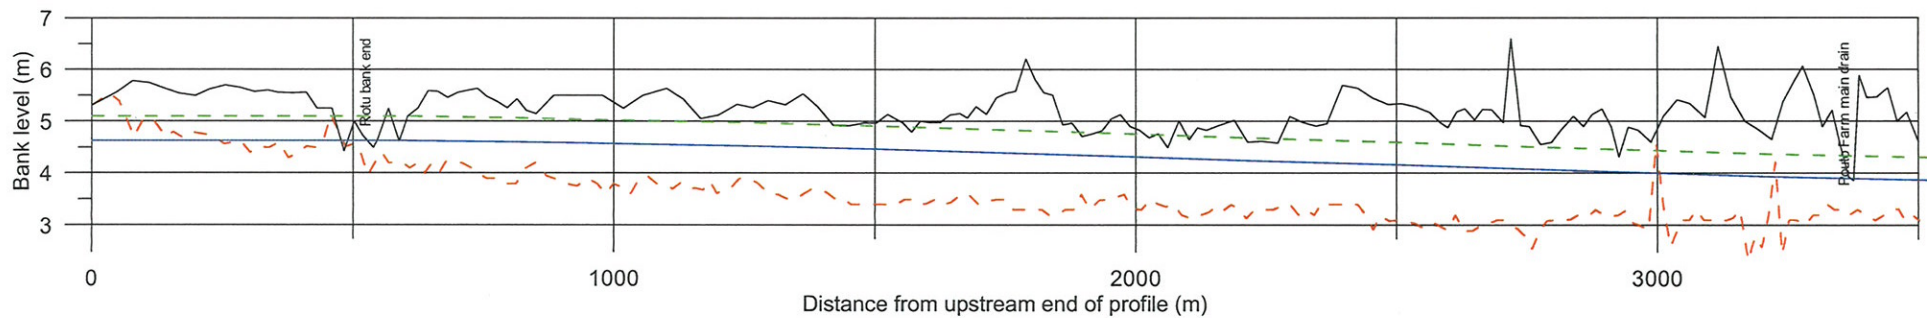
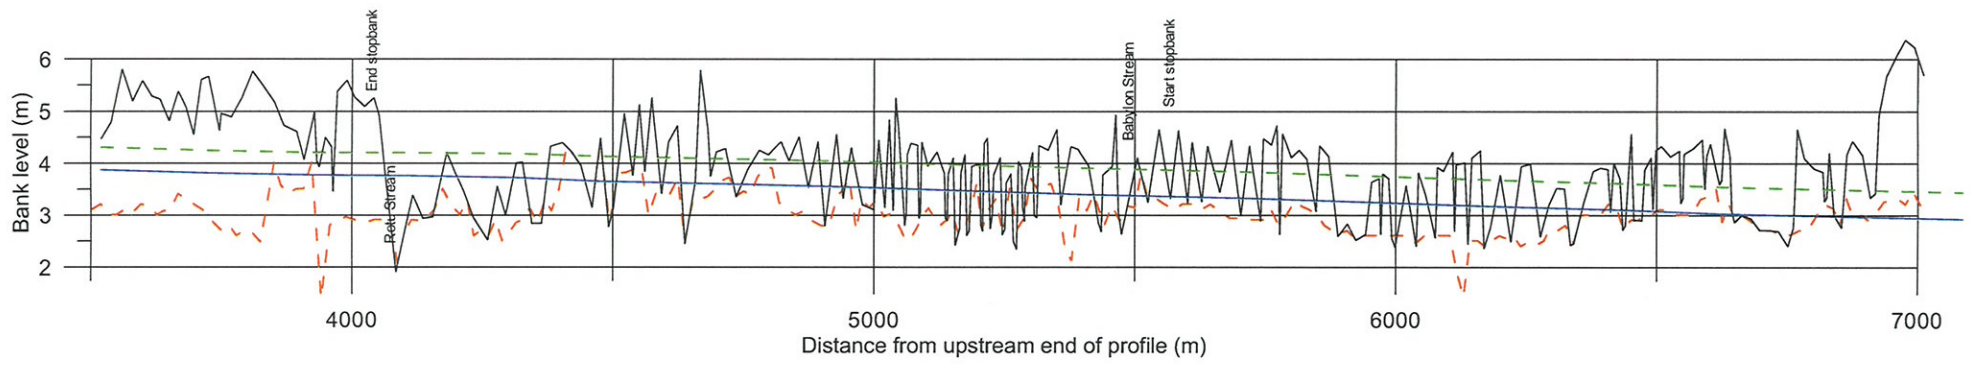
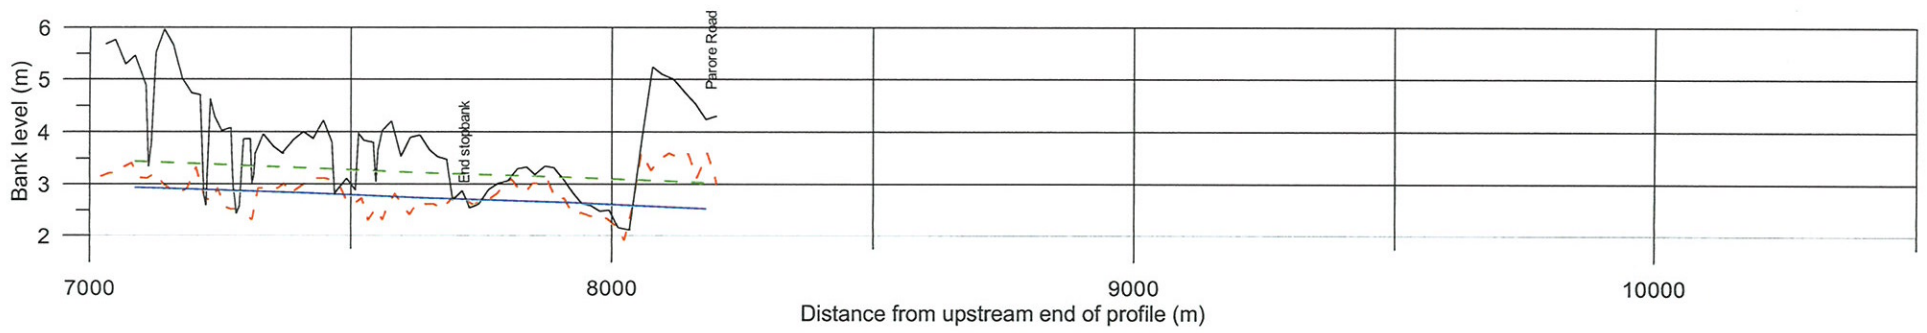
- - - Estimated natural unmodified bank level
- Bank crest surveyed 2010
- Maximum water level in 6 month ARI flood, with no bank overtopping
- - - Maximum water level in 1 year ARI flood, with no bank overtopping
