Te Hiku

Onepū (formerly Lake Bulrush) (Aupouri), NRC Lake No. 49.

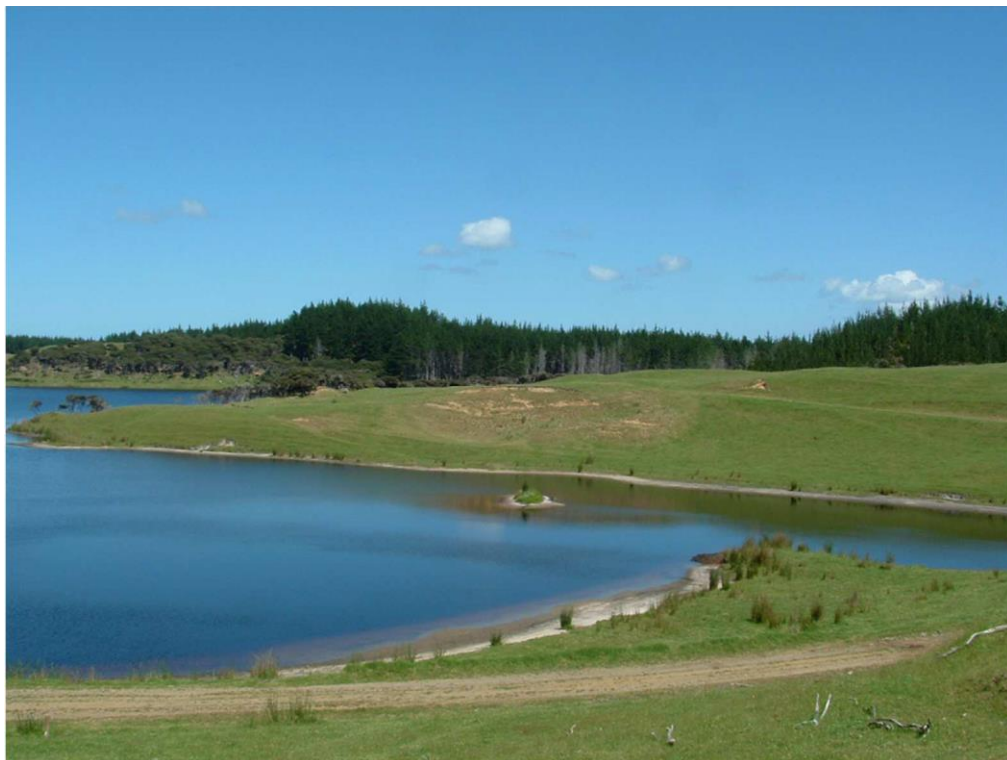
Onepū. Showing a lack of emergent vegetation due to a mostly unfenced shoreline.

Marginal vegetation was sparse (Figure 3-1) with *Juncus pallidus*, *Schoenoplectus tabernaemontani* and *Persicaria decipiens* present in patches. Turf communities were well developed on exposed sandy lake margins, with native species including *Rorippa palustris*, *Cotula coronopifolia*, *Pseudognaphalium luteo-album*, *Myriophyllum propinquum*, *Fimbristylis velata*, *Glossostigma elatinooides*, *Centipeda aotearoana* and *Alternanthera nahui*. Introduced species included *Ludwigia palustris* and *Cyperus sanguinolentus*.

Risk of pest introduction is moderate, with a well-formed track through private land affording relatively easy access and some invasive species could establish. However current indigenous values are minimal. Prolonged cattle access to this lake has removed emergent vegetation and the lake appears to be highly nutrient enriched.

No monitoring recommended. Riparian restoration is recommended after fencing to exclude livestock.
