Poutō Peninsula

Greville's Lagoon (Poutō), NRC Lake No. 295.

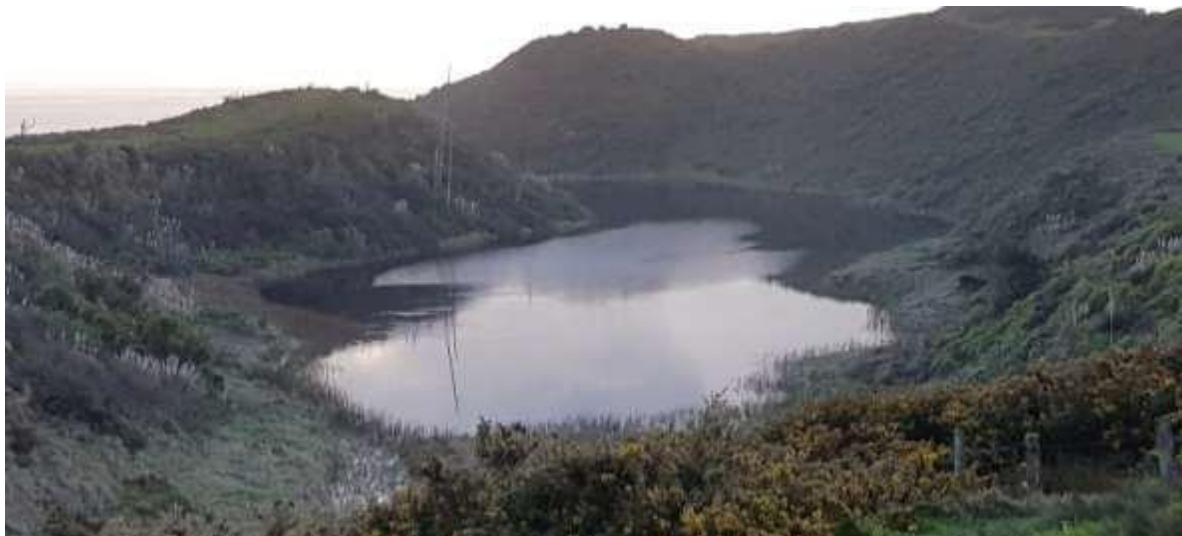
Greville's Lagoon. Photo from the east, showing the steep-sided fully fenced dune lake margins. (Photo: Paul Champion 17 September 2018).

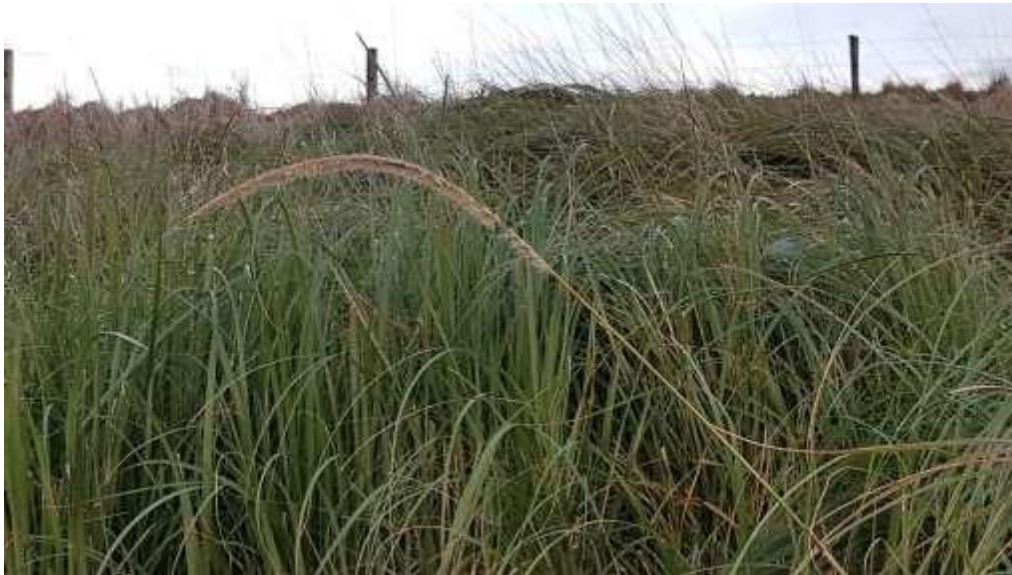
This dune lake (1674139E; 6011706N) is 2.6 ha in area and 9.8 m in depth, fully fenced, with a steep-sided catchment comprised of regenerating coastal scrub and pampas, also heavily impacted by the terrestrial weed African feather grass (*Cenchrus macrourus*). Some plantings are evident on the north-west dune face (e.g., the Chatham Island *Corokia macrocarpa*). Access to the lake is across 3 km of steep private farmland and access to the lake perimeter by vehicle not possible.

Figure 3-8: Flowerhead and plants of African feather grass (*Cenchrus macrourus*) on the margin of Greville's Lagoon. (Photo: Paul Champion 17 September 2018).
