## Te Hiku

Tāniko (formerly Te Paki Dune Lake) NRC Lake No. 15.

Summary	Lake Tāniko
<b>Surveyed:</b>	2005, 2007, 2013, 2015 and 2019.
<b>Overall ranking:</b>	<b>Outstanding:</b> This isolated shallow lake, within native scrub and dunes, has an outstanding indigenous vegetation including an endangered species but with some impact by the invasive <i>Utricularia gibba</i> . This lake supports the last recorded healthy population of the 'Nationally Critical' <i>Utricularia australis</i> in Northland.
<b>Threats:</b>	Low risk of introduction of invasive pests. There are few threats of nutrient enrichment if the catchment is not developed.
<b>Management recommendations:</b>	Lake biodiversity value monitoring every 5 years.

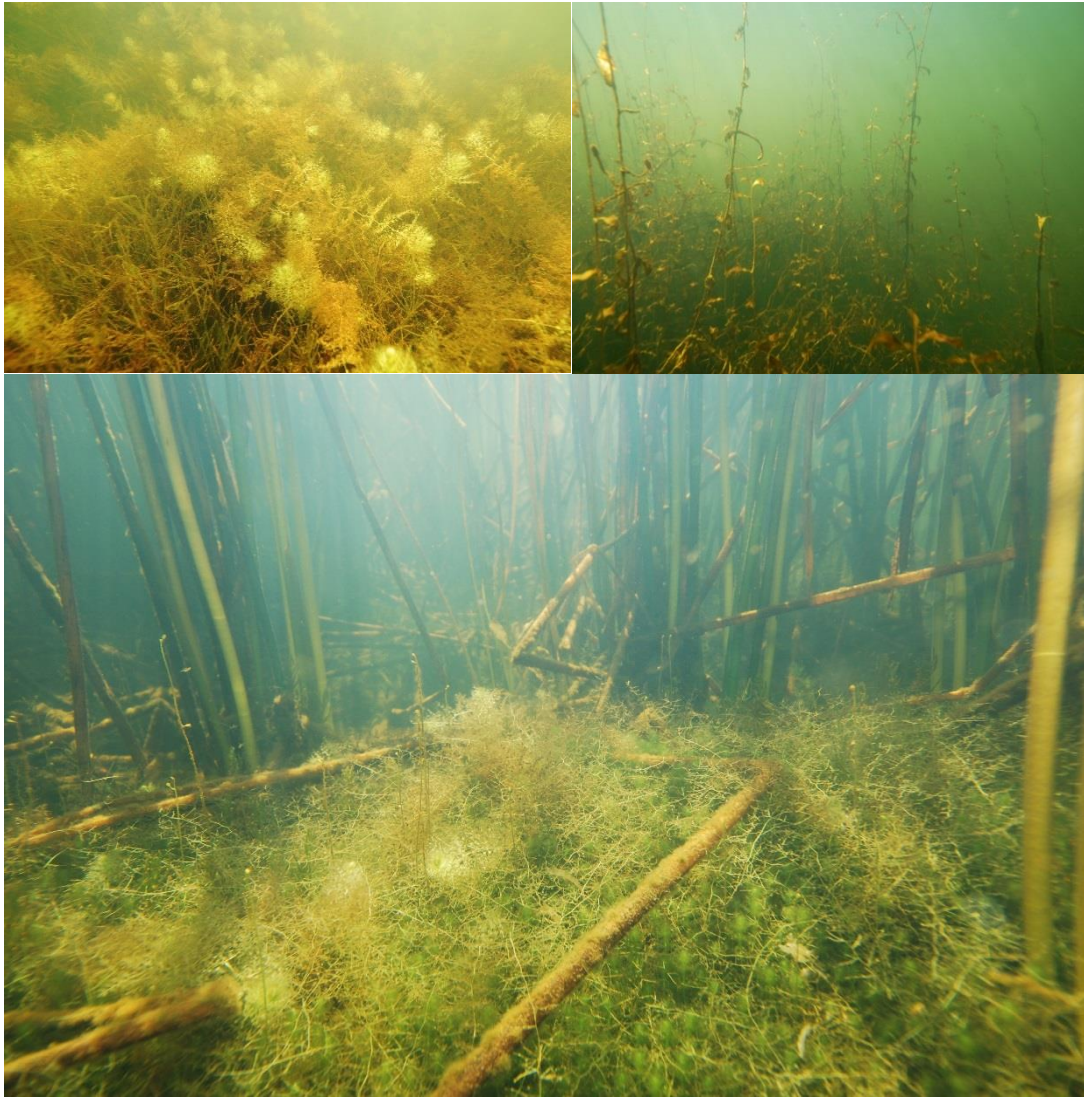
Charophyte meadows of *Chara fibrosa*, *C. australis* (~ 0.5 m tall) and *Nitella* sp. aff. *cristata* were present in open areas of water and amongst emergents with some areas of tall *Potamogeton cheesemanii* (2 m tall) and *Myriophyllum propinquum* (1 m tall). The nationally endangered *Utricularia australis* was abundant (about 50% cover) throughout the lake (Plate 2). The invasive exotic *Utricularia gibba* was the only invasive present but had native charophytes growing beneath it.

**Tāniko flora.** with the critically endangered *Utricularia australis* on a native charophyte meadow of *Nitella* sp. aff. *cristata* (top left); tall-growing *Potamogeton cheesemanii* reaching the surface (top right); and the emergent rush *Eleocharis sphacelata* in a meadow of *Chara fibrosa* covered with the invasive *Utricularia gibba* (bottom).

Lake biodiversity value monitoring every 5 years.
