Te Hiku

Lake Austria (Aupouri), NRC Lake No. 22

Summary	Lake Austria
Surveyed:	2004, 2015 and 2023
Overall ranking:	High to Moderate: This humic-stained lake supported a diverse submerged vegetation in shallow water with a restricted depth range (1.2 m maximum depth for the 3 m deep lake), but it provides valuable habitat for endangered water birds.
Threats:	Low risk of introduction of further invasive pests. Likely disturbance of the catchment and marginal emergent vegetation by wild horses and pigs. Moderate-low risk of nutrient enrichment from pine plantation activities (logging, fertilisers). Continued decline in water level may further deteriorate lake values.
Management recommendations:	No further monitoring.

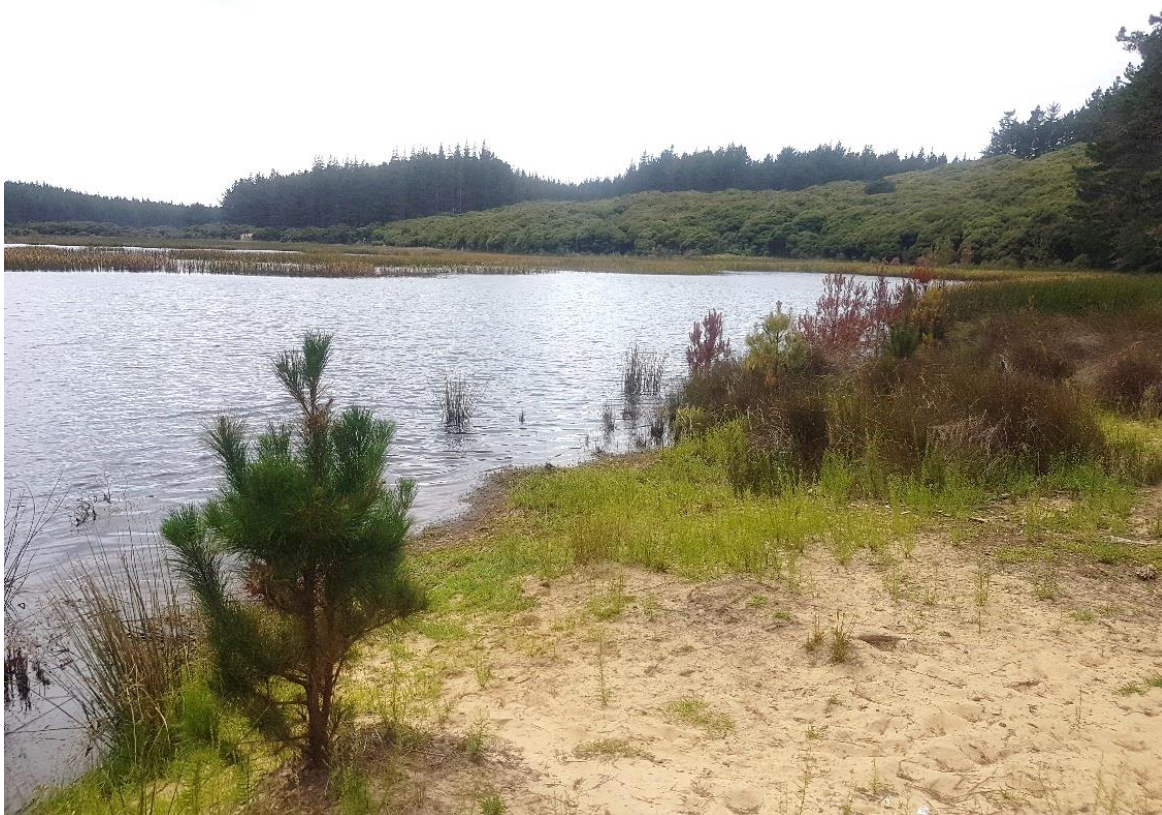
Lake Austria from the southwestern margin showing open shoreline with sparse emergent vegetation, with well-developed emergent beds of kuta away from the shore and the scrub covered eastern margin (2023, Paul Champion).
