## Te Hiku

Te Arai Lake 6 (Aupouri), NRC Lake No. 45.

Summary	Lake Te Arai 6
<b>Surveyed:</b>	2019.
<b>Overall ranking:</b>	<b>Moderate:</b> water heavily stained with the invasive <i>Utricularia gibba</i> the only submerged species present amongst emergent kuta.
<b>Threats:</b>	Well buffered by a scrub catchment, limited risk of nutrient enrichment. Water levels appear to have declined. Low risk of introduction and establishment of invasive pests.
<b>Management recommendations:</b>	No monitoring recommended, apart from monitoring of the Nationally Endangered <i>Mazus novae-zeelandiae</i> ssp. <i>impolitus</i> .

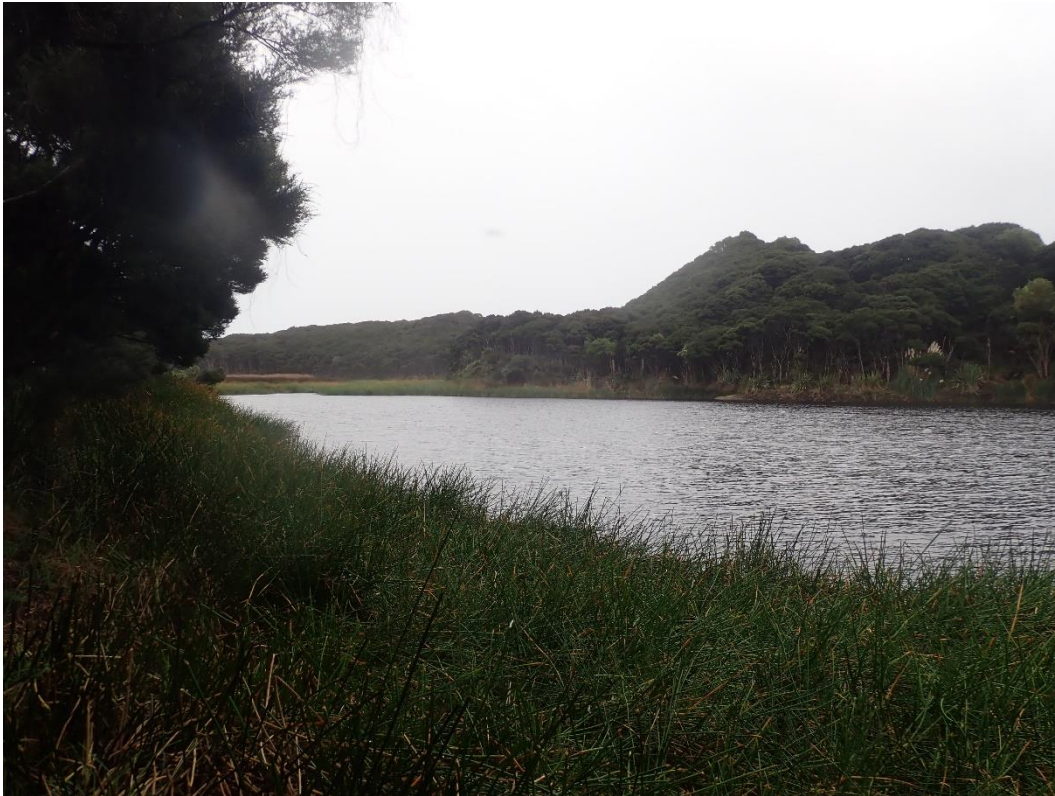
**Te Arai Lake 6.** A dune lake with scrub margins, note the extensive fringe of emergent kuta (Daniel Clements).

This dune lake (2510021E 6722874N) is recorded as a 0.95 ha area in the NRC database, but the lake occupies c. 1.2 ha, with contiguous kuta dominated marginal fringe. The lake had a maximum depth of 2.6 m. The catchment is mostly scrub. There are no inlets or outlets. Access was gained through forestry roads and scrub covered tracks.

The lake was predominately vegetated with emergent kuta (*Eleocharis sphacelata*), with raupo (*Typha orientalis*) and *Machaerina articulata* (0 to 1.5 m deep). Additional tall emergent species included *E. acuta* and the sprawling *Persicaria decipiens*.

Lake water was heavily stained water with only 0.2 m underwater visibility. No submerged vegetation was found outside of the emergent zone, with sparse *Utricularia gibba* the only submerged species found amongst kuta.

No monitoring recommended, apart from monitoring of the Nationally Endangered *Mazus novae-zeelandiae* ssp. *impolitus*.
