Case Study 1 – Estuarine Monitoring Programme

Introduction

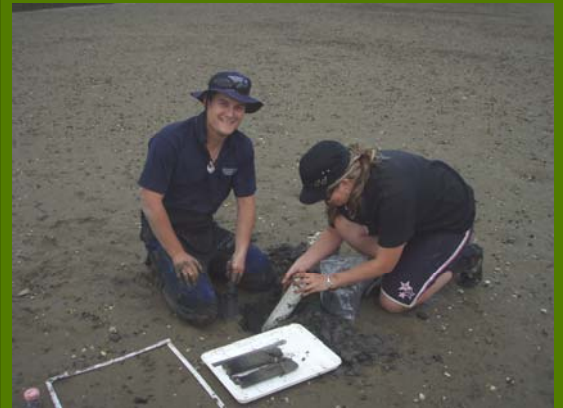
Regional Council monitoring staff take samples of one of the three estuaries monitored in Northland.

The programme involves identifying catchment land-use and possible inputs into each estuarine system; sampling the physical (sediment grain size) and chemical properties (nutrient and metal contaminants) of the sediment, and recording the animals (biological communities) and habitats within the intertidal habitat of each estuary in the programme.

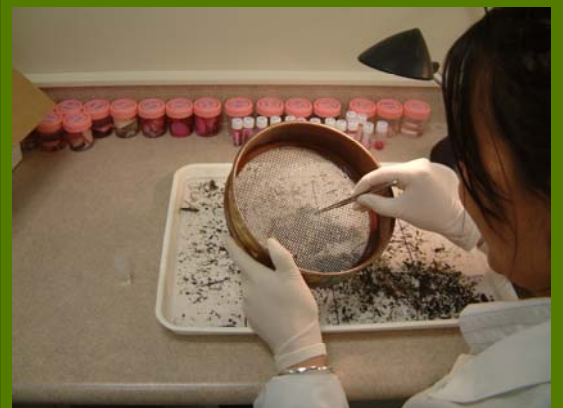
A Regional Council laboratory technician sorts sediment from an estuarine sample.

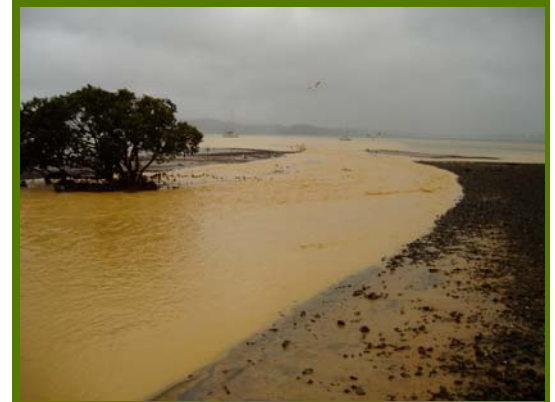
Sediment runoff into the Whāngārei harbour.

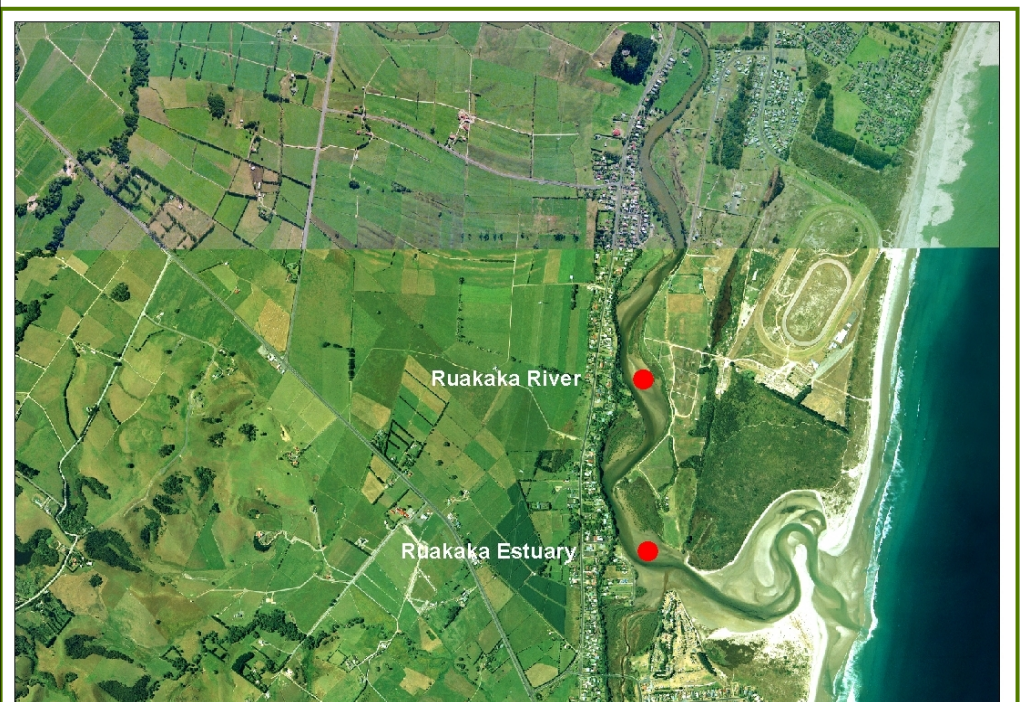
The image (above) shows the extent of the Ruakaka estuary. The red dots depict the two sites where samples are taken

In the Ruakaka Estuary, concentrations of zinc and lead were relatively high for an estuary with a largely rural catchment. Runoff from roading, urban areas, agricultural and horticultural land, and stormwater discharges are all likely sources of metal contamination in these catchments.
